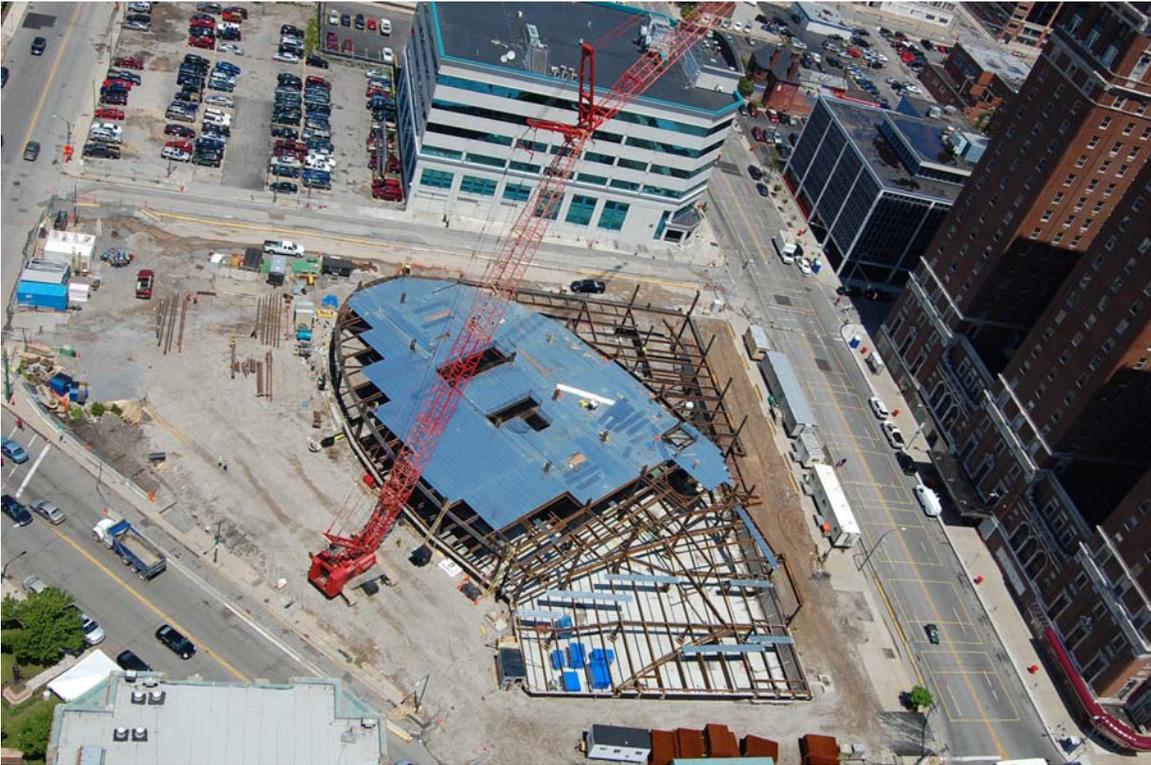
6/20/2008 12:51:56 PM Aerial View of second floor steel erection with metal deck placement ongoing. Including erection sequence 17 progress.

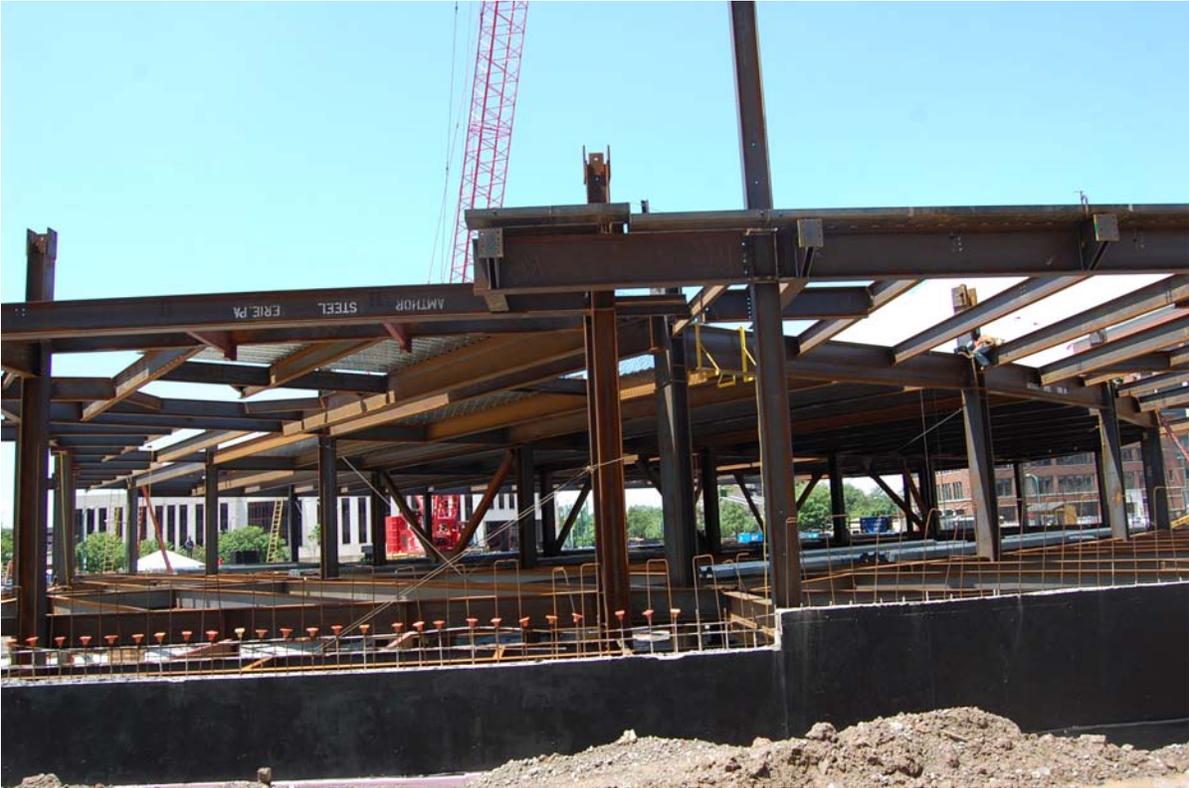
6/20/2008 12:29:55 PM Steel erection sequence 16 looking from the east side of the building along Delaware Avenue.

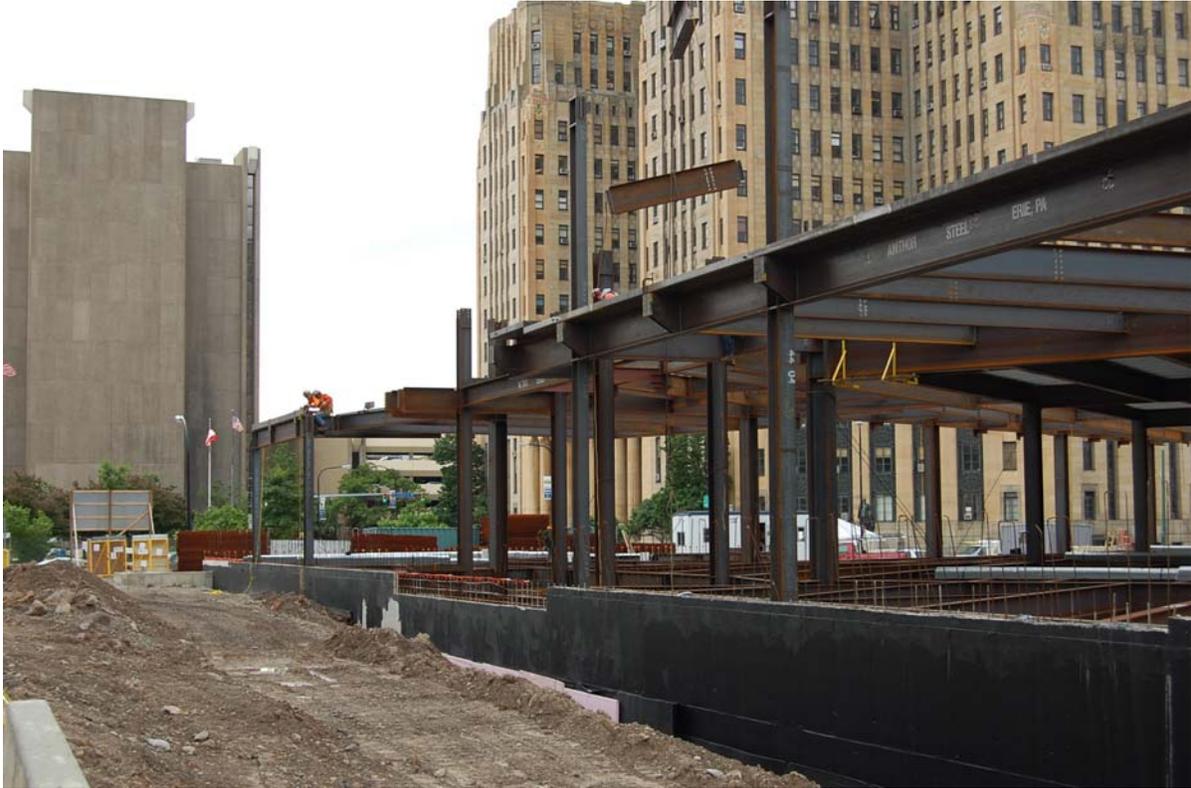
6/19/2008 1:17:23 PM Steel Erection sequence 5 and 6 at the southeast corner along Delaware Avenue.

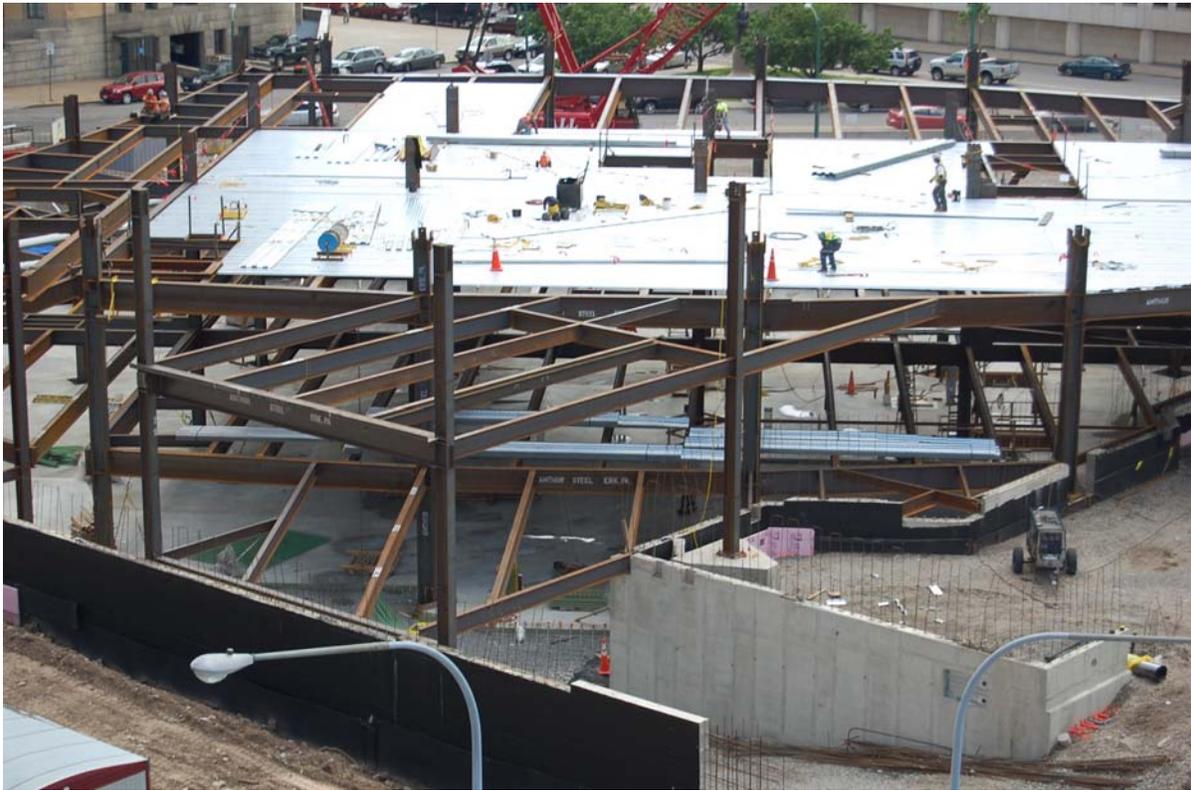
6/18/2008 2:18:05 PM Structural Steel Erection Sequence 17 along the basement entrance ramp at the northeast corner.

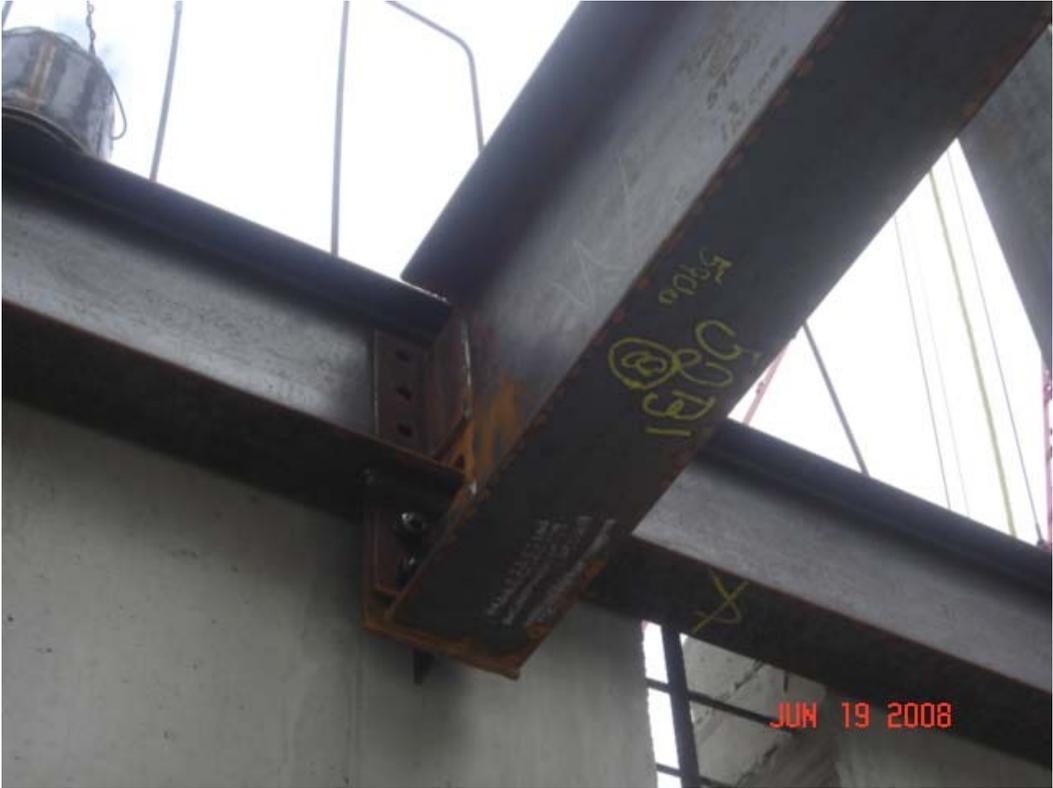
6/19/2008 7:47:56 AM Inaccessible bolted connection along the perimeter exterior foundation wall at 3.1/H line.

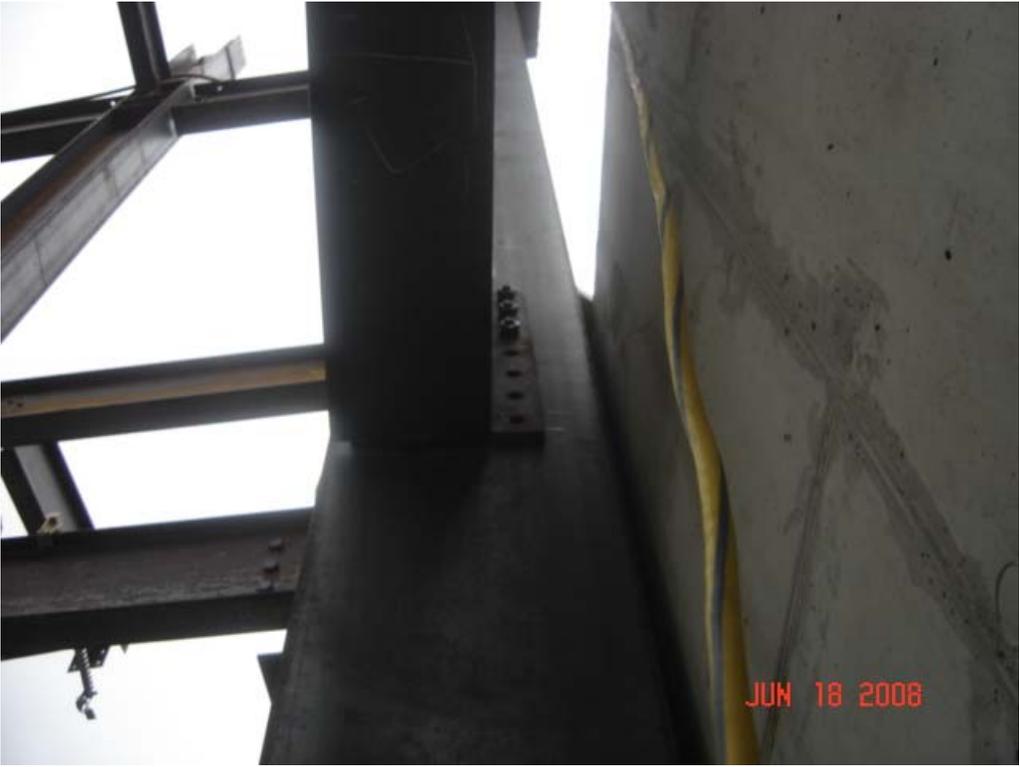
6/18/2008 7:22:08 AM Inaccessible bolted connection due to the exterior foundation wall location and column stiffner locations at 3.1/G line.
