Potomac Annex:  
Buildings 1 & 3-7

Historic Structures Report, Corrected Final Submission  
 General Services Administration Project Control Number: 44007  
 September 9, 1997  
 VOLUME 2 OF 2

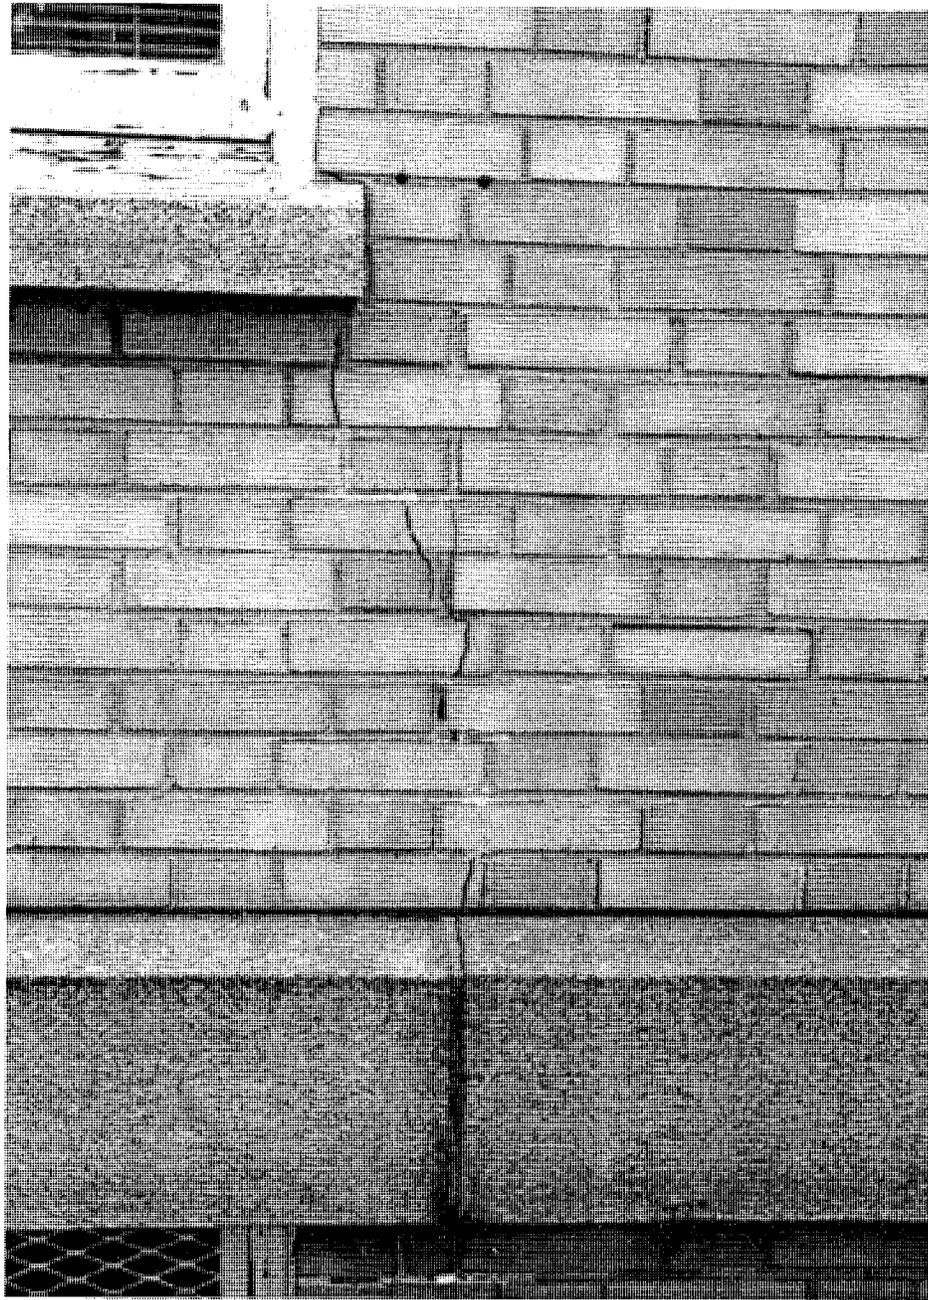
Figure 1-1

Location: North Elevation of Building 1 at West End

Suggested Remedy: Remove brickwork and assess for rusting iron anchors. If anchors are rusted they should be replaced with stainless steel anchors; brick should then be replaced to match existing texture, color and size and reset in mortar to match surrounding pointing in color, texture, and profile.

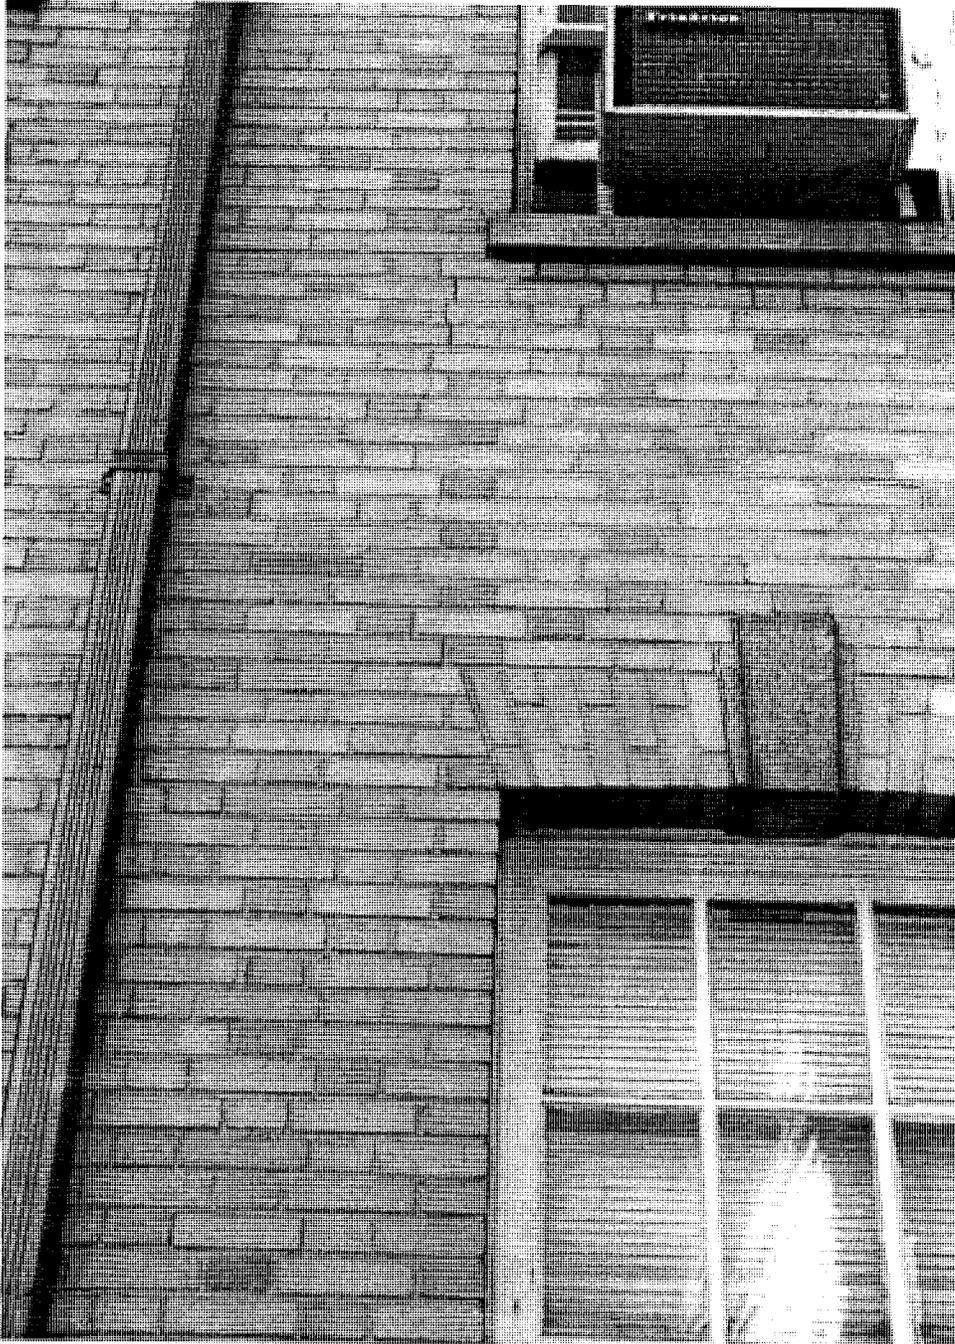
Figure 1-2

Location: East Elevation of Building 1 at North End

Suggested Remedy: Remove brickwork and assess for rusting iron anchors. If anchors are rusted they should be replaced with stainless steel anchors; brick should then be replaced to match existing texture, color and size and reset in mortar to match surrounding pointing in color, texture, and profile.

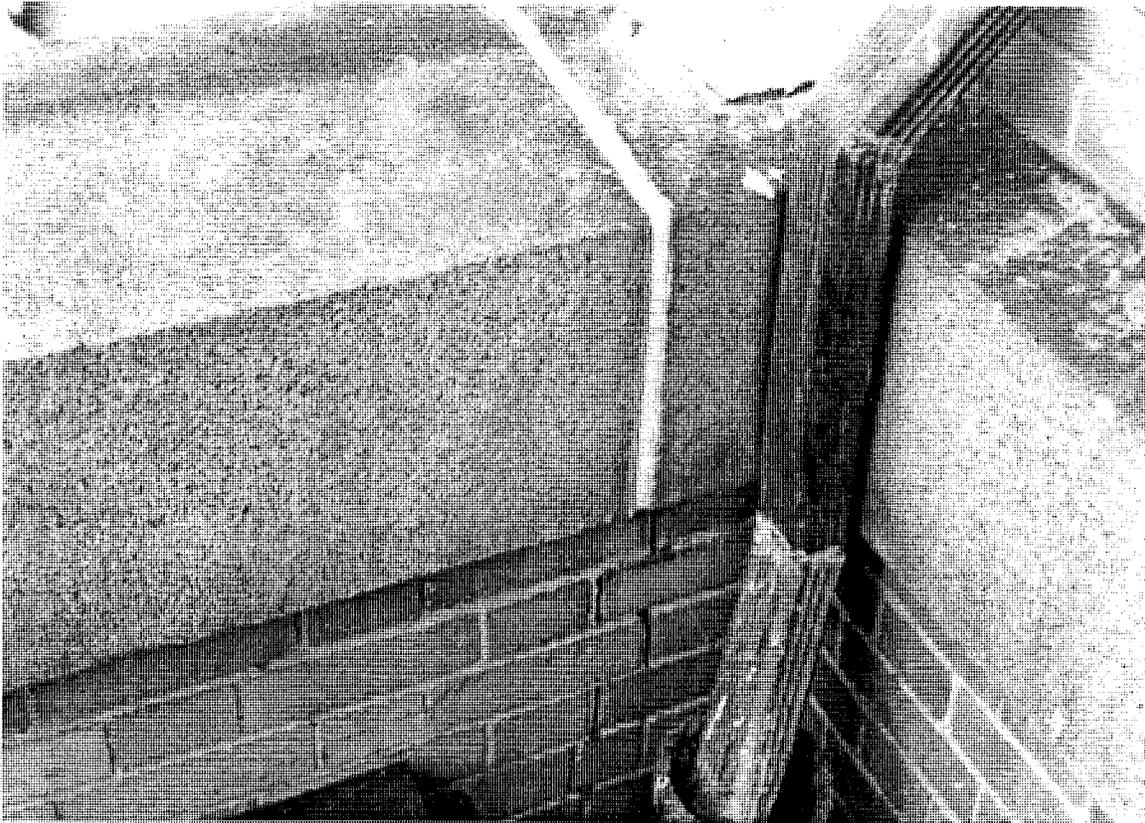
Figure 1-3

Location: East Elevation of Building 1 in South Areaway

Suggested Remedy: Existing mortar should be raked from the joints to a minimum depth of 3/4 inches. Repoint joints with fresh mortar that matches existing pointing mortar in color, texture and profile.

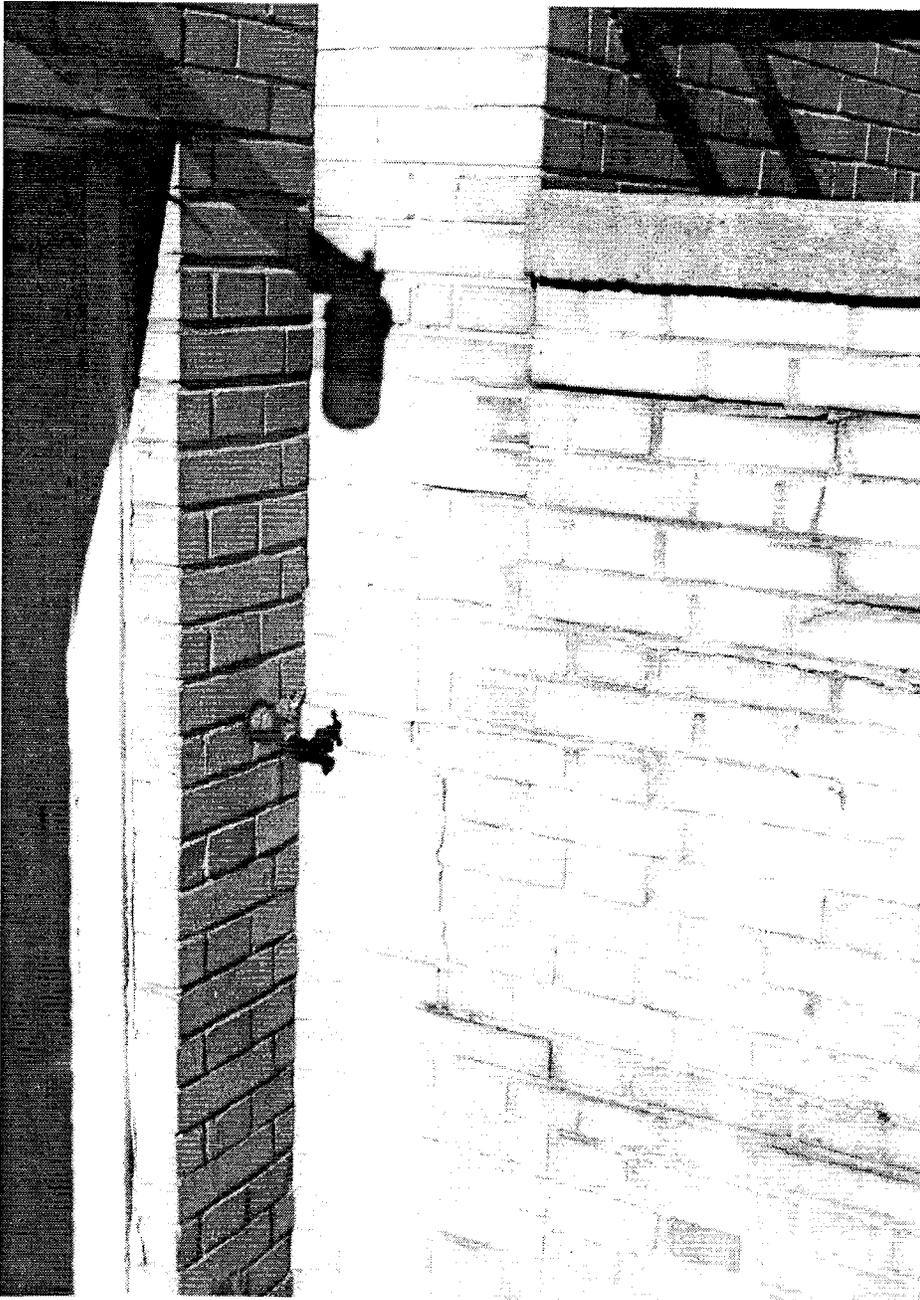
Figure 1-4

Location: East Elevation of Building 1 in Central Areaway

Suggested Remedy: Existing mortar should be raked from the joints to a minimum depth of 3/4 inches. Repoint joints with fresh mortar that matches existing pointing mortar in color, texture and profile. Crack brick should be removed and then replaced to match existing texture, color and size and reset in mortar to match surrounding pointing in color, texture, and profile.

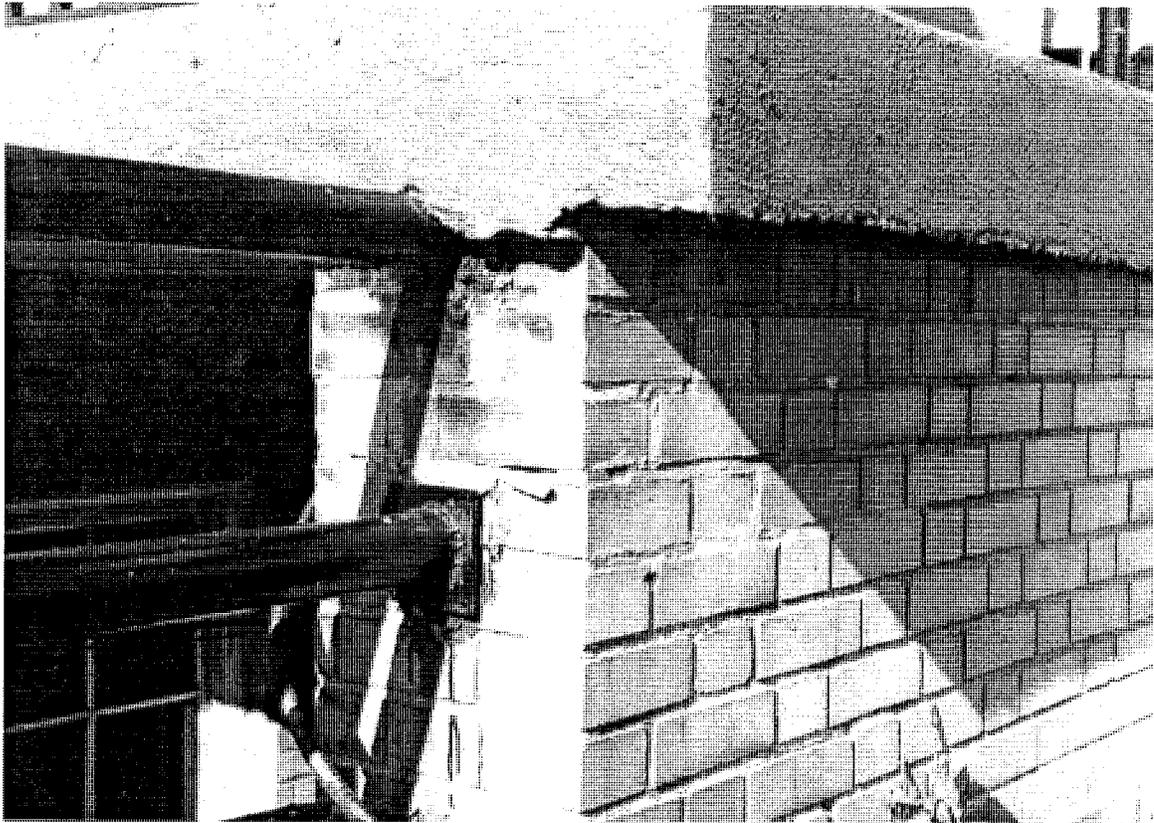
Figure 1-5

Location: East Elevation of Building 1 in South Areaway

Suggested Remedy: Existing mortar should be raked from the joints to a minimum depth of 3/4 inches. Repoint joints with fresh mortar that matches existing pointing mortar in color, texture and profile.

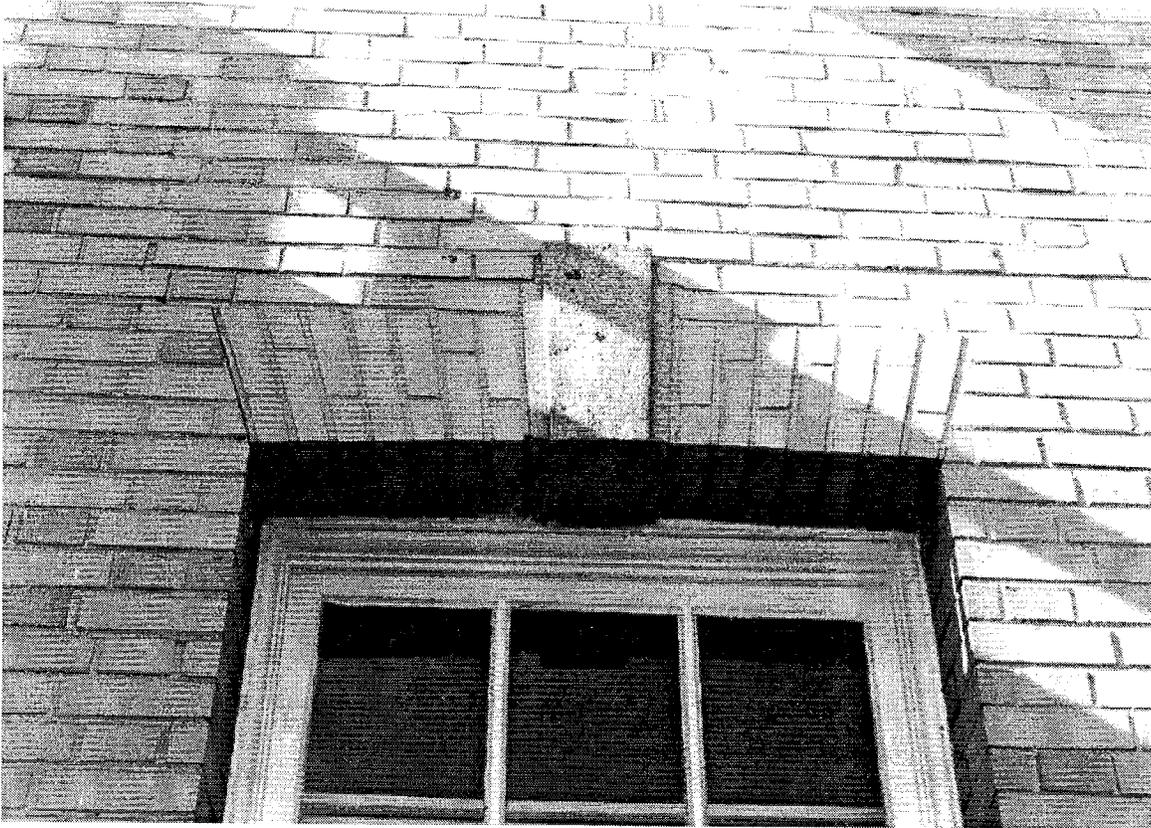
Figure 1-6

Location: East Elevation of Building 1 at North End

Suggested Remedy: Existing mortar should be raked from the joints to a minimum depth of 3/4 inches. Repoint joints with fresh mortar that matches existing pointing mortar in color, texture and profile.

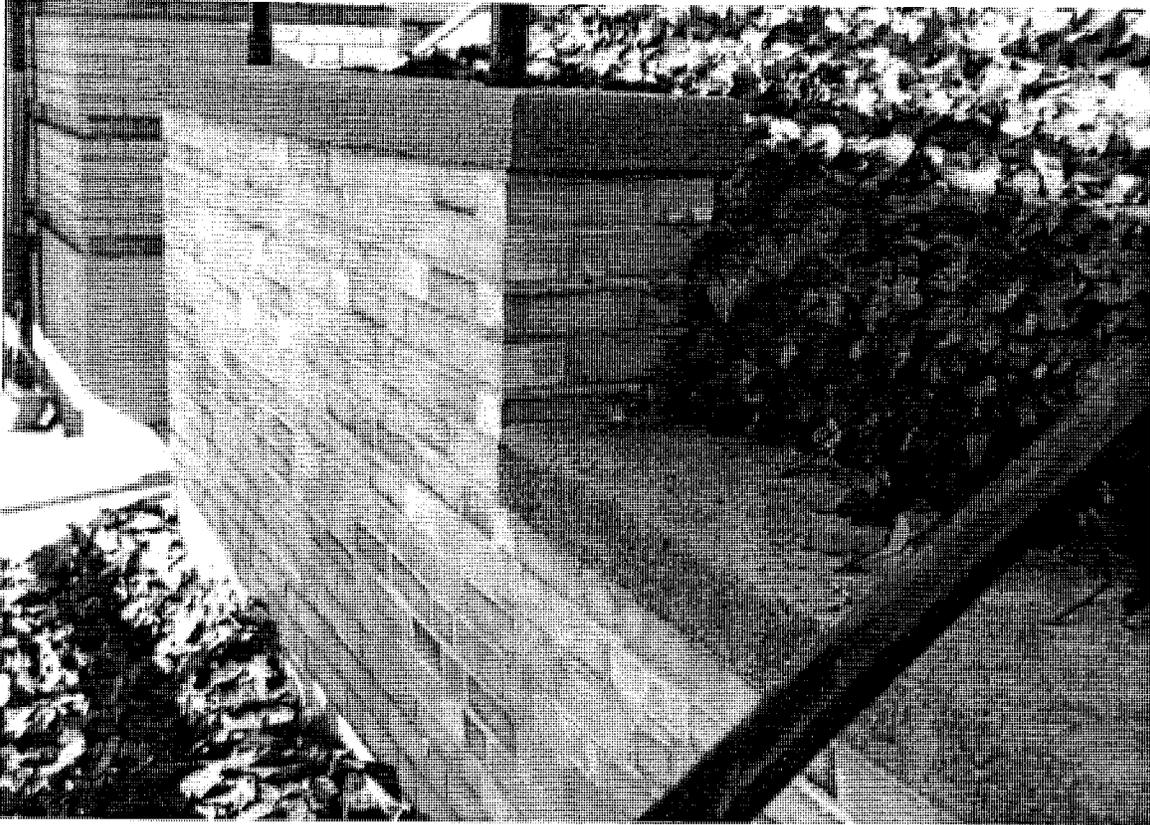
Figure 1-7

Location: South Elevation of Building 1 near South Areaway

Suggested Remedy: Earth should be excavated from next to the wall, the waterproofing skin renewed. The opposite side of the wall is cut and repointed.

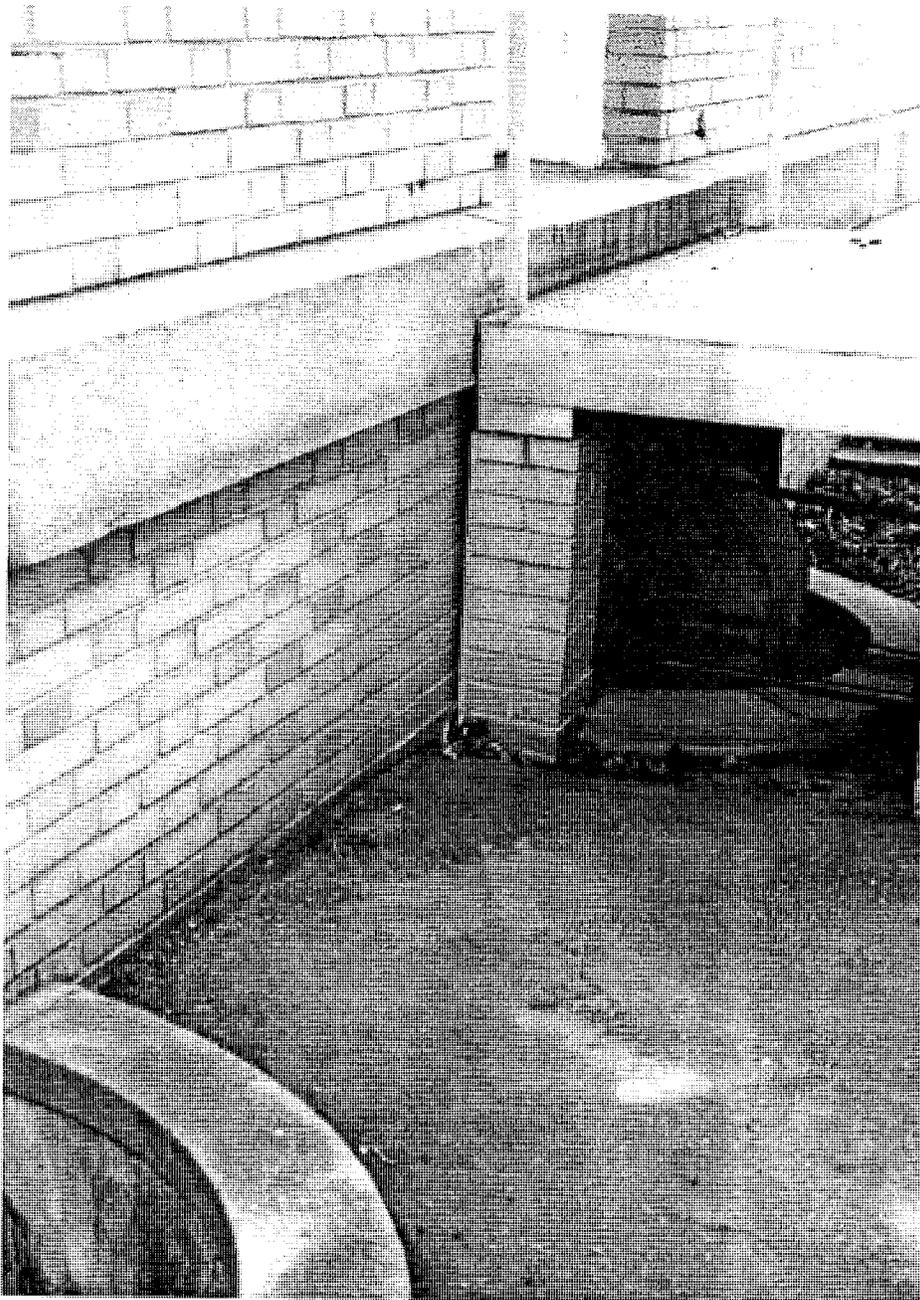
Figure 1-8

Location: North Elevation of Building 1 at Central Steps

Suggested Remedy: Rebuild piers anchoring rear ones to the wall

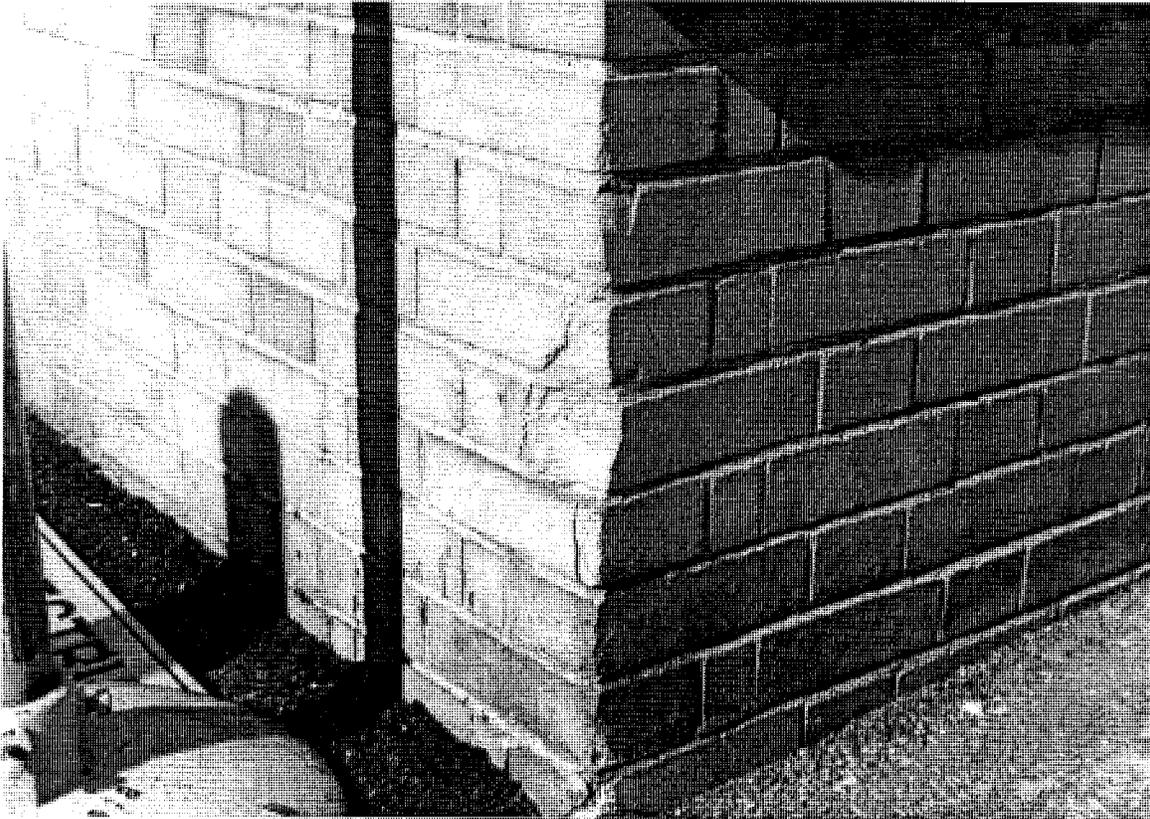
Figure 1-9

Location: Northeast Corner of Building 1

Suggested Remedy: Brick should be removed and replaced to match existing texture, color and size and reset in mortar to match surrounding pointing in color, texture, and profile.

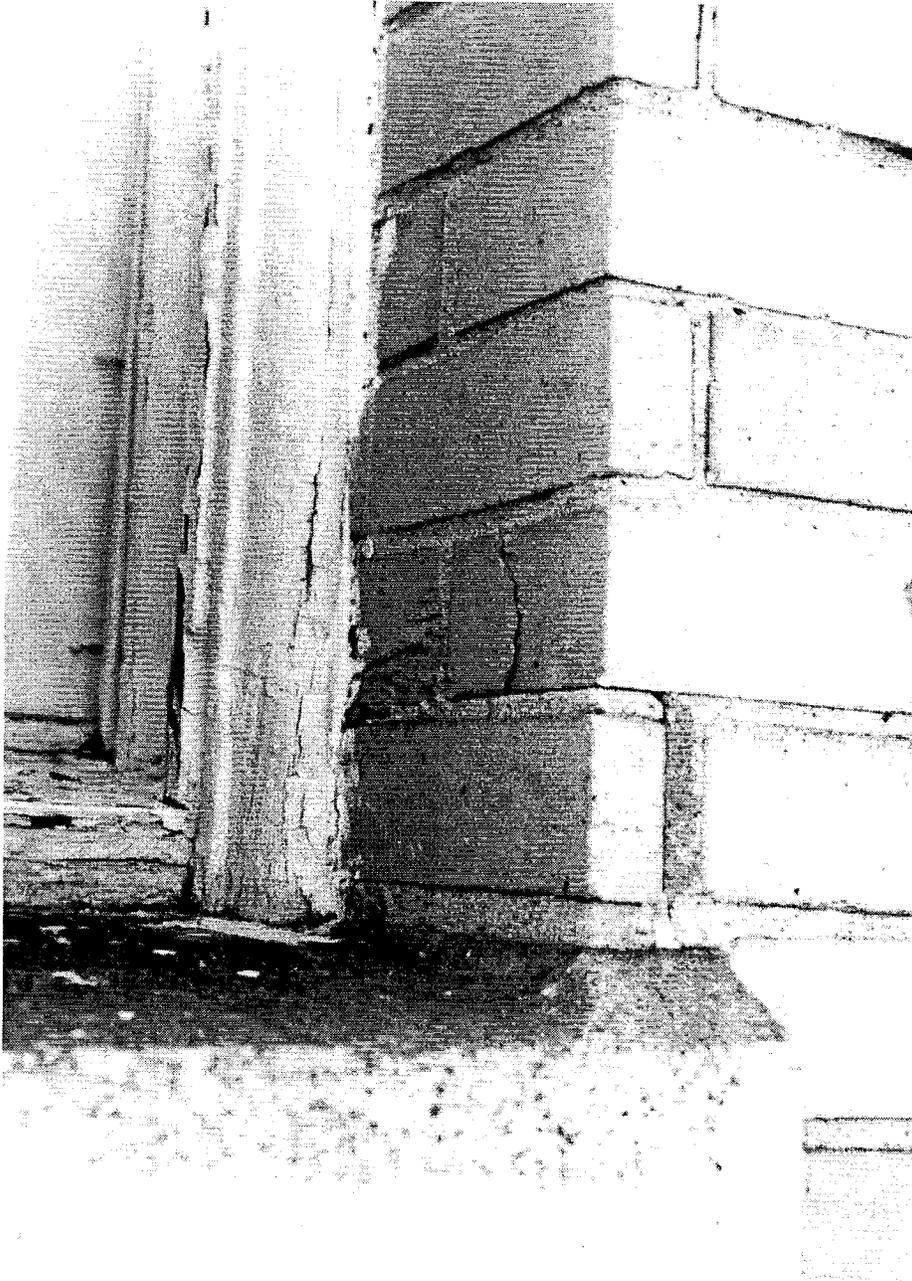
Figure 1-10

Location: East Elevation of Building 1 in Central Area

Suggested Remedy: Remove brickwork and assess for rusting iron anchors. If anchors are rusted they should be replaced with stainless steel anchors; brick should then be replaced to match existing texture, color and size and reset in mortar to match surrounding pointing in color, texture, and profile.

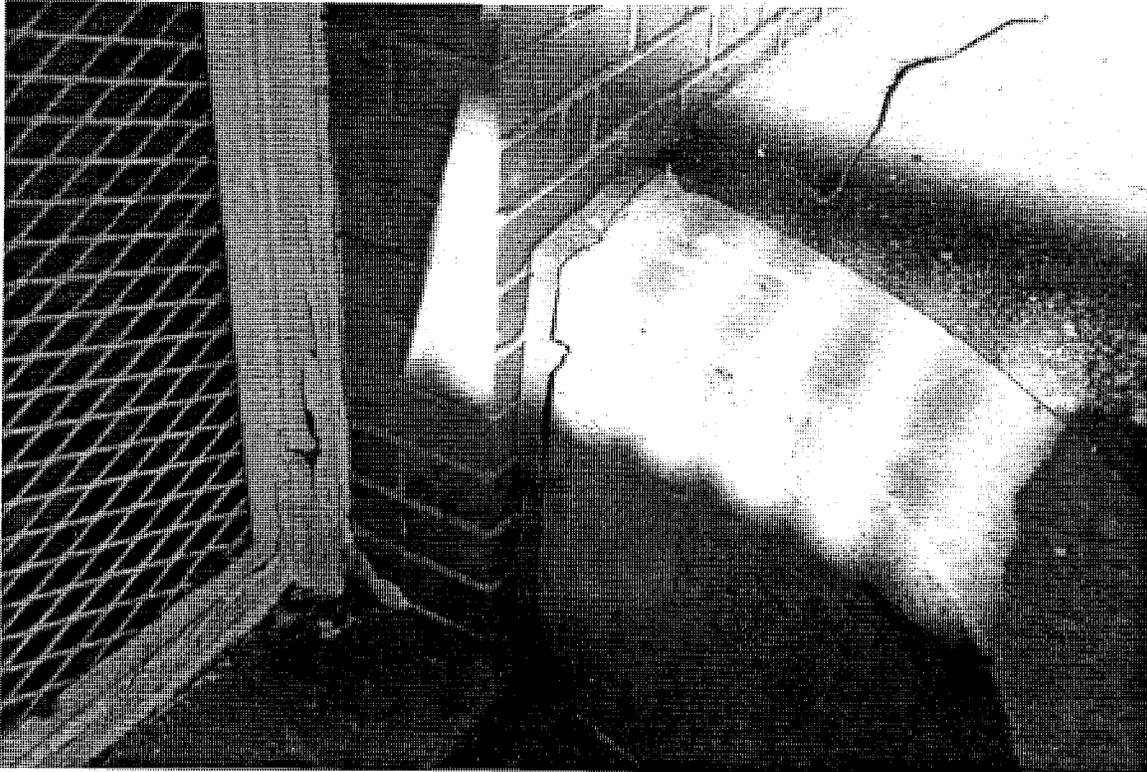
Figure 1-11

Location: East Elevation of Building 1 at North End

Suggested Remedy: Demolish and rebuild

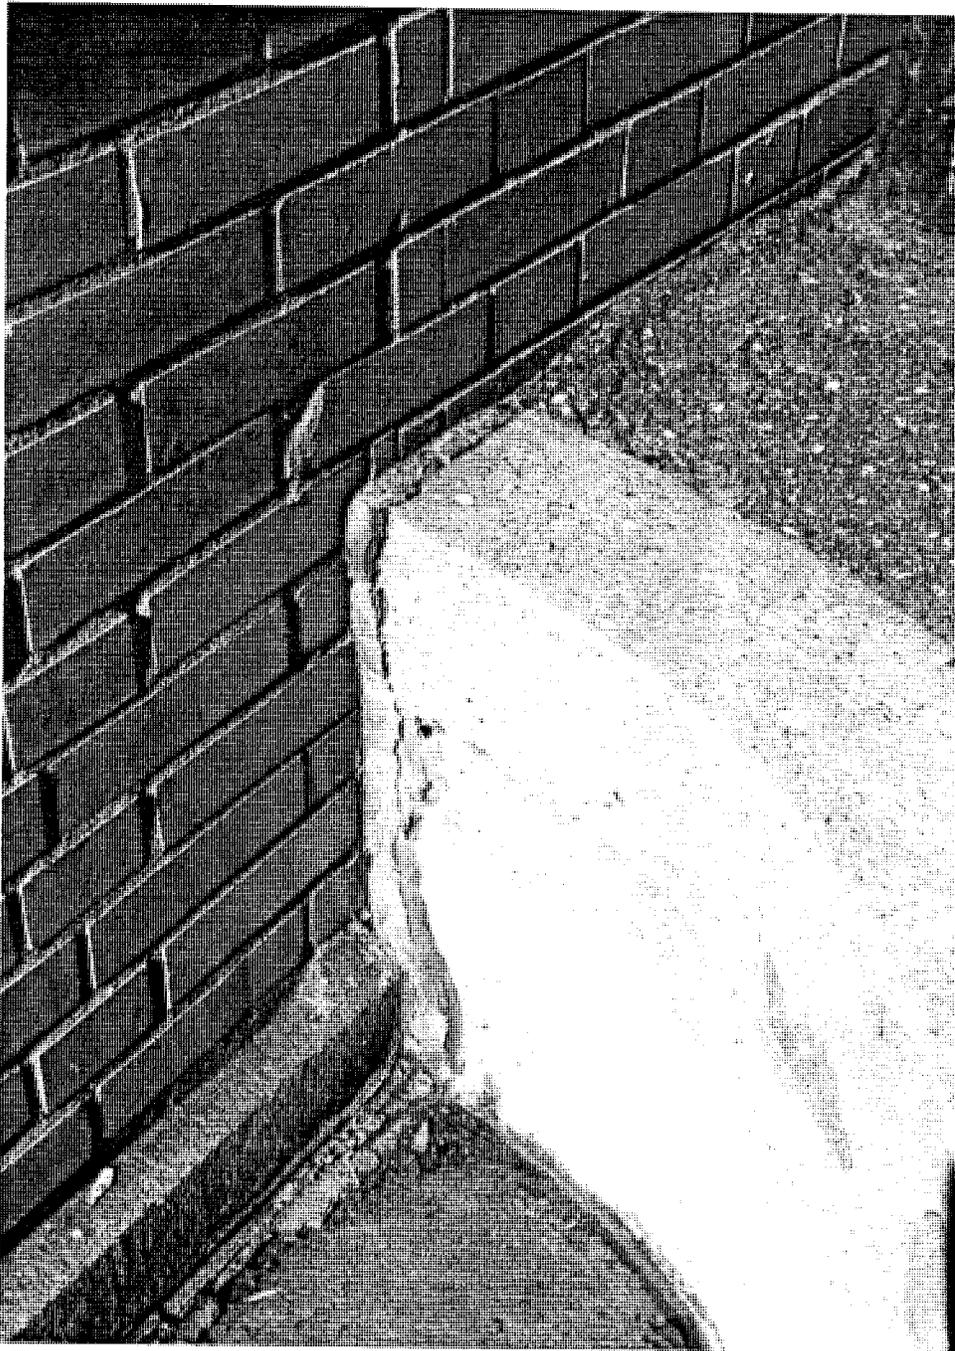
Figure 1-12

Location: East Elevation of Building 1 in Central Area

Suggested Remedy: Demolish and rebuild

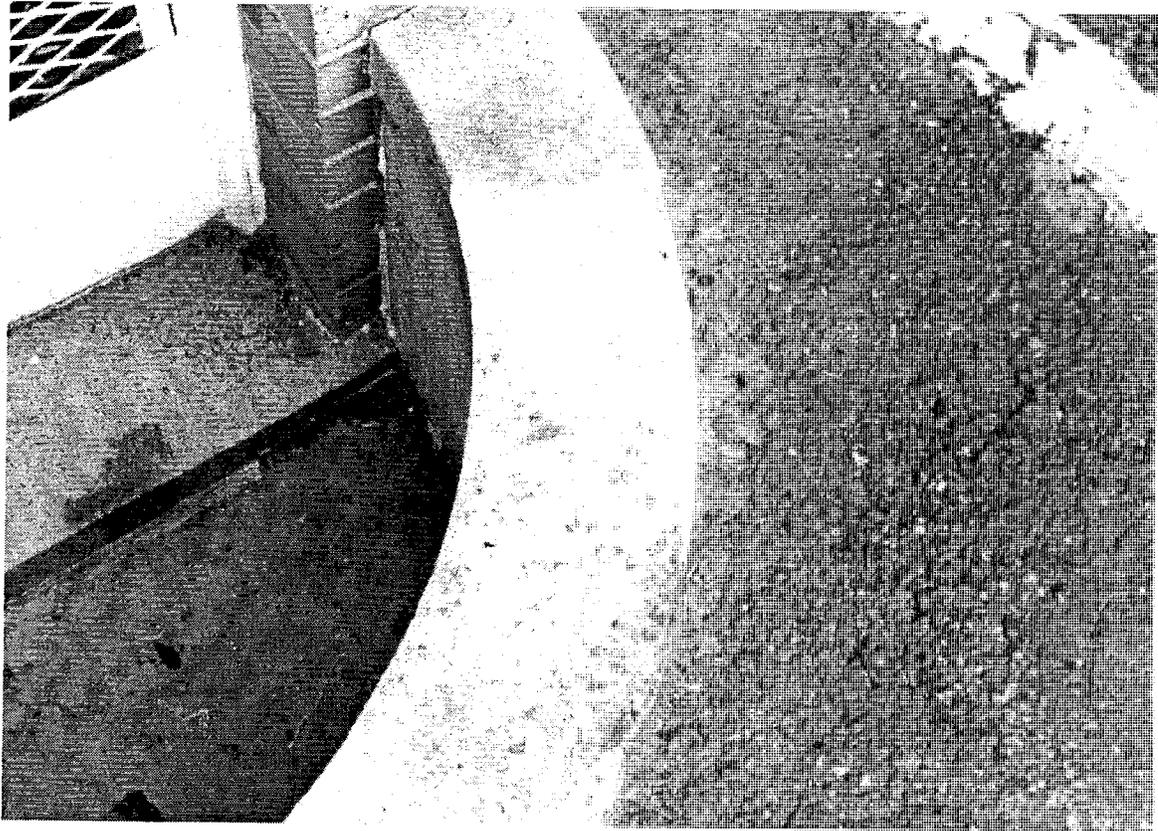
Figure 1-13

Location: East Elevation of Building 1 at North End

Suggested Remedy: Demolish and rebuild

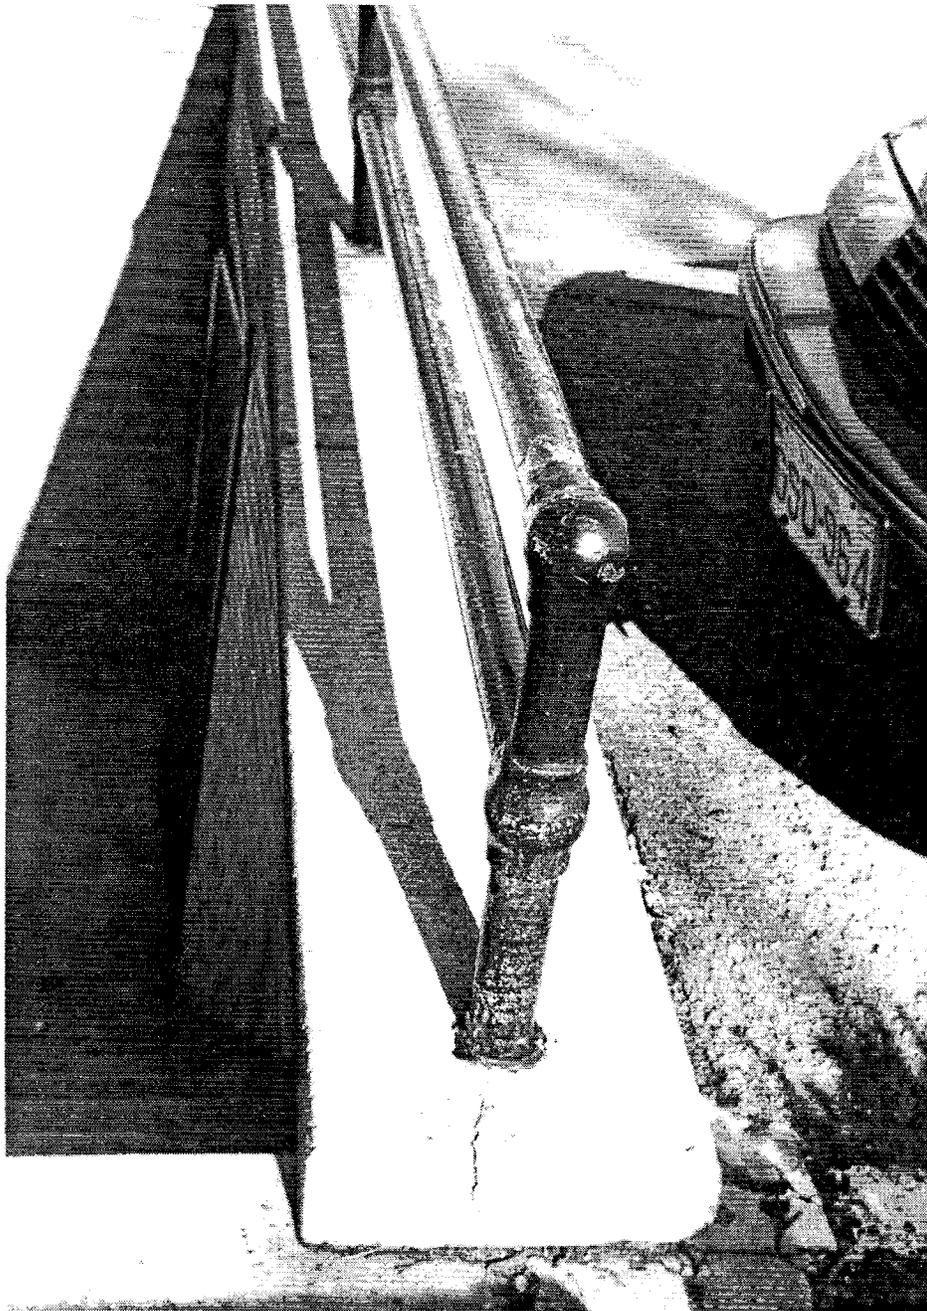
Figure 1-14

Location: East Elevation of Building 1 in Central Aeway

Suggested Remedy: Demolish and rebuild in concrete

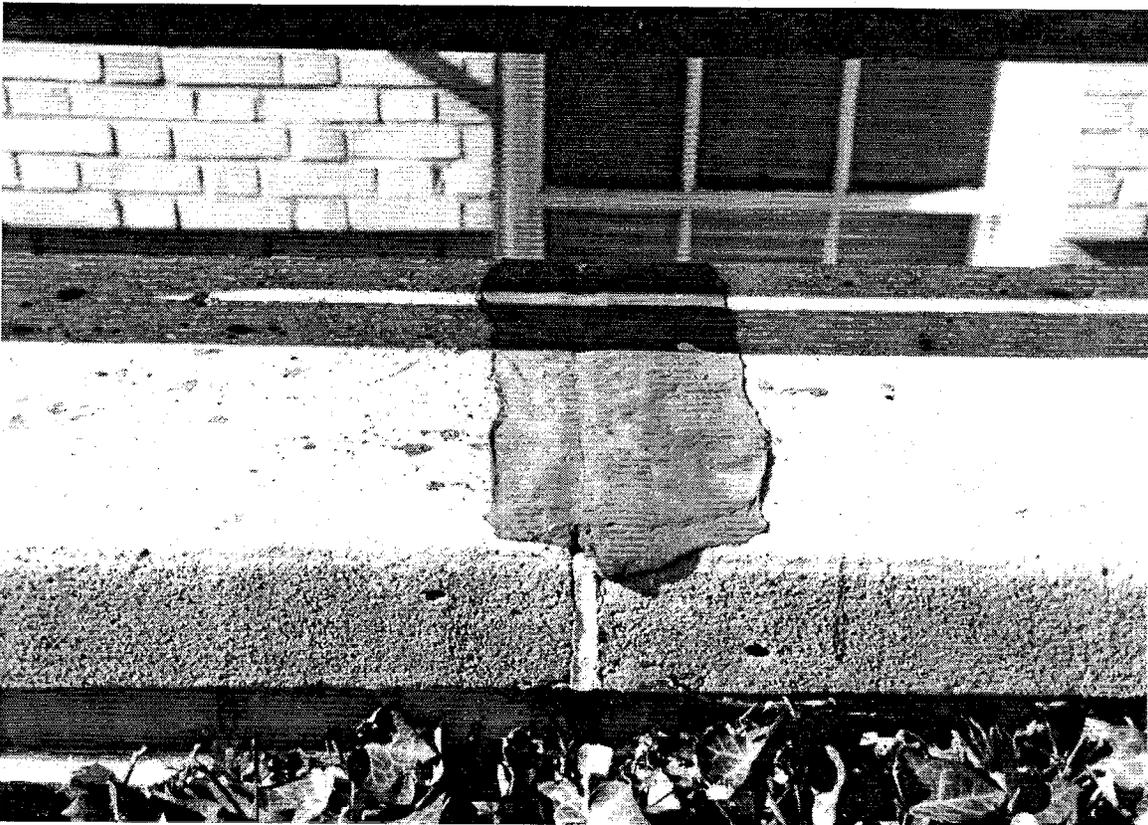
Figure 1-15

Location: East Elevation of Building 1 in South Areaway

Suggested Remedy: Remove bitumen; cut and repoint joint (if capstones are replaced this remedy is unnecessary)

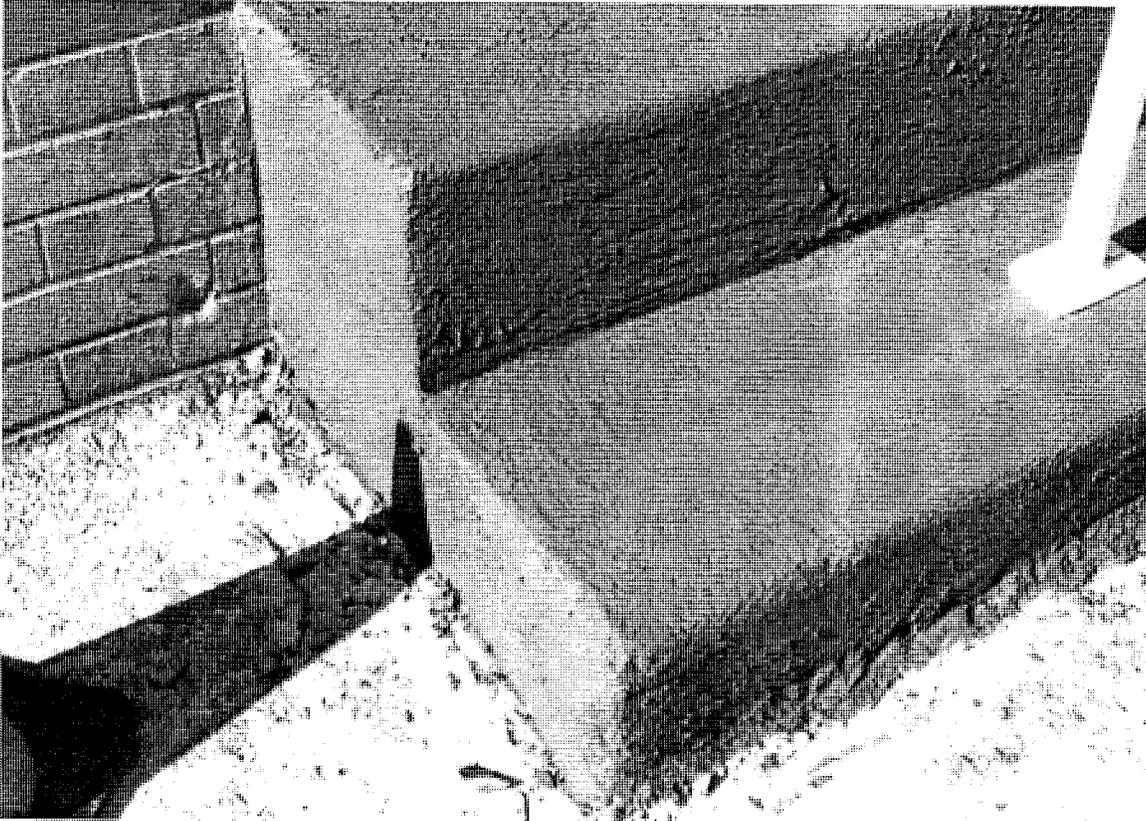
Figure 1-16

Location: East Elevation of Building 1 at South Entryway

Suggested Remedy: Demolish and repour concrete slab

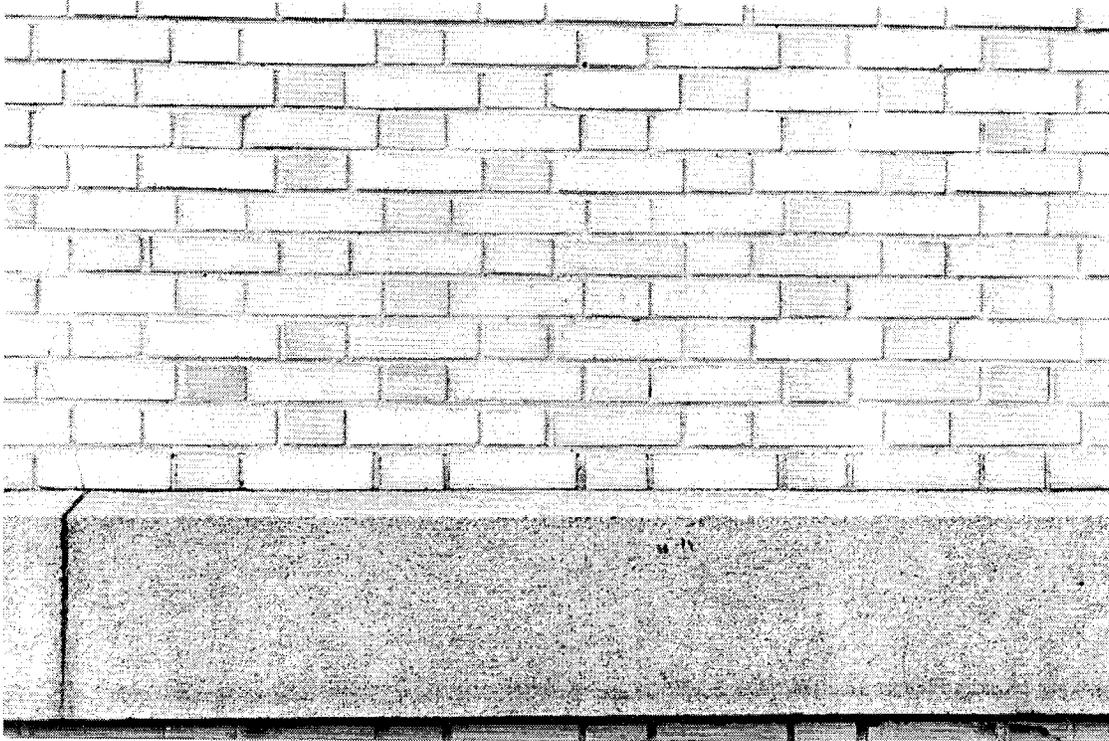
Figure 8-4

Condition of the lightly soiled brick on the east elevation of Building 5 before commencing cleaning tests.

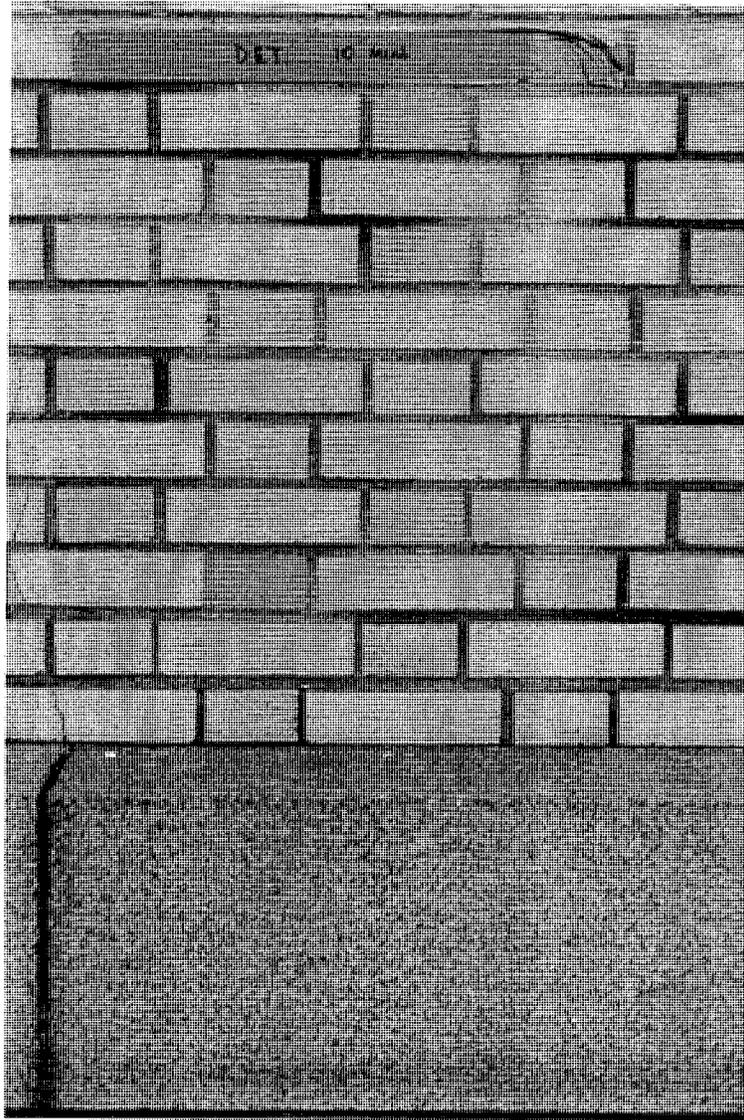
Figure 8-5

Condition of lightly soiled brick on the east elevation of Building 5 after cleaning with detergent (10 minute dwell time) and power wash (approximately 400 psi). Good results are obtained with little risk of damaging the brick.

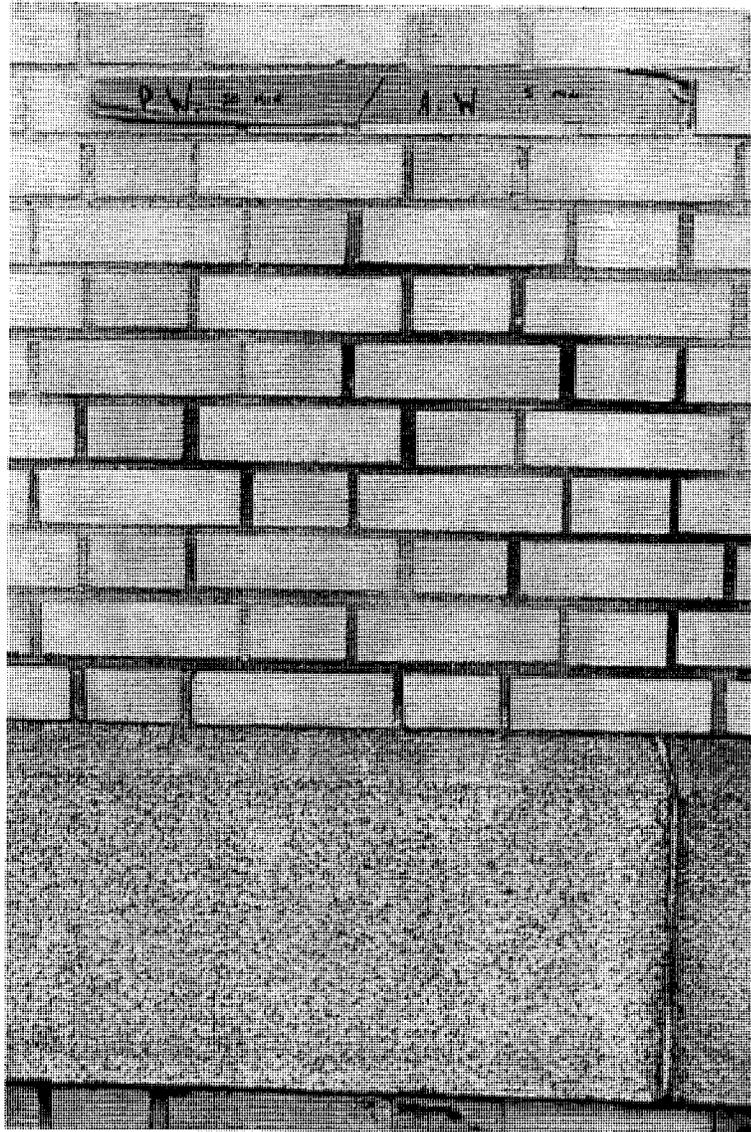
Figure 8-6

The light soiling of the brick on the east elevation of Building 5 was also cleaned by an alkaline pre-wash/acid after-wash system. The results of the cleaning are good but this system is more aggressive than the detergent cleaning which also achieved good results as seen in Figure 5. Therefore, the detergent cleaning is the recommended method for cleaning the lightly soiled brick on Buildings 1, 5, 6 and 7.

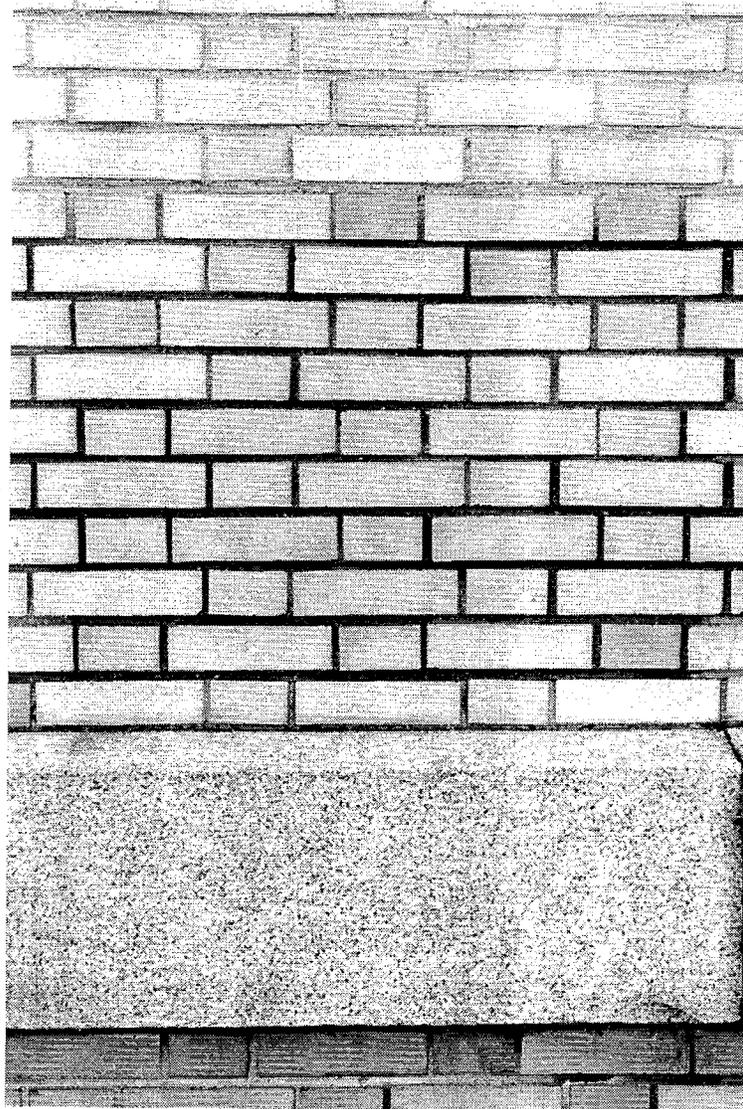
Figure 8-9

The lightly soiled granite was cleaned well by the alkaline pre-wash/acid after-wash system as seen here on the east elevation of Building 5. This method is recommended for the cleaning of all granite elements on Buildings 1, 5, 6 and 7.

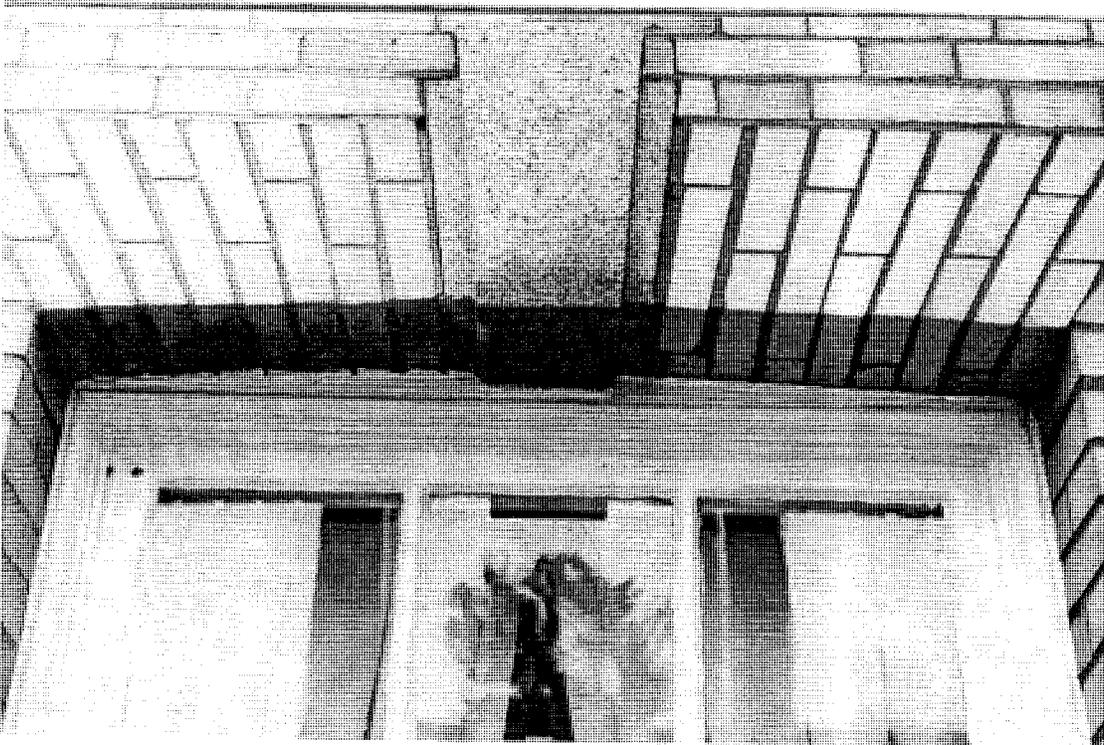
Figure 8-10

The water misting method was used to remove gypsum and flyash from the undersides of window lintels as shown here on the east elevation of Building 5. Good results were obtained after 6 hours (before cleaning condition can be seen on the right). This is a safe and effective method for removing this soiling and is the recommended techniques for this condition.
