Potomac Annex:  
Buildings 1 & 3-7

Historic Structures Report, Corrected Final Submission  
 General Services Administration Project Control Number: 44007  
 September 9, 1997  
 VOLUME 2 OF 2

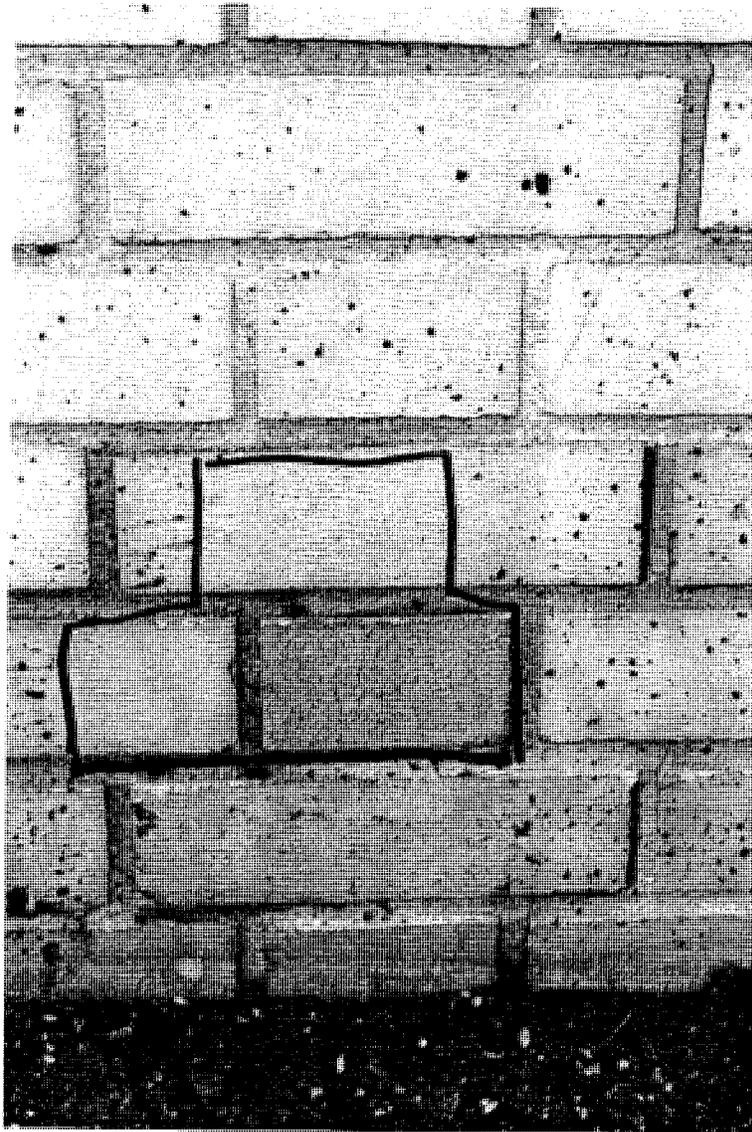
Figure 8-11

Bitumen-based deposits as shown here on the elevation of Building 5 were cleaned with PROSOCO'S Asphalt and Tar Remover - a solvent-based cleaner. The applied as a paste in attapulgate for 4 hours the deposit was then dislodged with paint scrapers taking care not to scrape the brick. The results shown here (uncleaned area on the left and cleaned area on the right) are good and this is the recommended method for removing these deposits.

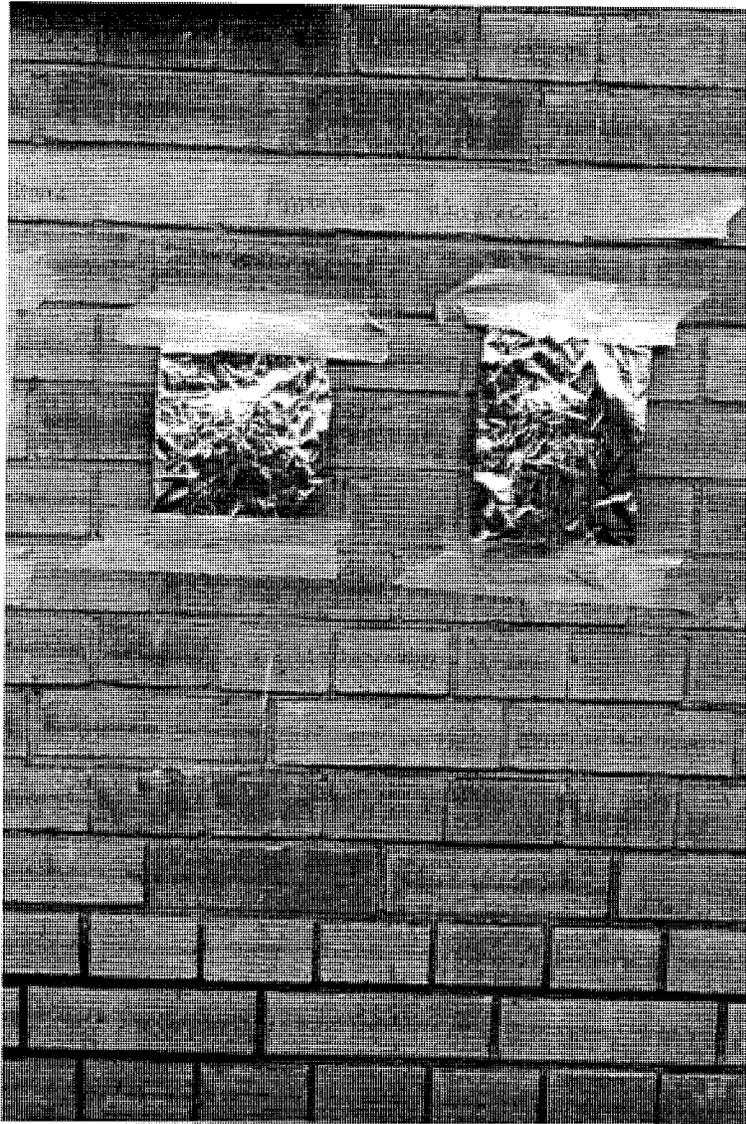
Figure 19

Application of ammonium thioglycolate poultice to brick to remove soiling from Buildings 3 & 4. Note the typical soiling conditions immediately adjacent to the poultices at Building 3.

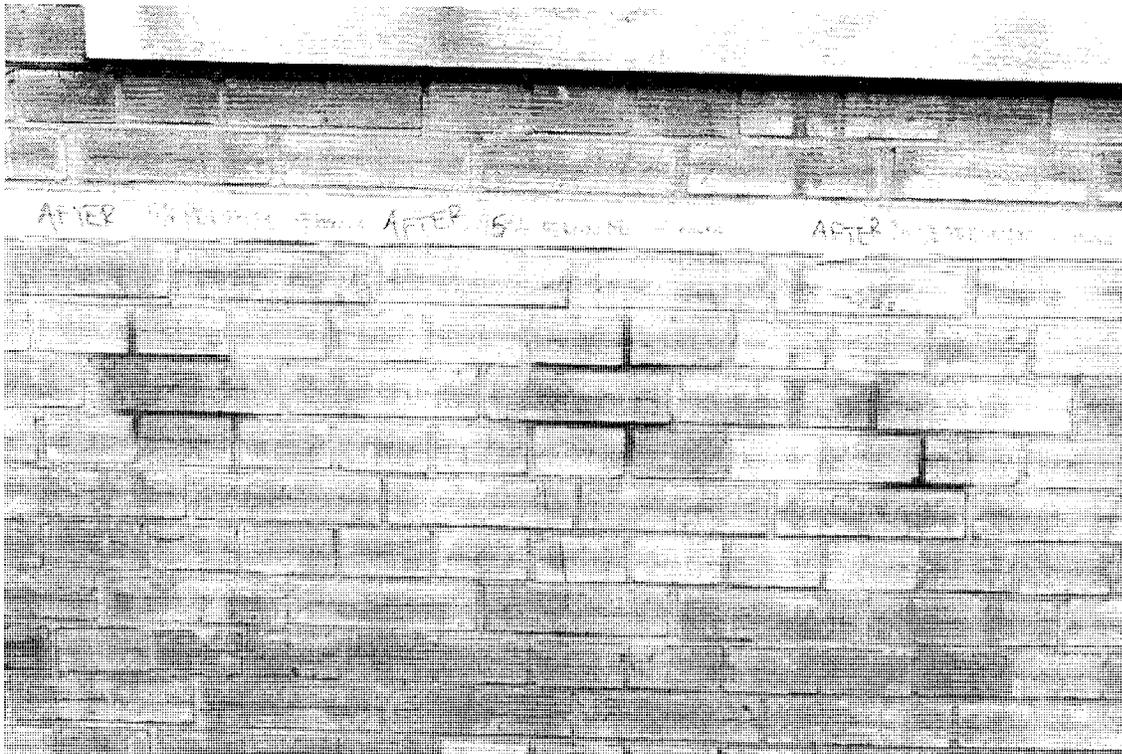
Figure 20

Unsuccessful results of the hydrogen peroxide cleaning tests; there was little or no change from “before” and “after” on Building 3.

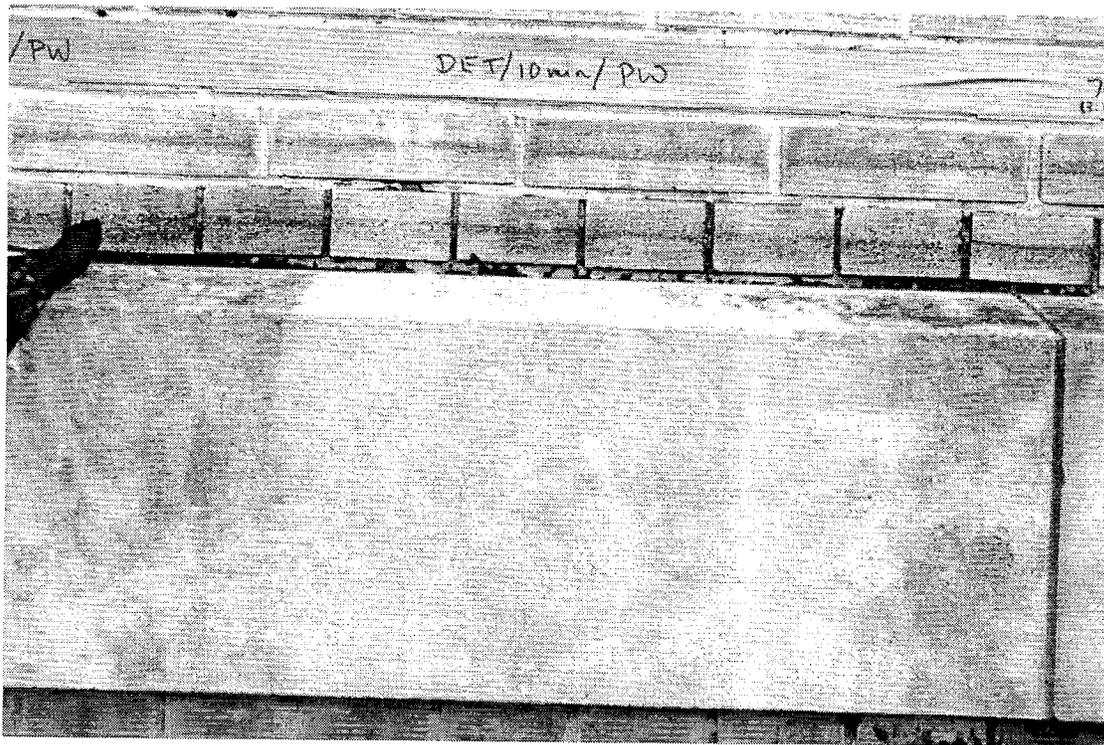
Figure 8-21

A section of the limestone water table on the north elevation of Building 4 was cleaned by several methods. Here can be seen the result when cleaning with a detergent followed by power washing. Good cleaning is achieved with little harm to the substrate. The before cleaning condition can be seen to the left and the to the right of the cleaned area.

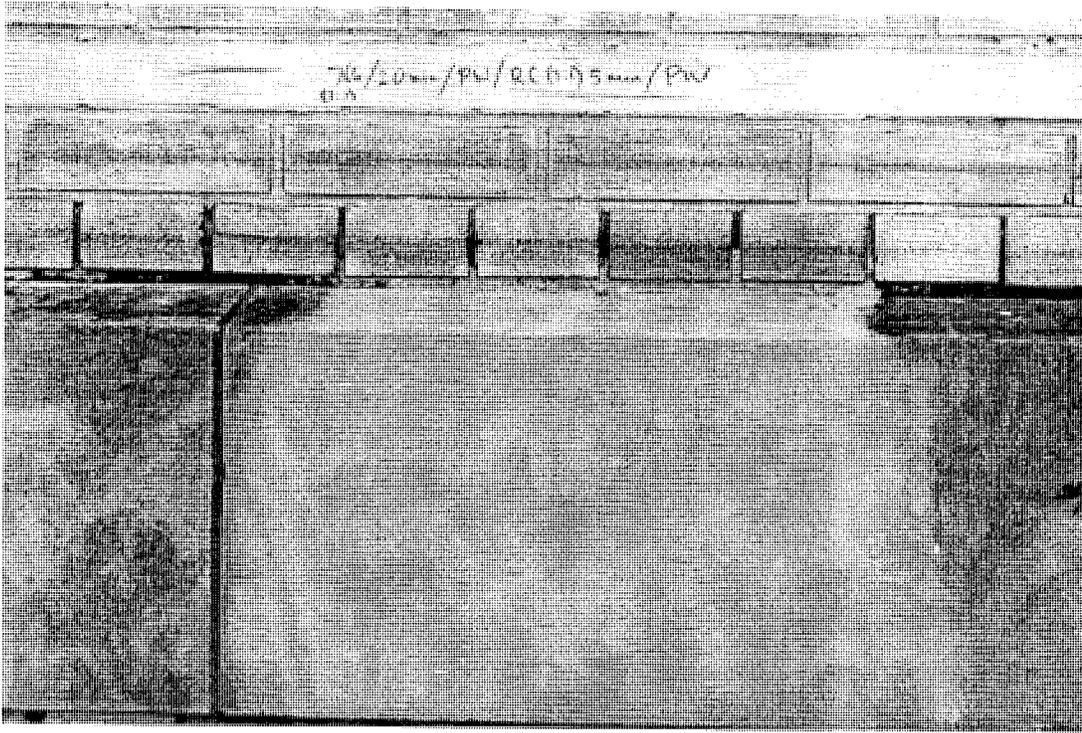
Figure 8-22

A section of the limestone water table on the north elevation of Building 4 was also cleaned by the alkaline pre-wash/acid after-wash method. Good cleaning is also achieved but the method is more aggressive on the substrate. The before cleaning condition can be seen to the left and the to the right of the cleaned area.
