BUILDING PRESERVATION PLAN

202 South State Street
Chicago, Illinois, IL0318ZZ

Final Submittal

June 30, 2009

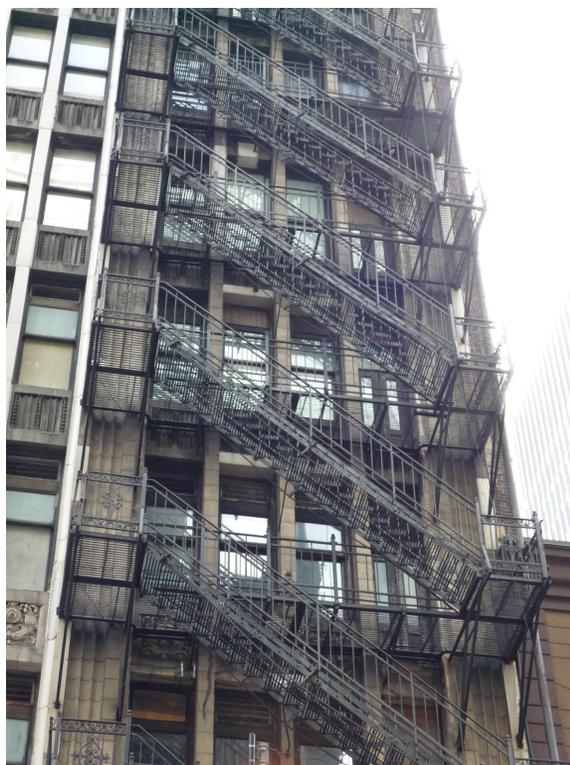
Image 28: Original fire escape, north façade.

The fire escape, located on the north elevation, is an original and highly decorative element. This feature should also be preserved as code permits. An ongoing (May 2009) project at the building proposes the removal of a lower portion of the existing fire escape. It is recommended that the removed portion be salvaged and stored within the building until it may be remounted in its original location.

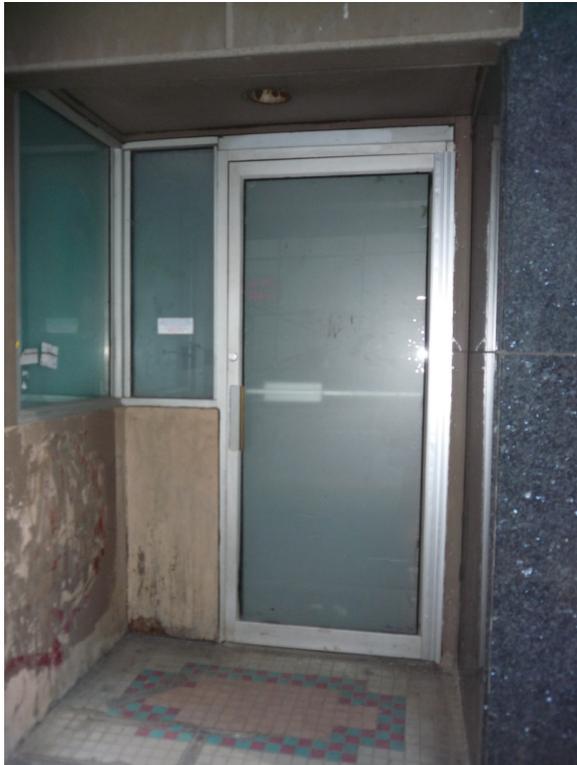
Image 76: Northwest entry, cladding over 1951 storefront.
