BUILDING PRESERVATION PLAN

220 South State Street
Chicago, Illinois, IL0315ZZ

GSAGS05P04GAD0224
JLA# 08622
Final Submittal
June 30, 2009

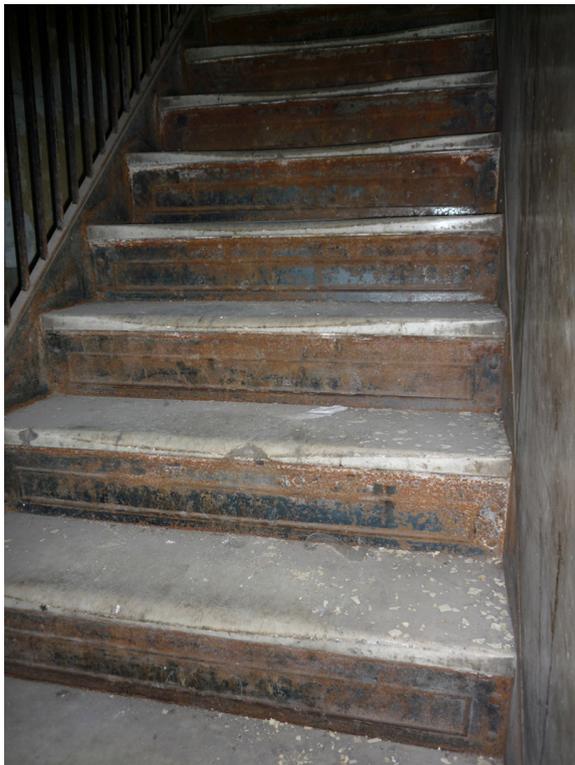
Image 112: Typical condition of railing finish, east stair.

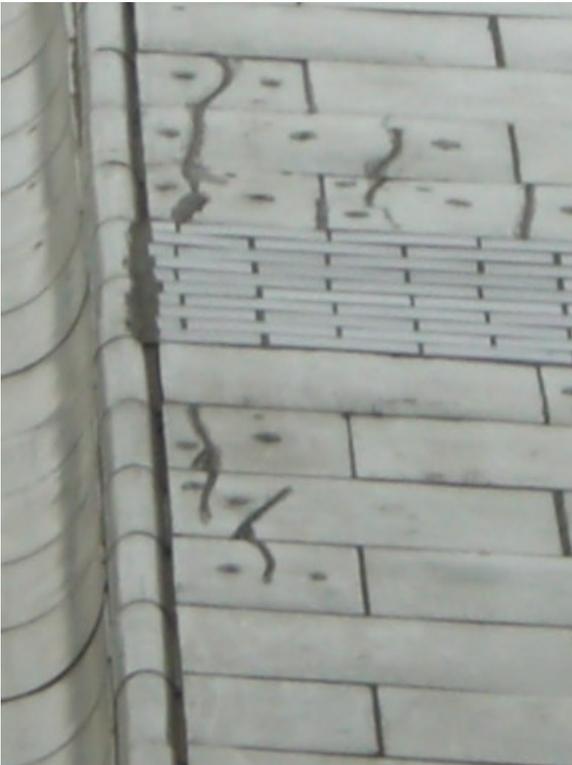
Image 116: Poor substitution of glazed brick for terra cotta, east façade.

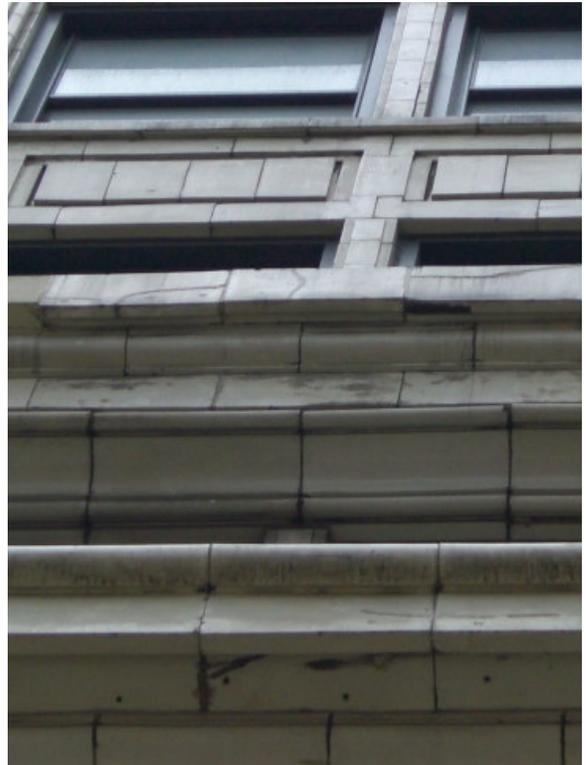
Image 117: Poor substitute cladding material and failure of surrounding terra cotta.

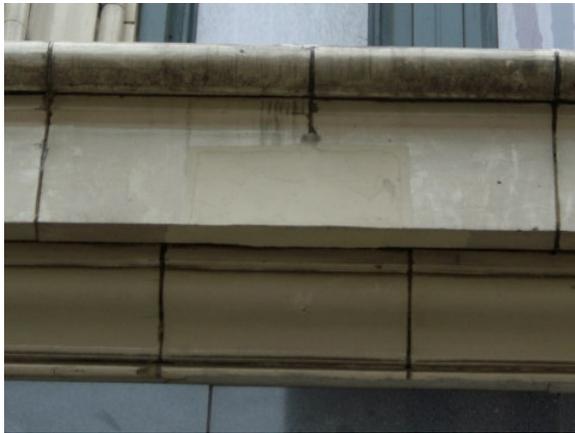
Image 118: Stresses in terra cotta resulting from anchor failure and stresses in wall.

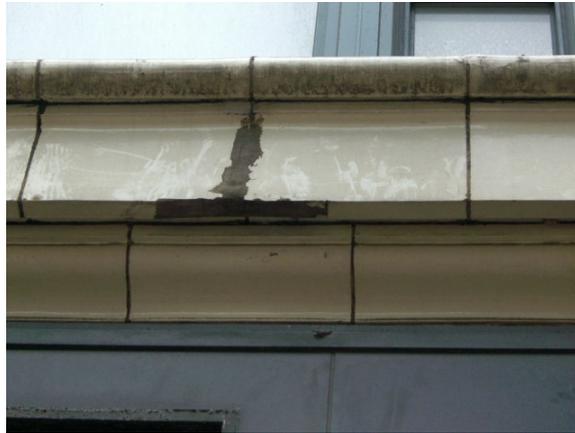
Image 119: Unsightly mortar patch. Doomed to fail.

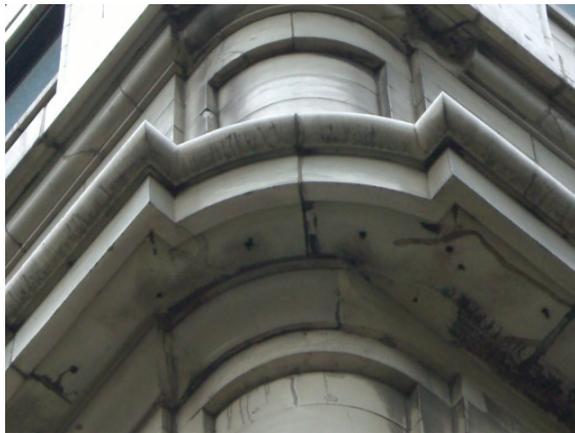
Image 120: Improper repair of failing terra cotta.

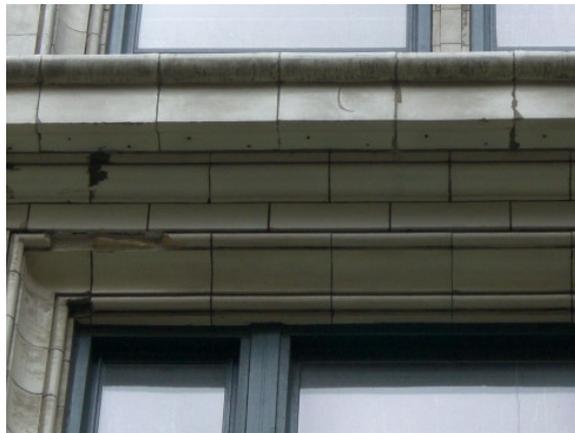
Image 121: Stresses in terra cotta due to anchor failure and stresses in wall. Poor substitution of glazed brick for terra cotta and improper patching also evident.

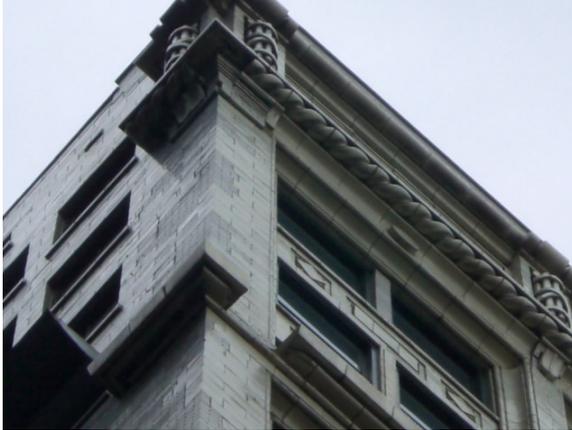
Image 122: Delamination of terra cotta due to stresses in the failing lintel.

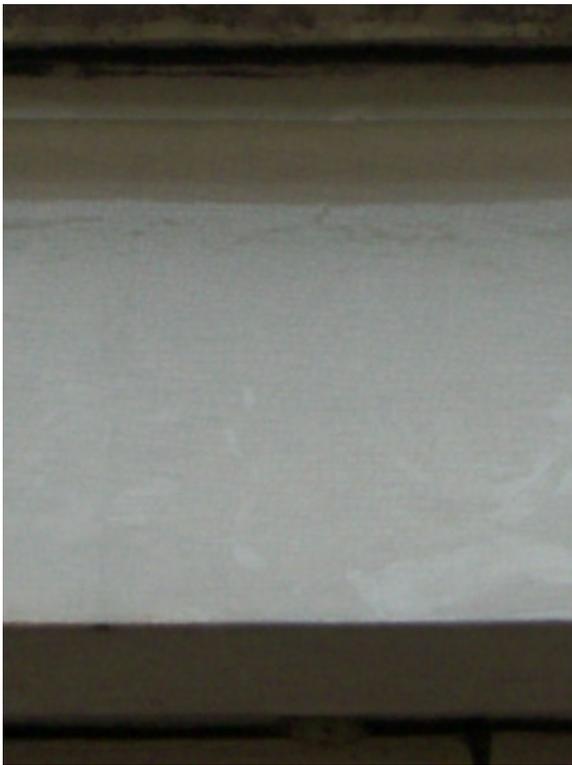
Image 124: Poor substitute cladding material and insensitive replacement of window.

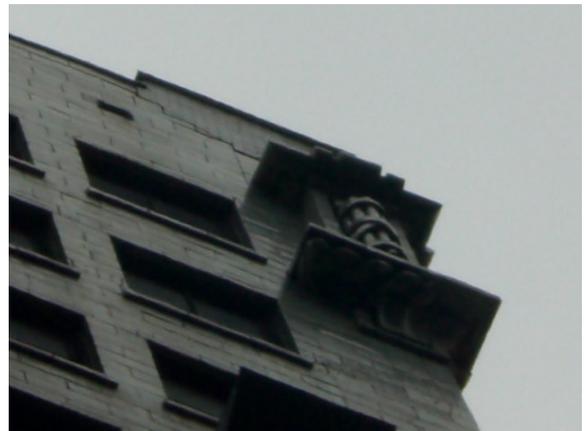
Image 125: Crazing evident in glazed finish of masonry units throughout the facades.
