BUILDING PRESERVATION PLAN

**230 South State Street
Chicago, Illinois, IL0316ZZ**

Final Submittal

June 30, 2009

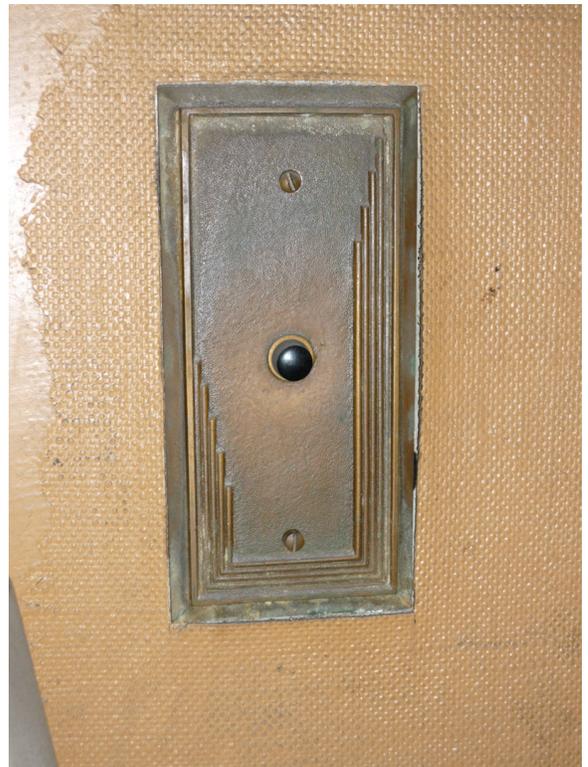
Image 37: Elevator call button, sixth floor.

Preserve in place, repair, and reuse the elevator doors, frames, and call button. Replace non-original elevator call buttons (basement through 5th floor) with new based on original design. Preserve, repair, and reuse the Mosler safe. Salvage, repair, and reuse other original doors and frames, wall base, and window trim. Restore and reuse original light fixtures using existing material wherever possible.

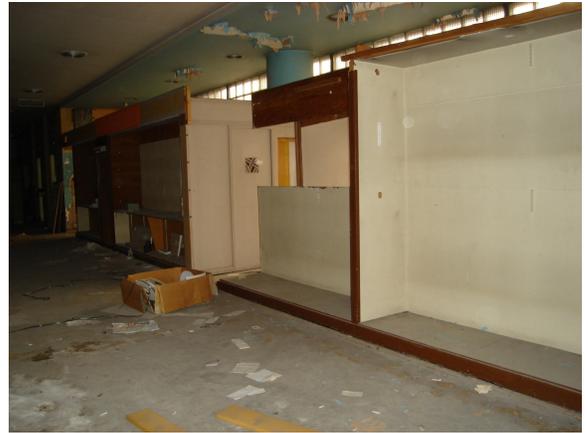
Image 43: Remains of wardrobes, fourth floor.

For 4th through 6th floors, partition walls and remains of clothes closets and dressing rooms should be removed. The existing wood cabinetry covering the decorative stairway on the 4th floor should also be removed. It is recommended that new walls reflect some of the curvilinear design of the originals. An axial part of an open space surrounded by ancillary rooms on tenant floors 4 and 5 is also suggested.

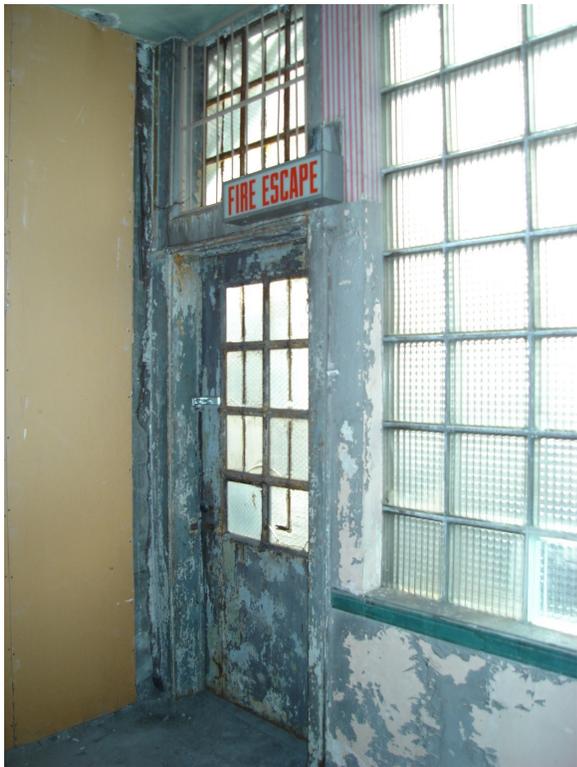
Image 48: Fire escape door, typical of floors 4 through 6..

Non-original fire escape doors are to be replaced with doors based on original design.

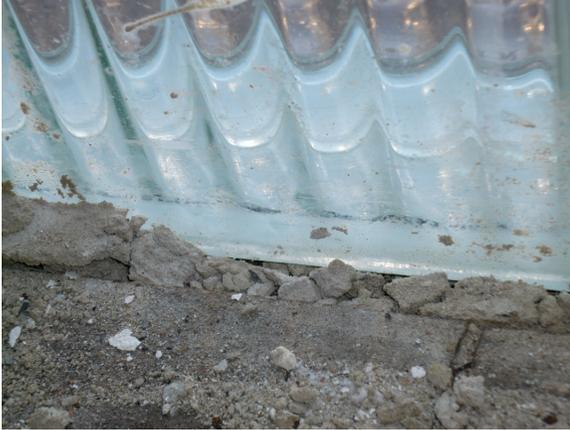
Image 58: Windowsill, typical condition.

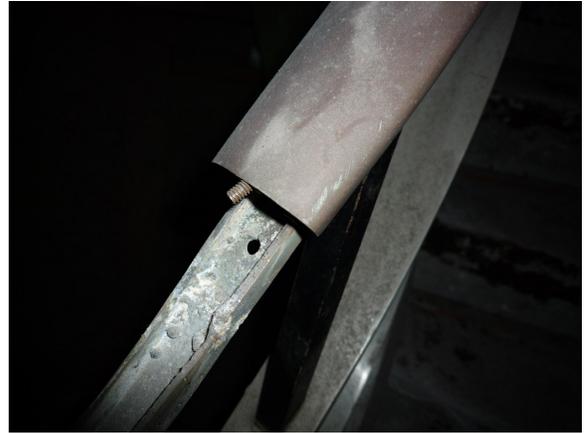
Image 59: Decorative stair, missing/damaged handrail.

This stairway should be reopened at the 4th floor level and the lower flight reconstructed, including railings. The remaining treads, risers, posts and railings should be cleaned, repaired, and restored. Niches, still suitable for display, should be repaired and restored. Clean and refinish cove ceiling above stair. Restore existing pendant light above stair and the two flanking the stair. Paint analysis should be conducted on wall and ceiling surfaces to determine original finishes. Results should be kept on record.

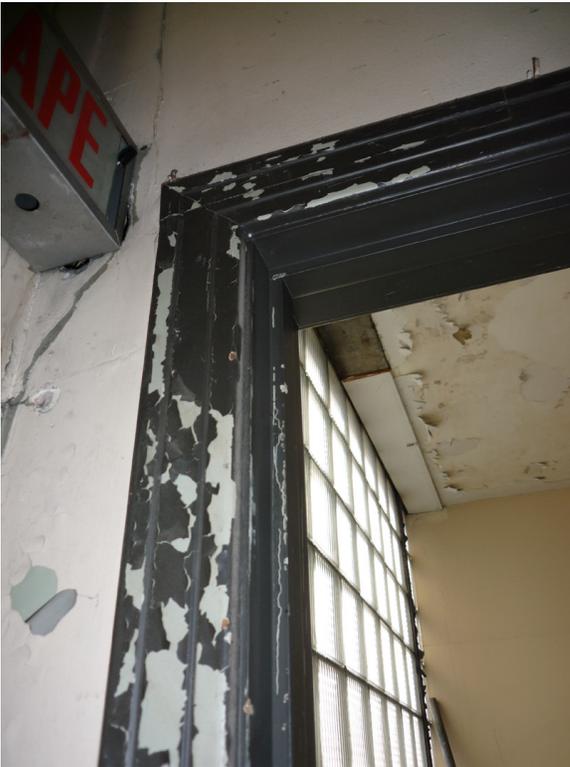
Image 60: Door frame, typical condition.

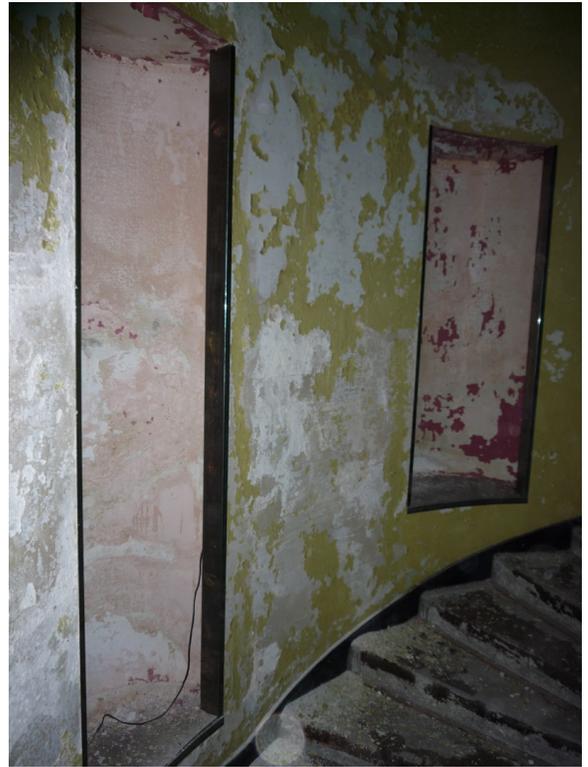
Image 61: Wall behind decorative stair, typical condition of wall paint.

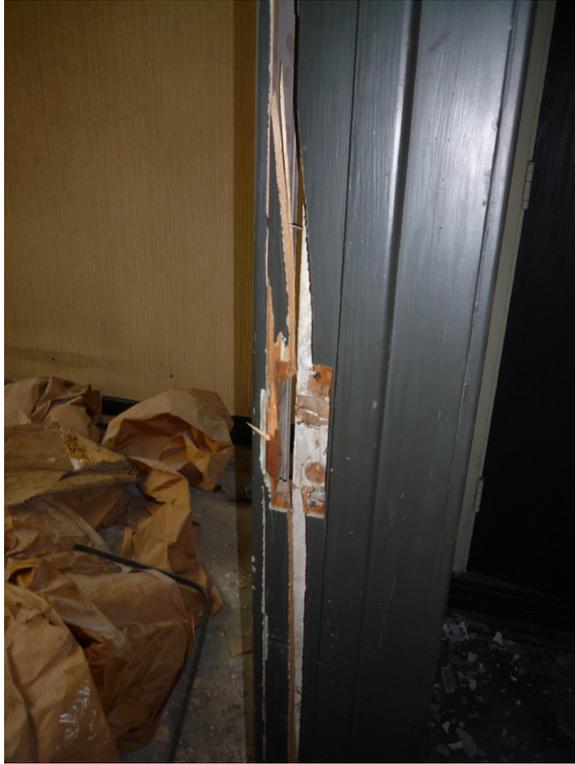
Image 62: Door frame, sixth floor. One of two needing major repairs.

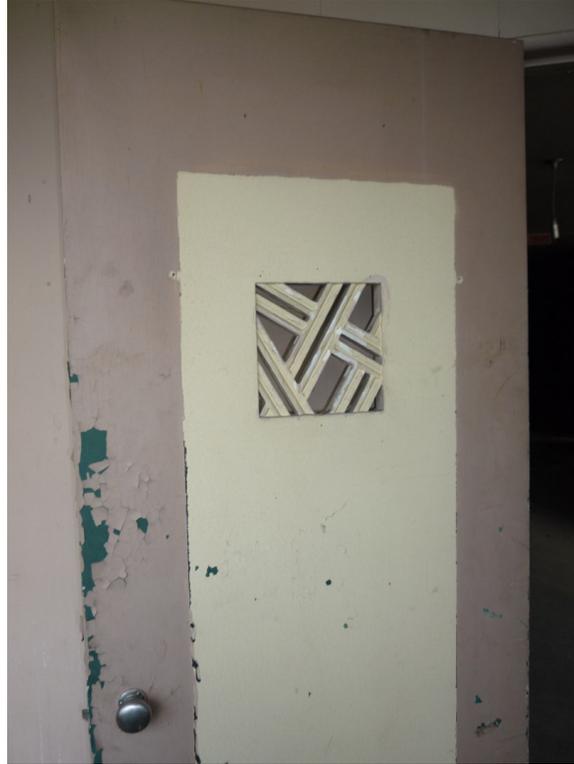
Image 63: Wardrobe door, fifth floor, non-original finish.

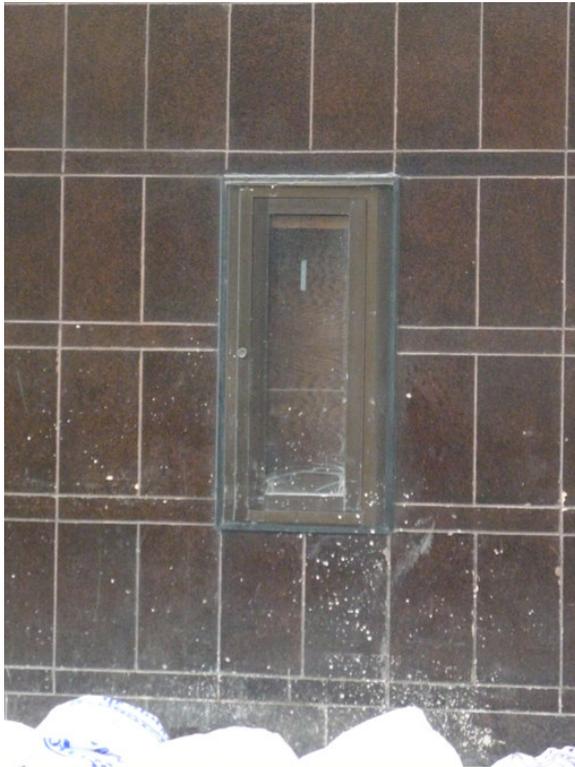
Image 64: One of 3 display cases on north elevation. In need of cleaning.
