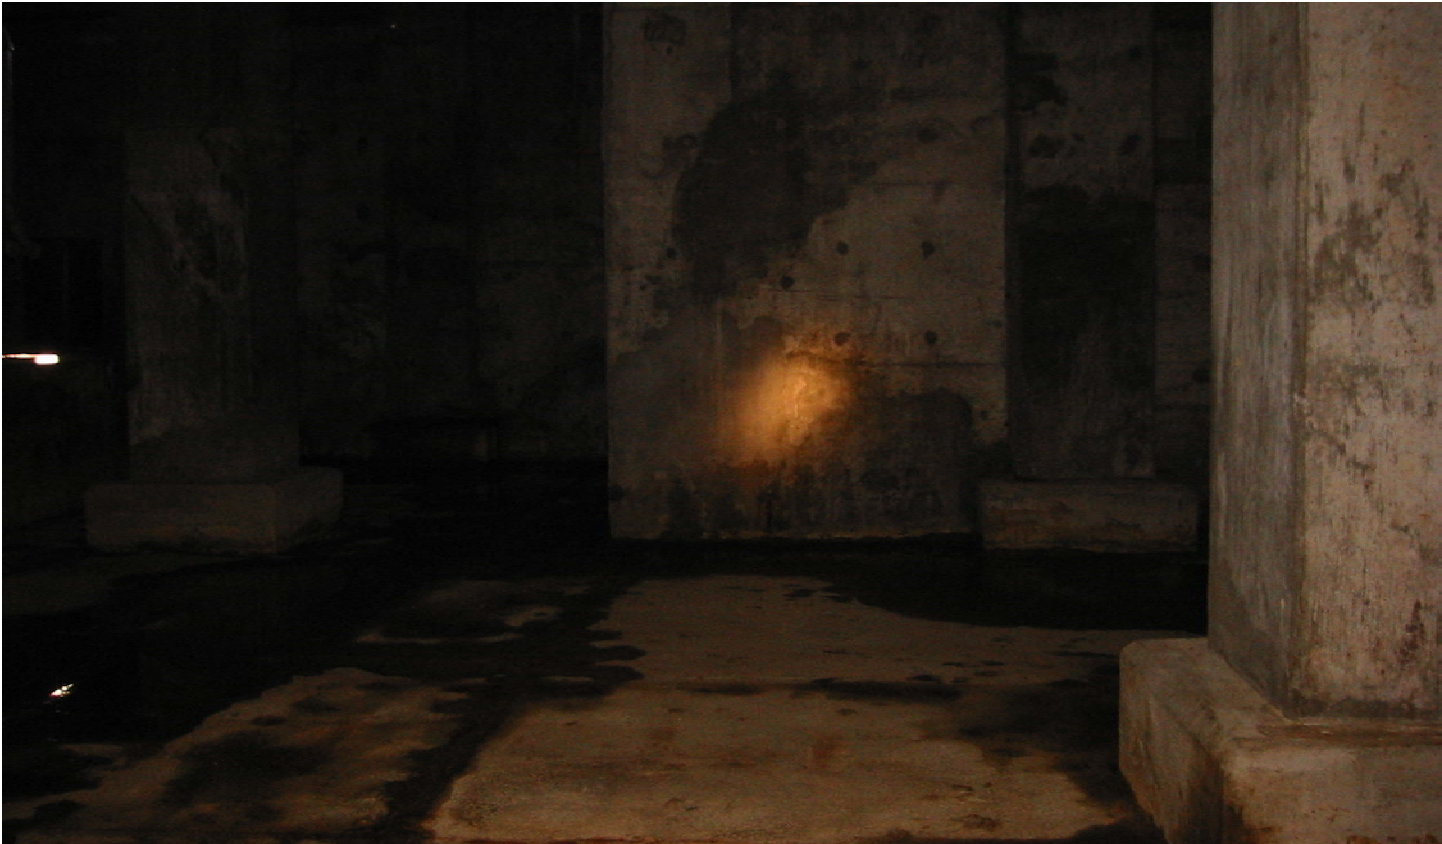
Photograph 37. Building 105 SAFR. Floor post-remediation, September 2002.

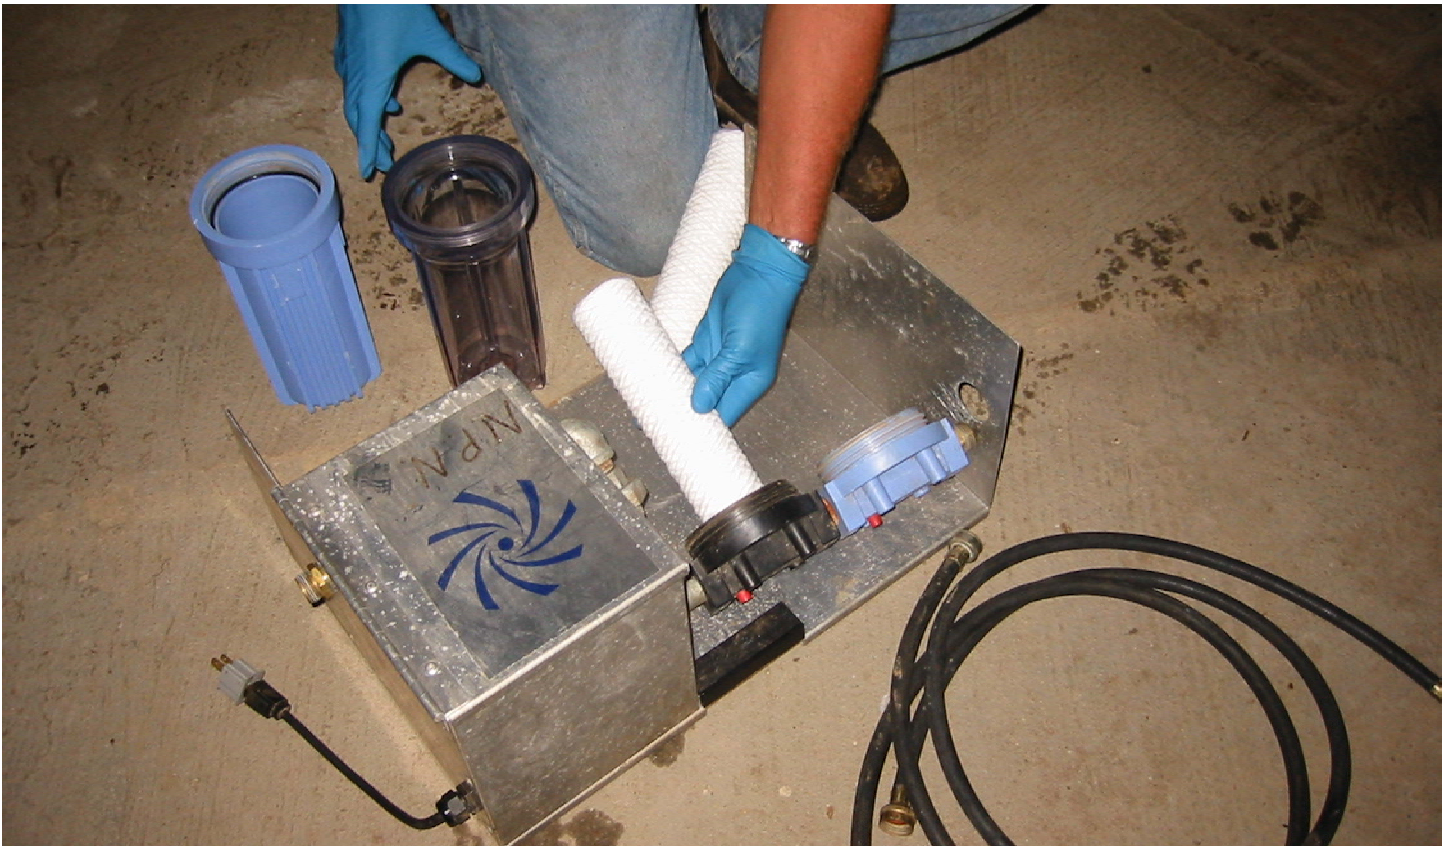
Photograph 33. Building 105 SAFR. Typical 50 micron filter assembly, September 2002.

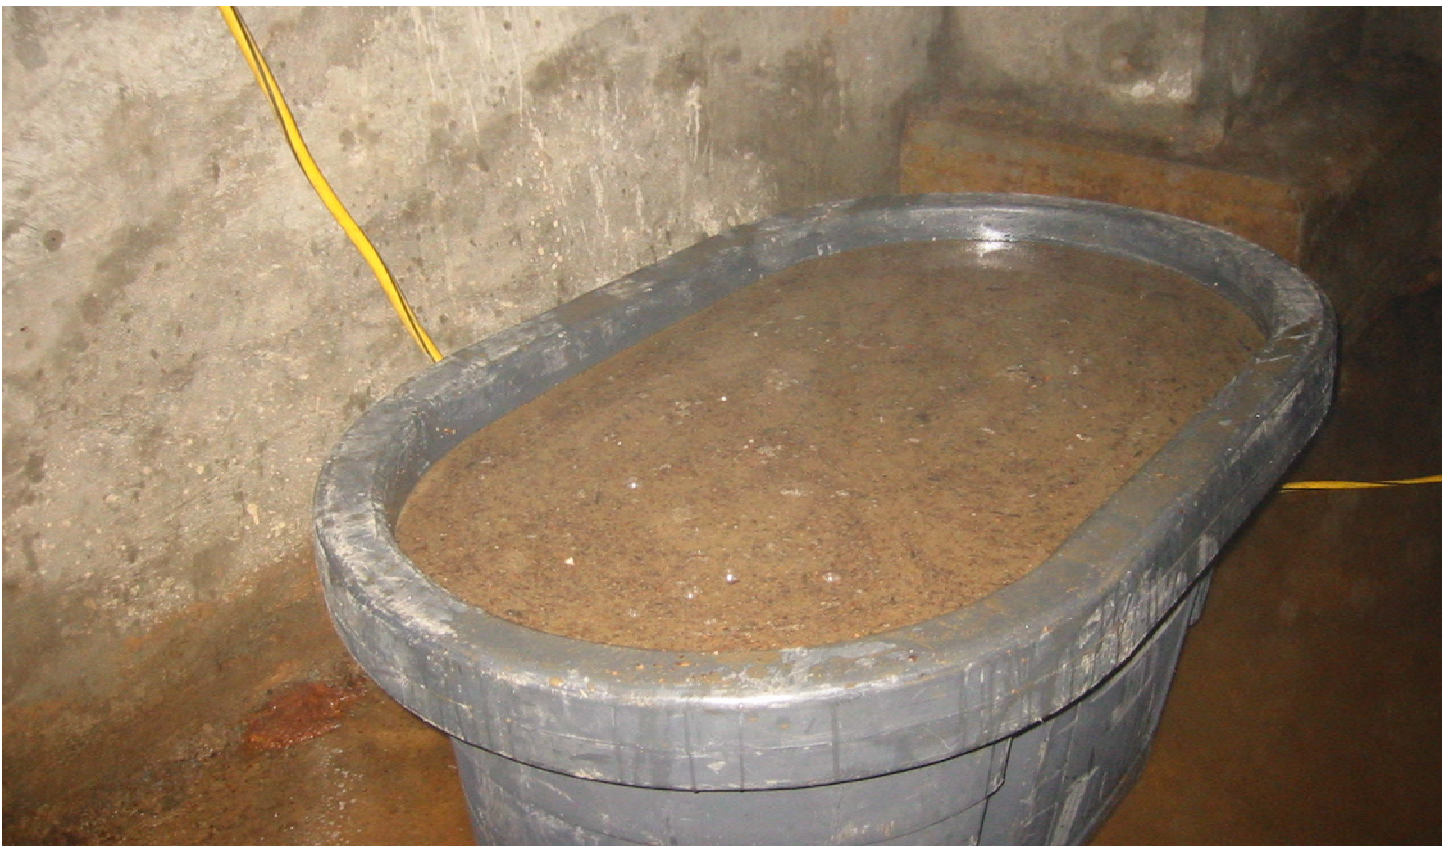
Photograph 34. Building 105 SAFR. Rinsate after 50 micron filtration and before 0.5 micron filtration, September 2002.

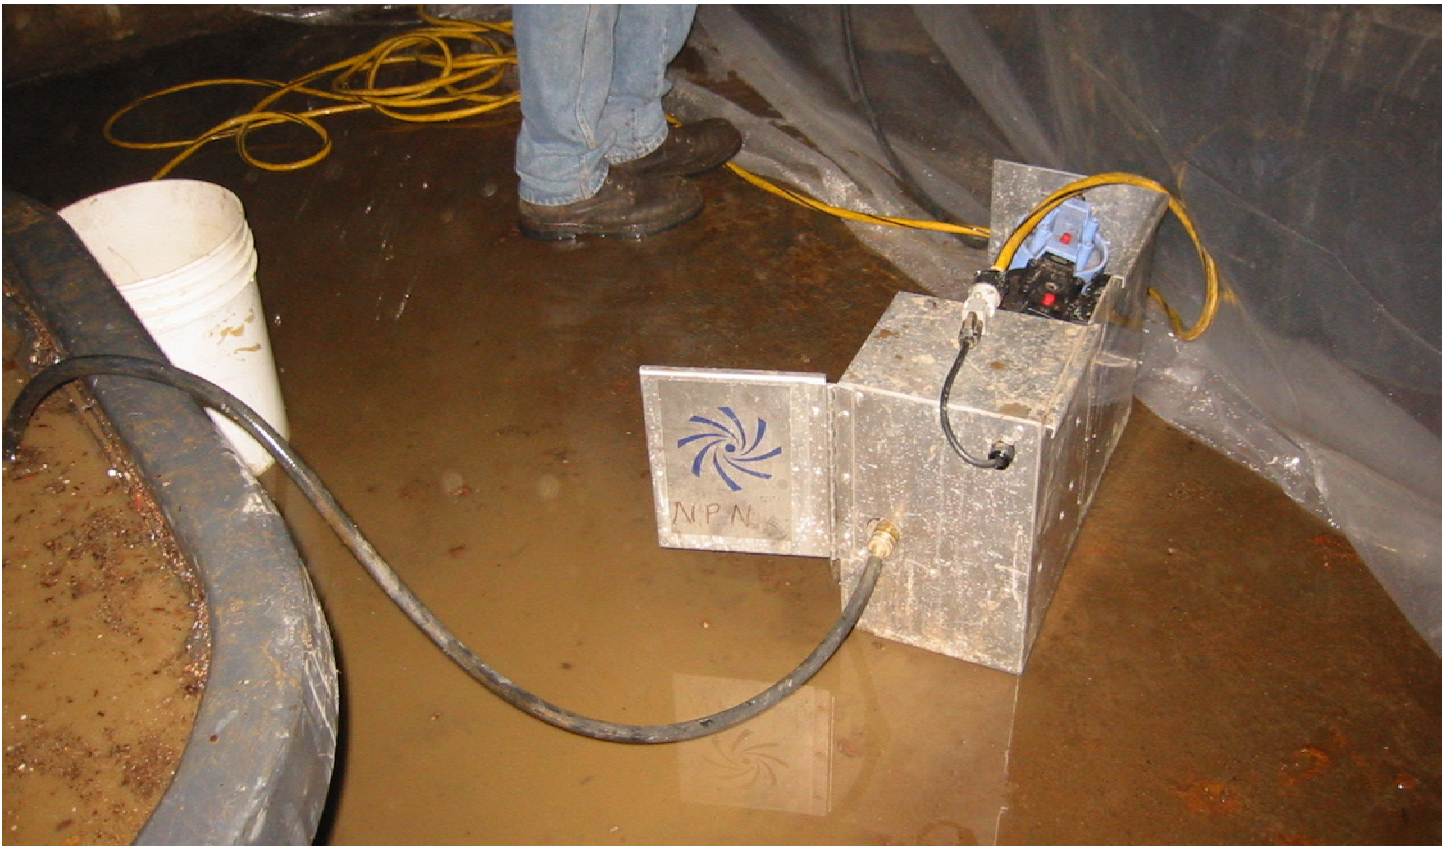
Photograph 35. Building 105 SAFR. 50 micron filter assembly at work, September 2002.

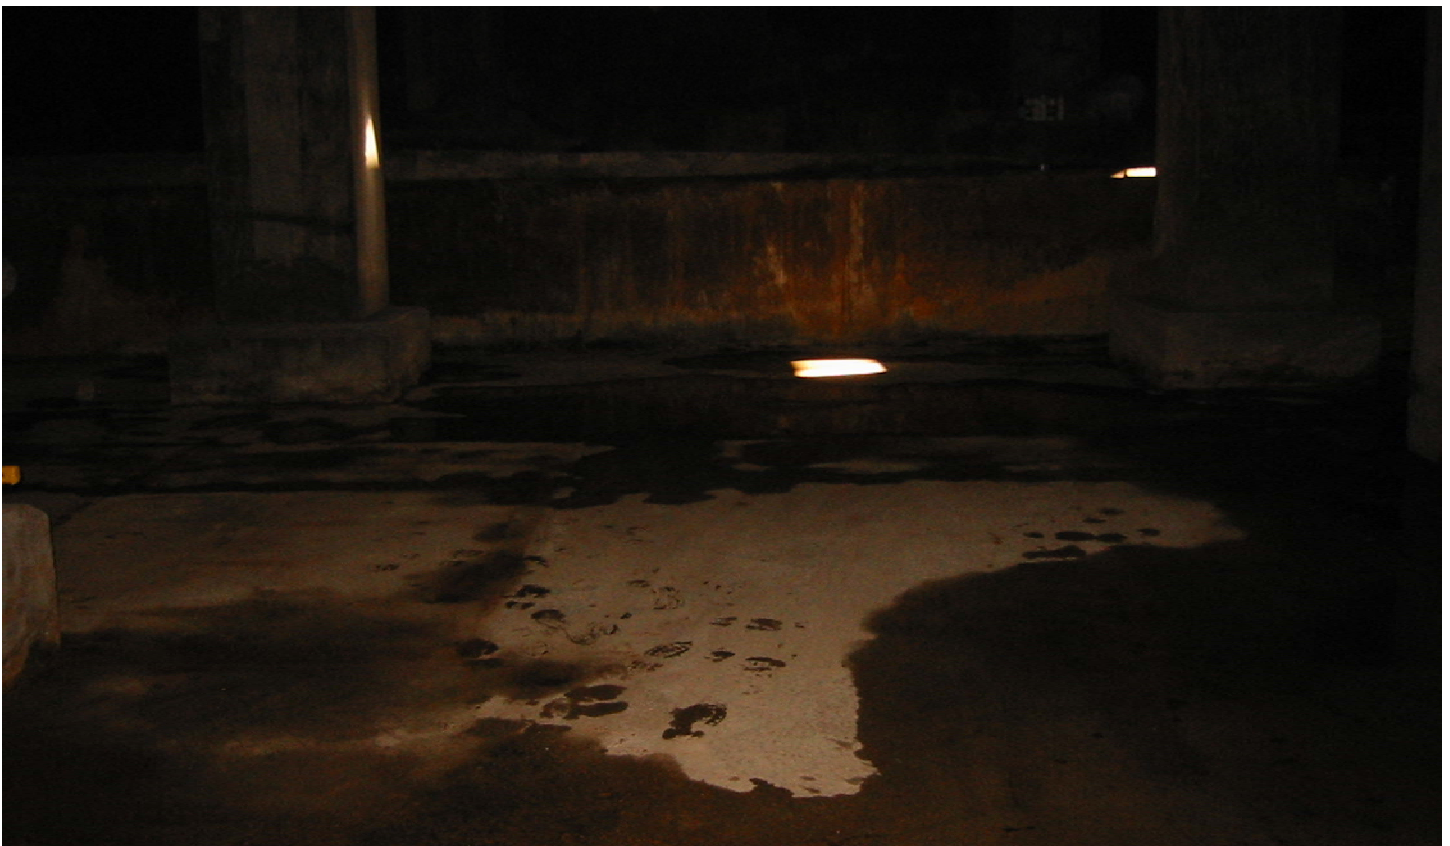
Photograph 36. Building 105 SAFR. SAFR floor post-remediation, September 2002.

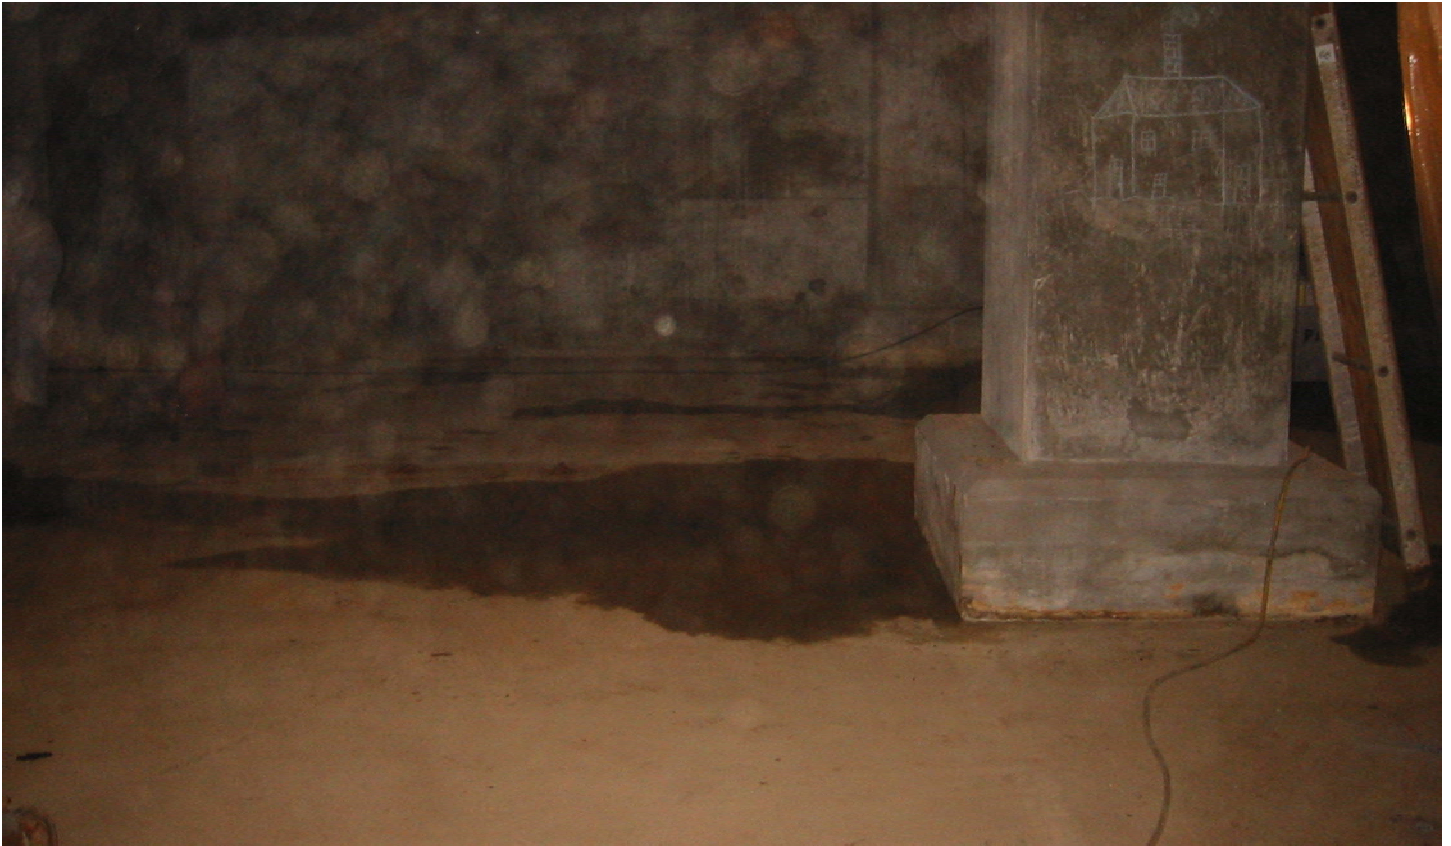
Photograph 29. Building 105 SAFR. After demolition and pressure washing, September 2002.

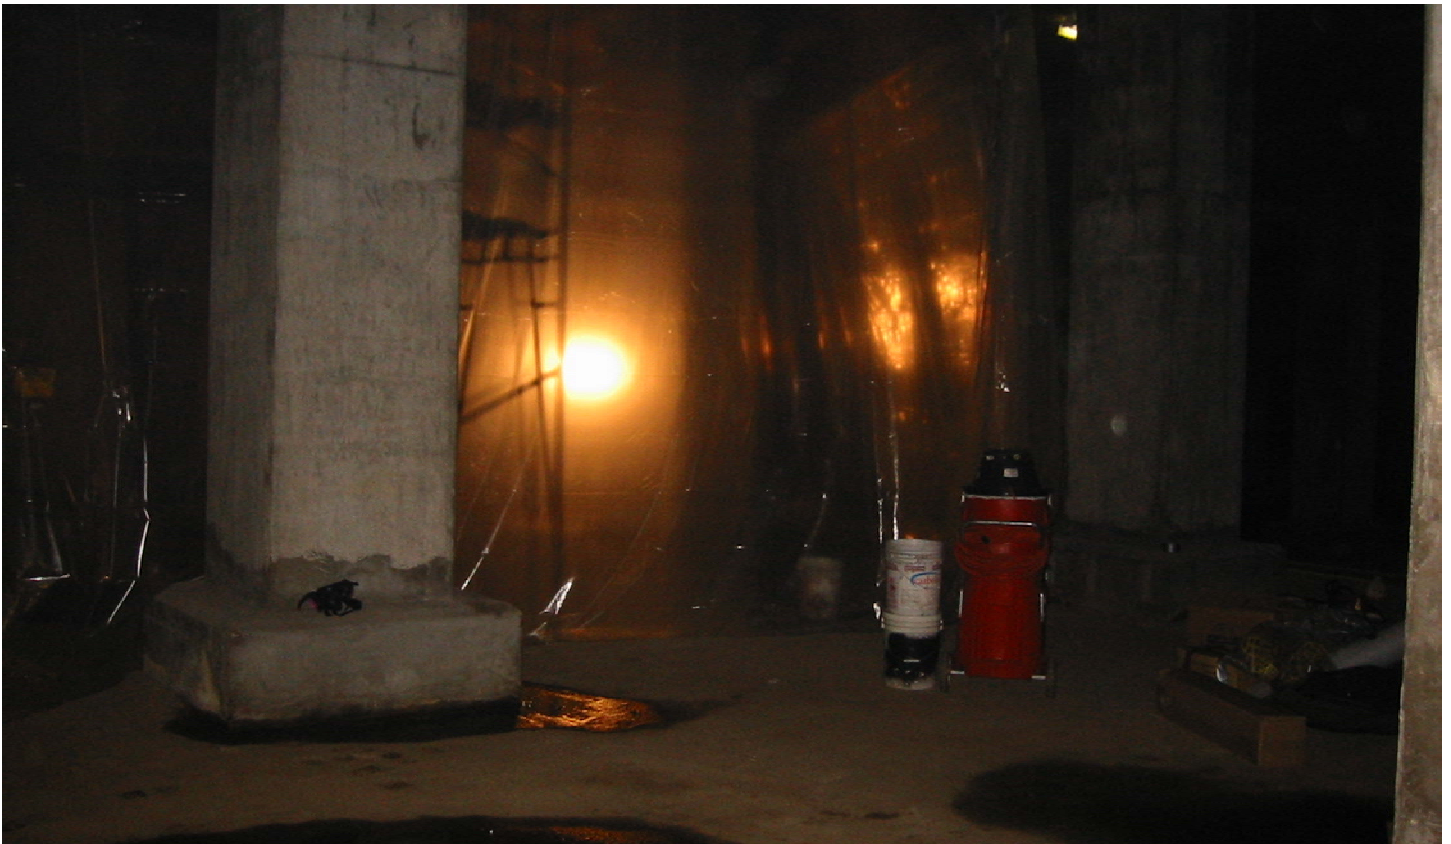
Photograph 30. Building 105 SAFR. Post remediation, after washdown, September 2002.
