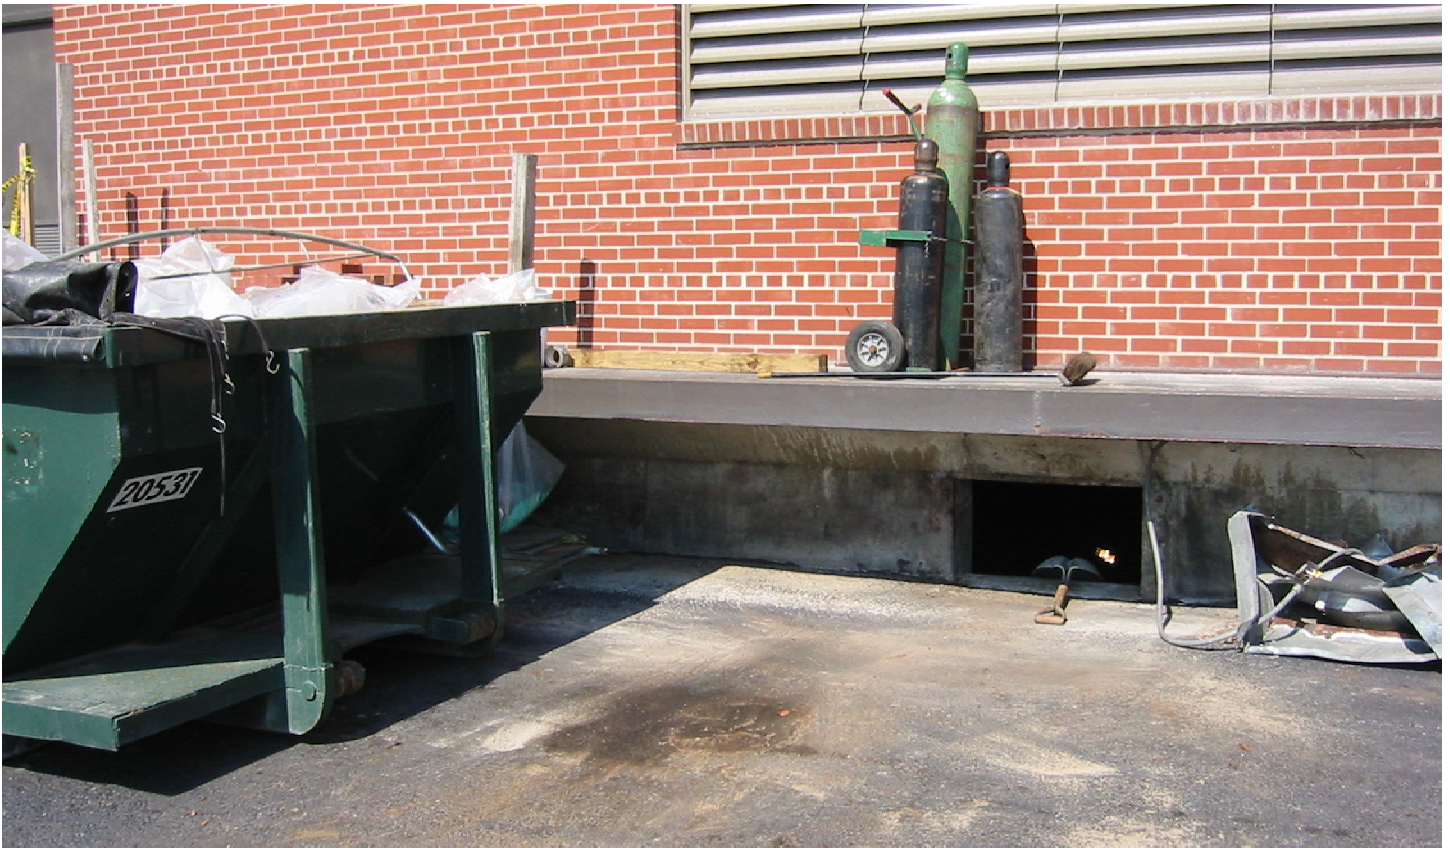
Photograph 19. Building 105 SAFR. Roll-off staged outside ventilation window east side of Building 105, September 2002.

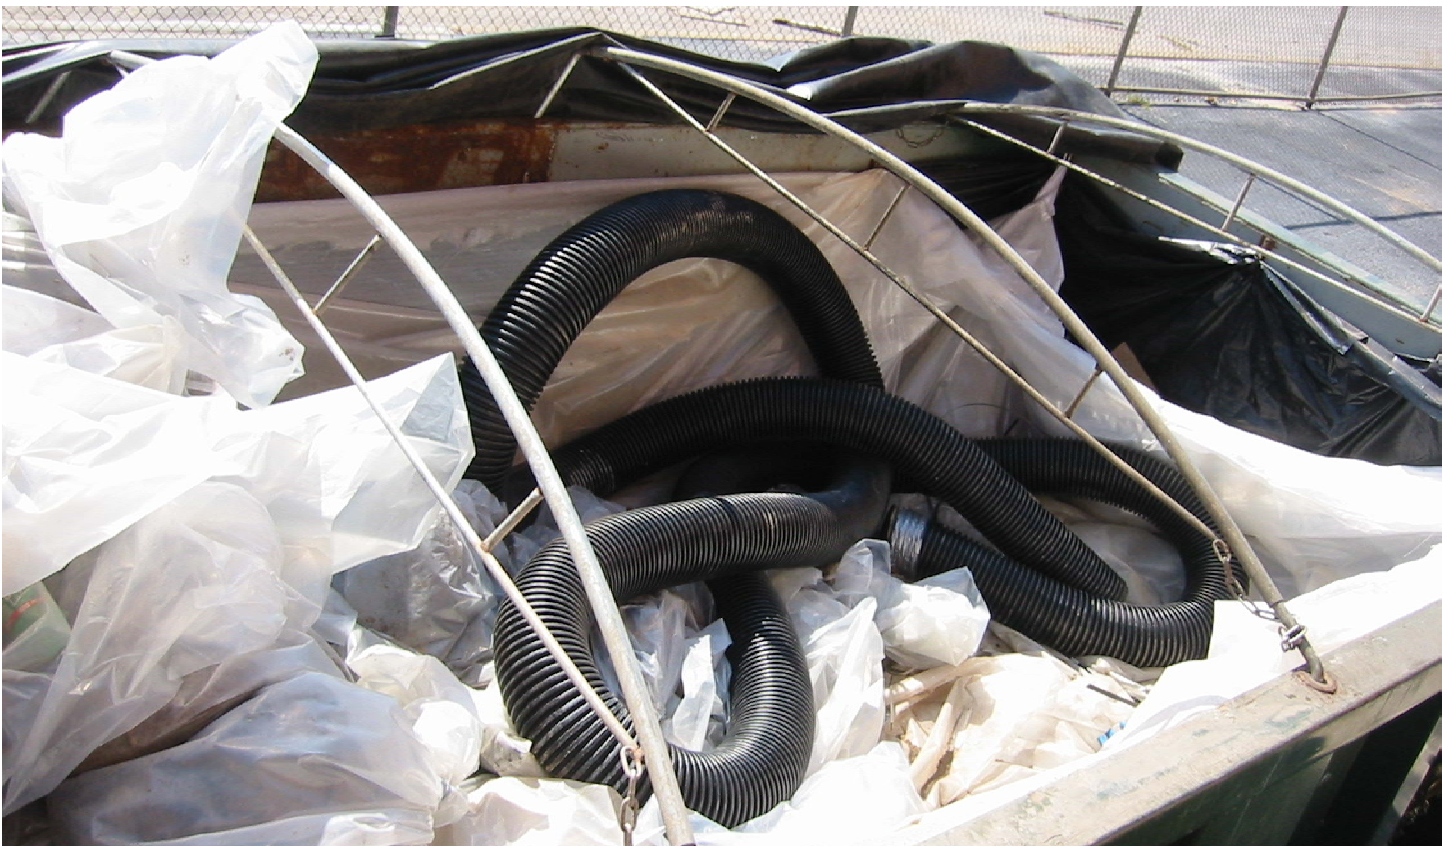
Photograph 20. Building 105 SAFR. Hose used to remove sand from basement; disposed as hazardous wastet, September 2002.

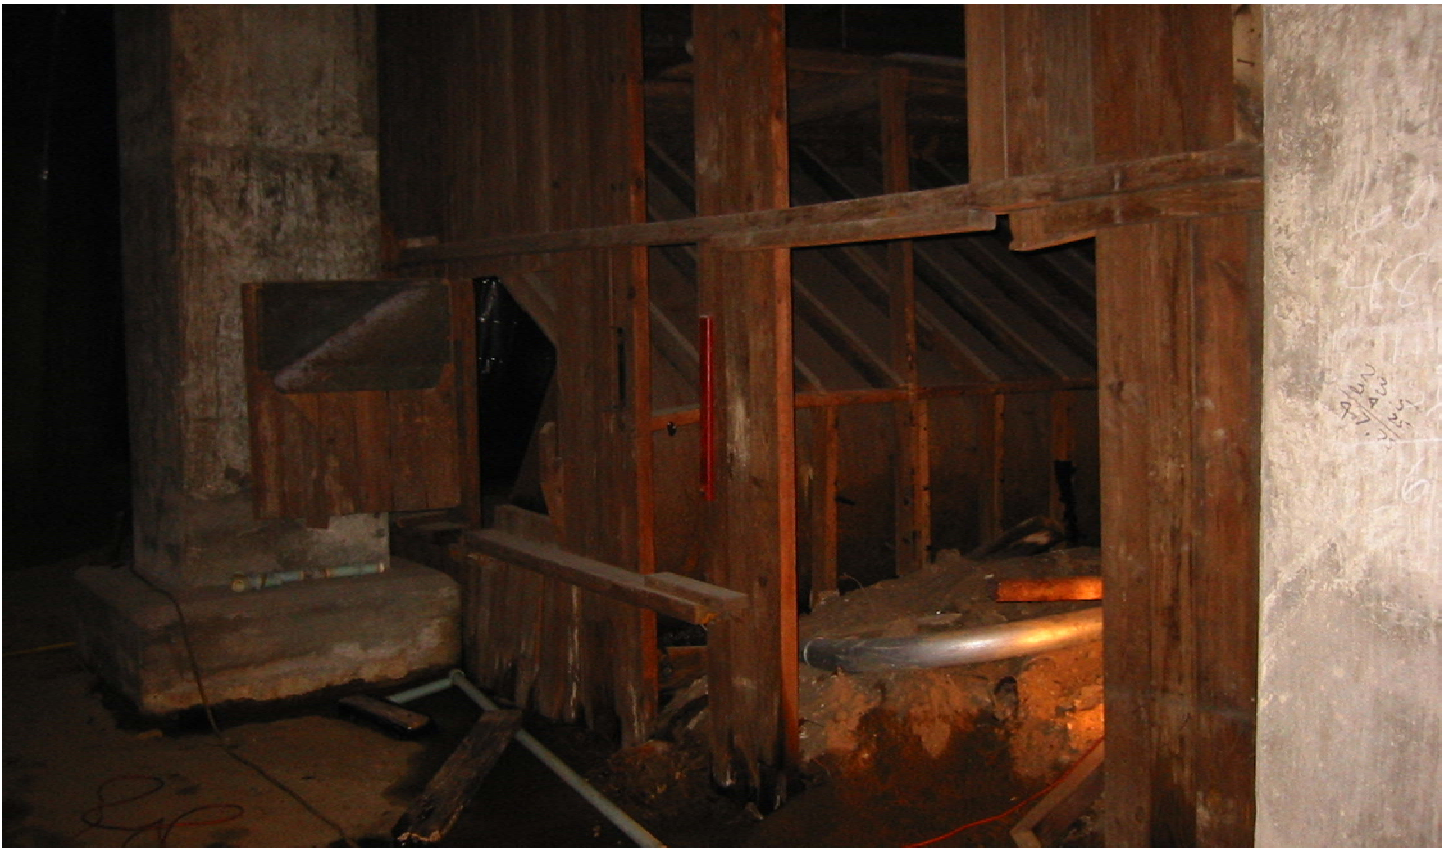
Photograph 13. Building 105 SAFR. Rear of SAFR prior to demolition, September 2002.

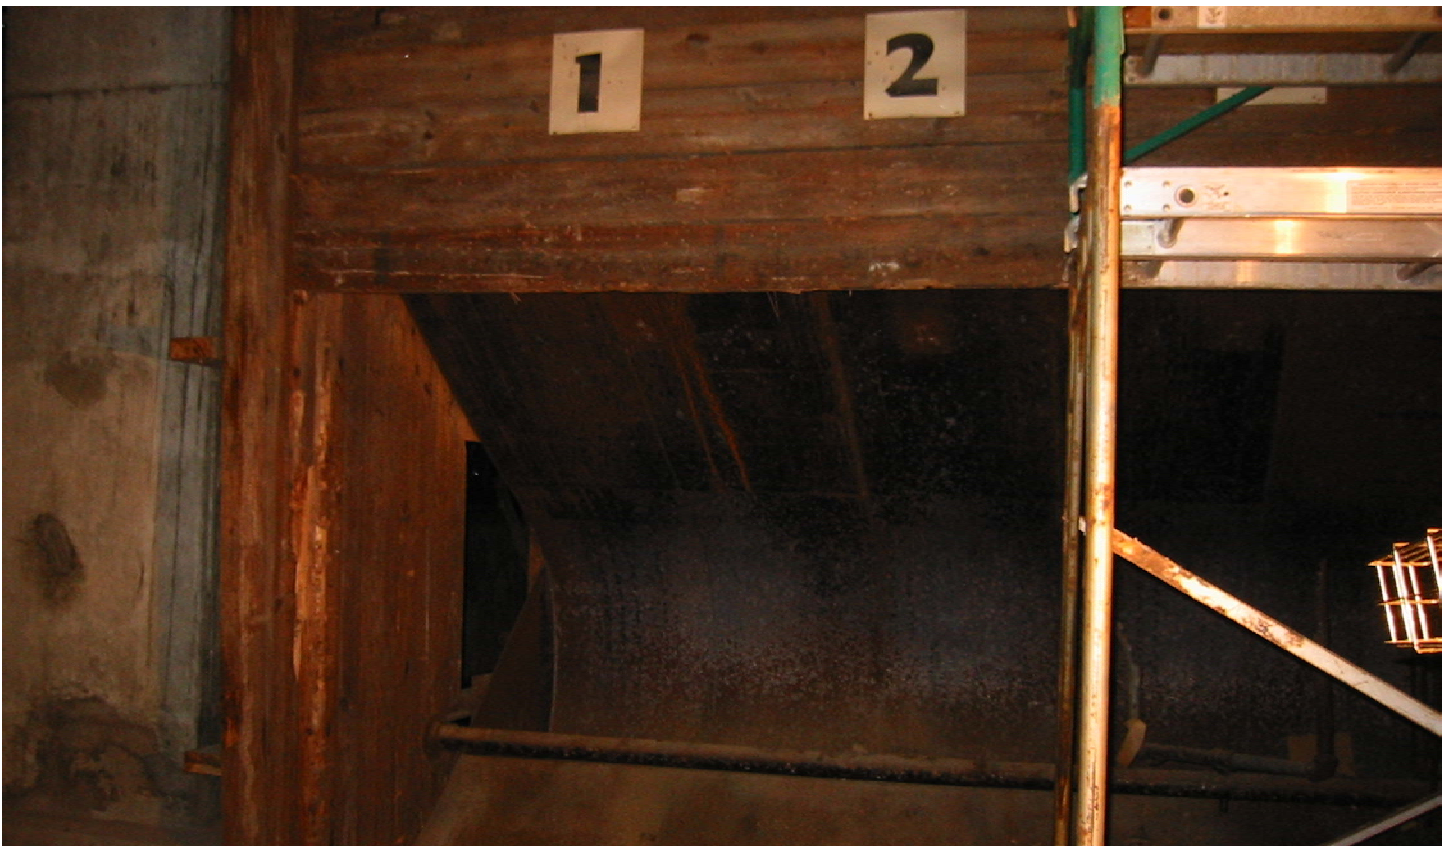
Photograph 14. Building 105 SAFR. Typical scarification evidence on Bullet Pit backstop and of wood framing, September 2002.

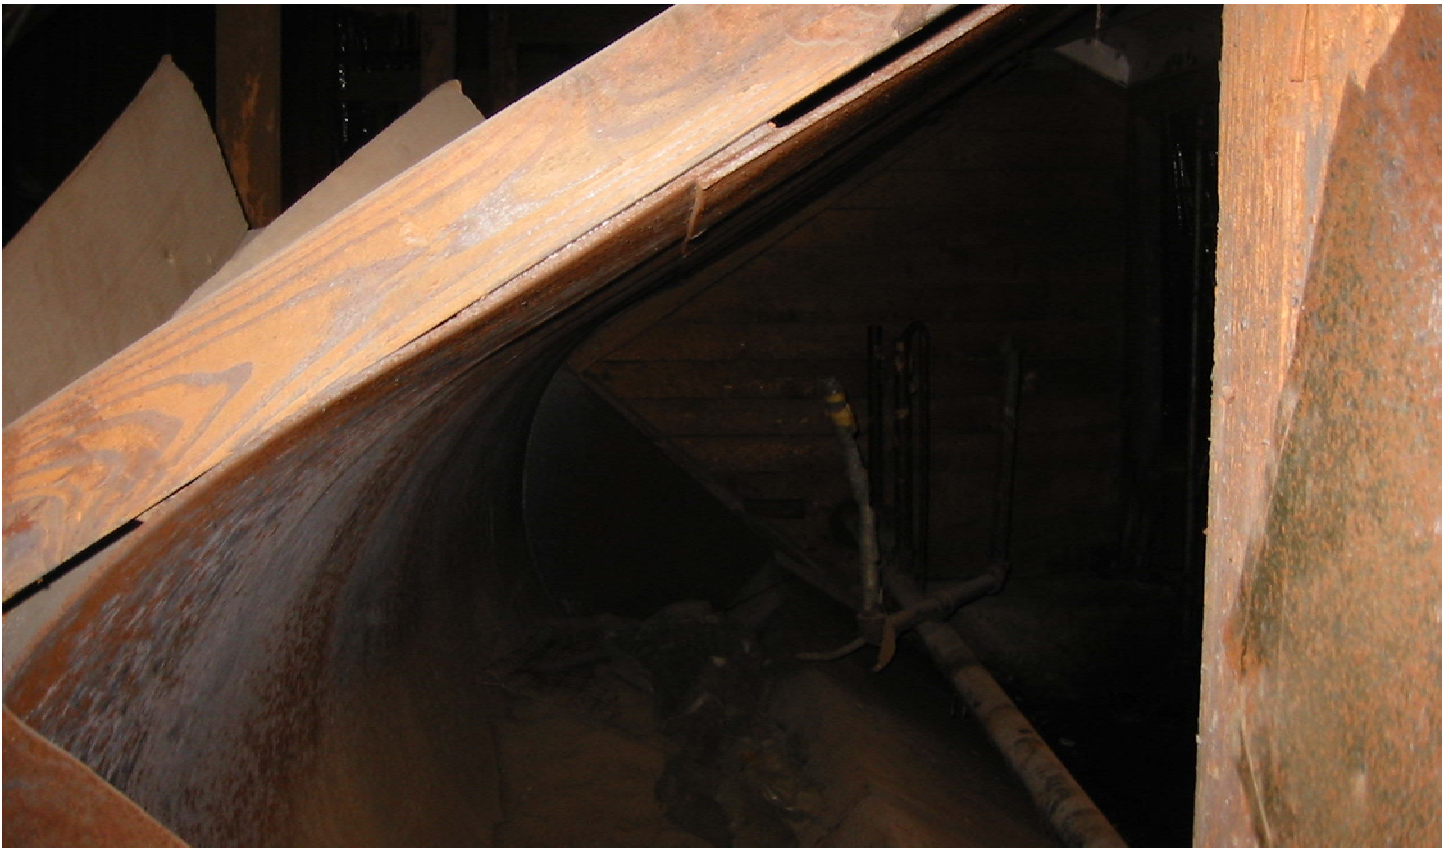
Photograph 15. Building 105 SAFR. End on view of Bullet Pit metal backstop showing curvature, September 2002.

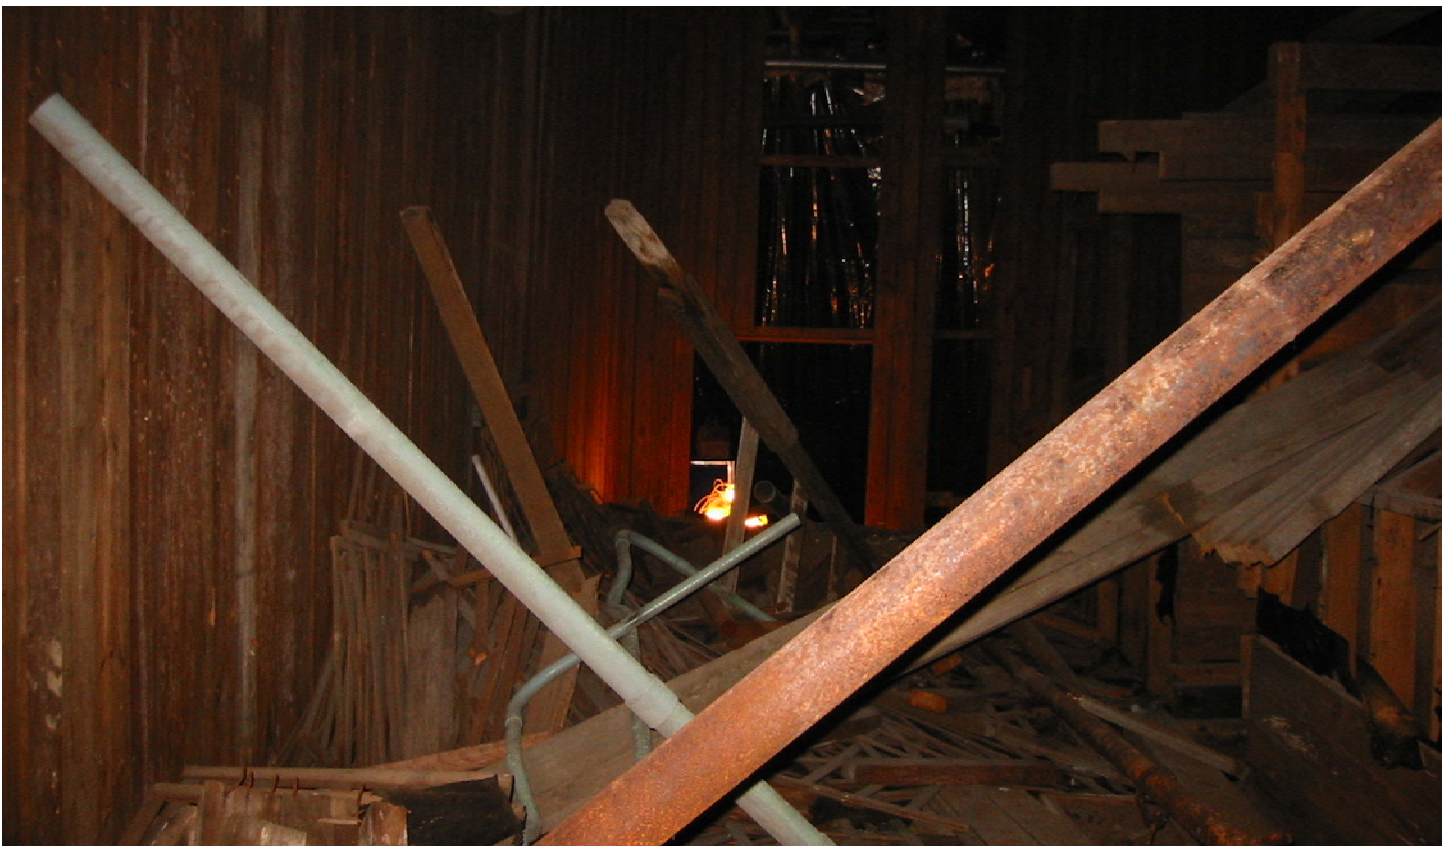
Photograph 16. Building 105 SAFR. Debris (metal pipe, wood, plastics) behind range, September 2002.
