# Thornton Tomasetti

## Project

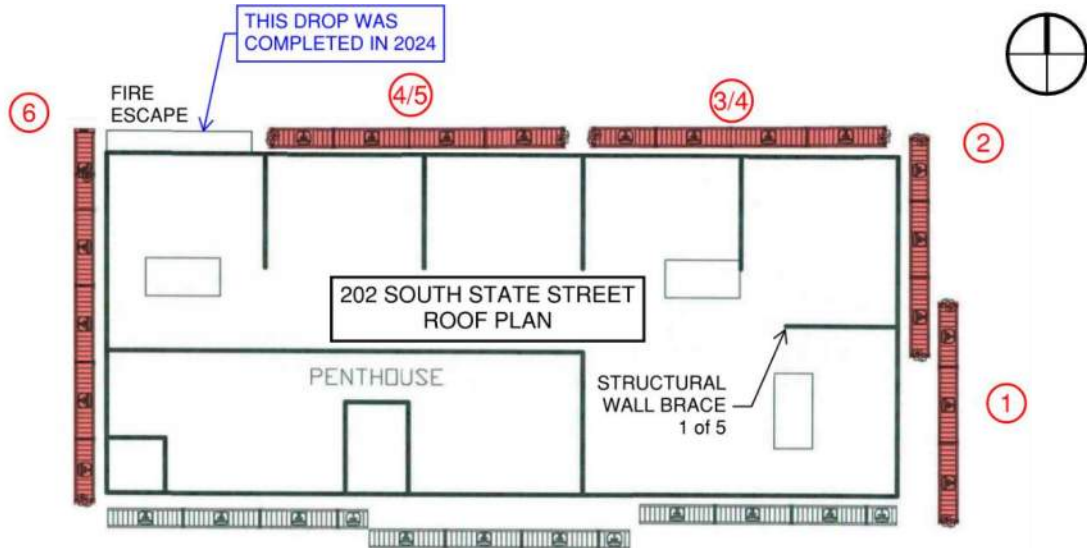
TT's observations were limited to up-close visual inspections performed at arm's length with the aid of hammer or mallet devices to sound the terra cotta surface and check for loose or delaminated pieces. This project did not include destructive material testing nor individual probe openings. The contractor implemented temporary stabilization repairs at cracked or severely damaged areas as part of this examination. Refer to the Stabilization Repairs Section 3.04 herein.

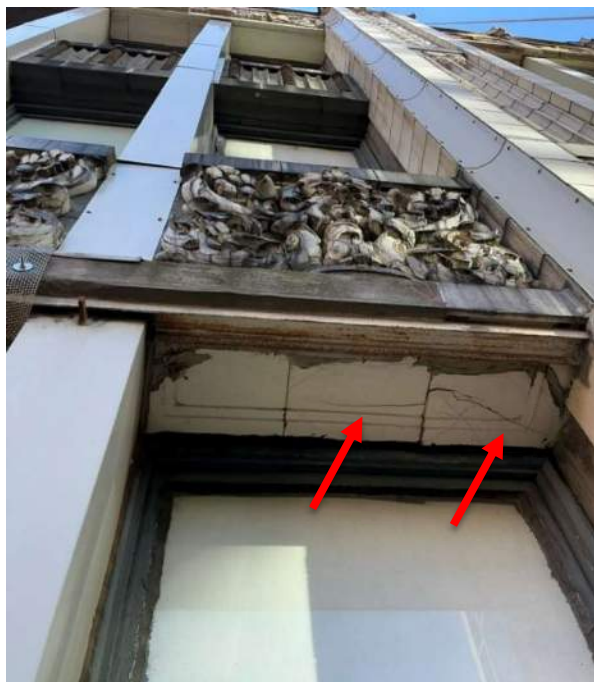
**Photo 7.** Ornamental spandrel at 14<sup>th</sup> floor North Elevation (cracks noted on underside of window head units) – subsequently strapped

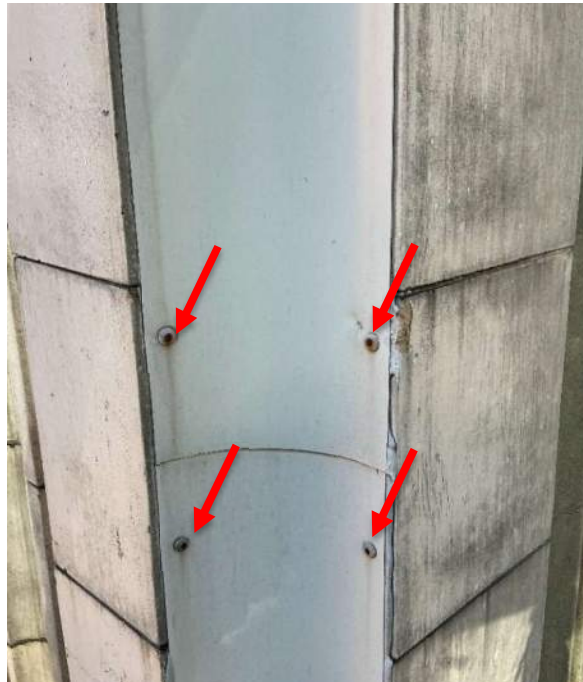
**Photo 8.** Typical corrodible anchors observed on aluminum sheeting

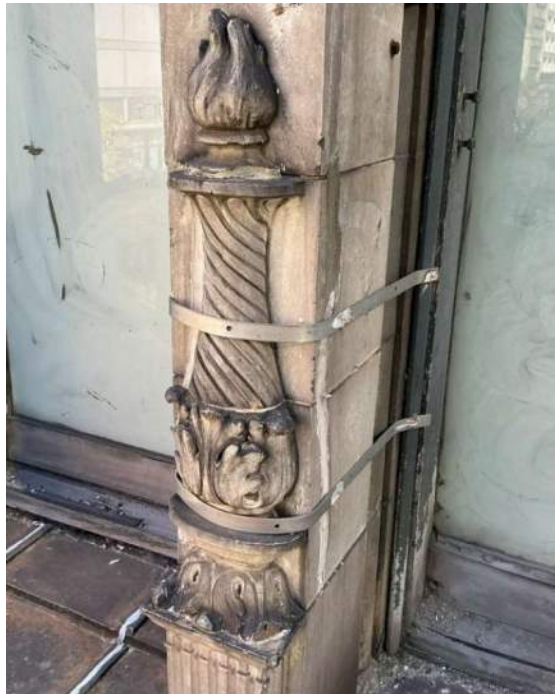
**Photo 9.** Mullion unit at 3<sup>rd</sup> floor with previously installed straps

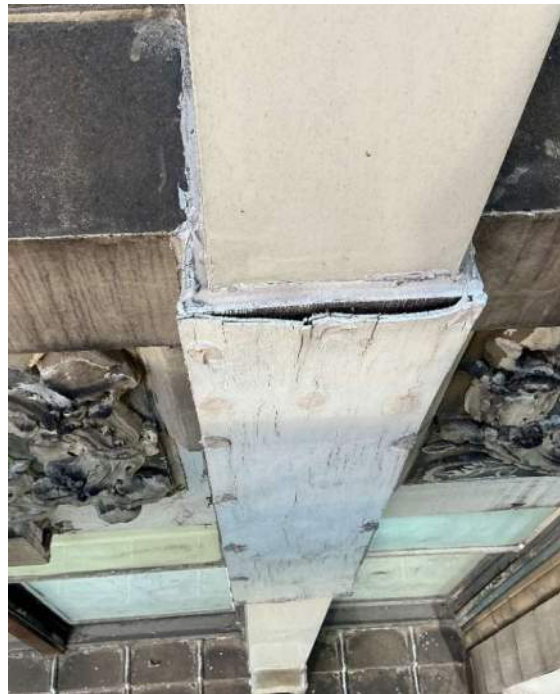
**Photo 10** Typical weathered deteriorated plywood coverings at previously removed terra cotta units. This condition was subsequently replaced.

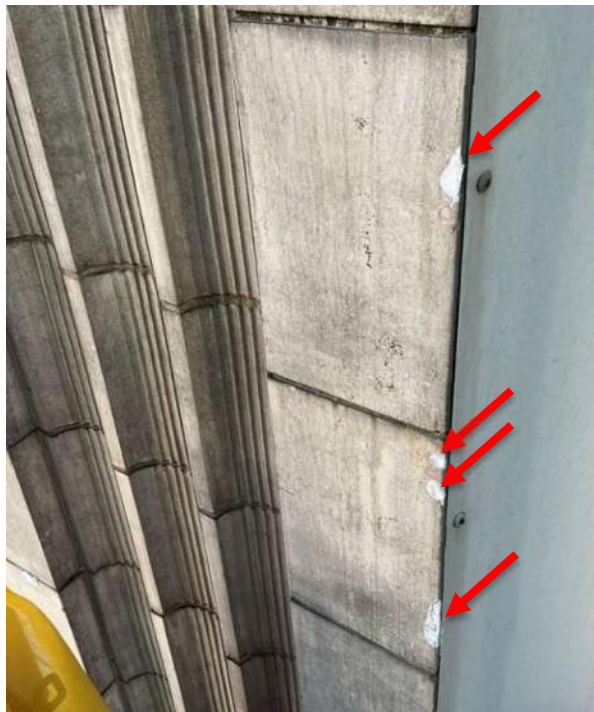
**Photo 11.** Sealed spalls at terra cotta units along full length of column

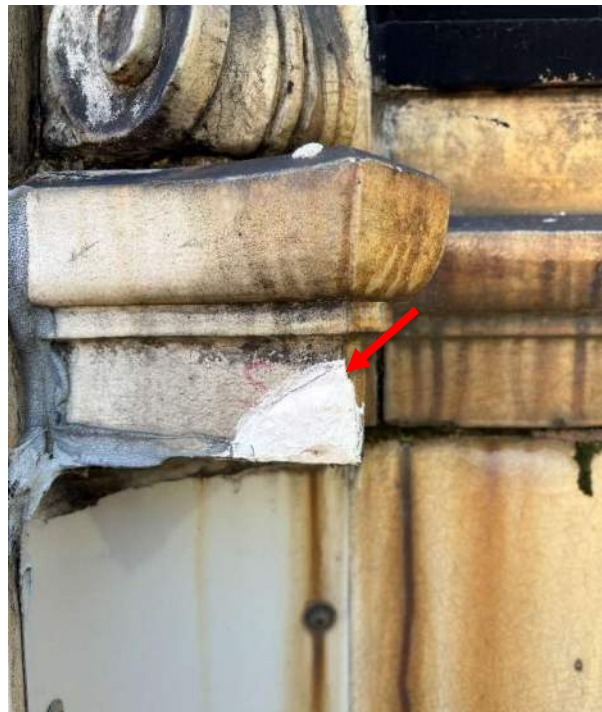
**Photo 12.** Sealed spall at terra cotta unit

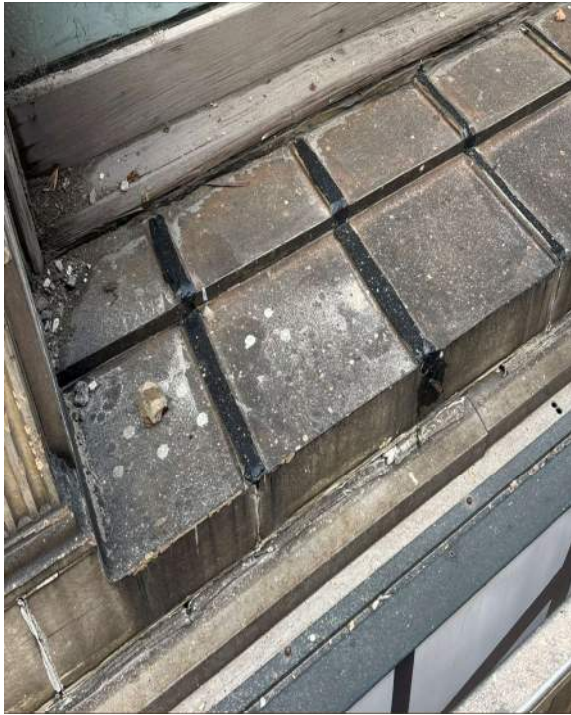
**Photo 13.** Sealed skyward joints at windows

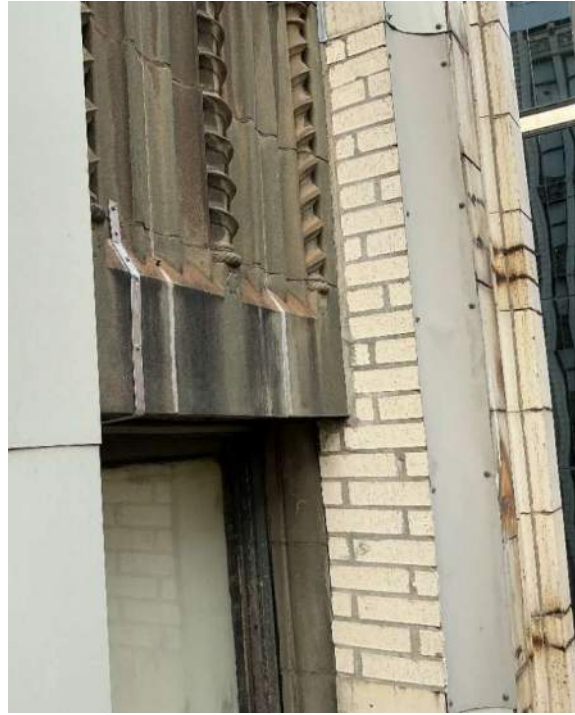
**Photo 14.** Replacement of terra cotta units with brick masonry

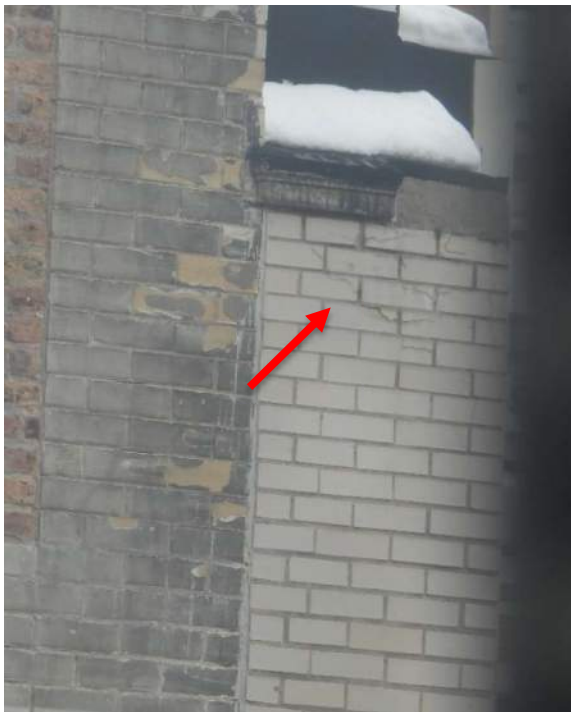
**Photo 15.** Deteriorated brick at southeast corner of Floor 15. This area was subsequently meshed.

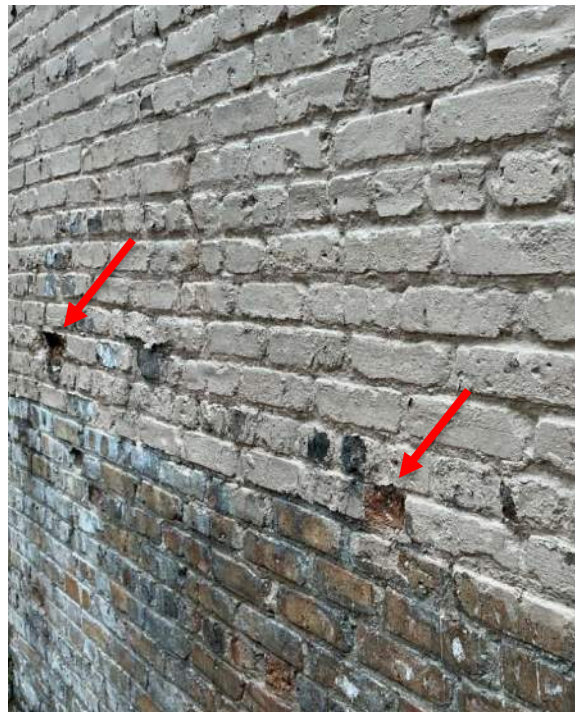
**Photo 16.** Spalled brick at west elevation

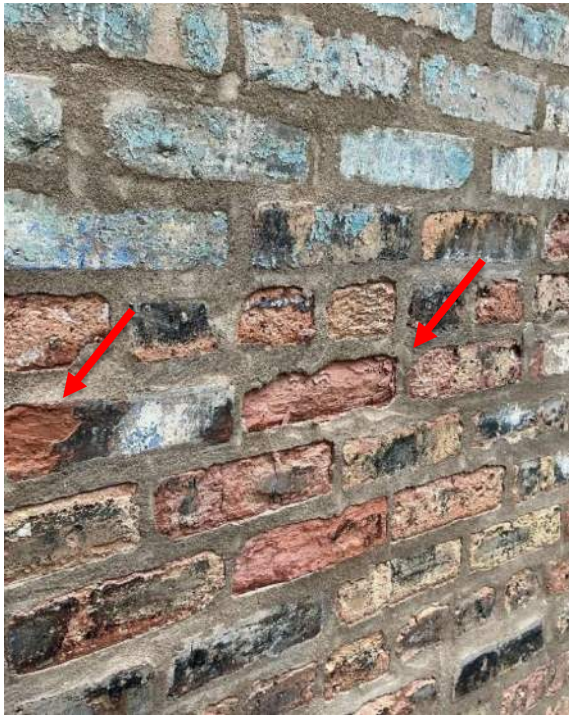
**Photo 17.** Deteriorated brick at west elevation

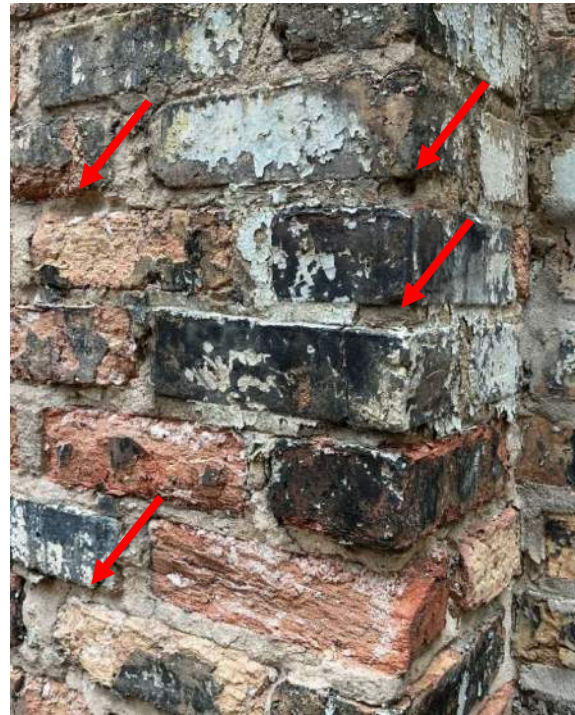
**Photo 18.** Severely deteriorated mortar joints. Subsequently repointed.

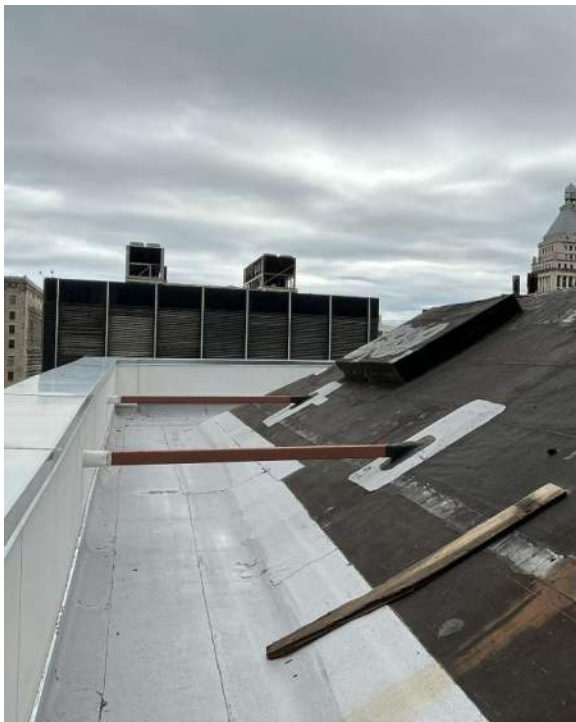
**Photo 19.** Newly-constructed parapet wall with metal coping and roof flashing.

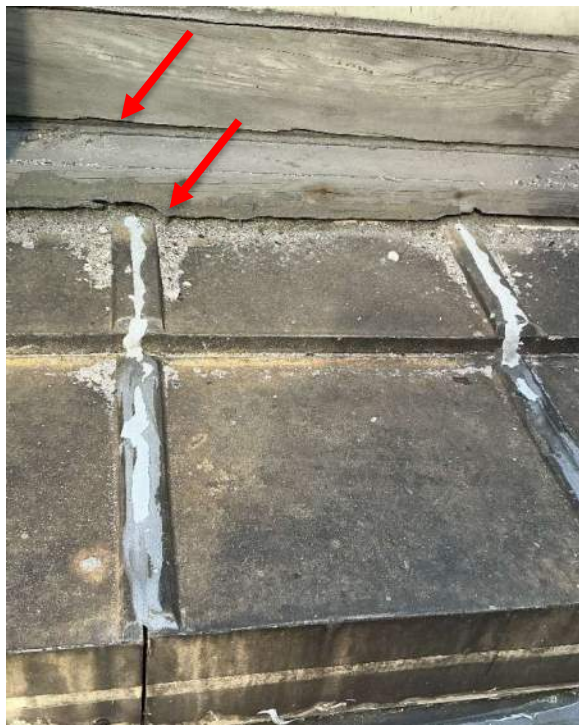
**Photo 21.** Deterioration of wood sill and sash at window

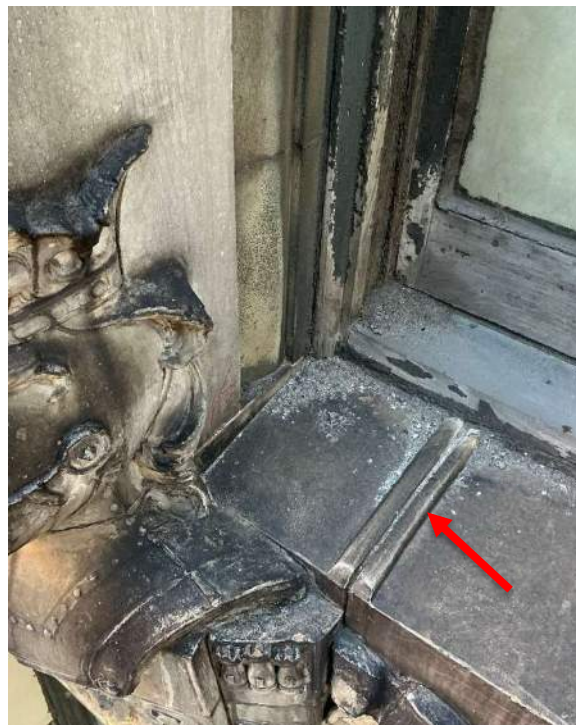
**Photo 22.** Deteriorated mortar joint at 4<sup>th</sup> floor window sill

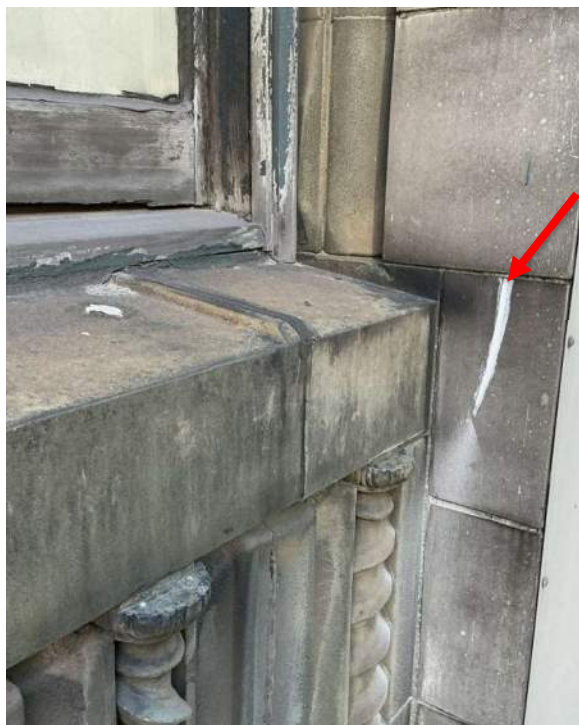
**Photo 23.** Typical terra cotta rout and seal repair

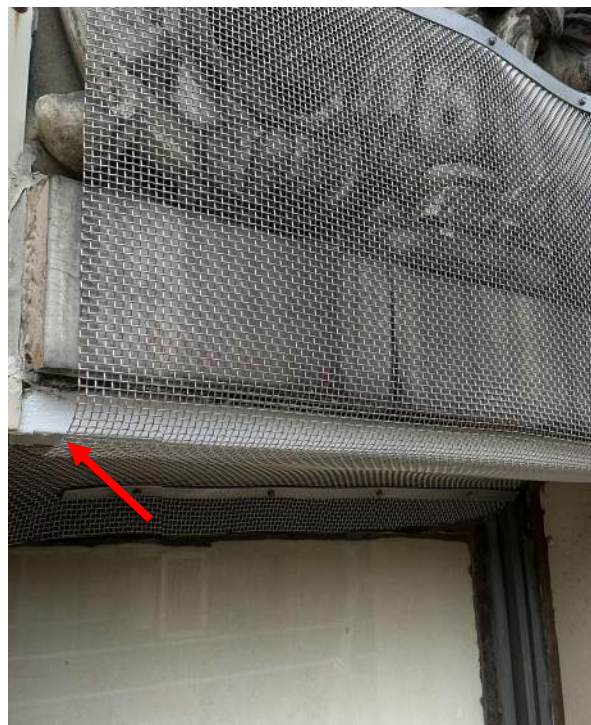
**Photo 24.** Typical mesh and painted horizontal metal channel repair

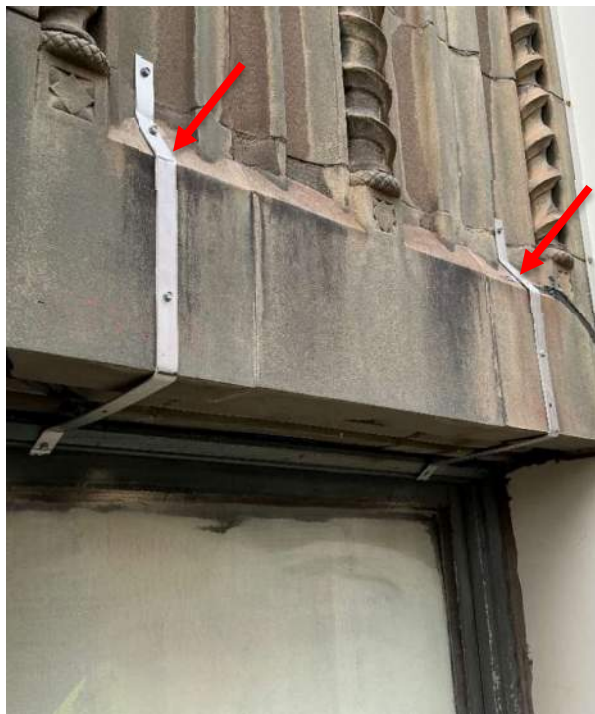
**Photo 25.** Typical cracked terra cotta metal strap stabilization repair

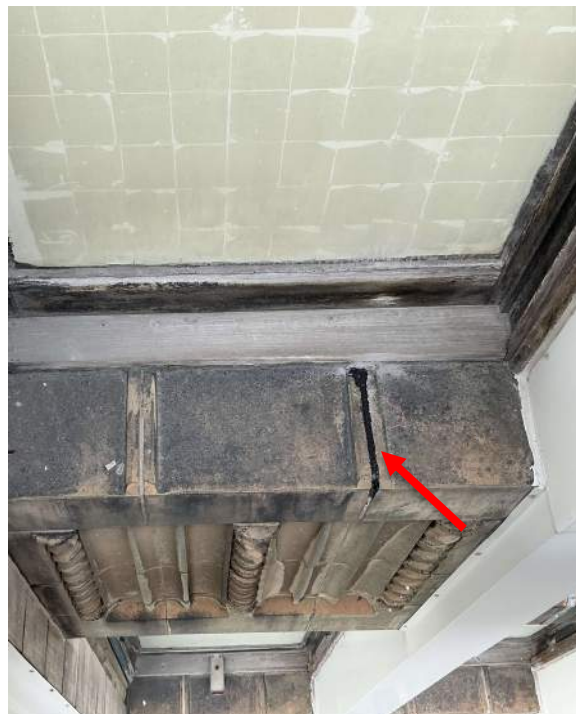
**Photo 26.** Typical skyward facing joint sealant repair

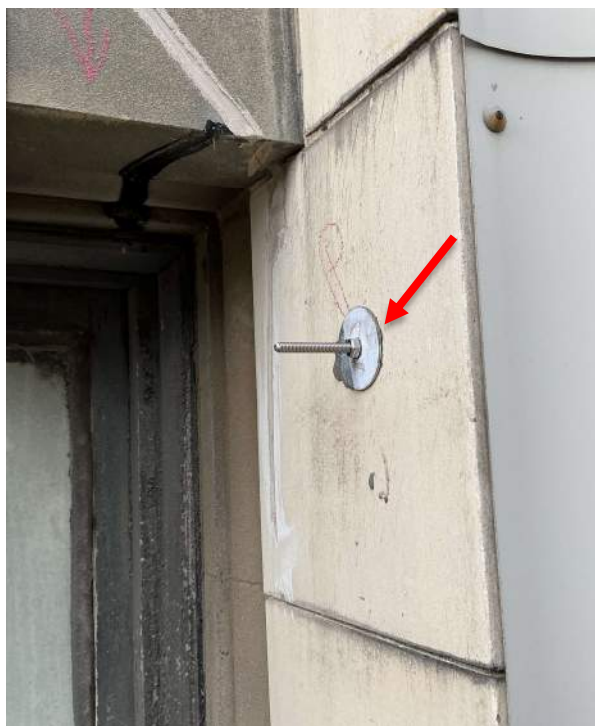
**Photo 27.** Typical installation of supplemental metal pins

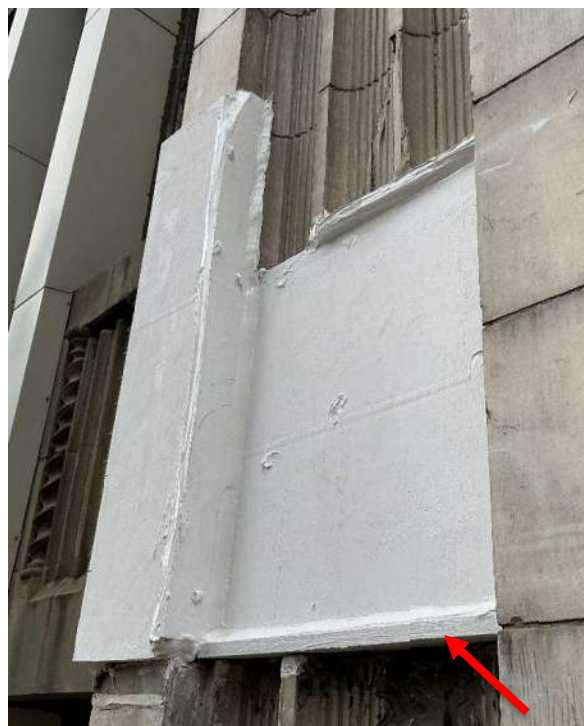
**Photo 28.** Typical plywood cover replacement

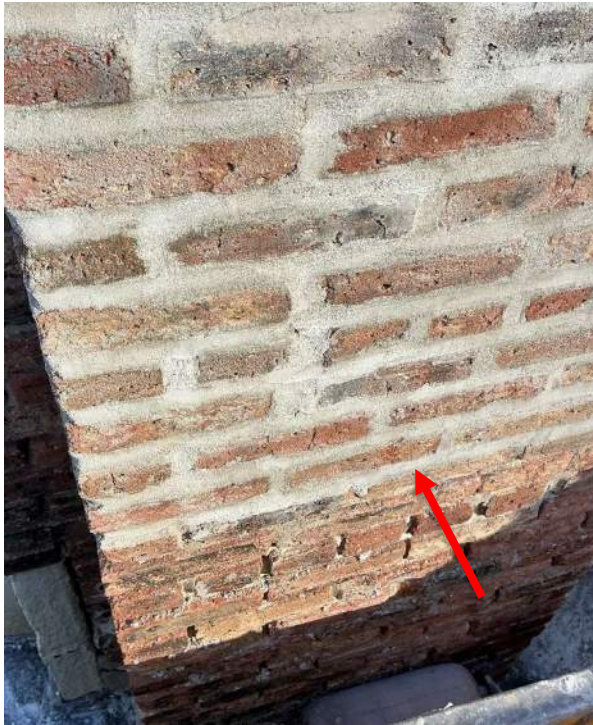
**Photo 29.** Typical brick repointing at West Elevation

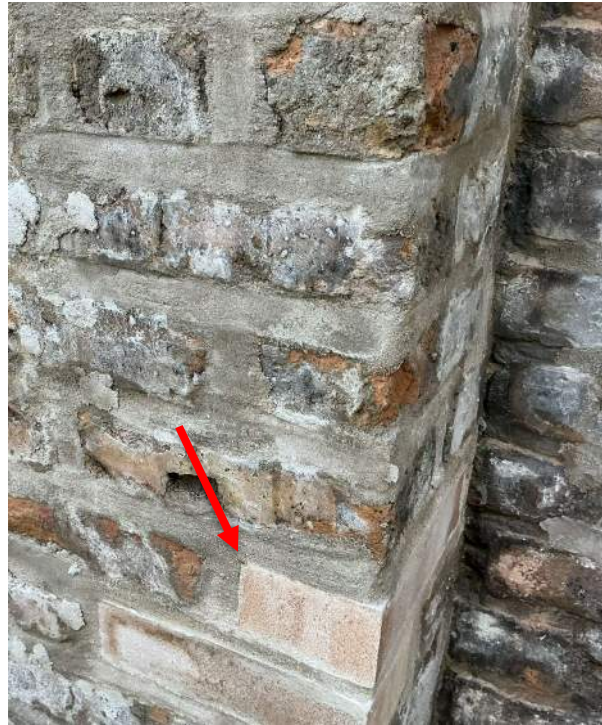
**Photo 30.** Typical brick replacement at West Elevation.

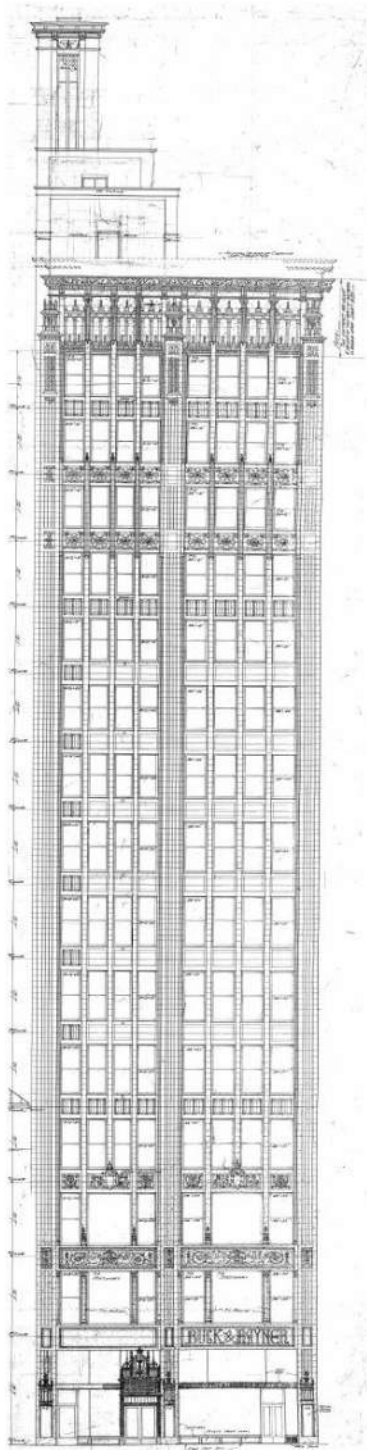
*Figure 1: East Elevation from original Holabird and Roche architectural drawings*

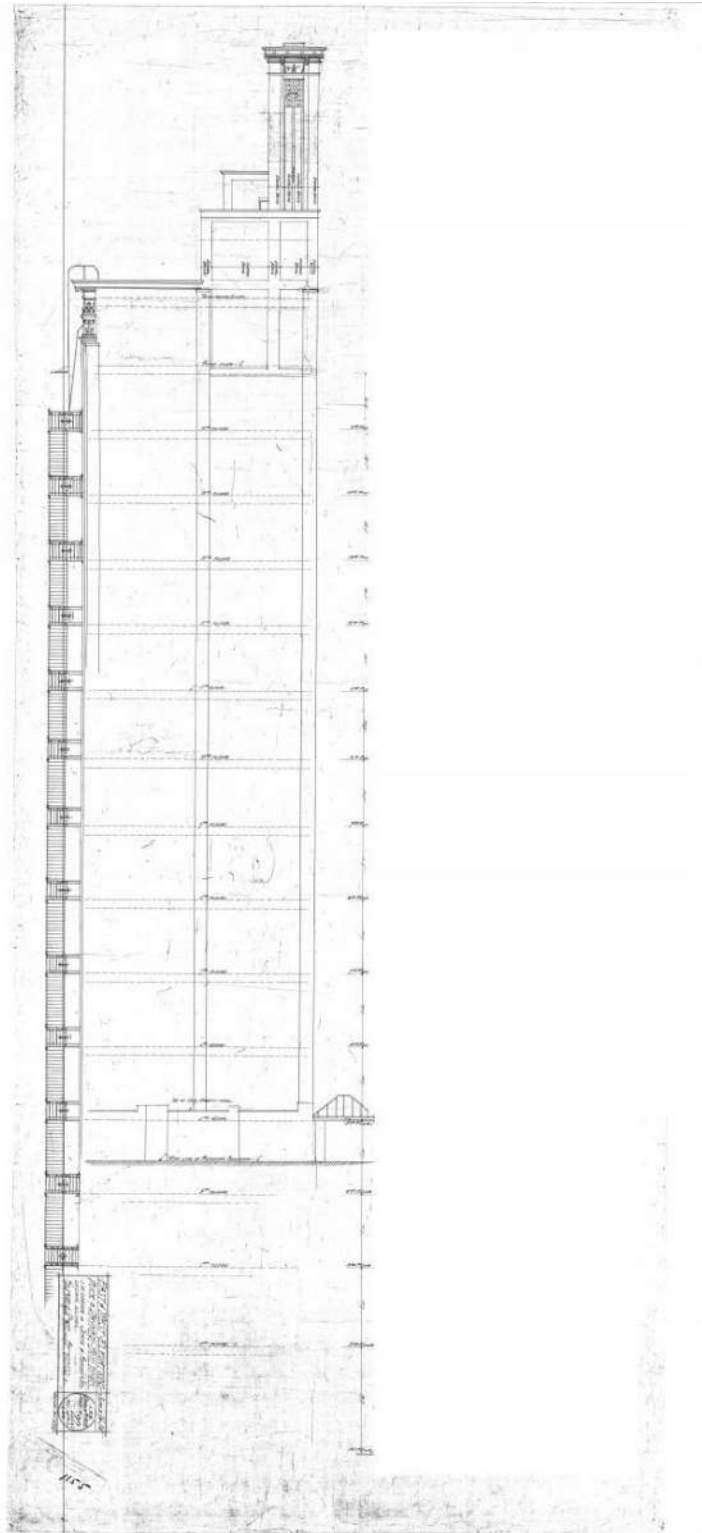
*Figure 3: West Elevation from original Holabird and Roche architectural drawings*
