## Project

### Critical Examination Report Consumers Building

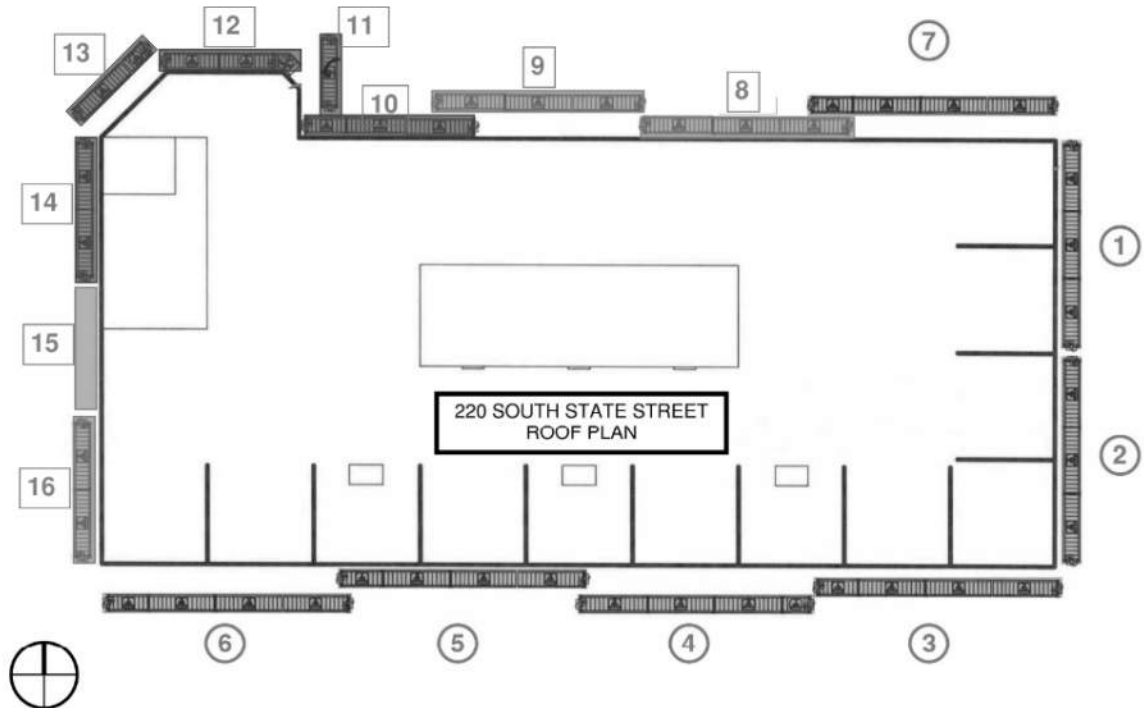
TT's observations were limited to up-close visual examinations performed at arm's length with the aid of hammer or mallet devices to sound the terra cotta surface and check for loose and delaminated pieces. This project did not include destructive material testing, and no new individual probe openings were performed as a part of this Critical Examination. The contractor implemented temporary stabilization repairs at cracked or severely damaged areas as part of this examination. Refer to the Temporary Stabilization Repairs Section 3.04 herein.

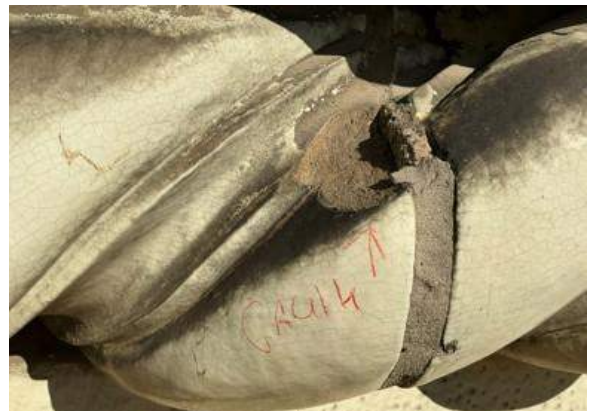
**Photo 4.** Spall along torsade on the 21<sup>st</sup> floor water table.

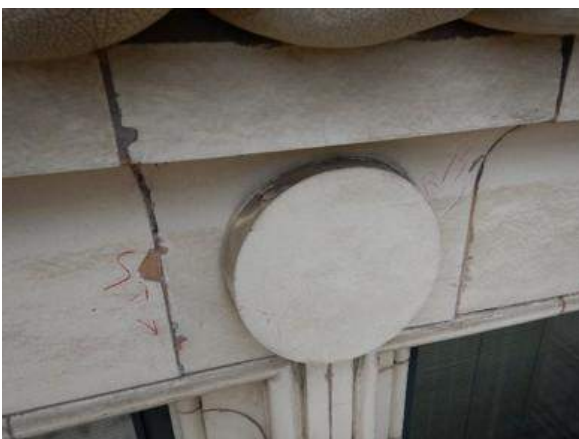
**Photo 5.** Terra cotta capping at columns below 21<sup>st</sup> floor water table (2021 photo for reference only, repairs have been completed).

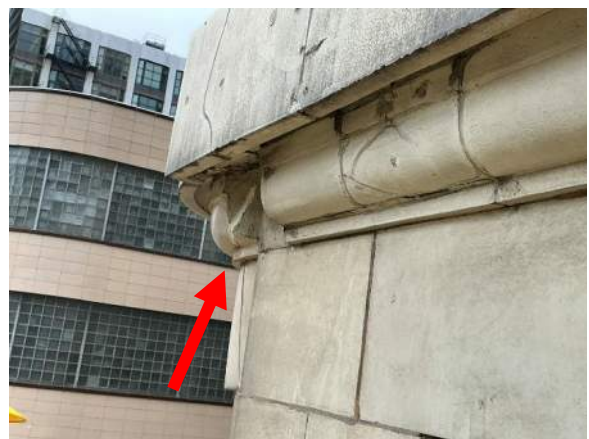
**Photo 6.** Previously removed water table piece at the northeast corner of the building, cracks routed and sealed.

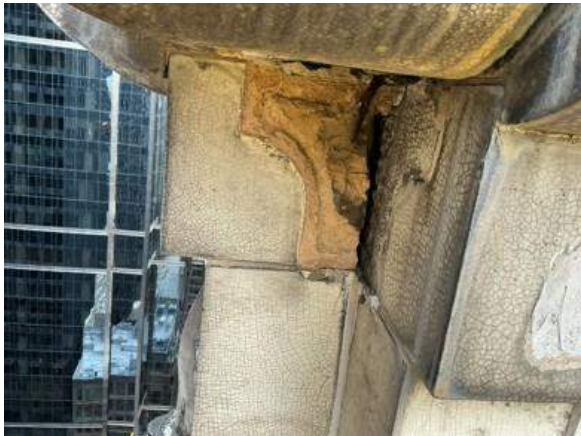
**Photo 7.** 22<sup>nd</sup> floor water table with missing terra cotta portion with corroded steel tie shown, exposed terra cotta subsequently covered with plywood.

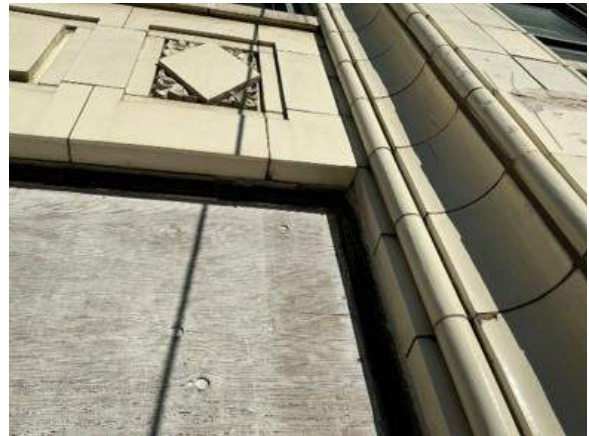
**Photo 8.** Typical decorated spandrels.

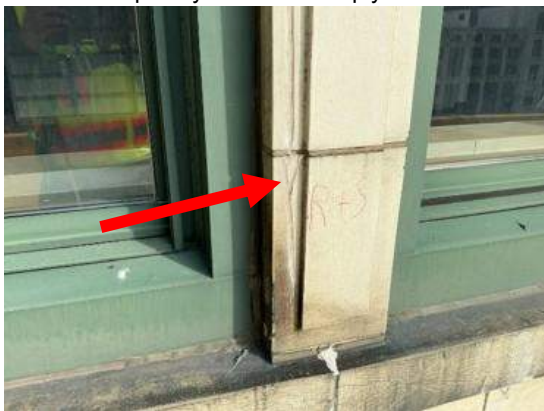
**Photo 9.** Typical terra cotta mullion on the east elevation, with crack noted by red arrow, subsequently routed and sealed.

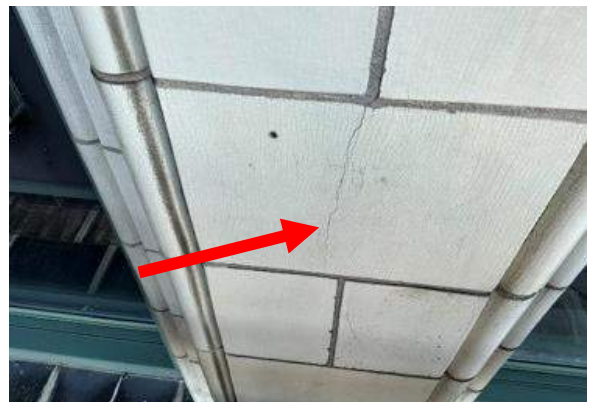
**Photo 10.** Typical cracked terra cotta mullion units on the south elevation, subsequently routed and sealed.

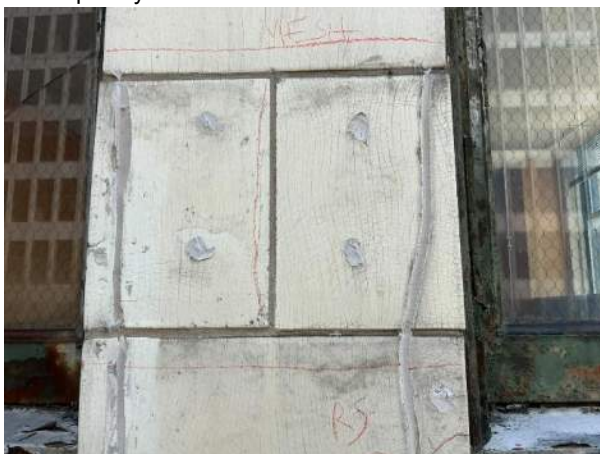
**Photo 11.** Previous terra cotta repairs at column units in poor condition.

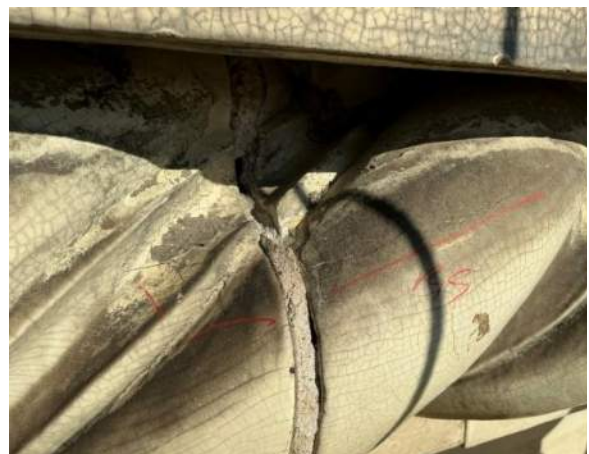
**Photo 12.** Deteriorated mortar joints at cornice torsade at the south elevation.

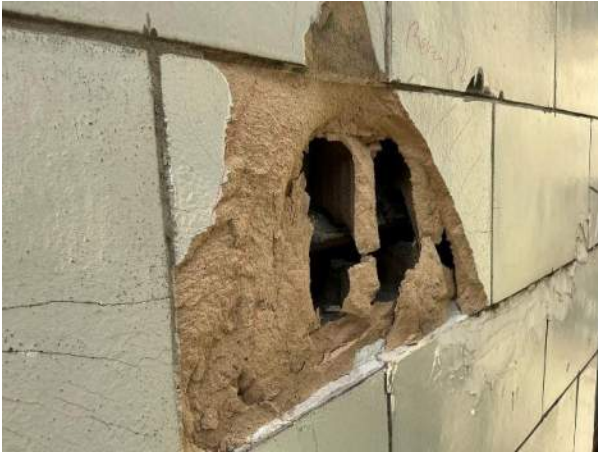
**Photo 13.** Exposed terra cotta core due to face spall, subsequently rebuilt with white glaze brick.

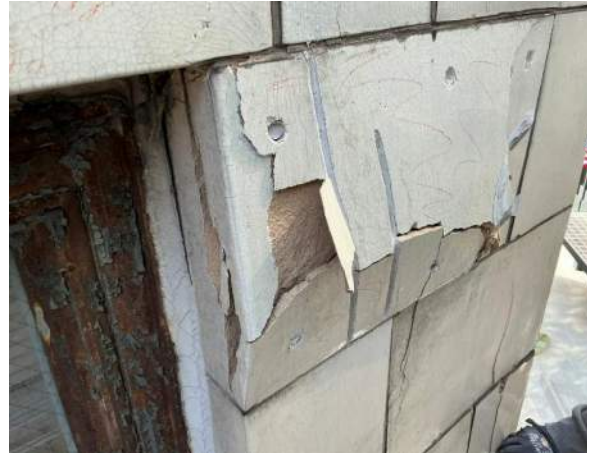
**Photo 14.** Terra cotta face spall, subsequently rebuilt with white glaze brick.

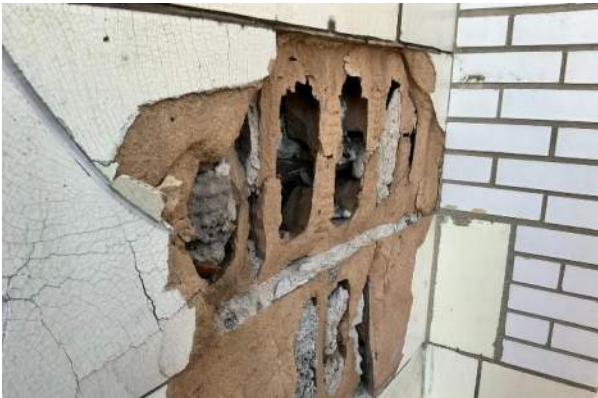
**Photo 15.** Exposed terra cotta core due to face spall, subsequently rebuilt with white glaze brick.

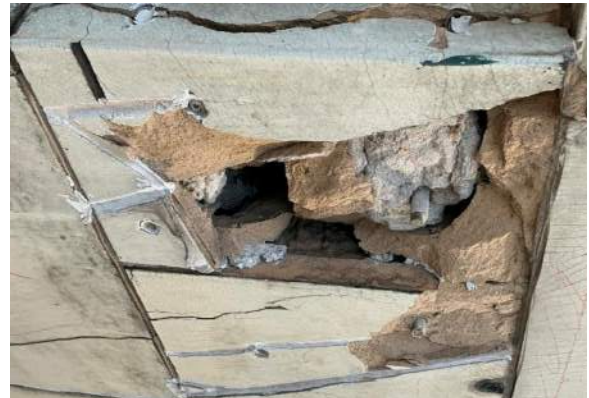
**Photo 16.** Exposed terra cotta core due to face spall, subsequently rebuilt with white glaze brick.

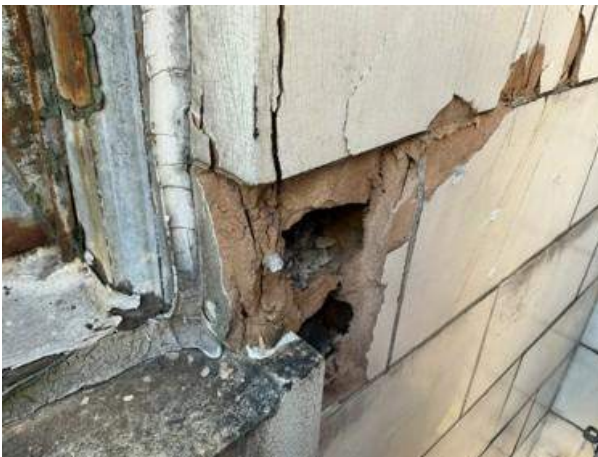
**Photo 17.** Exposed terra cotta core due to face spall, subsequently rebuilt with white glaze brick.

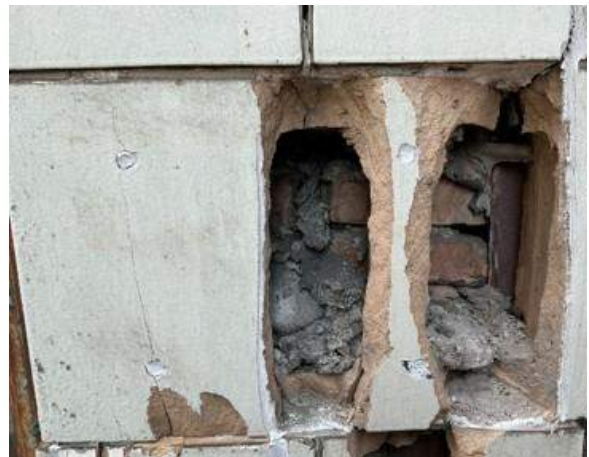
**Photo 18.** Exposed terra cotta core due to face spall, subsequently rebuilt with white glaze brick.

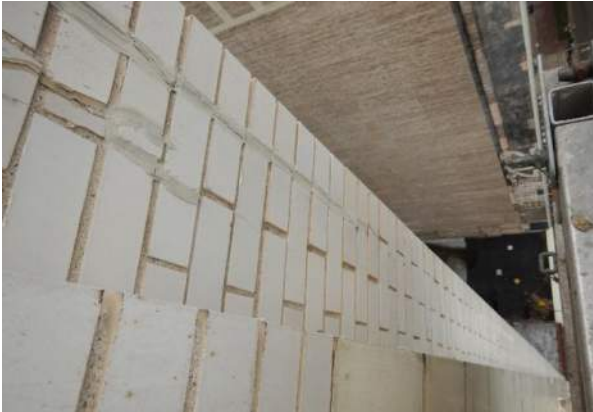
**Photo 19.** Previously rebuilt brick at the northeast corner of the building.

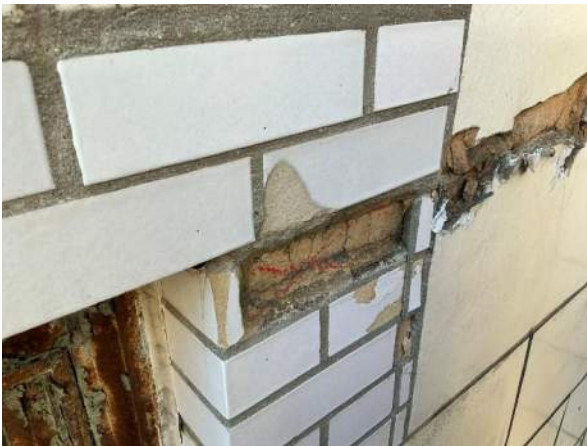
**Photo 21.** Typical spall at the white glaze brick infill, subsequently replaced in kind.

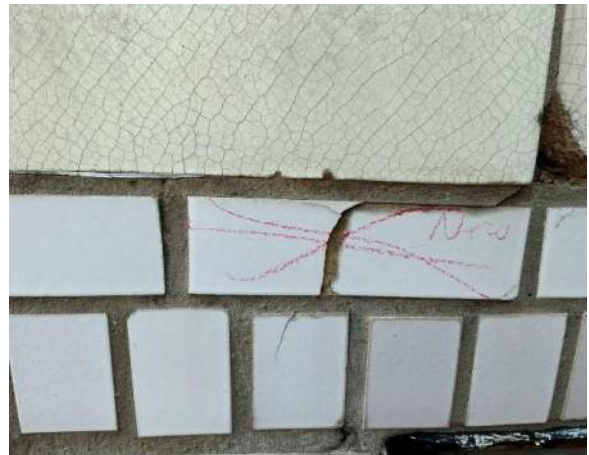
**Photo 22.** Cracked white glaze brick at masonry infill, subsequently replaced in kind.

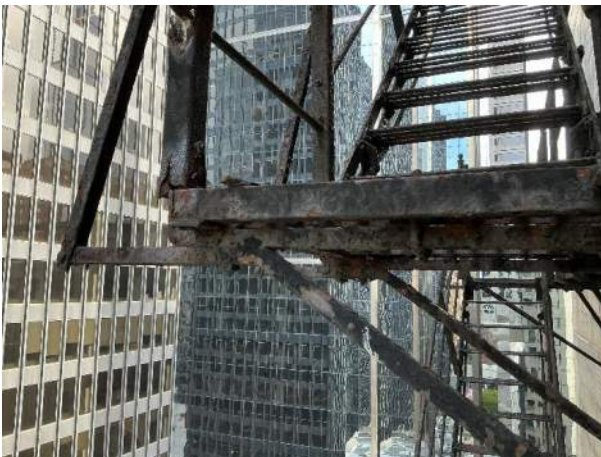
**Photo 23.** Corrosion at the west elevation fire escape steel members

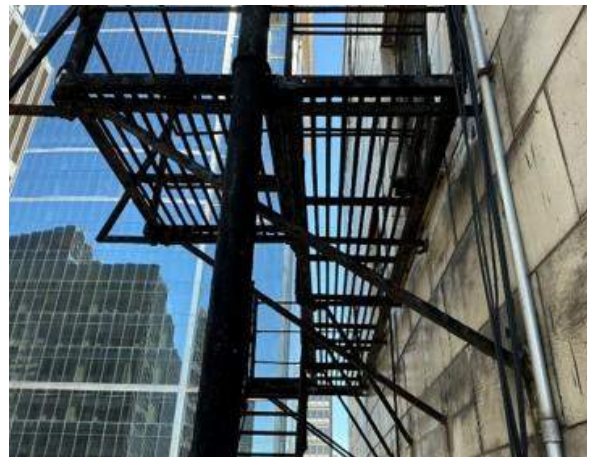
**Photo 24.** West elevation fire escape steel members.

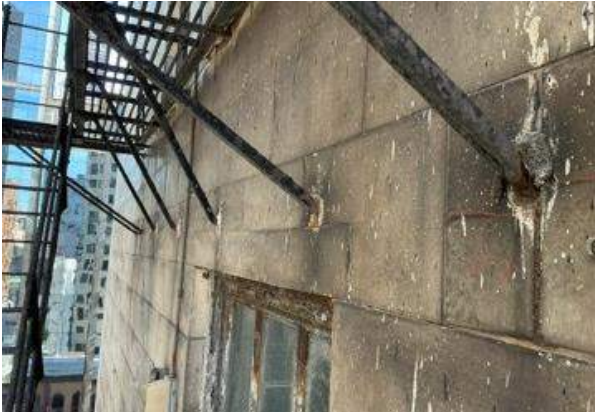
**Photo 25.** Spalling terra cotta at west elevation fire escape anchorage.

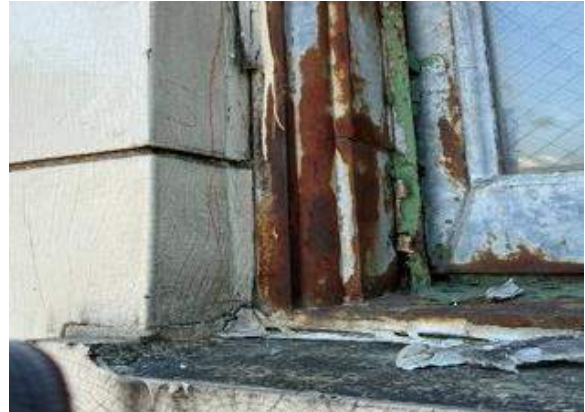
**Photo 26.** Corrosion at metal window frame.

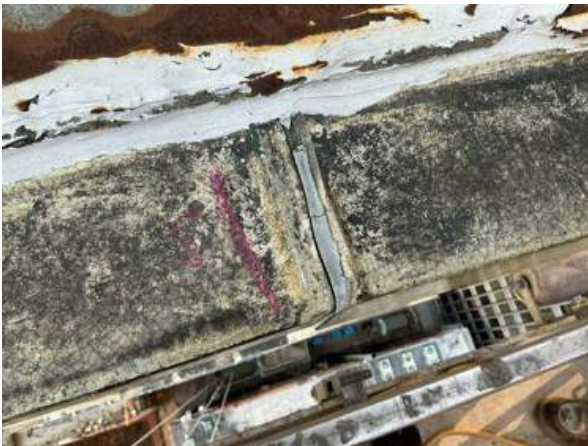
**Photo 27.** Typical debonded skyward sealant joint at terra cotta window sill, subsequently replaced in kind.

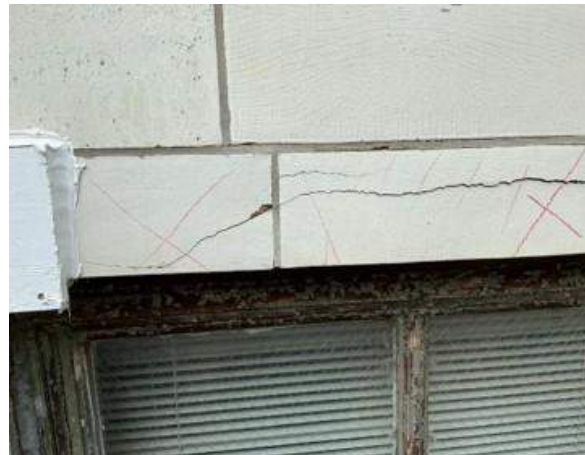
**Photo 28.** Severe cracking at terra cotta window head units, subsequently removed and covered with plywood.

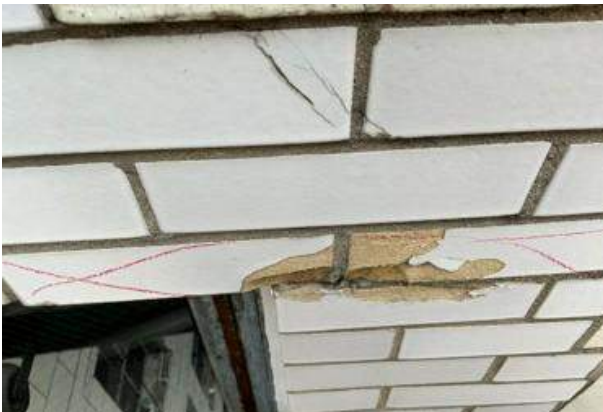
**Photo 29.** Typical glaze spalling on white glaze masonry infill.

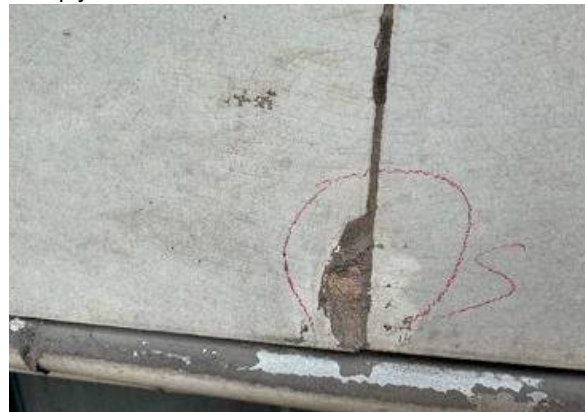
**Photo 30.** Typical terra cotta glaze spall.

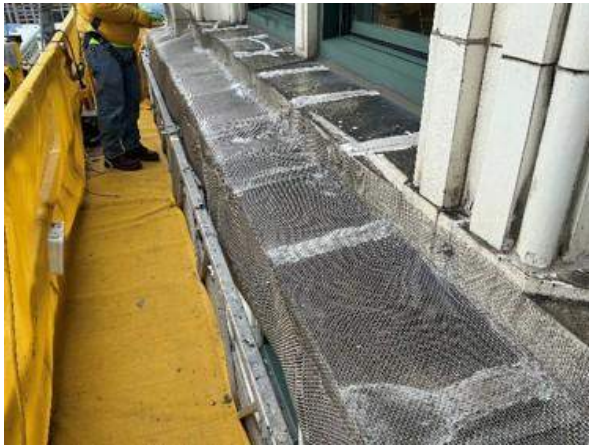
**Photo 31.** Previously installed mesh at the east elevation water table.

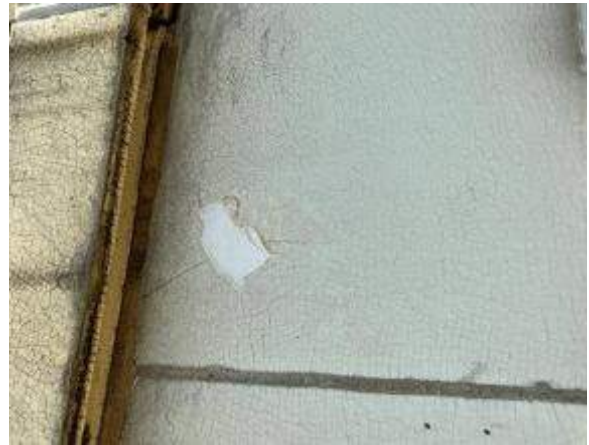
**Photo 32.** Typical sealant repair at spalled glaze.

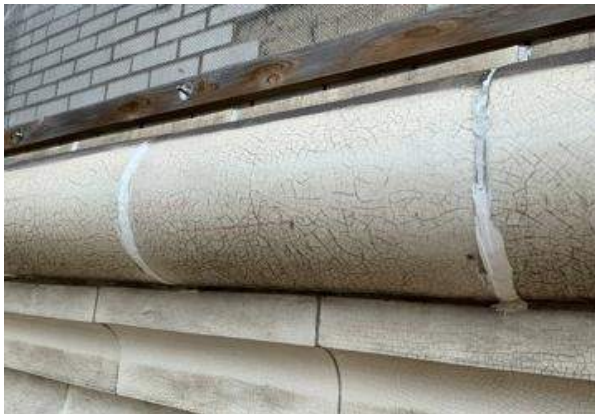
**Photo 33.** Open mortar joint sealed with polyurethane sealant.

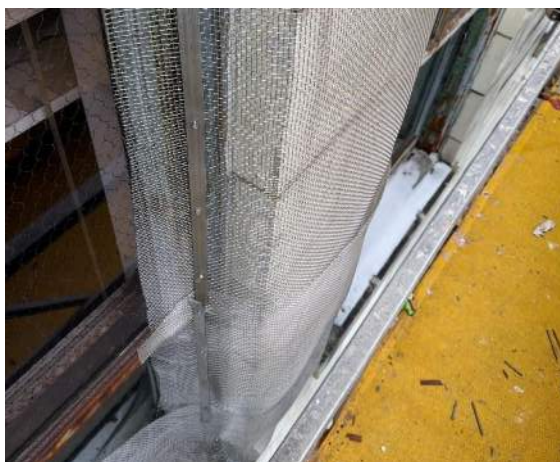
**Photo 35.** Typical stainless steel mesh installation.

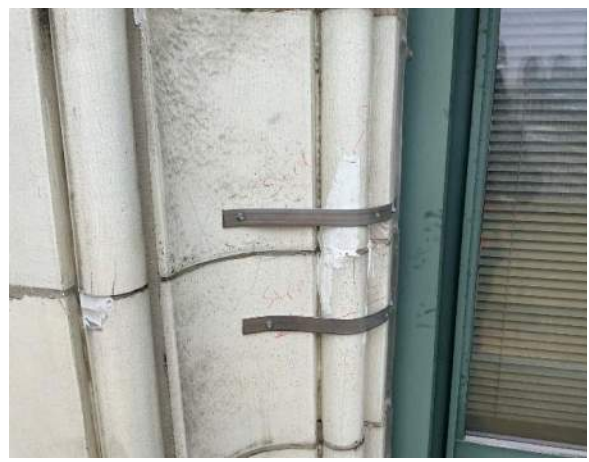
**Photo 36.** Typical stainless steel strap installation.

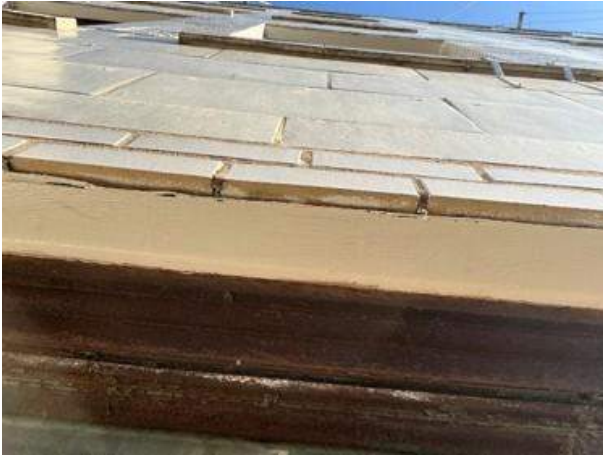
**Photo 37.** Existing steel at the window heads, cleaned and recoated with a corrosion-inhibitive coating.

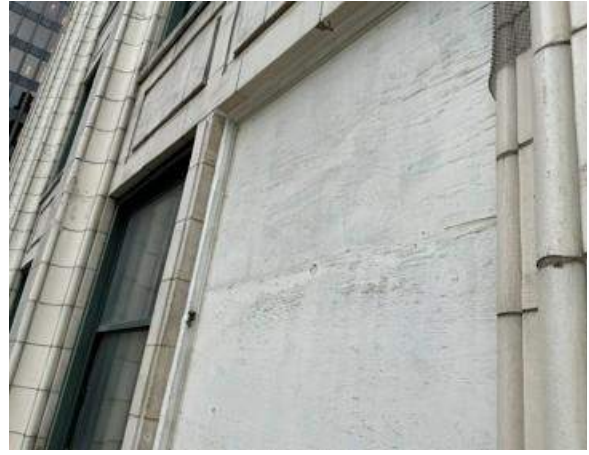
**Photo 38.** Existing plywood over window in good condition, scraped and repainted.

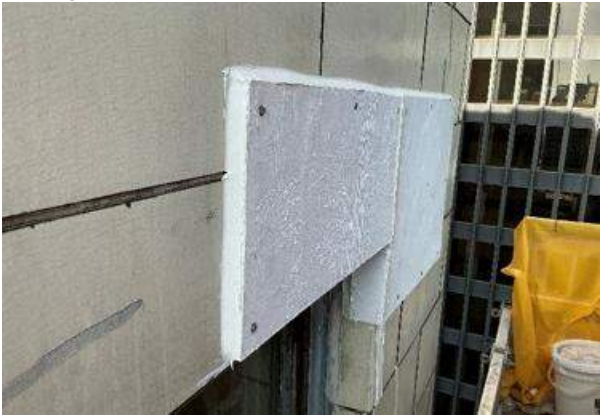
**Photo 39.** New plywood coverings over removed unsound material.

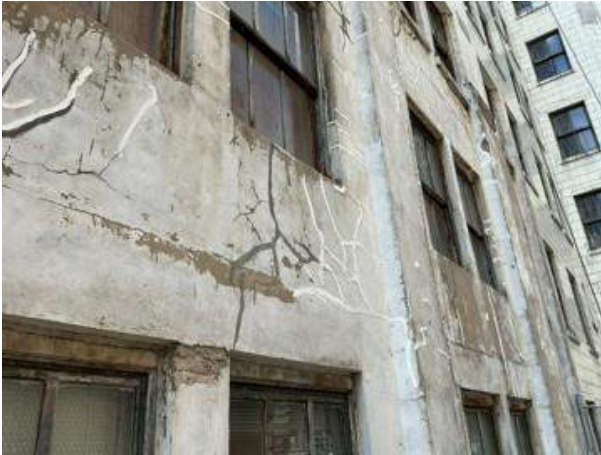
**Photo 43.** Typical cementitious parge coat sealant repair at north elevation.

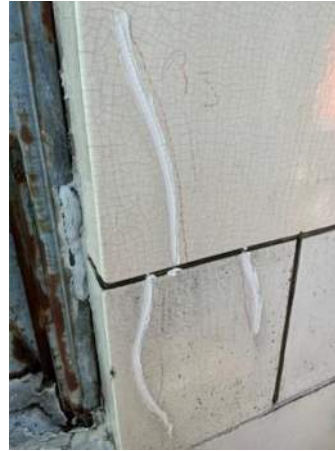
**Photo 44.** Typical route & seal repair.

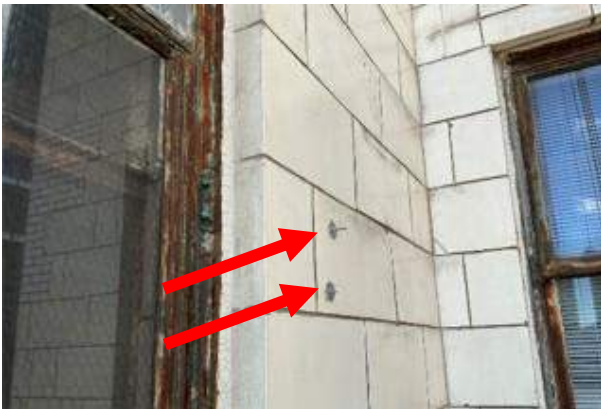
**Photo 45.** Typical stainless-steel pinning.

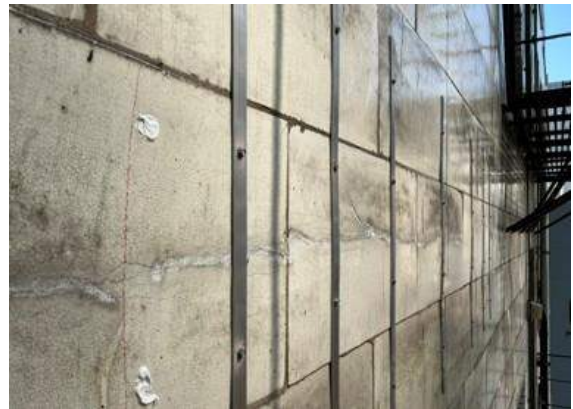
**Photo 46.** Typical strapping of bulging terra cotta pieces at lintel level.

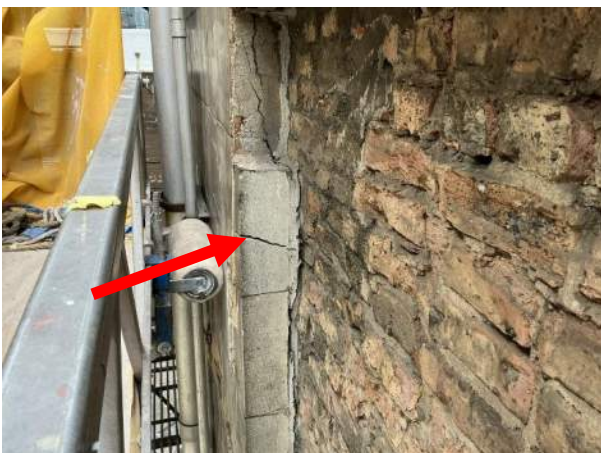
**Photo 47.** Window jamb cracking at west elevation, 4<sup>th</sup> floor.

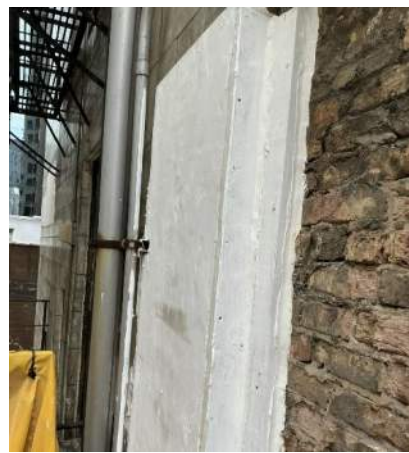
**Photo 48.** Plywood cover at window jamb cracking at west elevation, 4<sup>th</sup> floor.

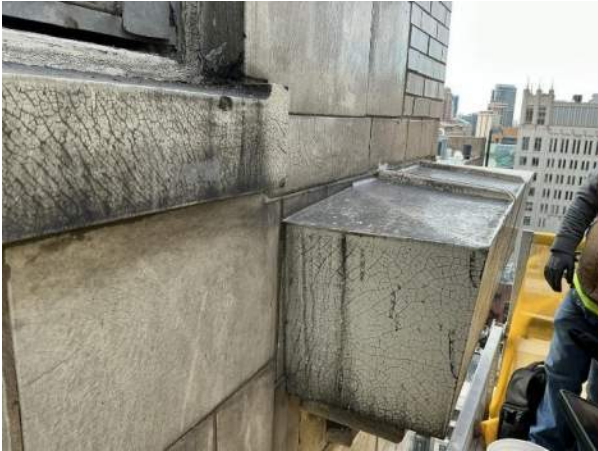
**Photo 49.** Cracked water table corner pieces at west elevation, 18<sup>th</sup> floor removed in 2026 (see next photo for completed repair)

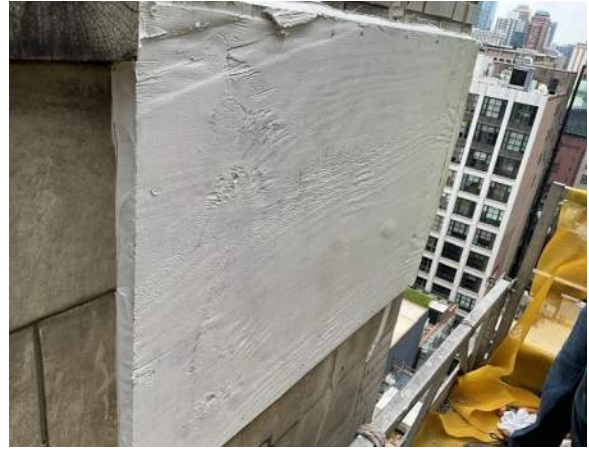
**Photo 50.** Plywood cover at removed water table corner pieces at west elevation, 18<sup>th</sup> floor.

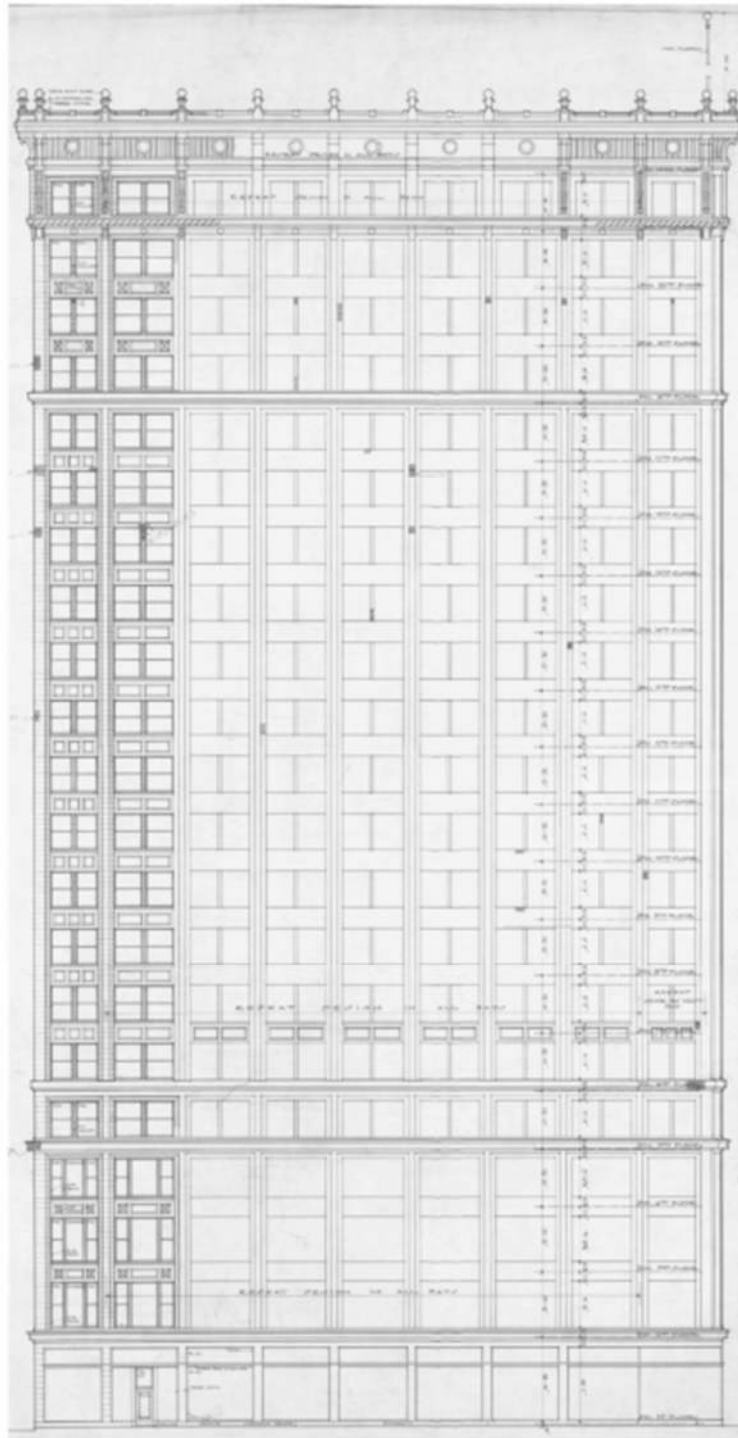
*Figure 4: West Elevation from original Holabird and Roche architectural drawings*

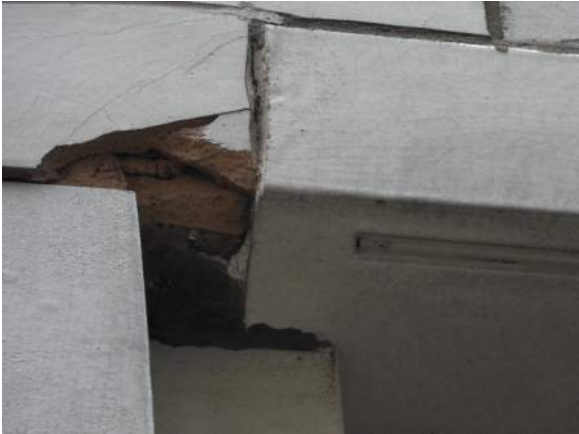
**Photo 51.** Cracked window header observed from binocular review.

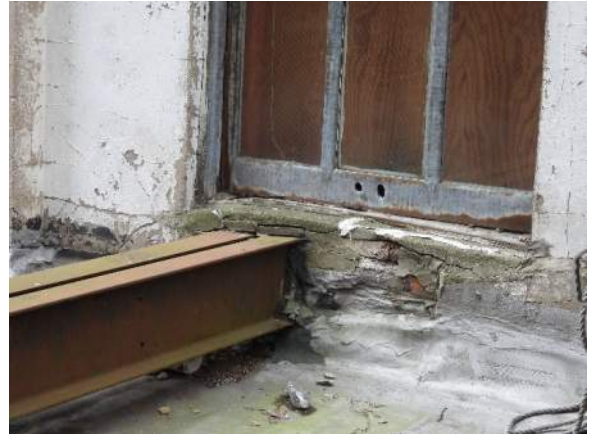
**Photo 52.** Cracked window sill observed from binocular review.

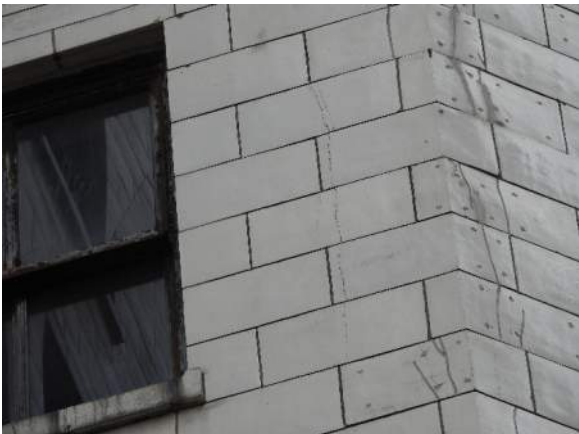
**Photo 53.** Large terracotta crack observed from binocular review.

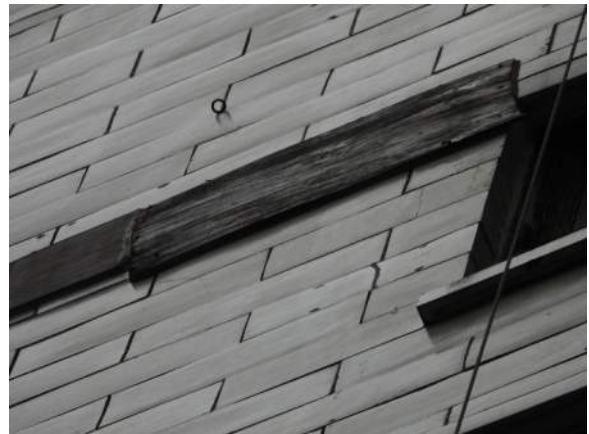
**Photo 54.** Existing plywood that needs be repainted observed from binocular review.

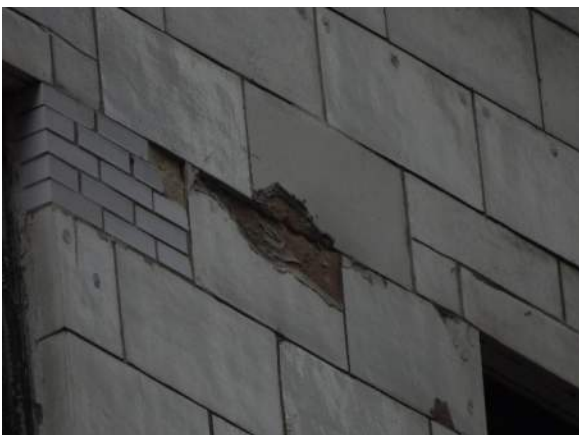
**Photo 55.** Large spall to be reconstructed with brick observed from binocular review.

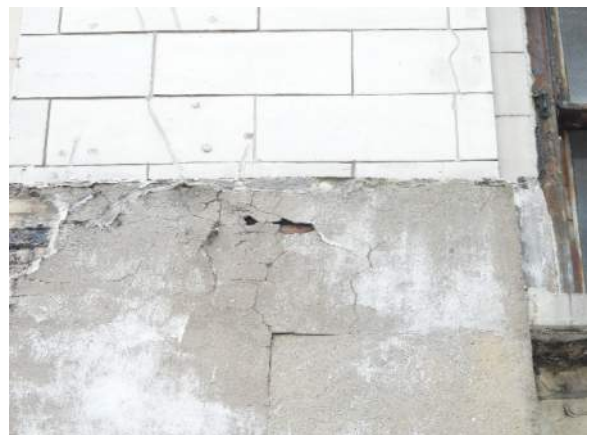
**Photo 56.** Concrete siding that has spalled and cracked observed from binocular review.

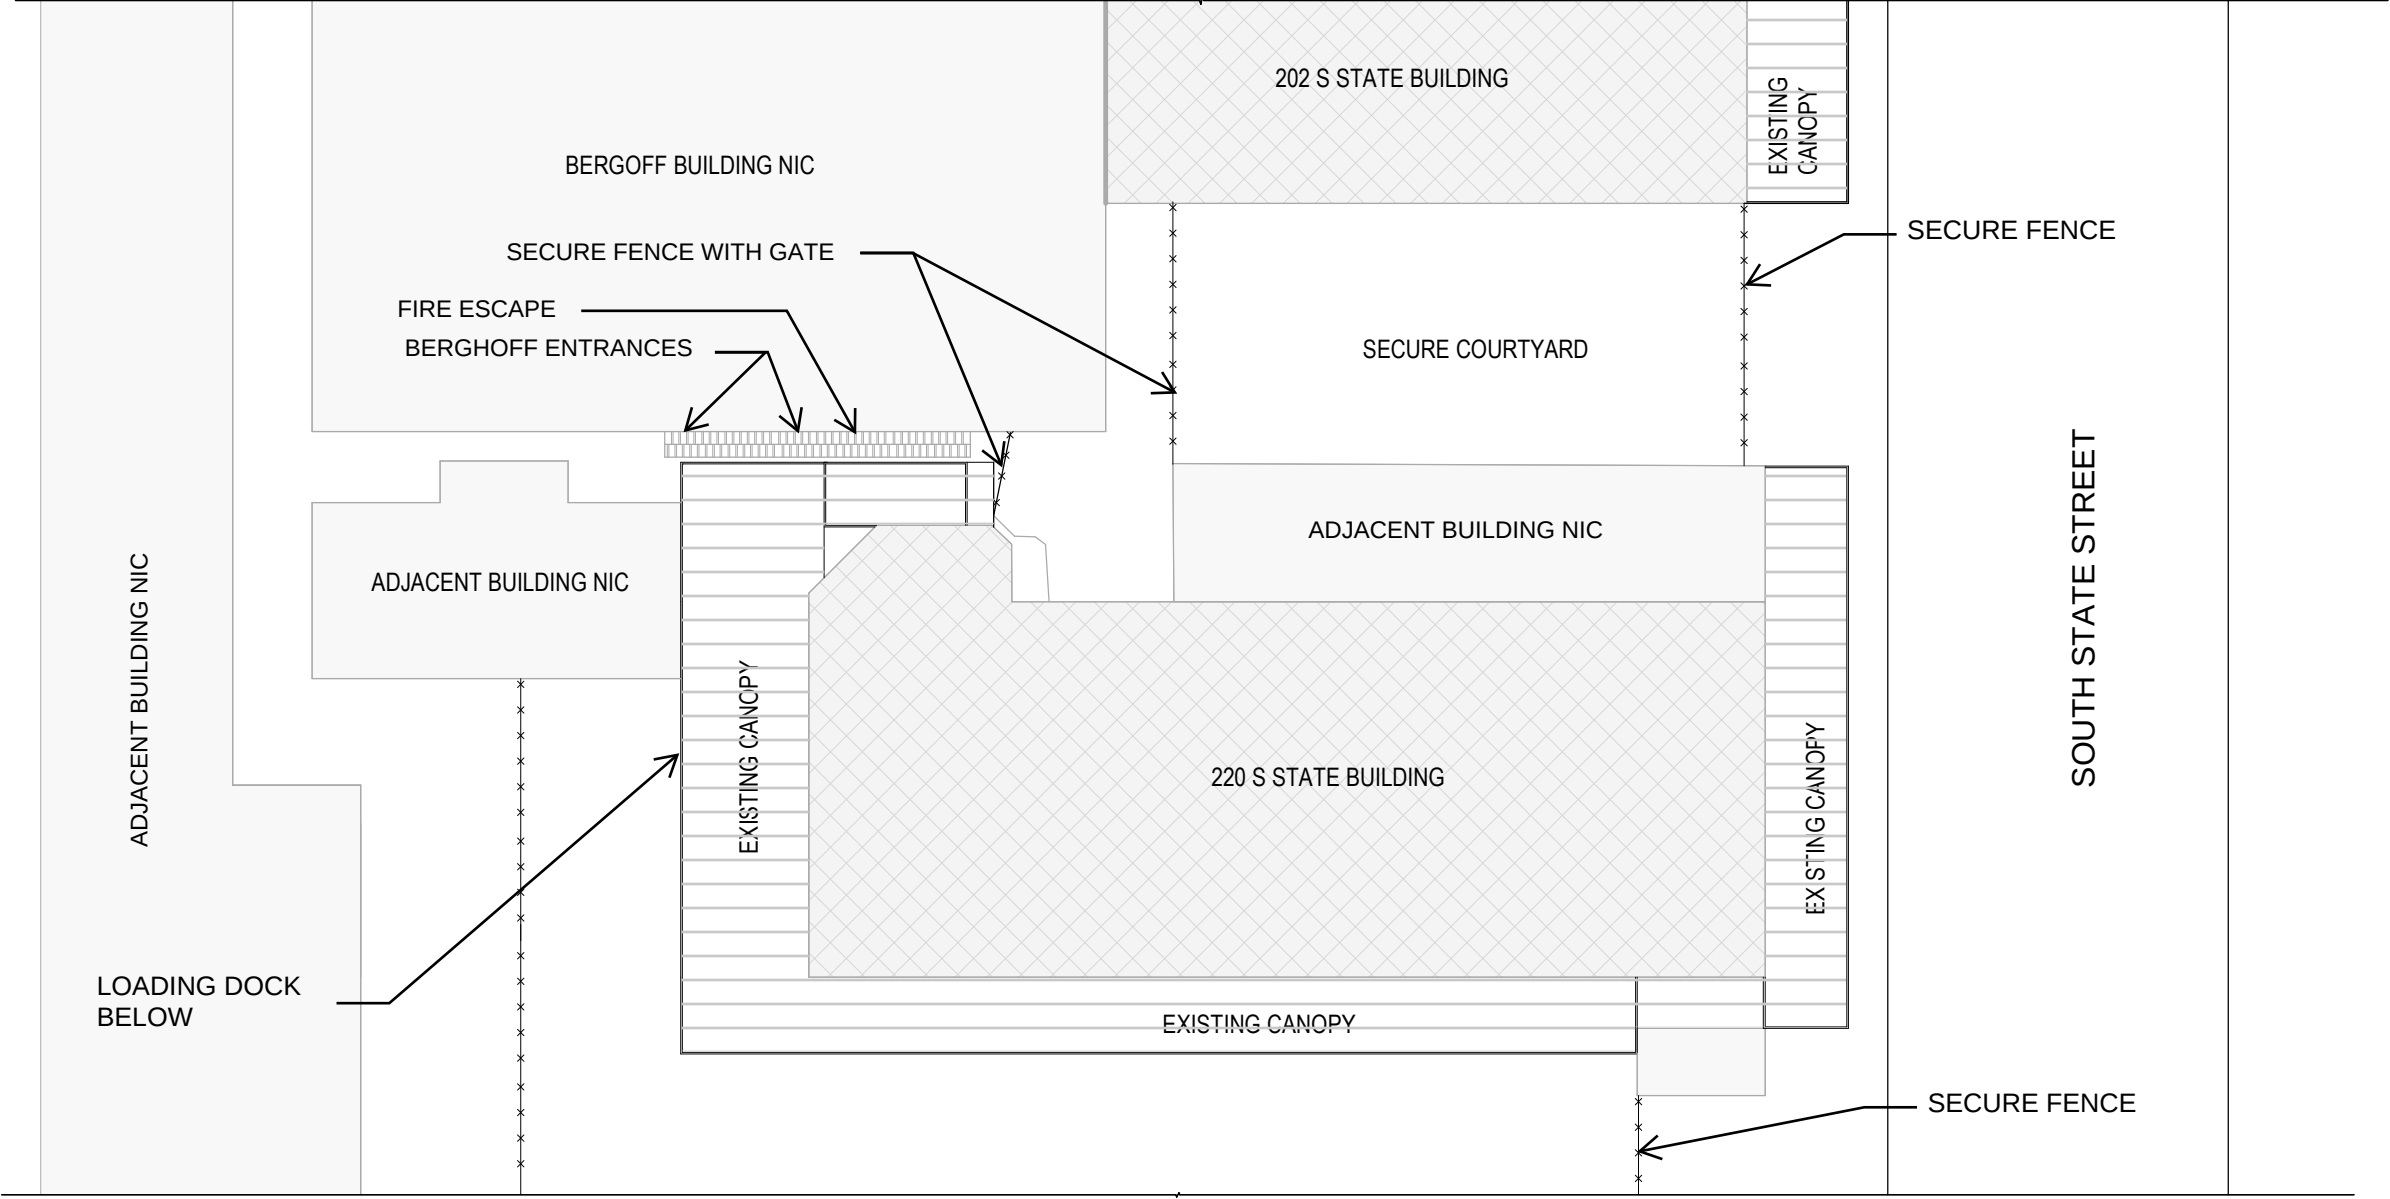
**1 SITE PLAN**  
NTS
