GSA Great Lakes Region

220 State Street Evaluation Report

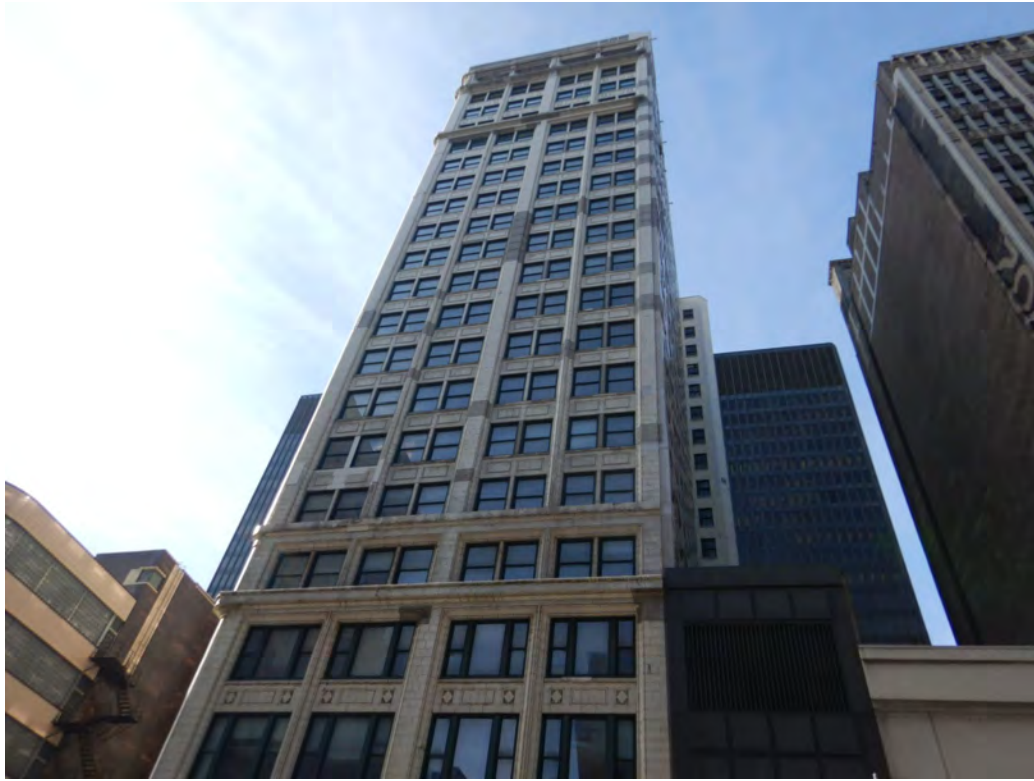
Exterior East elevation

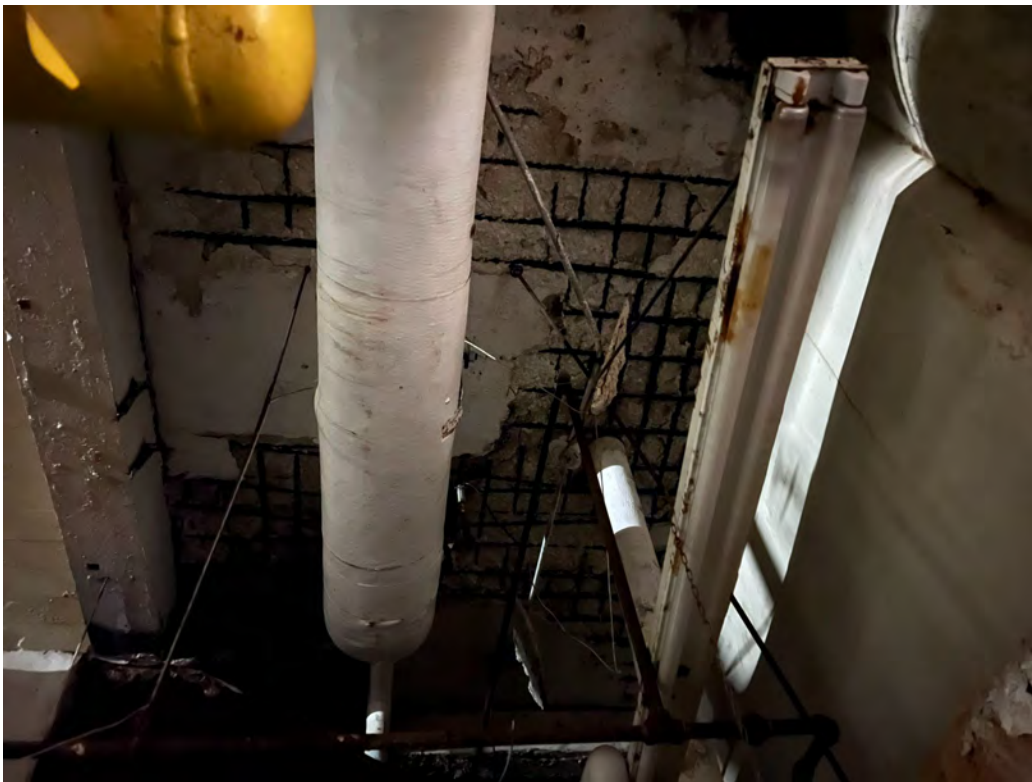
Middle basement slab from below: Area with exposed and corroded rebar

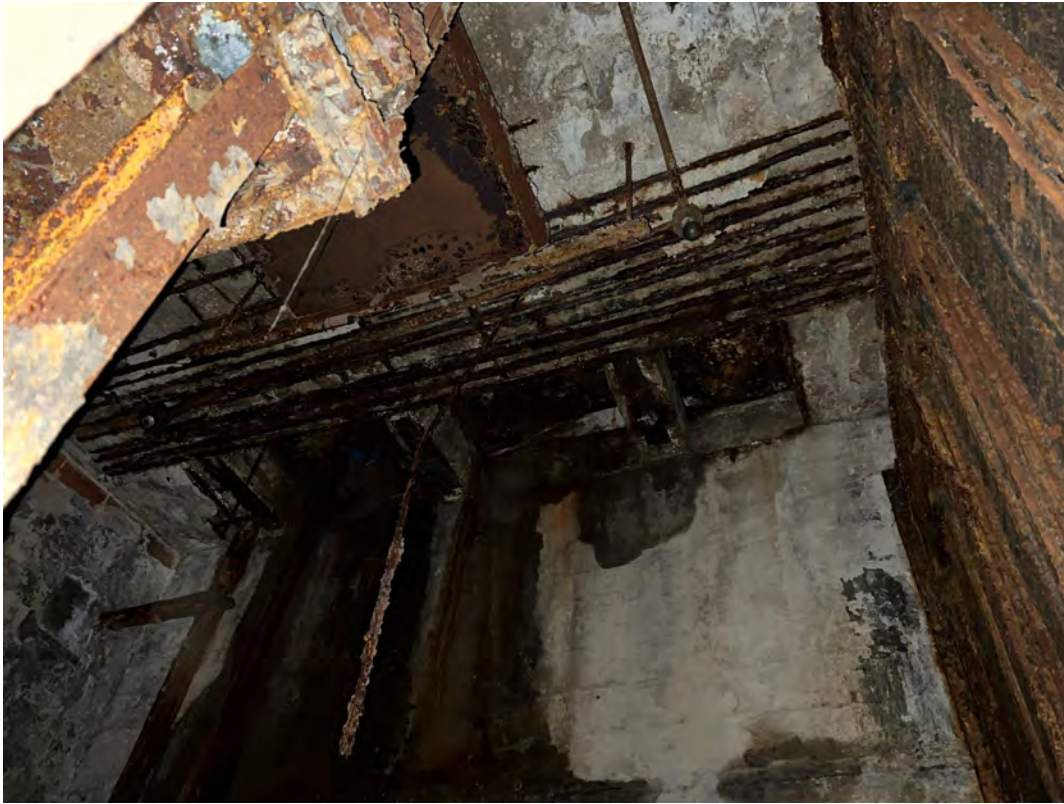
Middle basement slab from below: Southwest room heavily spalled and rebar is corroded

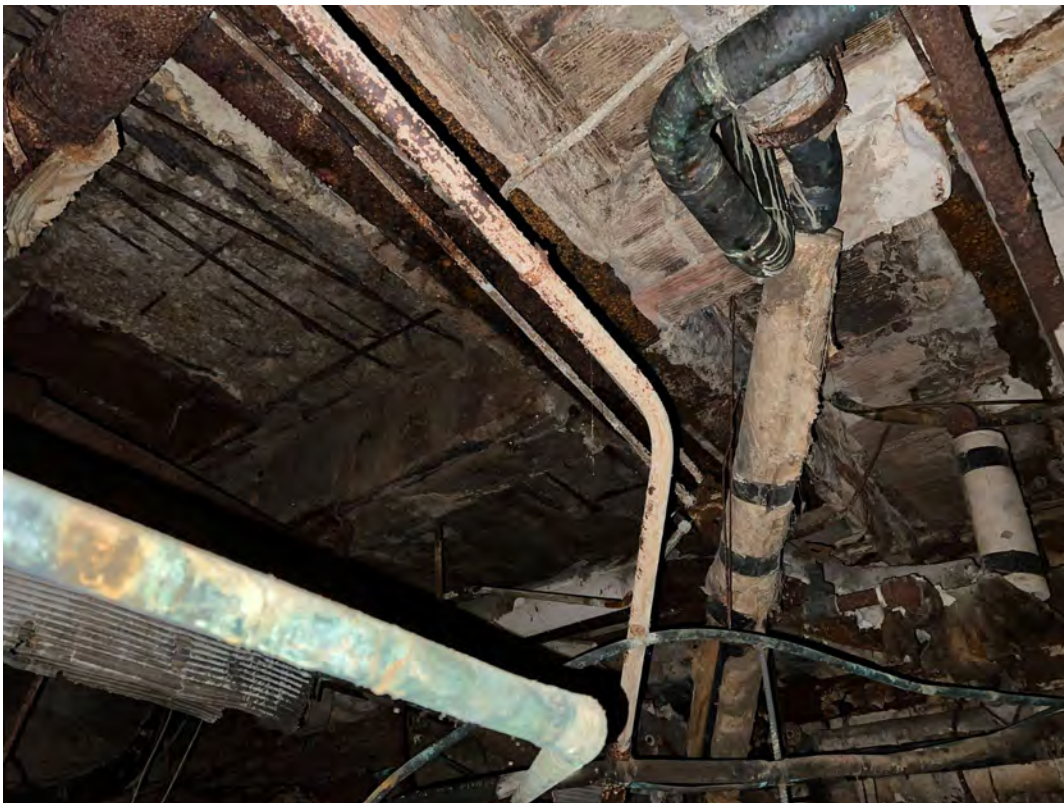
Ground level slab from below: Northwest room, heavy spalling and corroded and displaced rebar

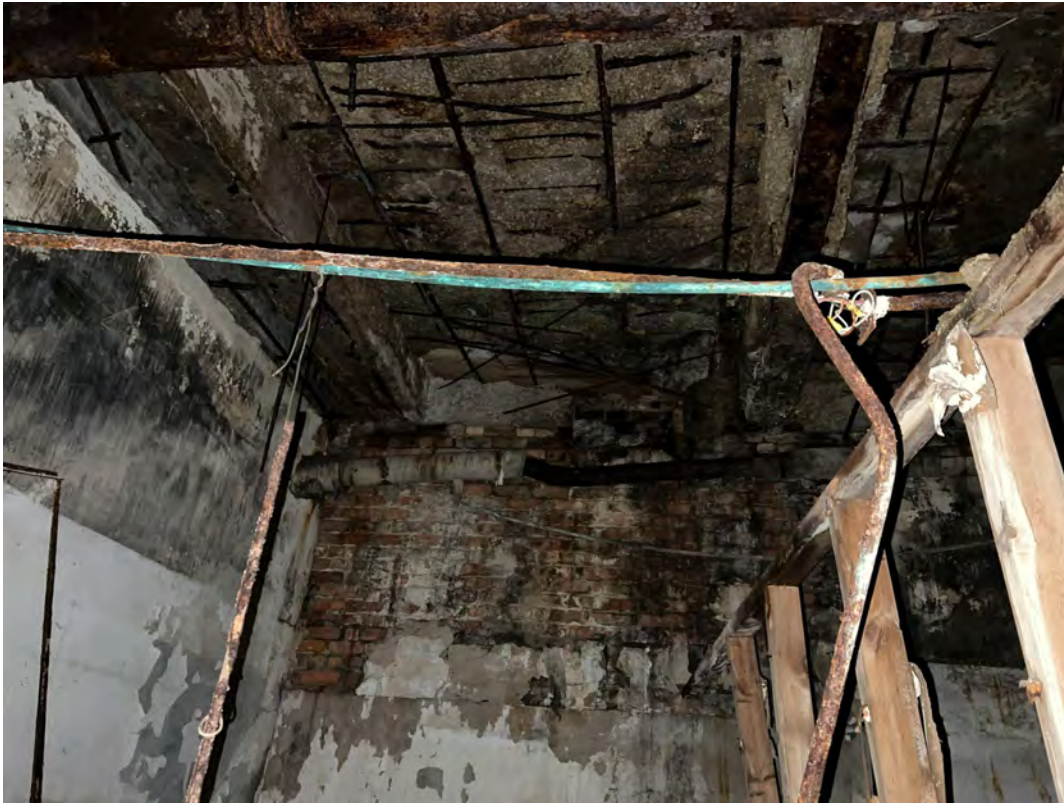
Ground level slab from below: Northwest room, heavy spalling and corroded and displaced rebar

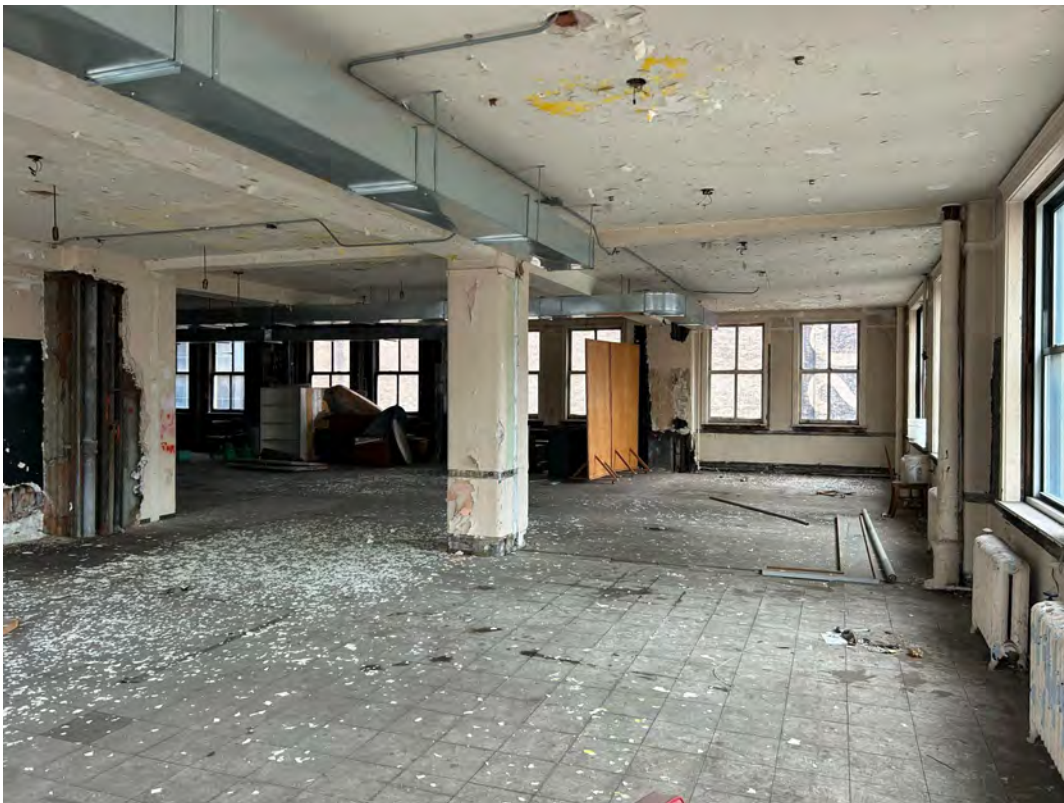
Superstructure: Framing layout, structure typically covered in finishes

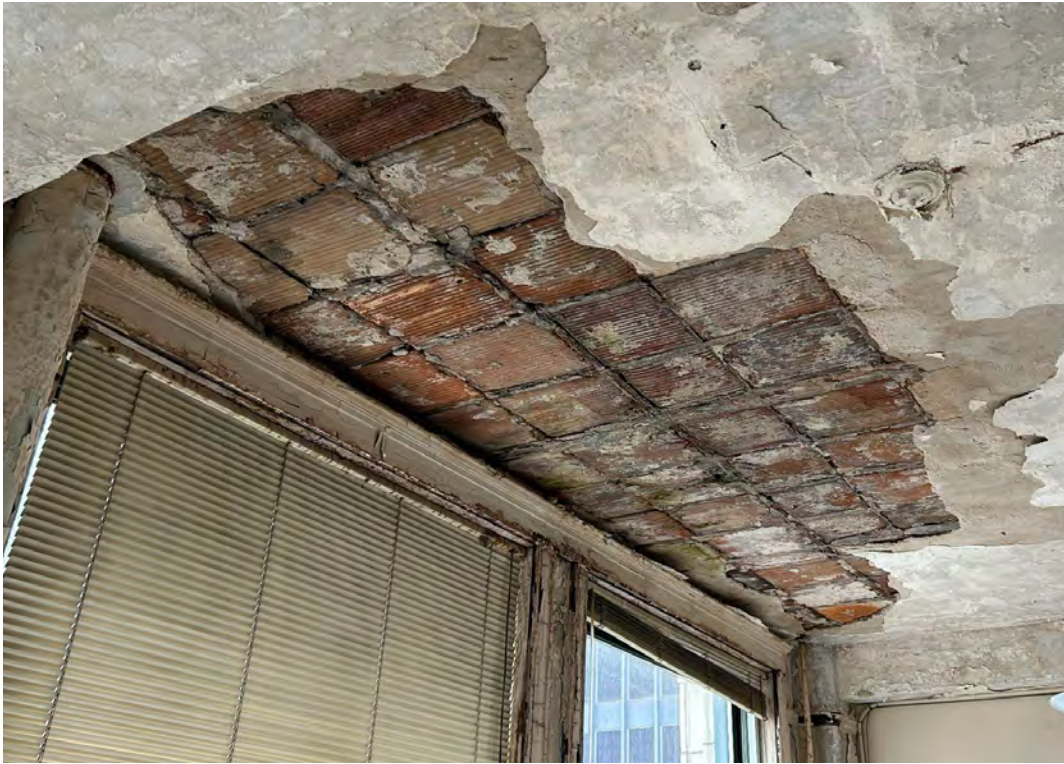
Superstructure: Exposed clay tile arch floor structure at localized area of past water infiltration

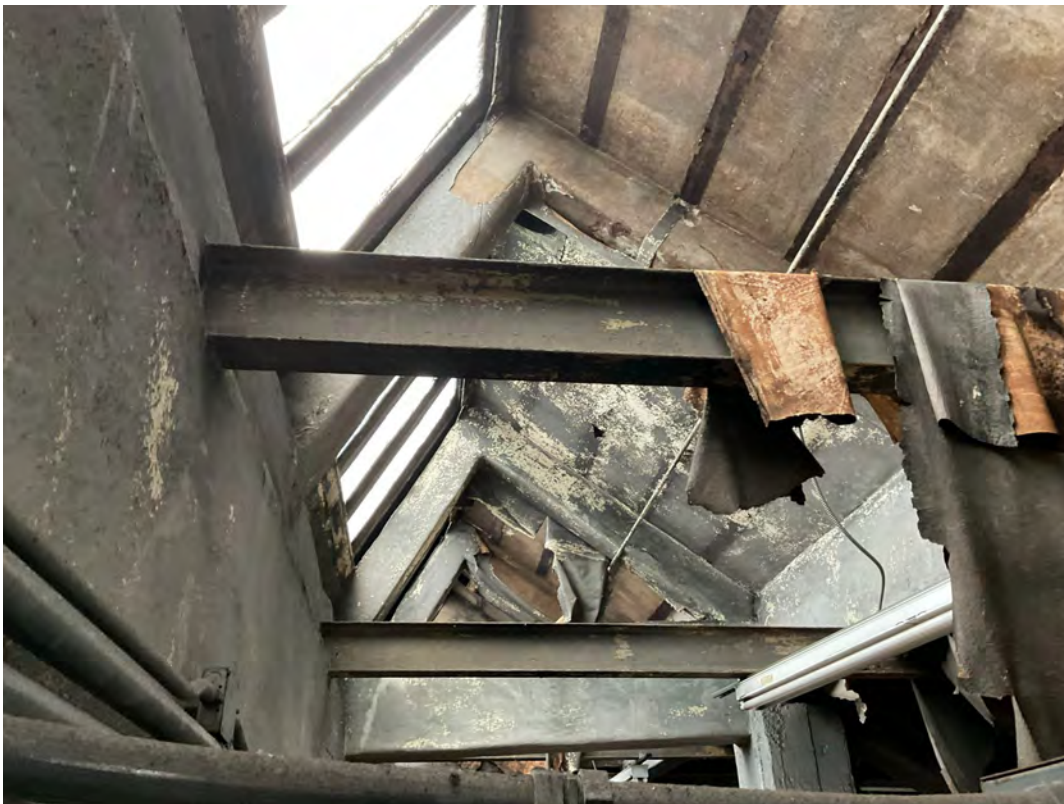
Roof structure: Structural support at glass skylight

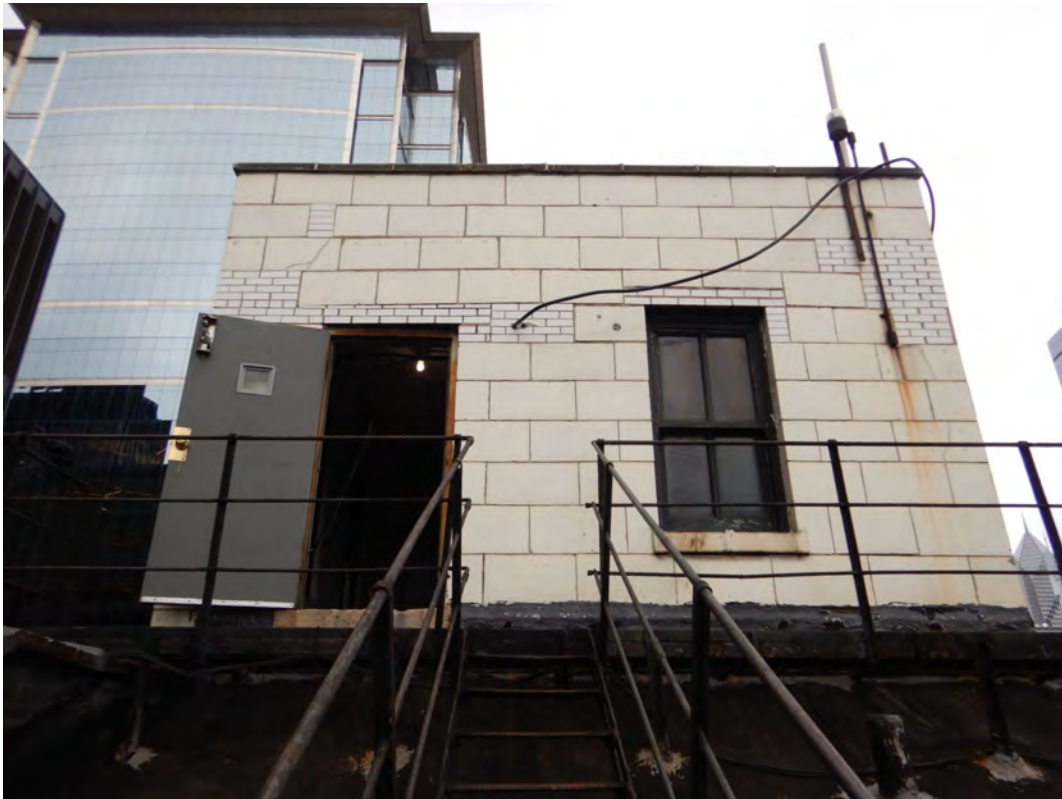
South elevation of terra cotta clad penthouse

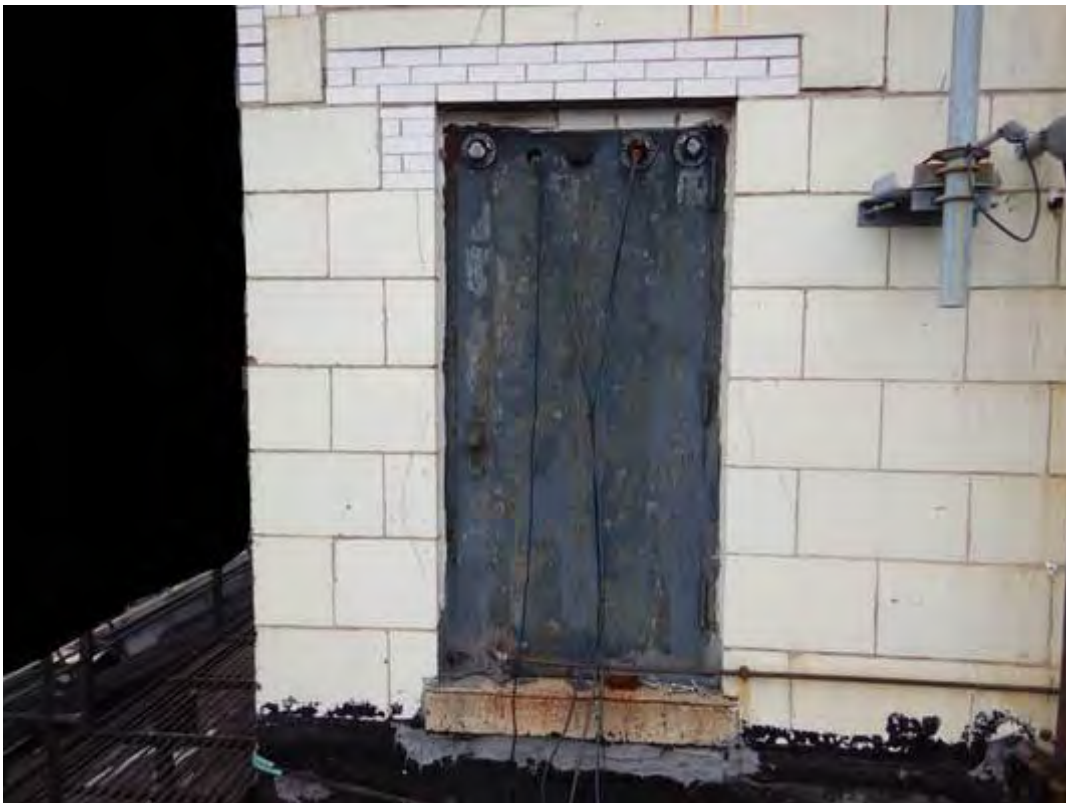
Deteriorated penthouse door and cladding

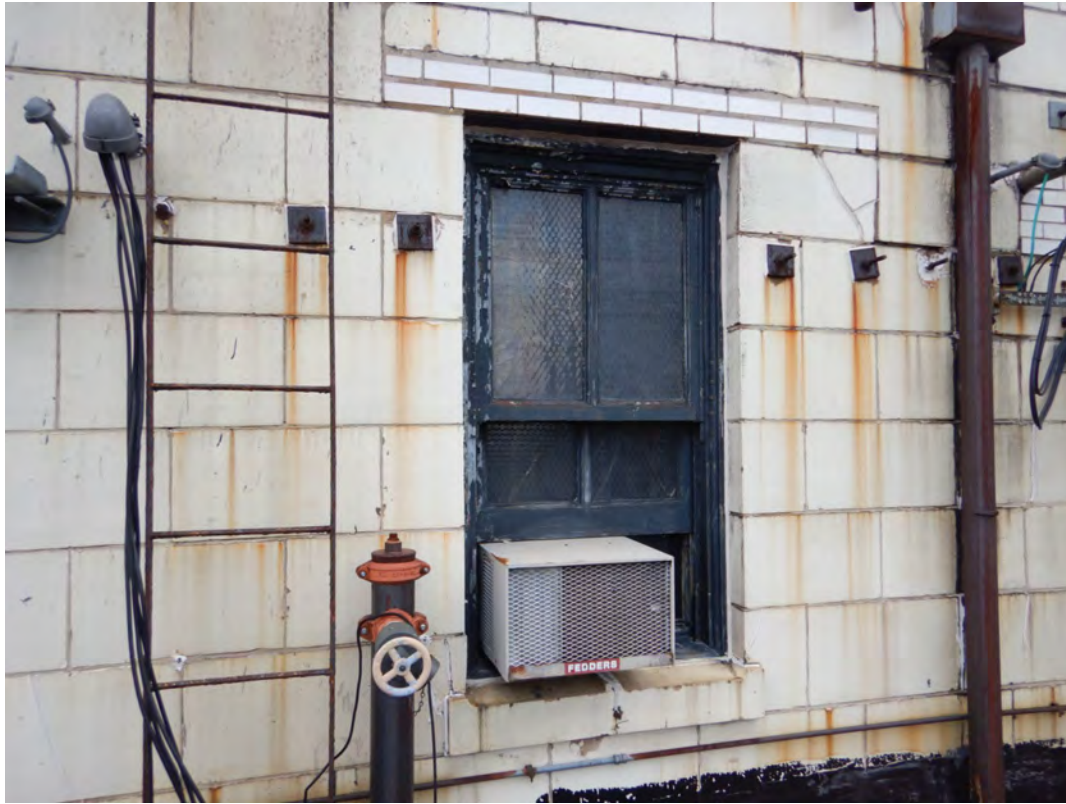
Deteriorated penthouse window and roof ladder

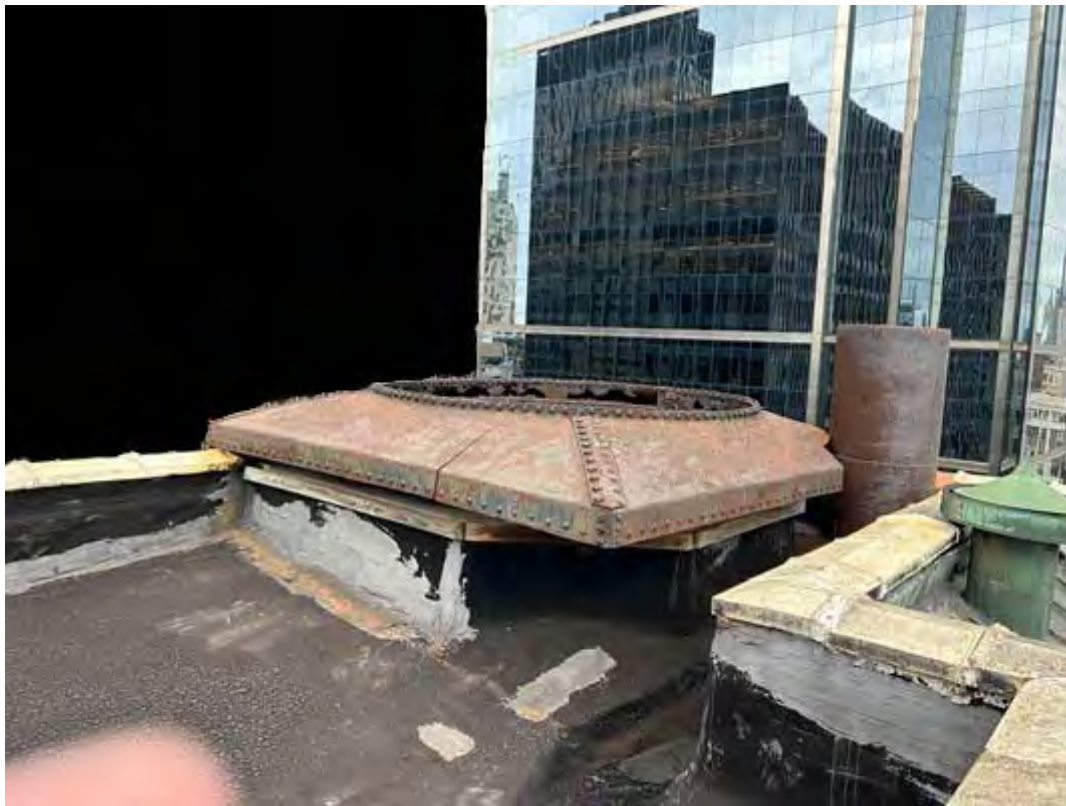
Penthouse roof with terra cotta coping

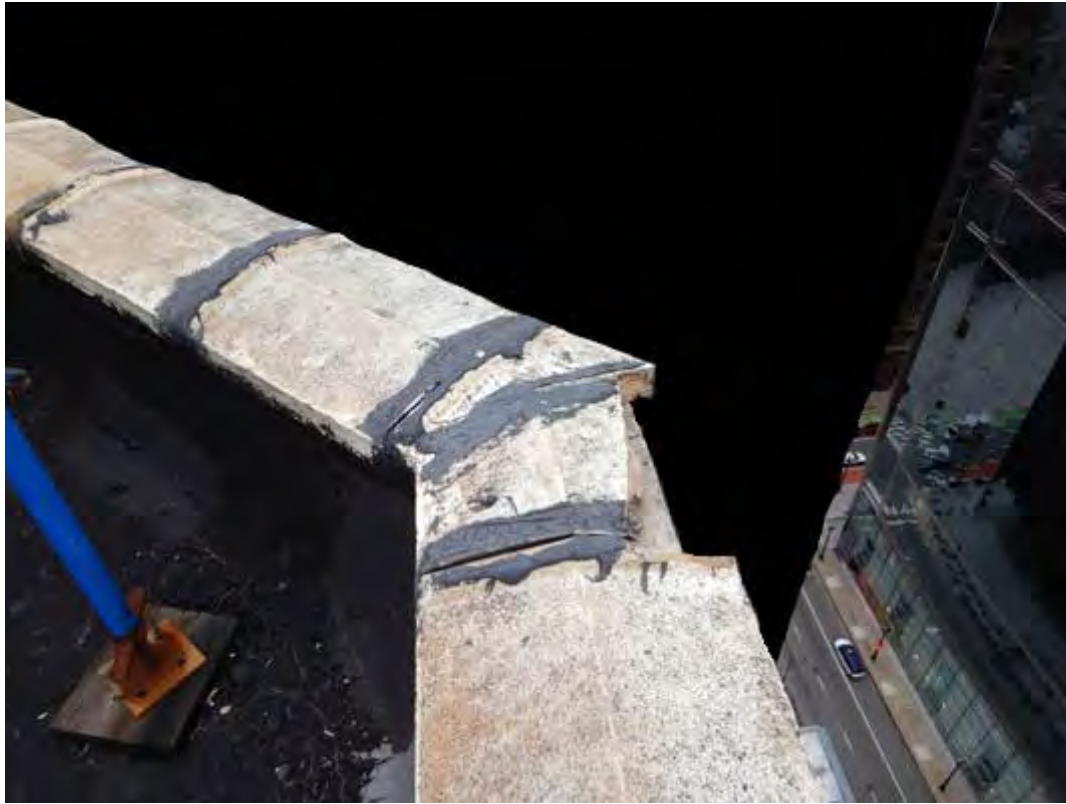
Damaged terra cotta coping

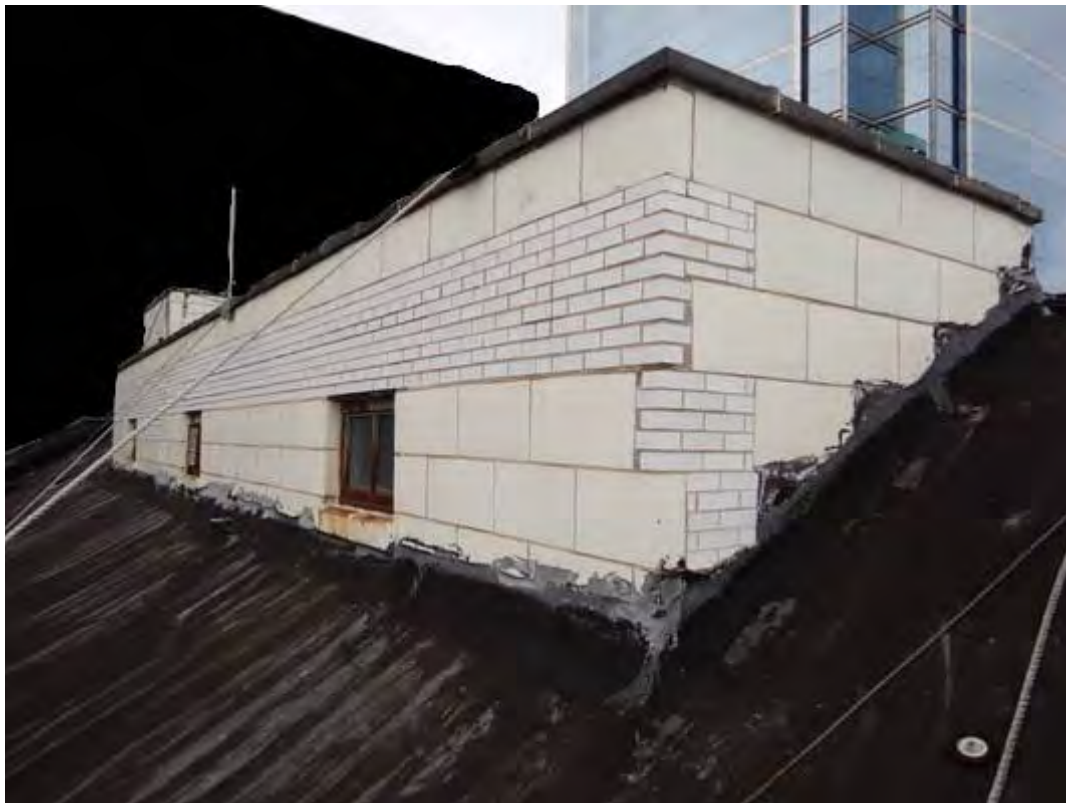
Temporarily repaired interior parapet structure

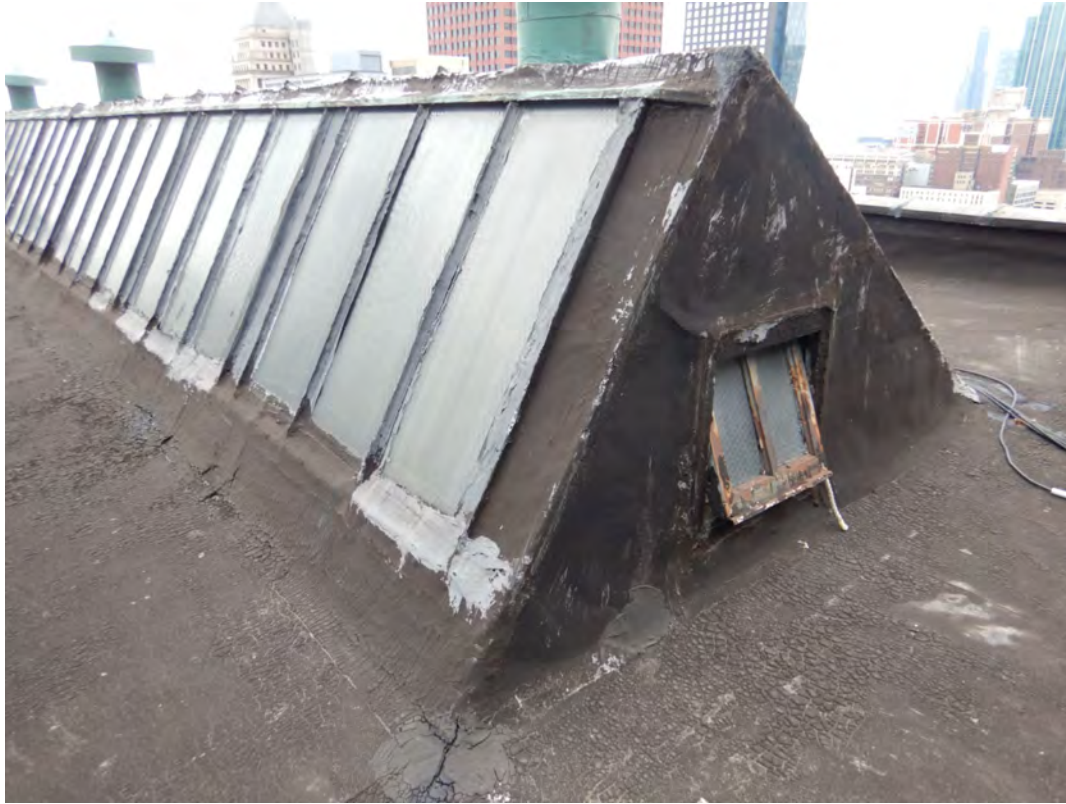
Skylight structure on upper roof, north elevation

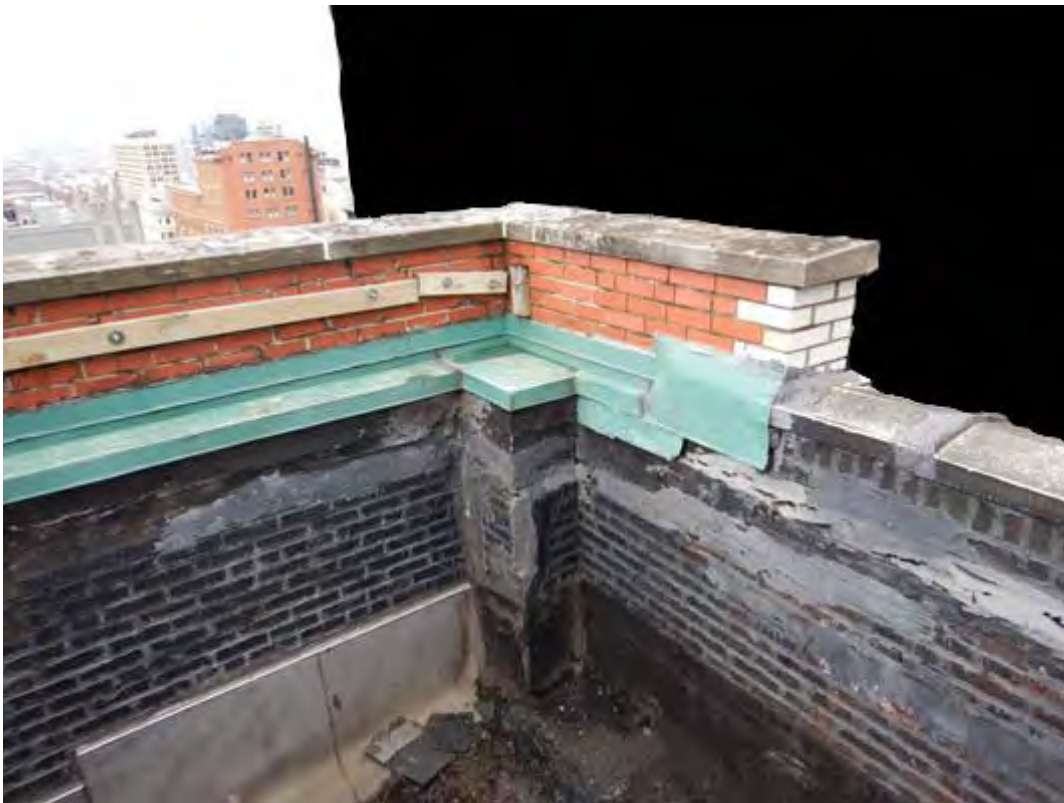
Southwest parapet corner with multiple copings, flashings, and temporary repairs

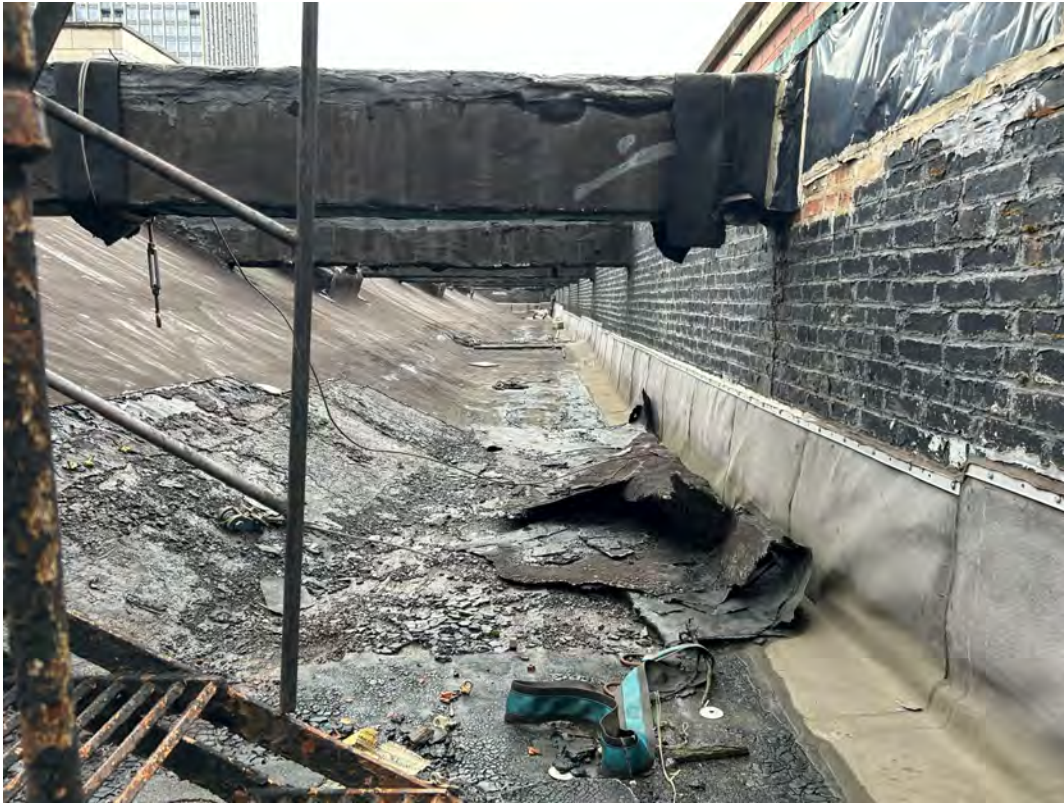
Severely deteriorated roofing membrane at south east corner

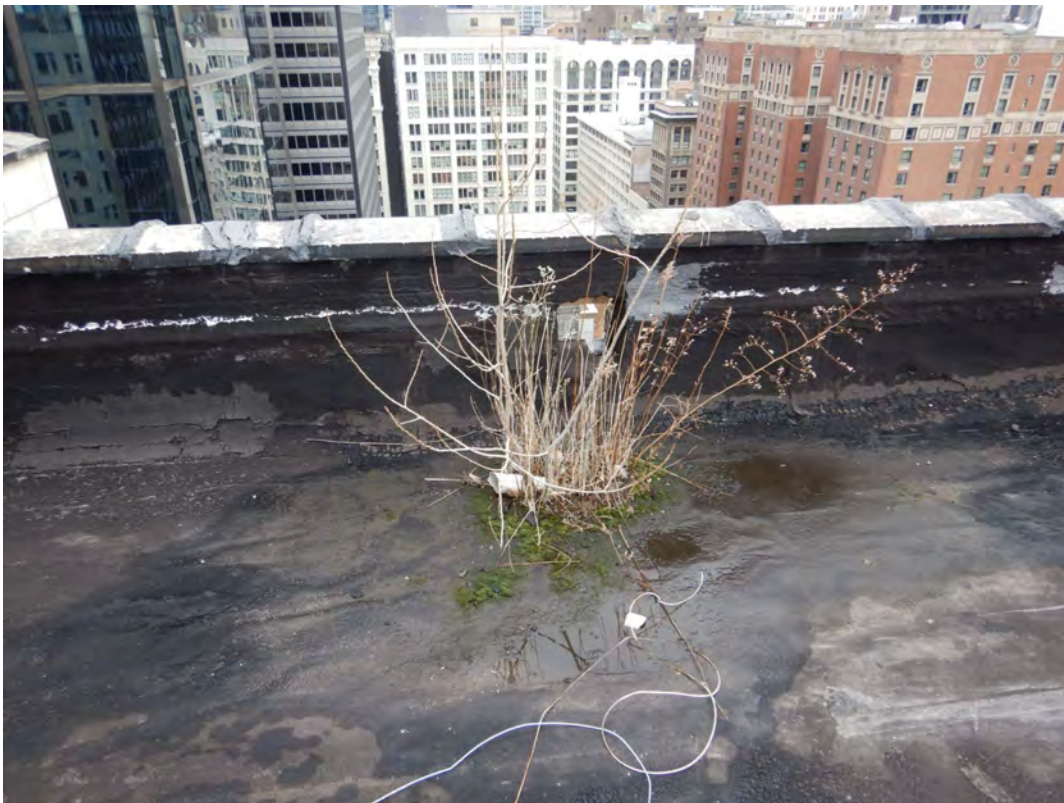
Clogged upper roof drain with vegetation

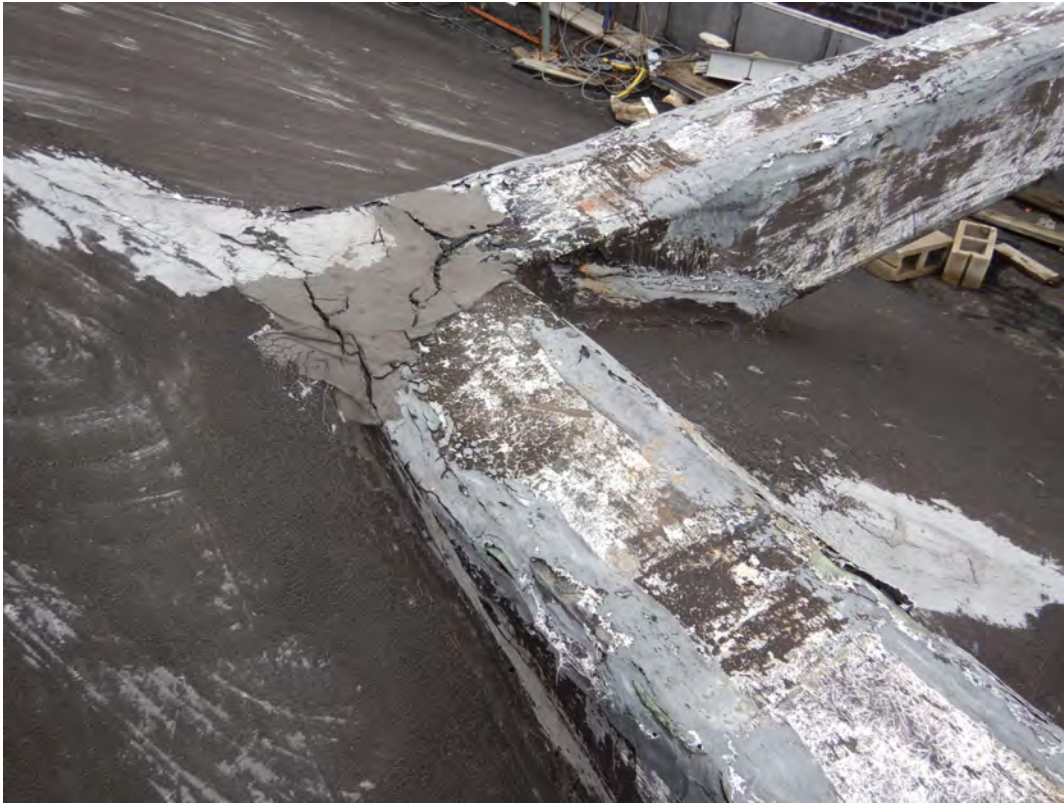
Severely deteriorated horizontal braces intersecting sloped roof

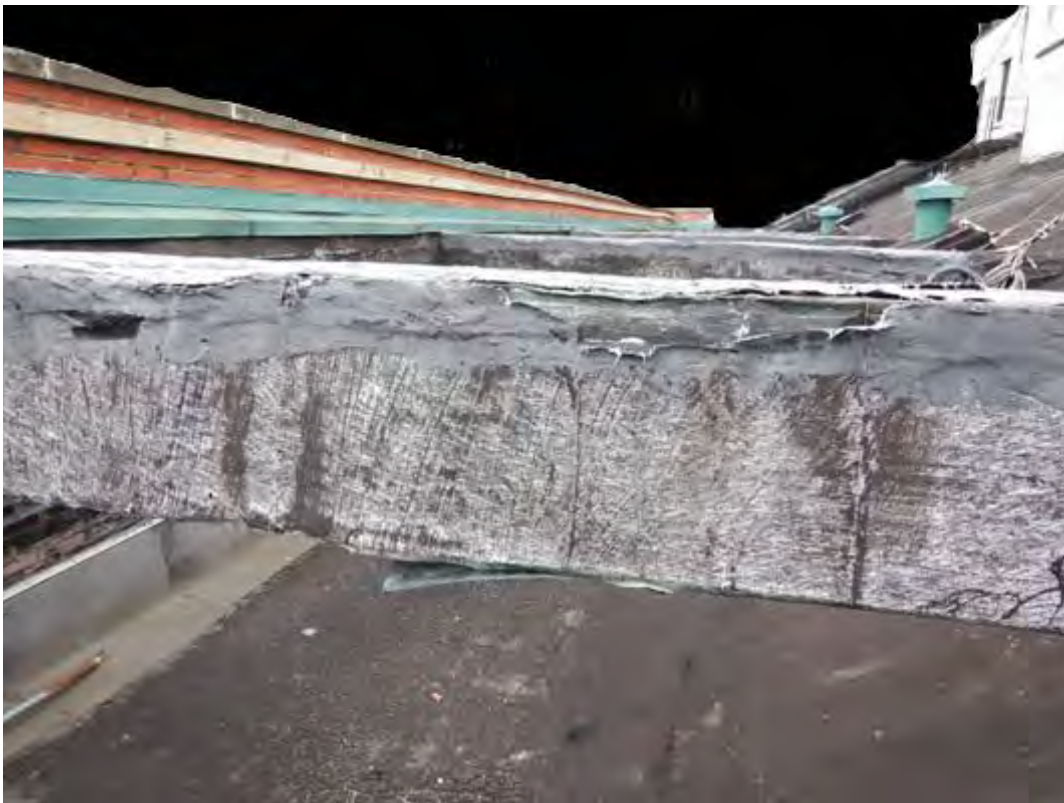
Severely deteriorated horizontal brace enclosure

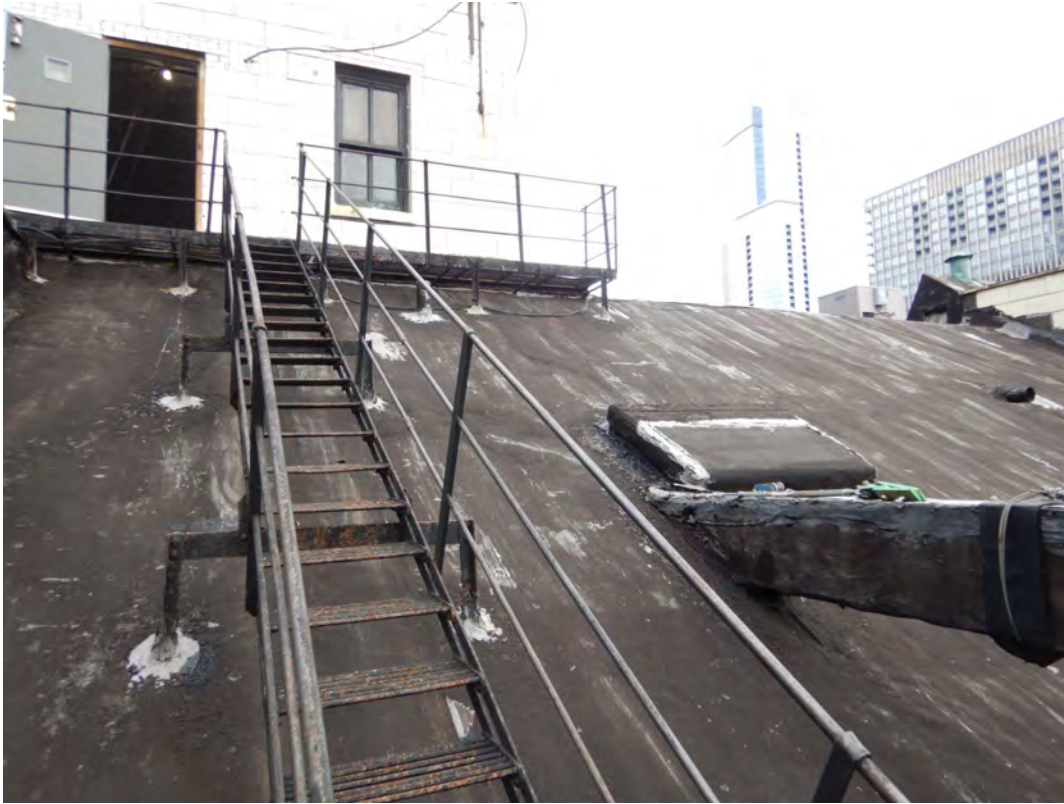
Steel stair structure to lower roof

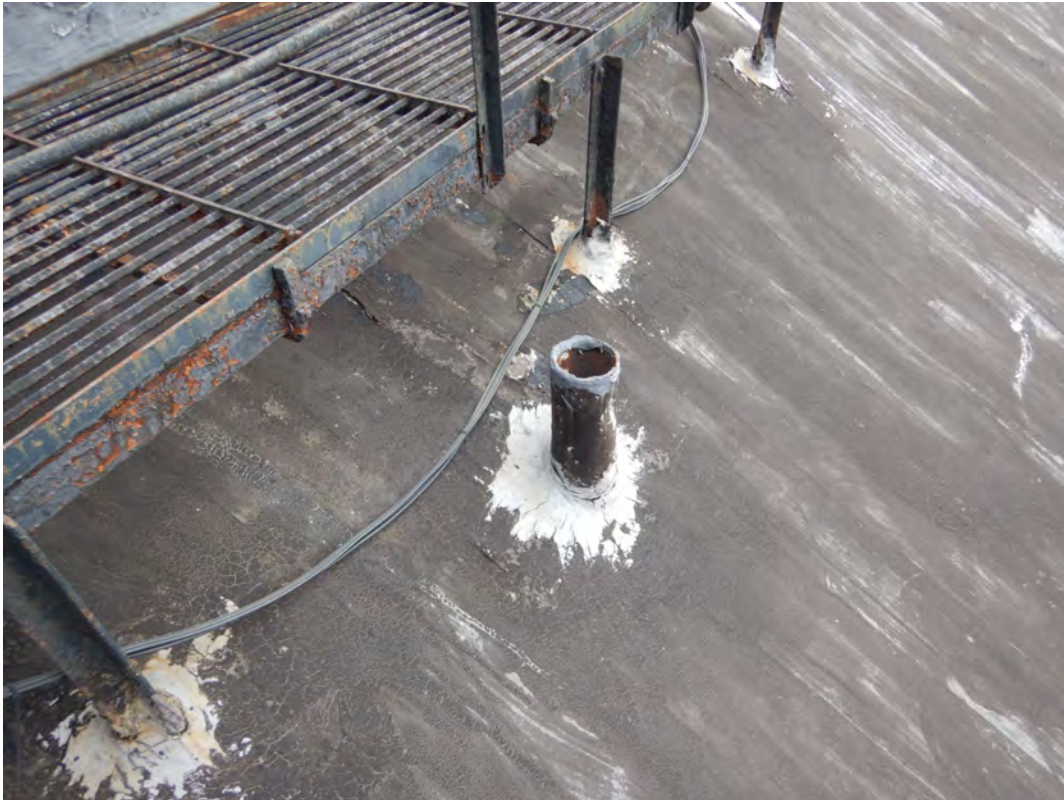
Failed roofing membrane around stair supports and vent stack

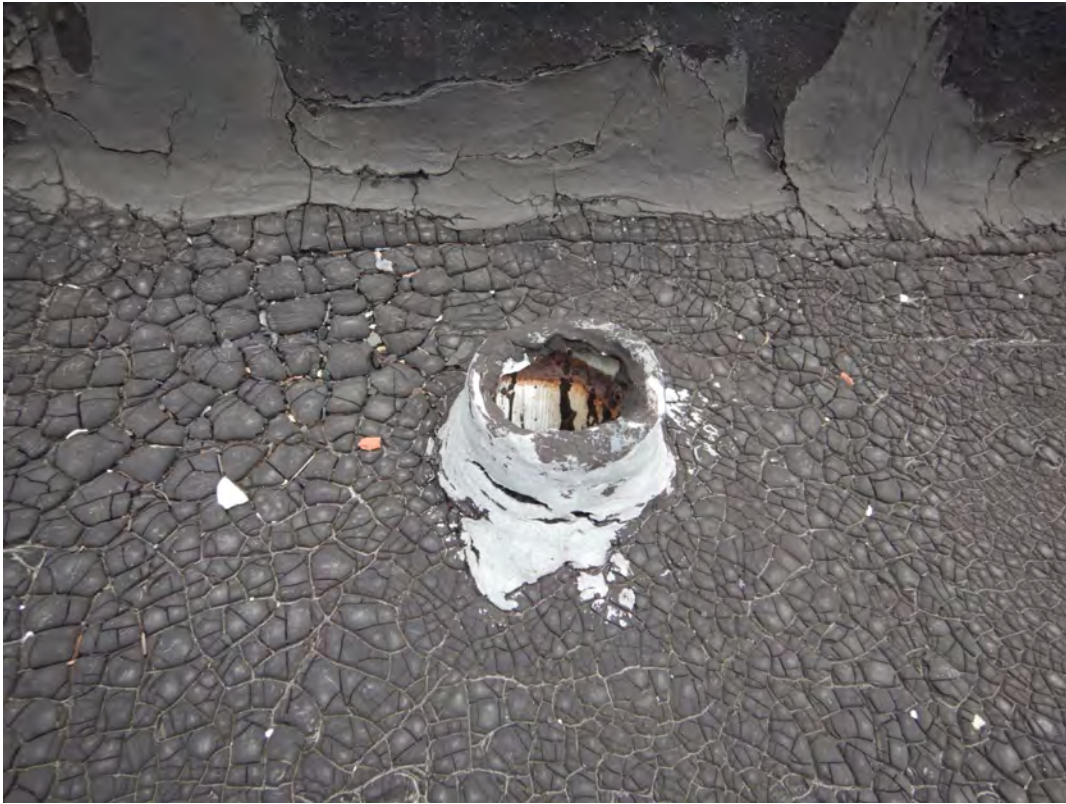
Failed vent stack roofing detail and deteriorated roofing membrane

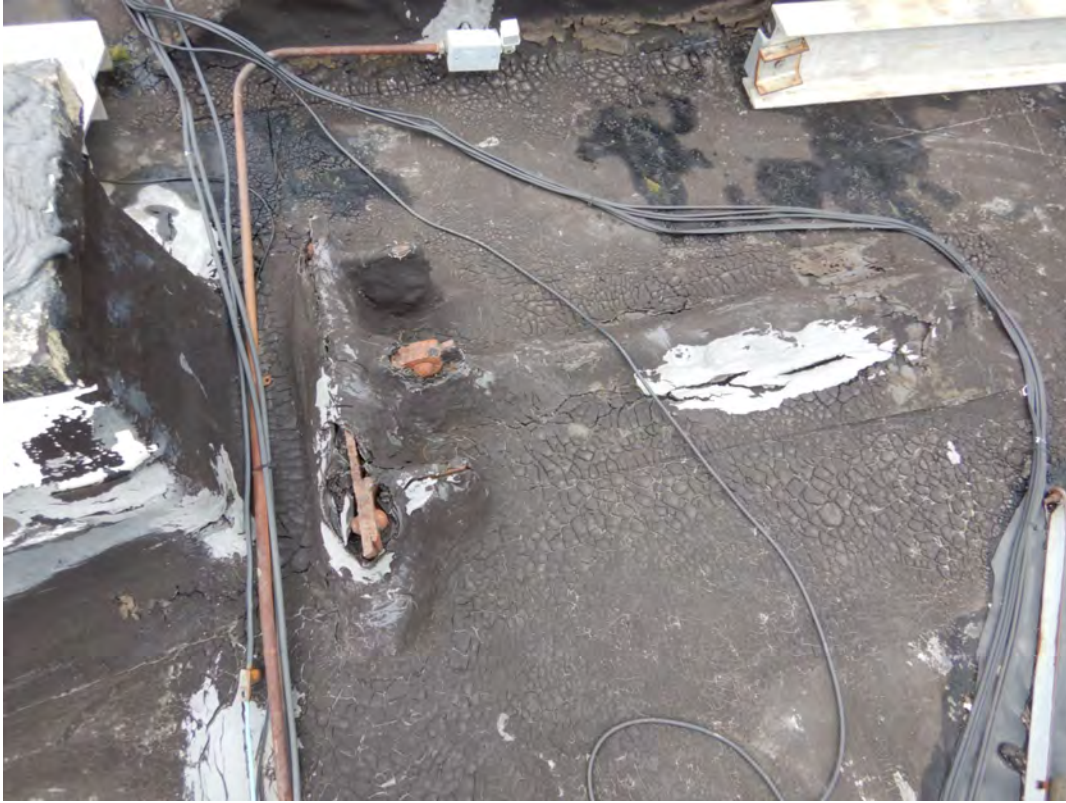
Open tears within the roofing membrane on the upper roof

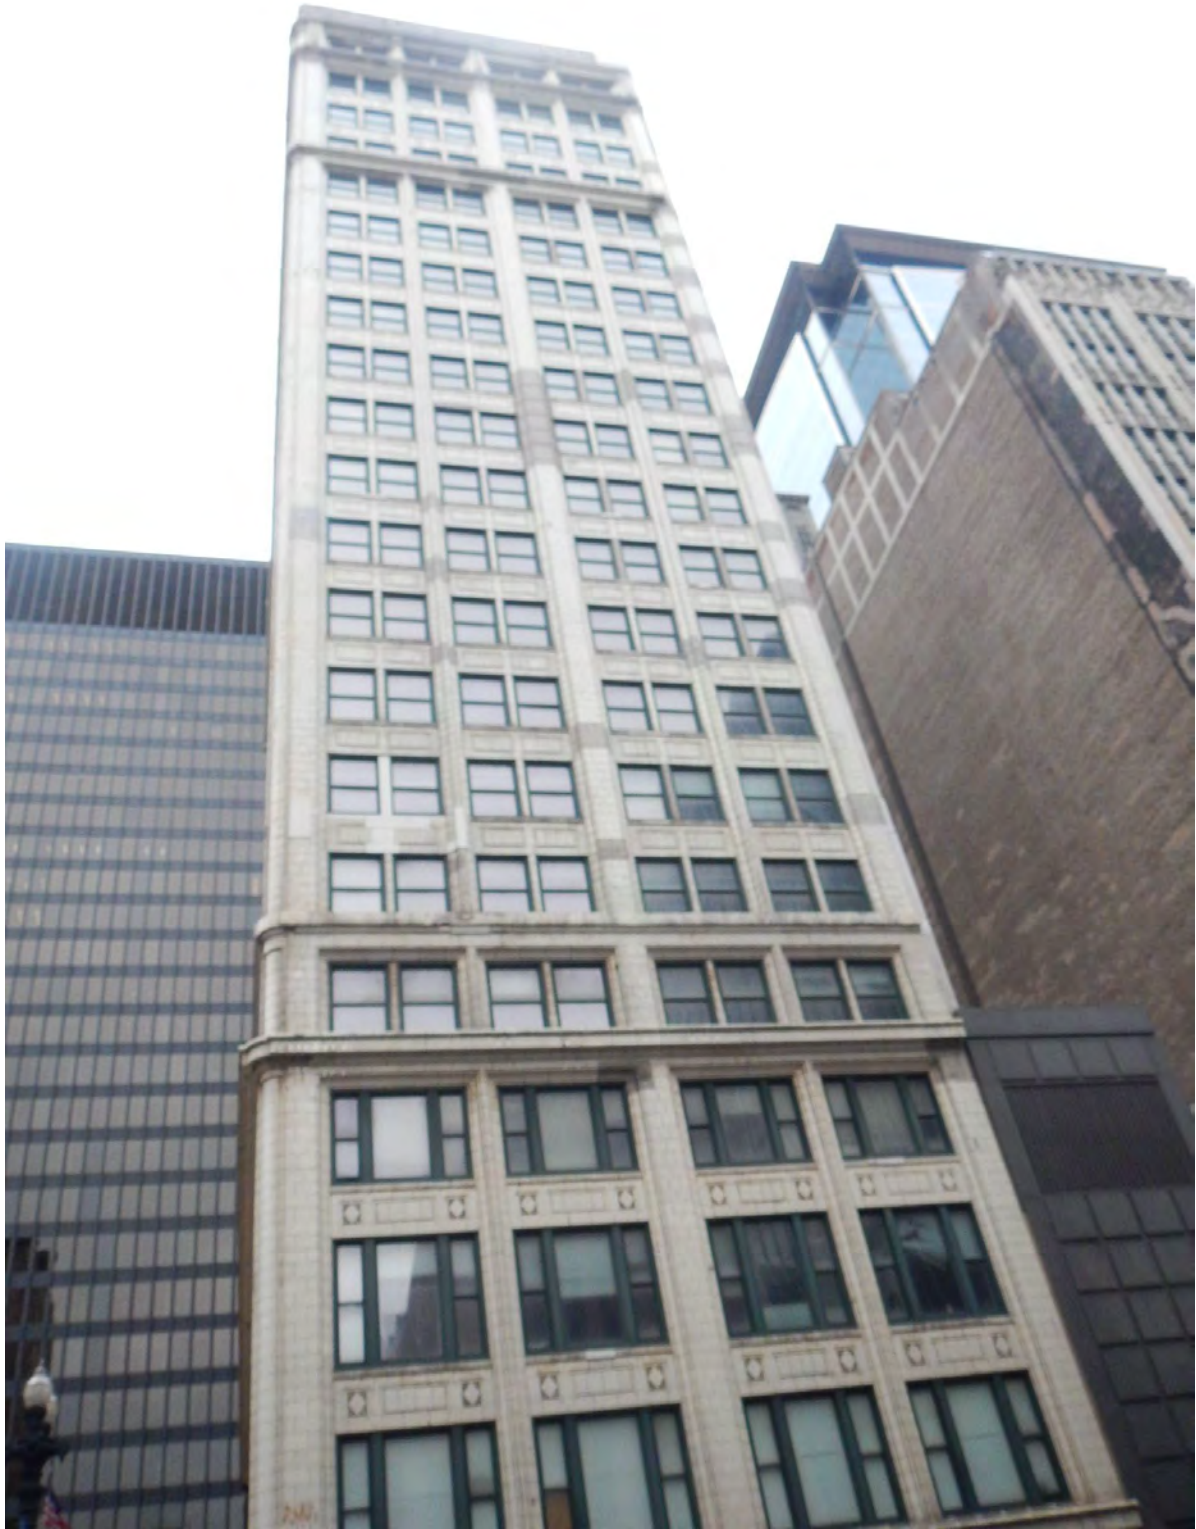
Overview of east elevation
