GSA Great Lakes Region

220 State Street Evaluation Report

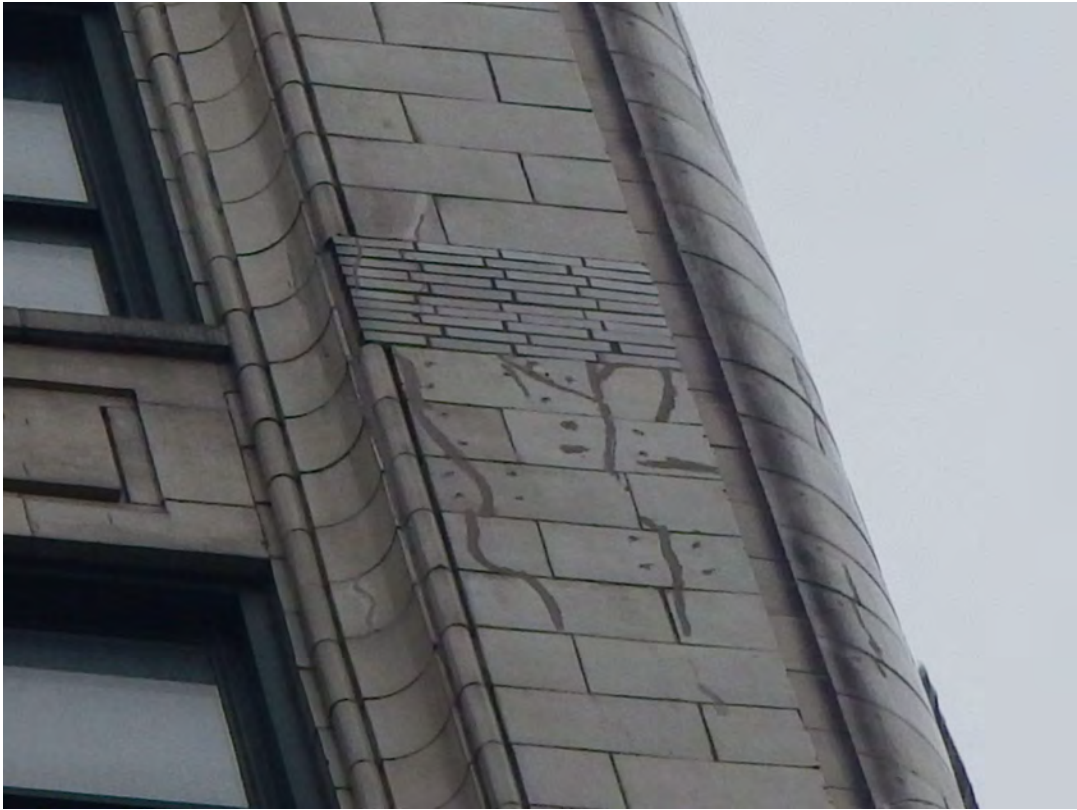
Terra cotta column with various previous repair efforts

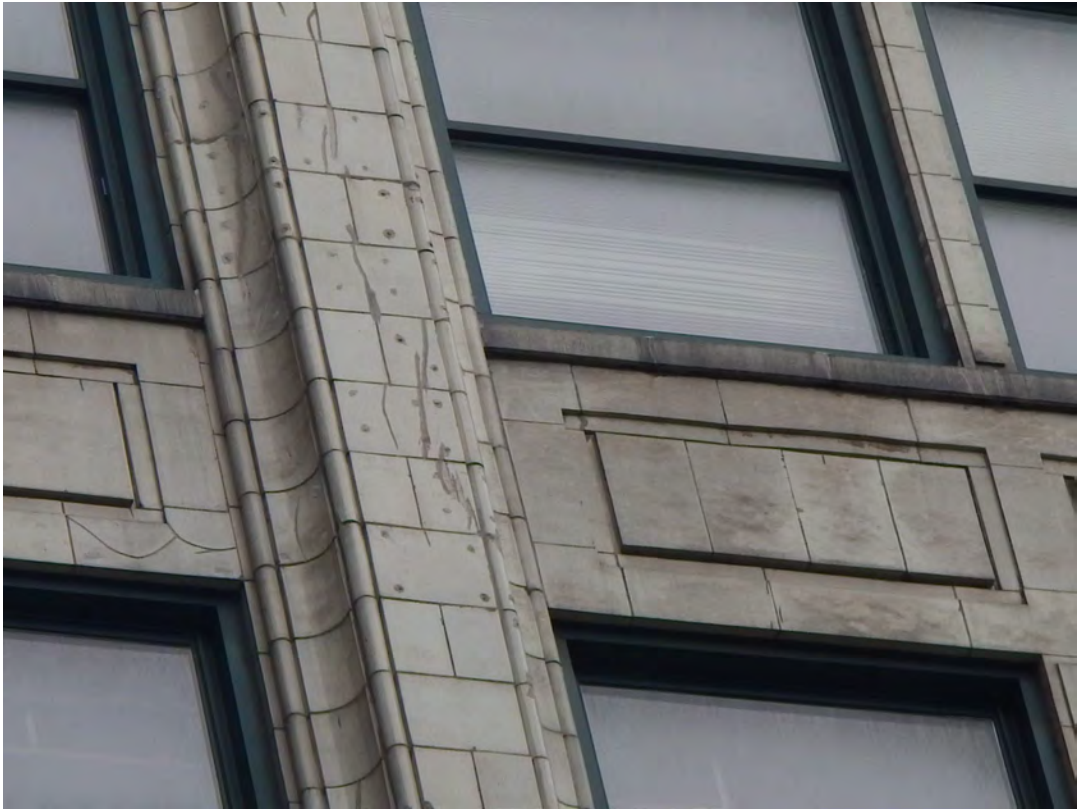
Terra cotta column with various previous repair efforts

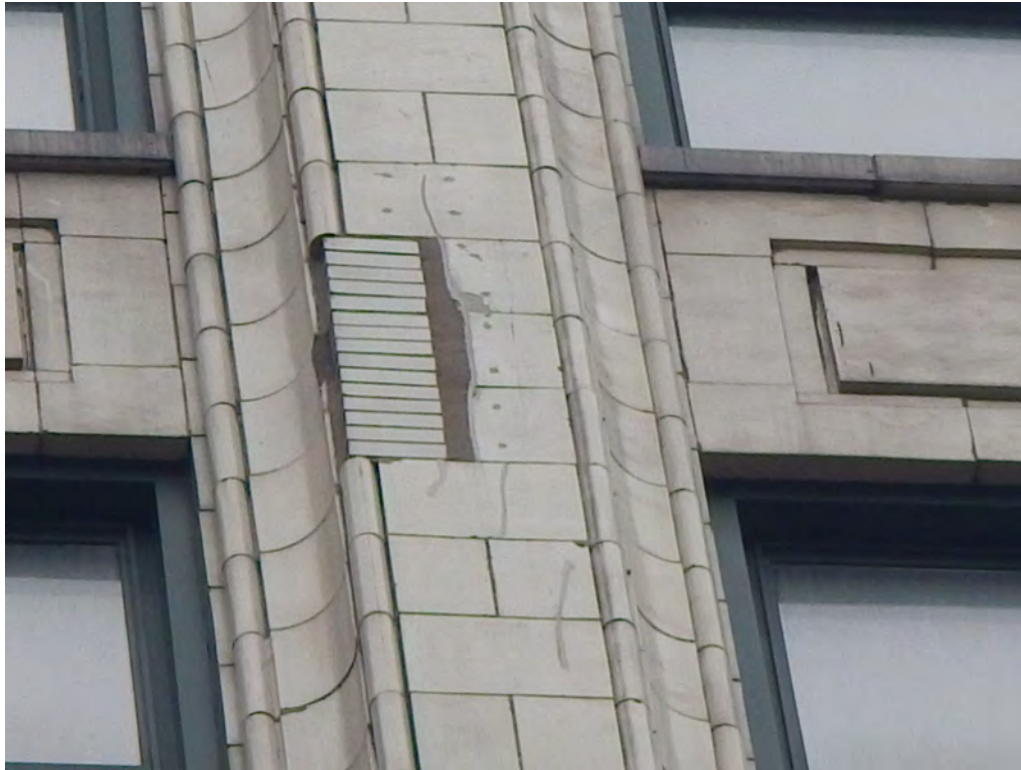
Terra cotta column with various previous repair efforts

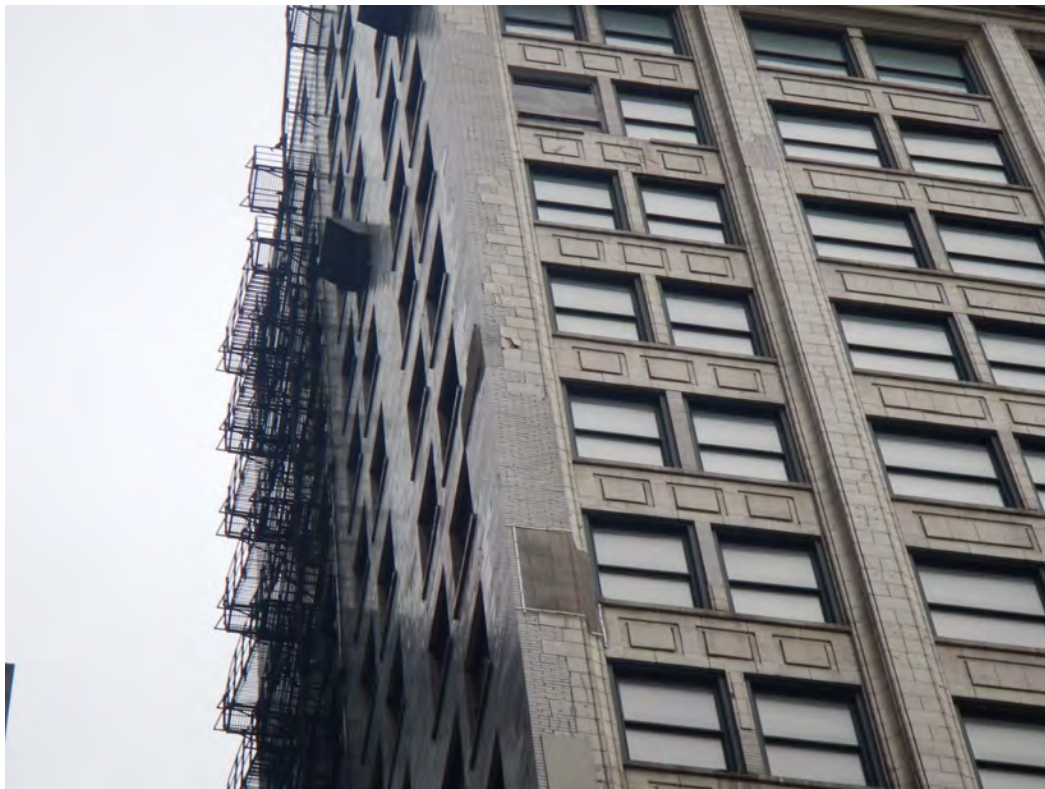
Terra cotta column with various previous repair efforts and new area of spall (dark area at mid-height of west column)

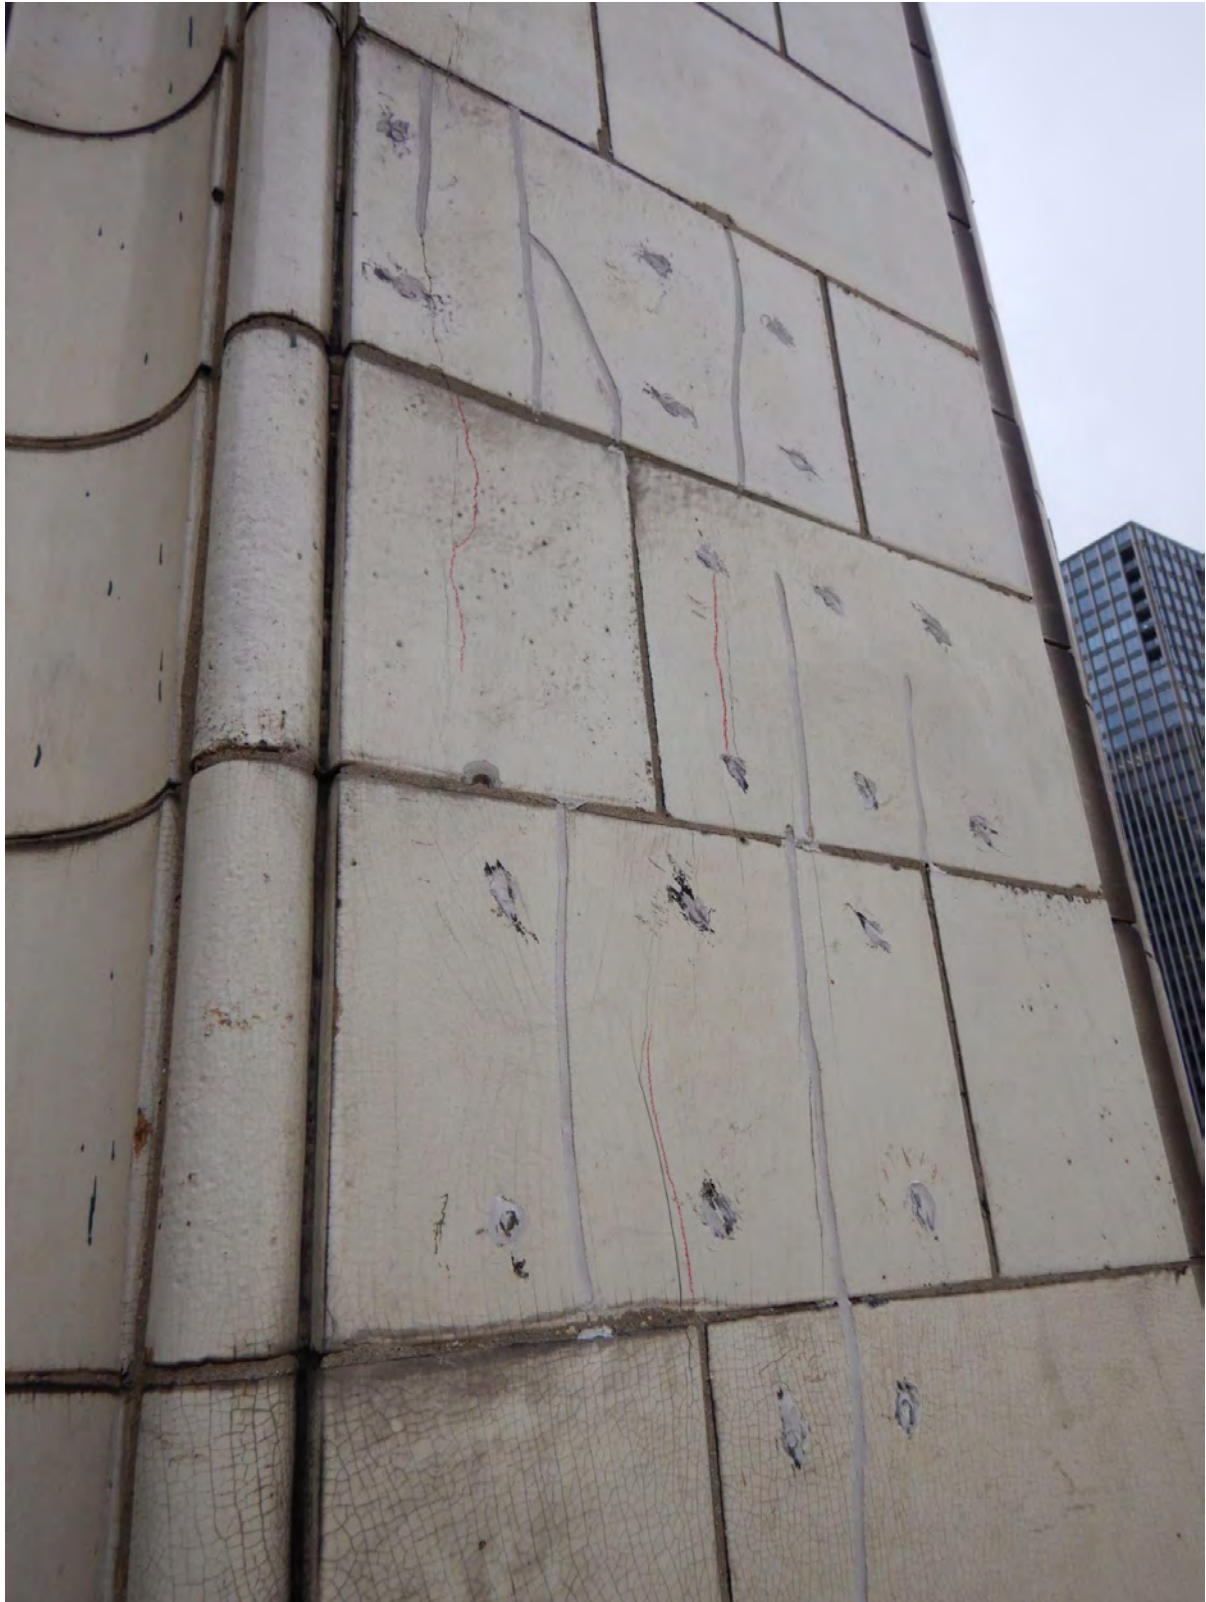
Terra cotta column with various previous repair efforts

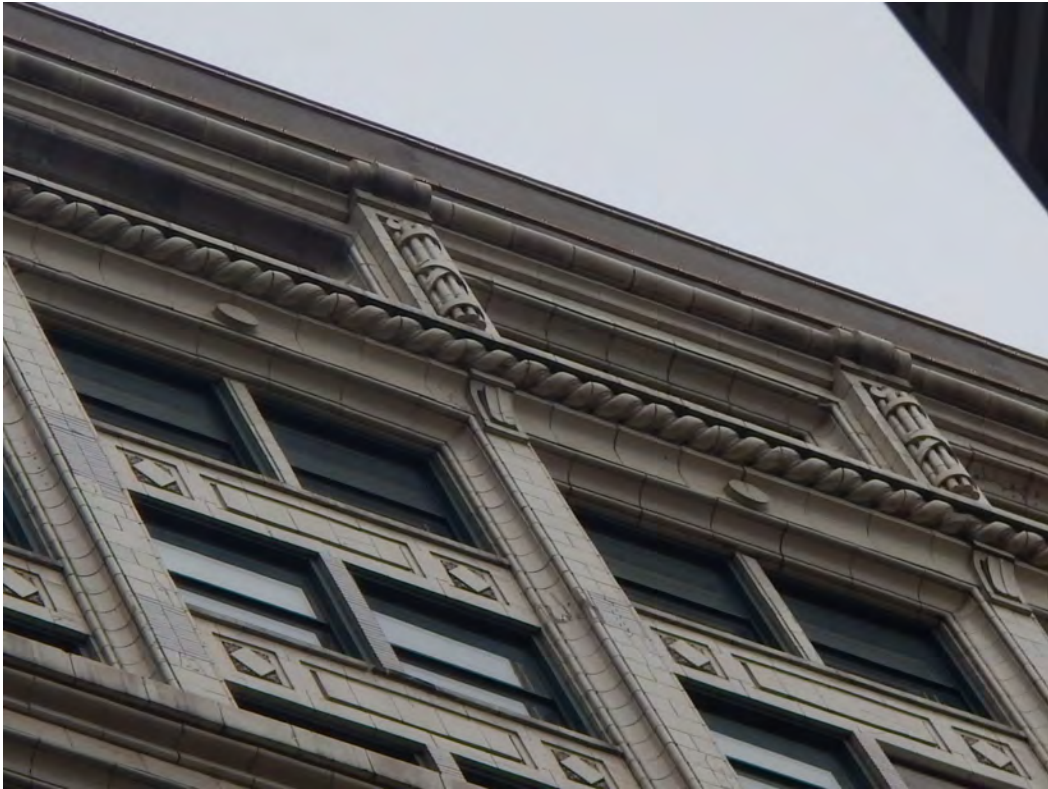
Overview of water tables at upper floors

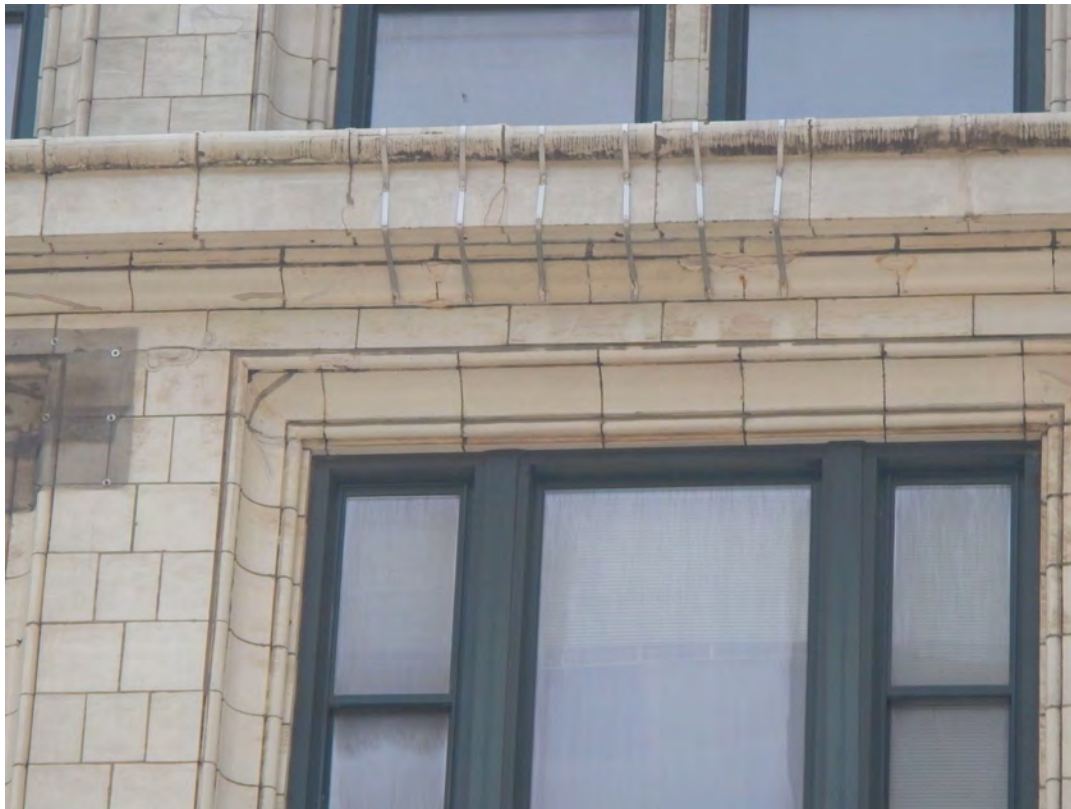
Overview of steel straps installed at water table and cracking at terra cotta lintel units

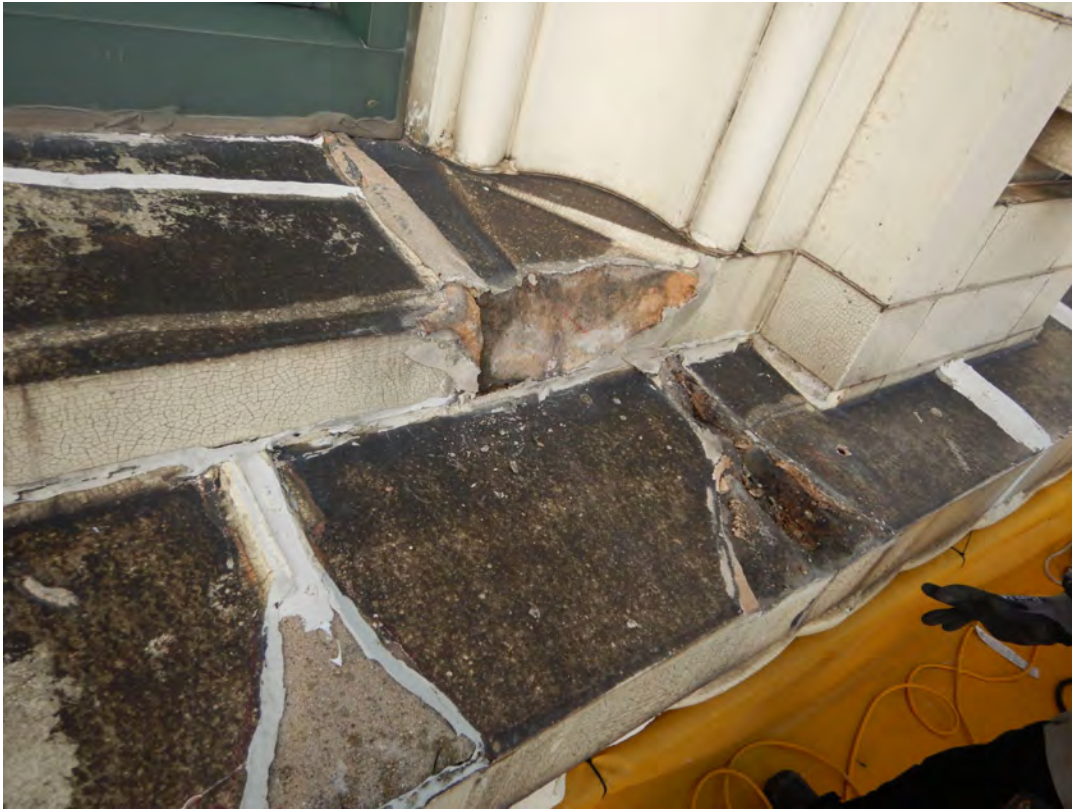
Overview of previous repair efforts and open joint at top of water table

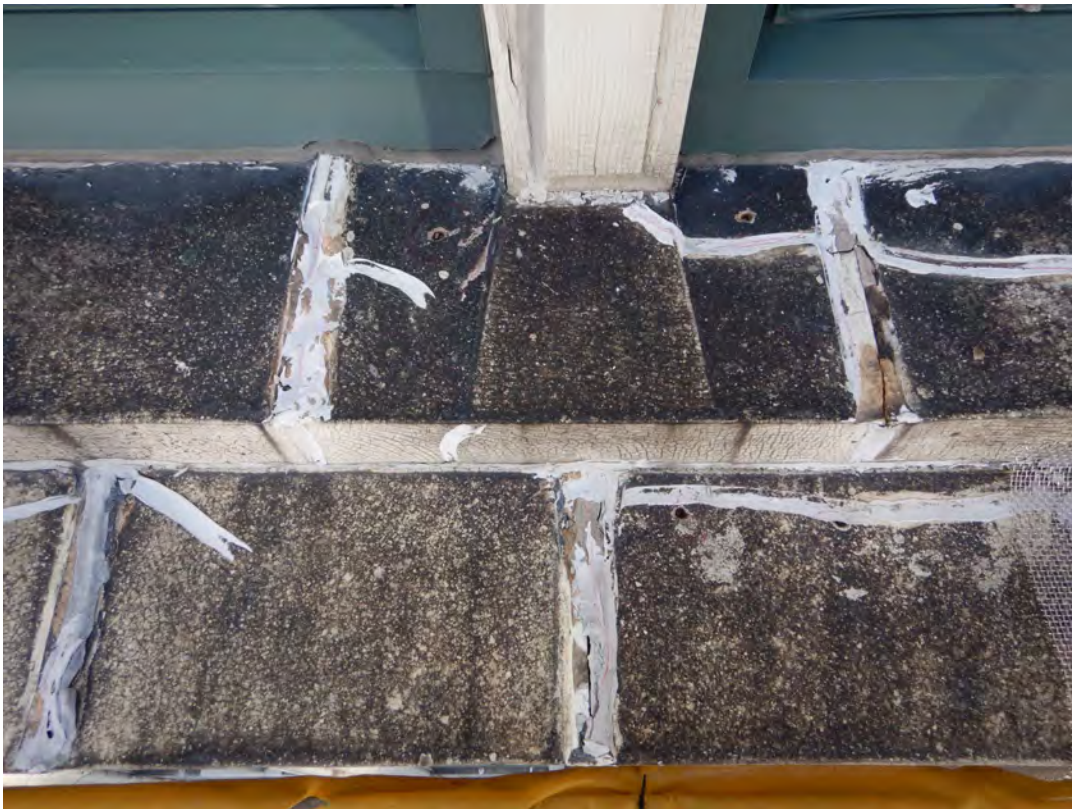
Overview of previous repair efforts and open joint at water table

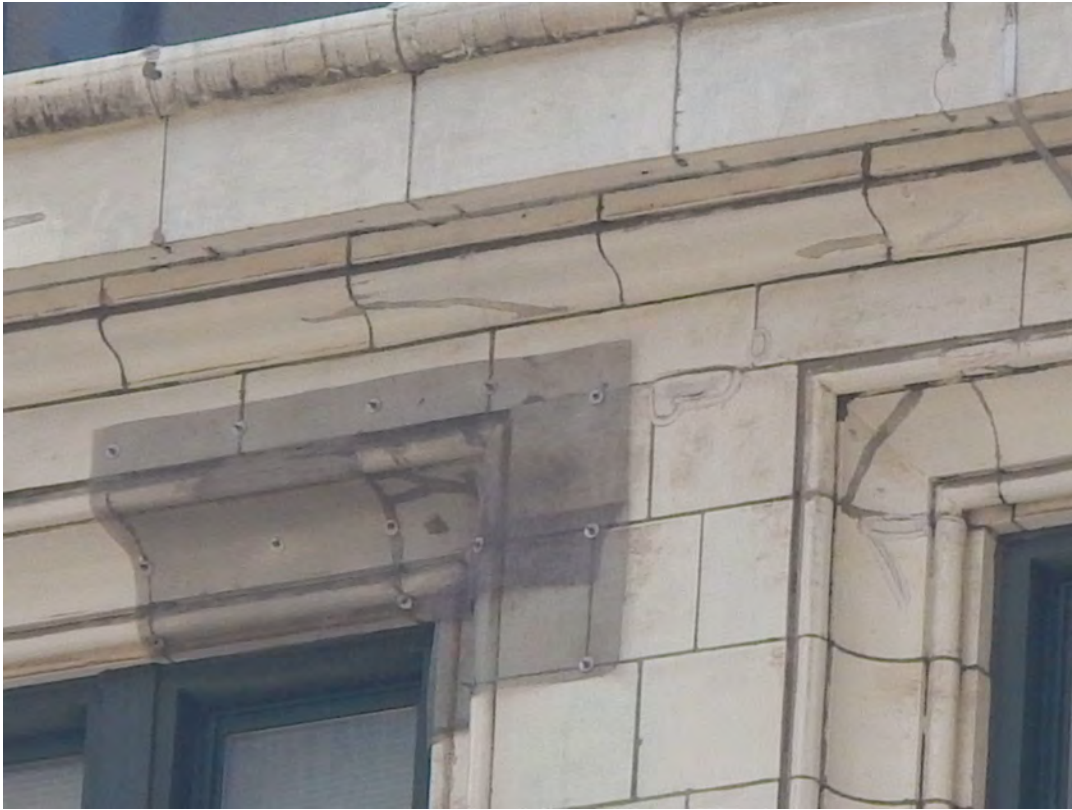
Overview of steel mesh repair effort and crack repair efforts and window lintel

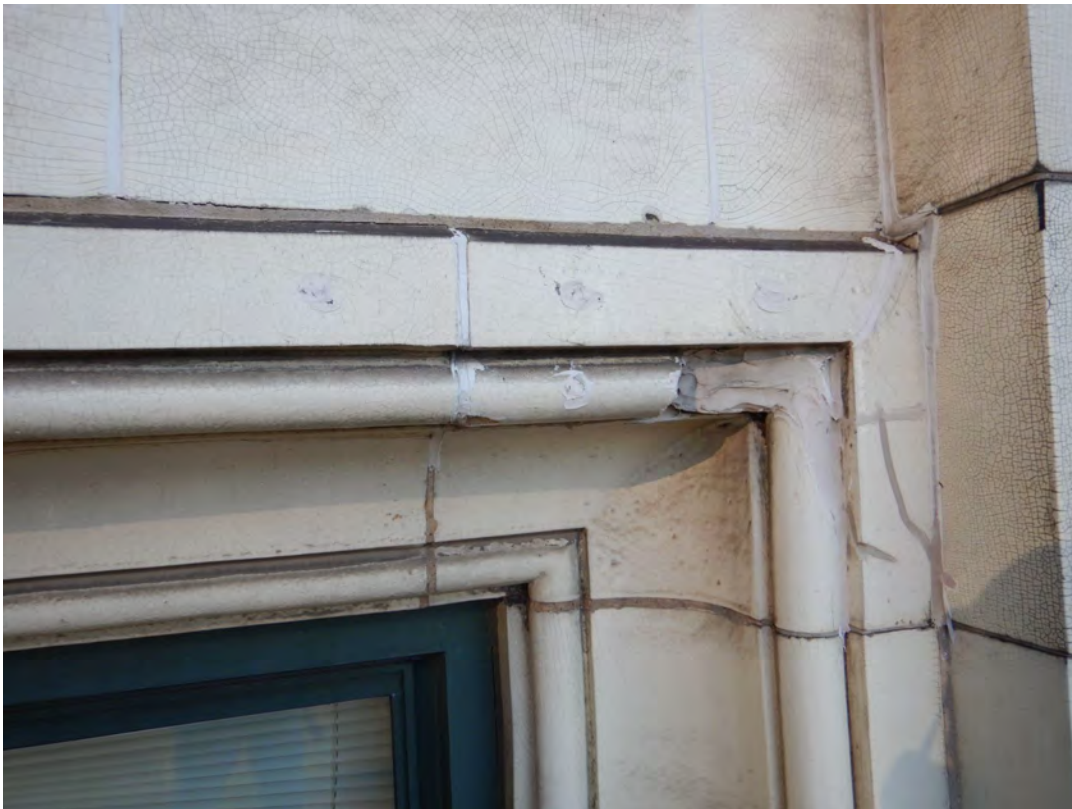
Previous repair efforts at terra cotta window lintel

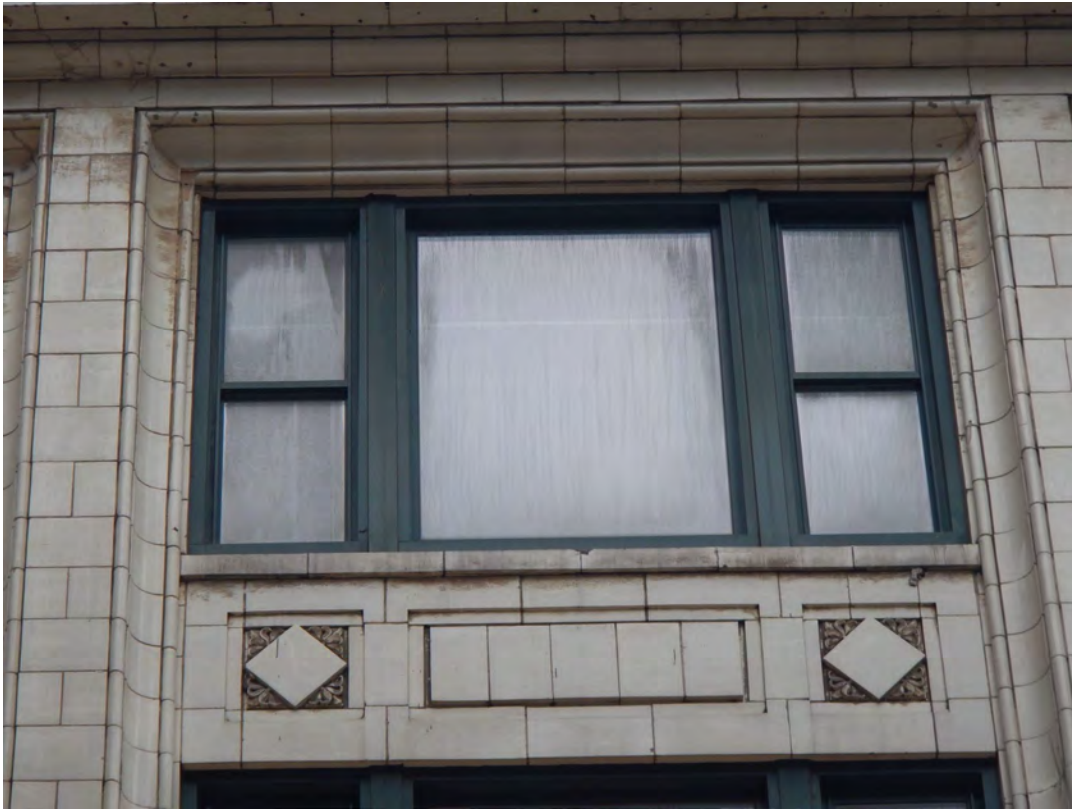
Overview of terra cotta spandrel and Chicago style window

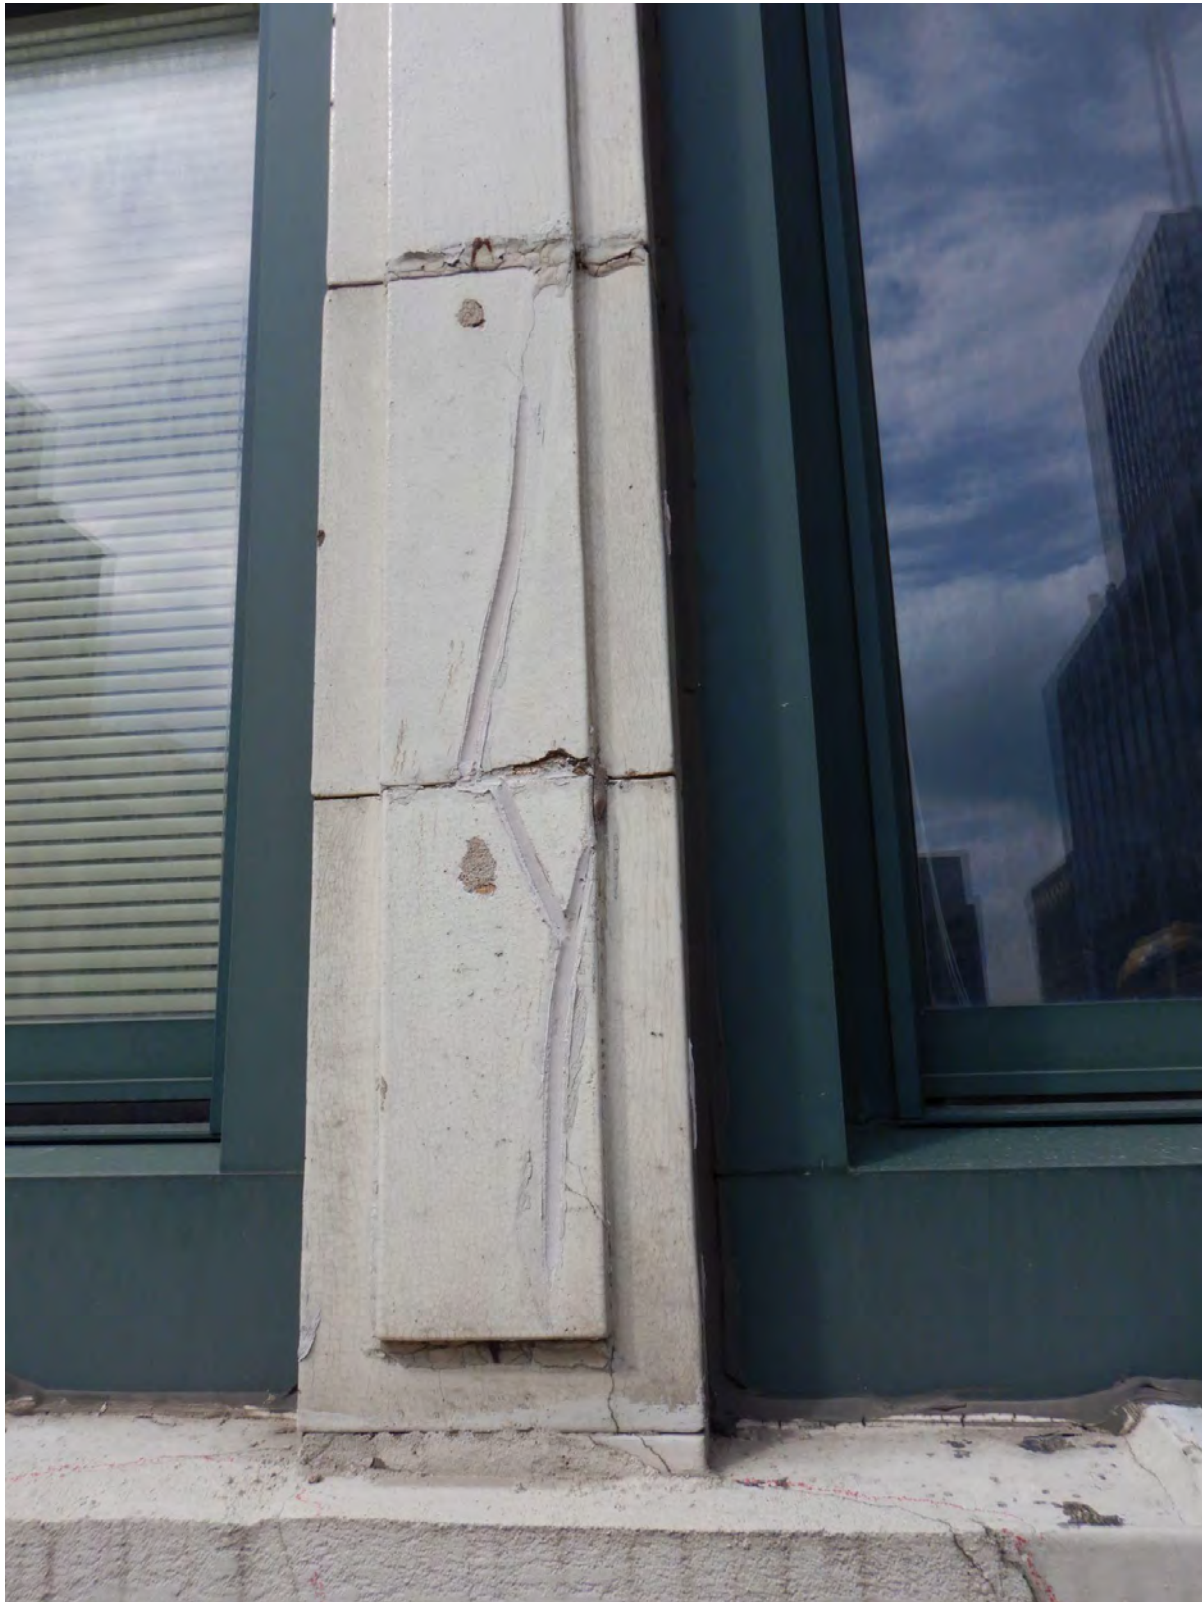
Overview of terra cotta mullion with previous repair efforts and newer crack

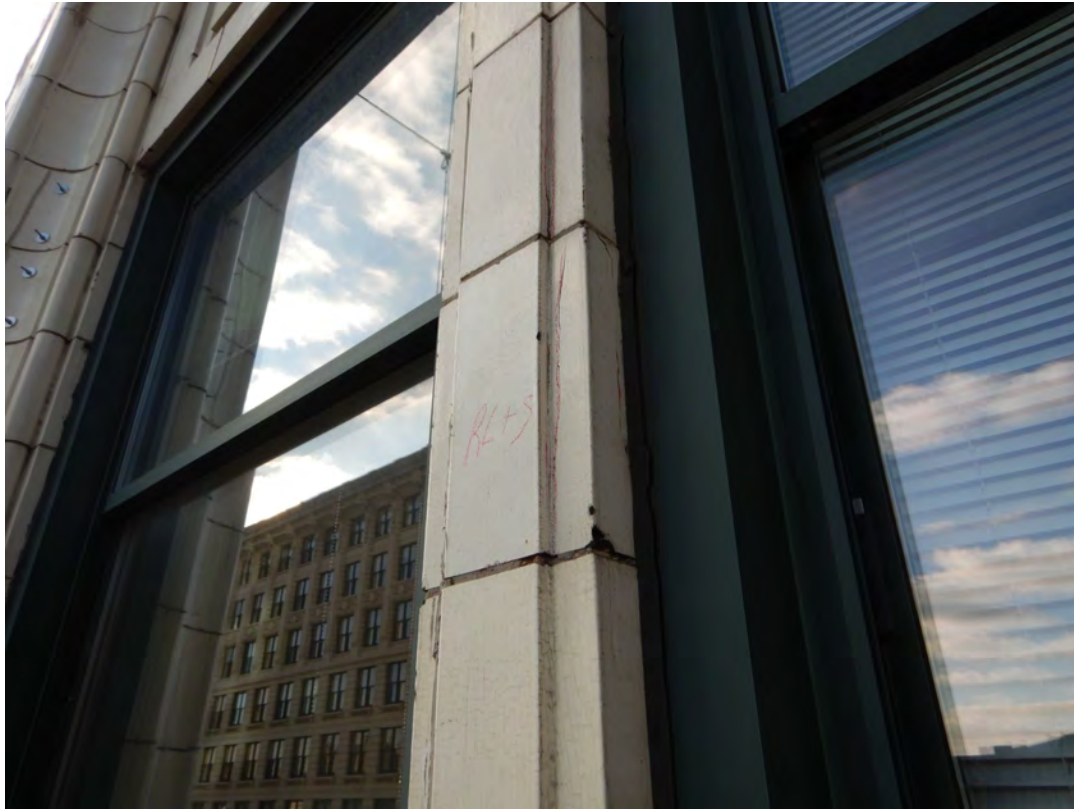
Overview of terra cotta mullion units with newer crack

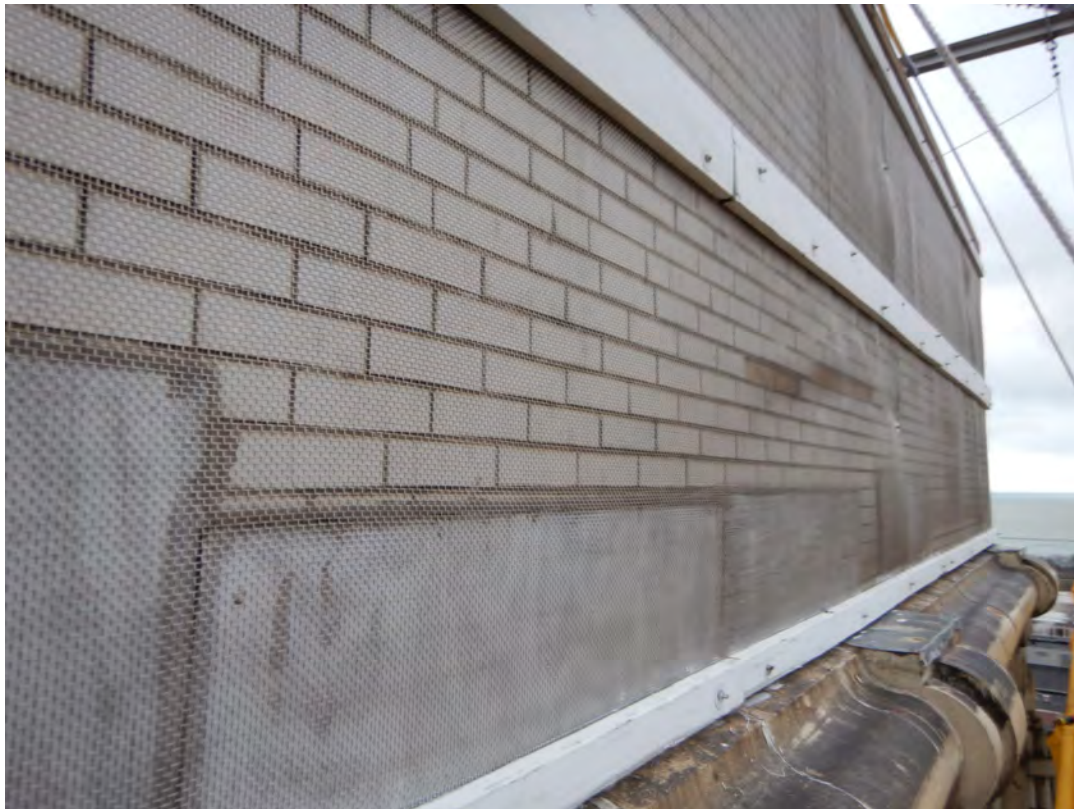
Overview of parapet wall with wood 2x and steel mesh

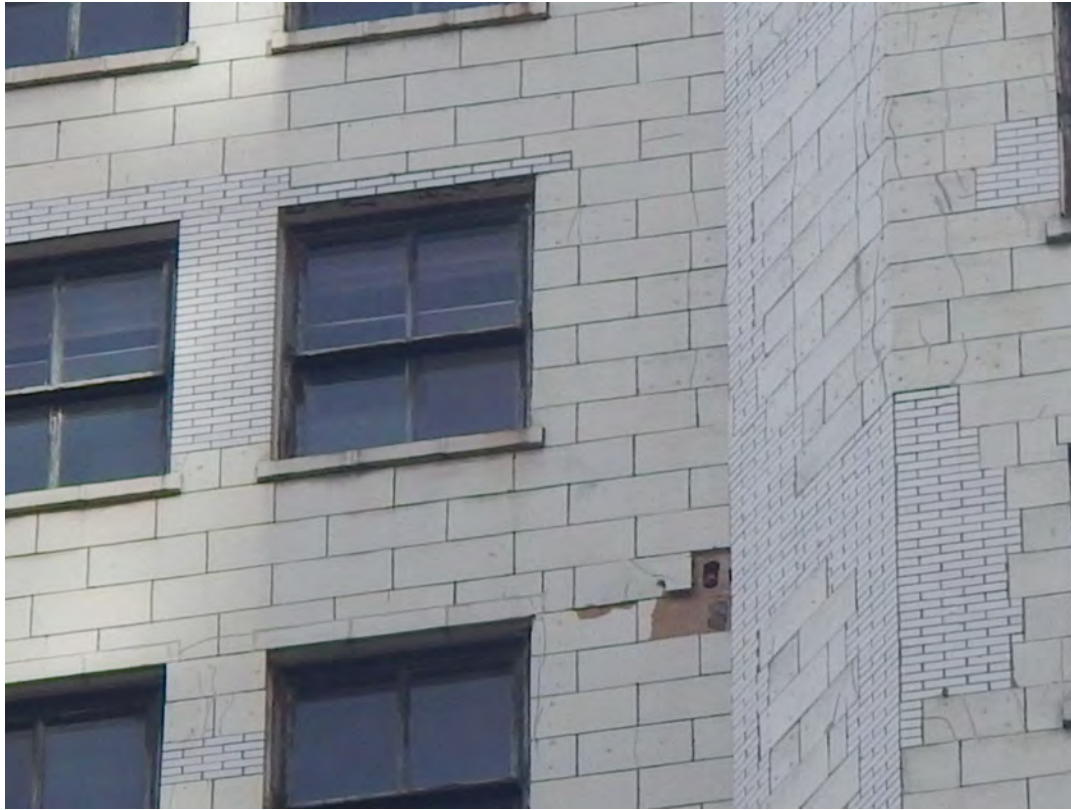
Overview of north elevation with terra cotta spalled units and cracked units

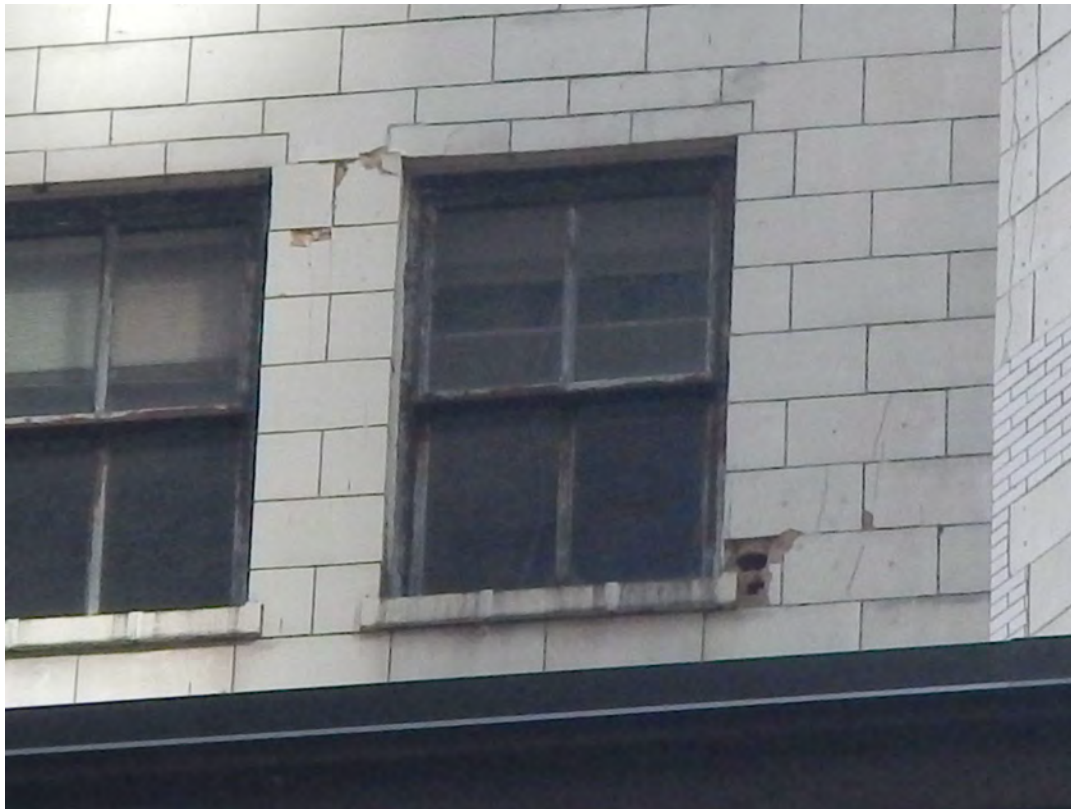
Overview of north elevation with terra cotta spalled units and cracked units

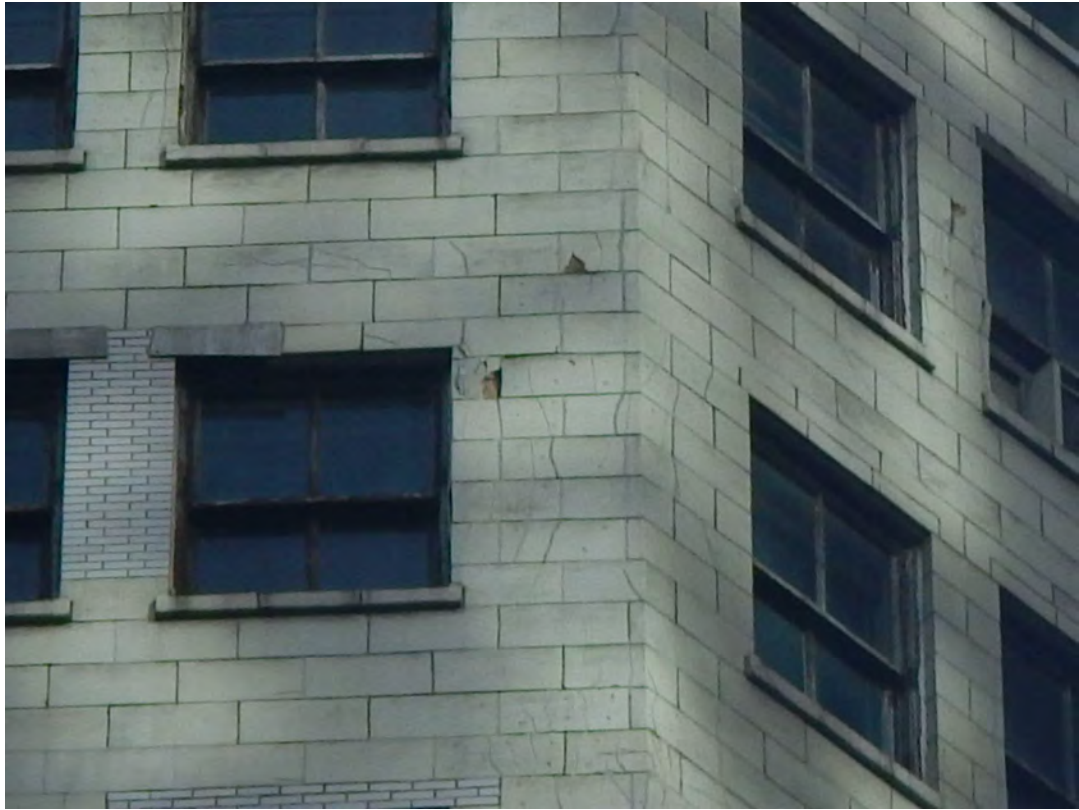
Overview of north elevation with terra cotta spalled units and cracked units

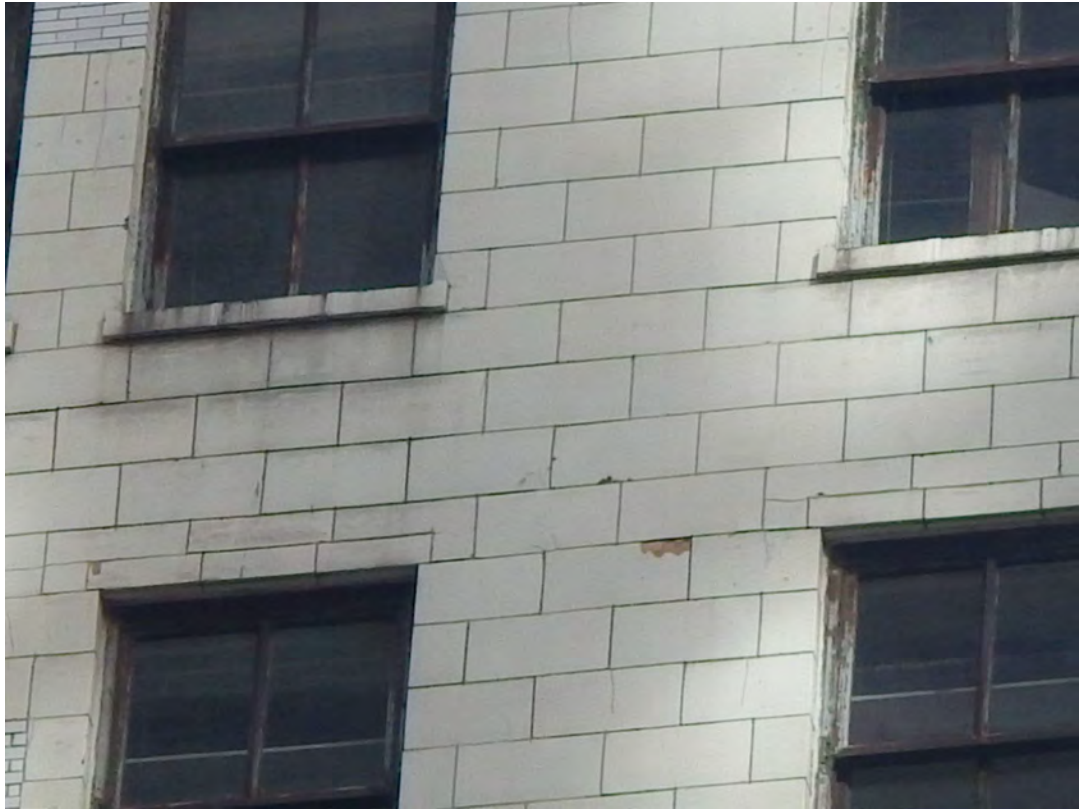
Overview of north elevation with terra cotta spalled units and cracked units

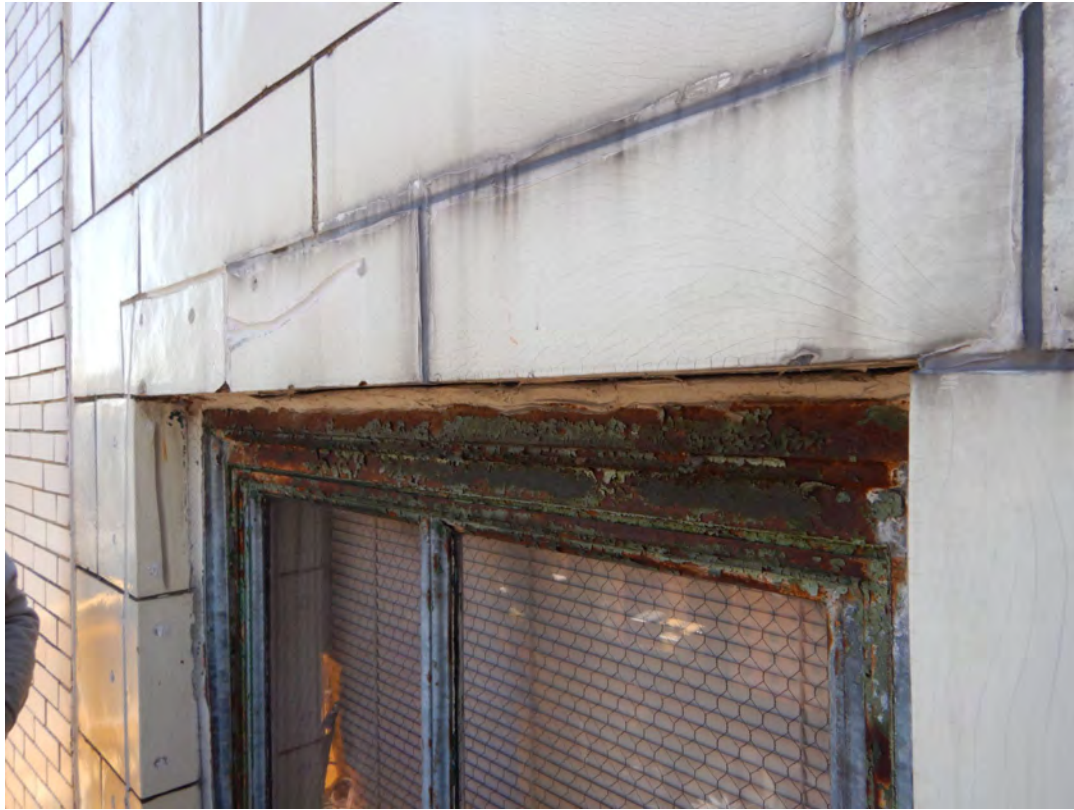
Overview of typical steel window head

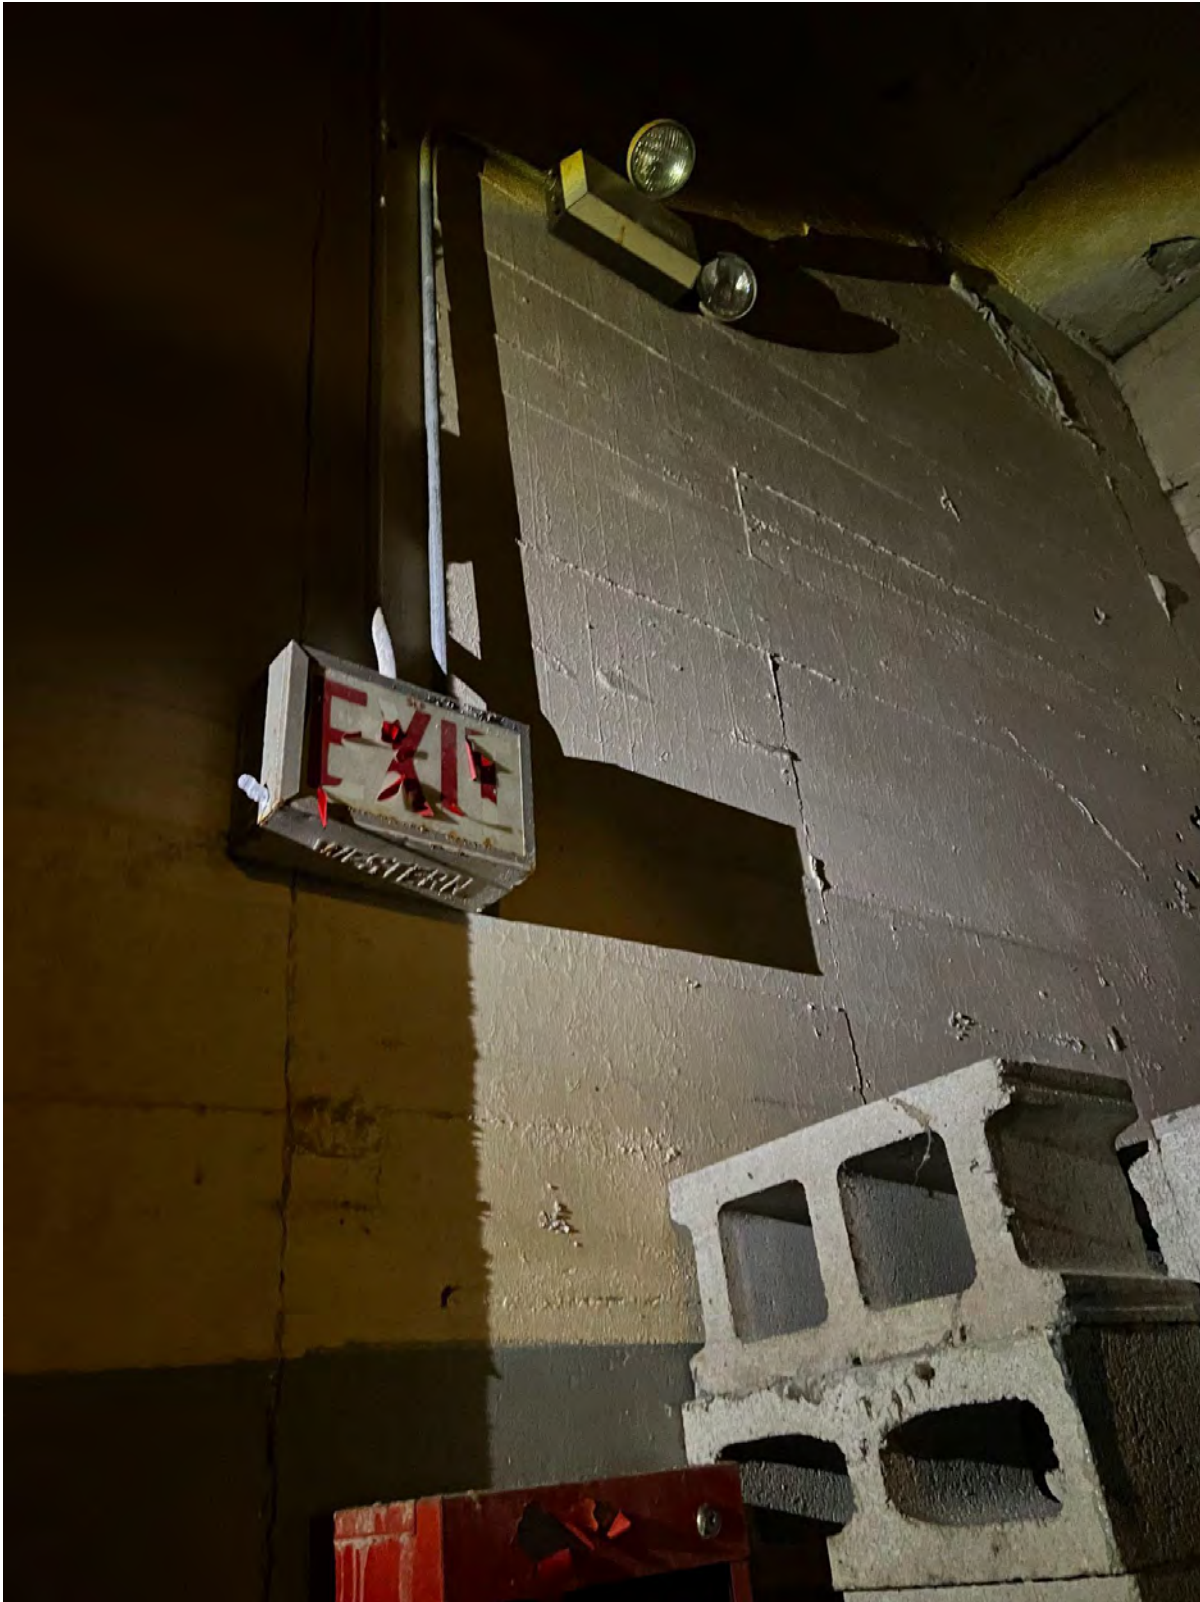
Basement: Damaged exit and emergency lights.
