GSA Great Lakes Region

220 State Street Evaluation Report

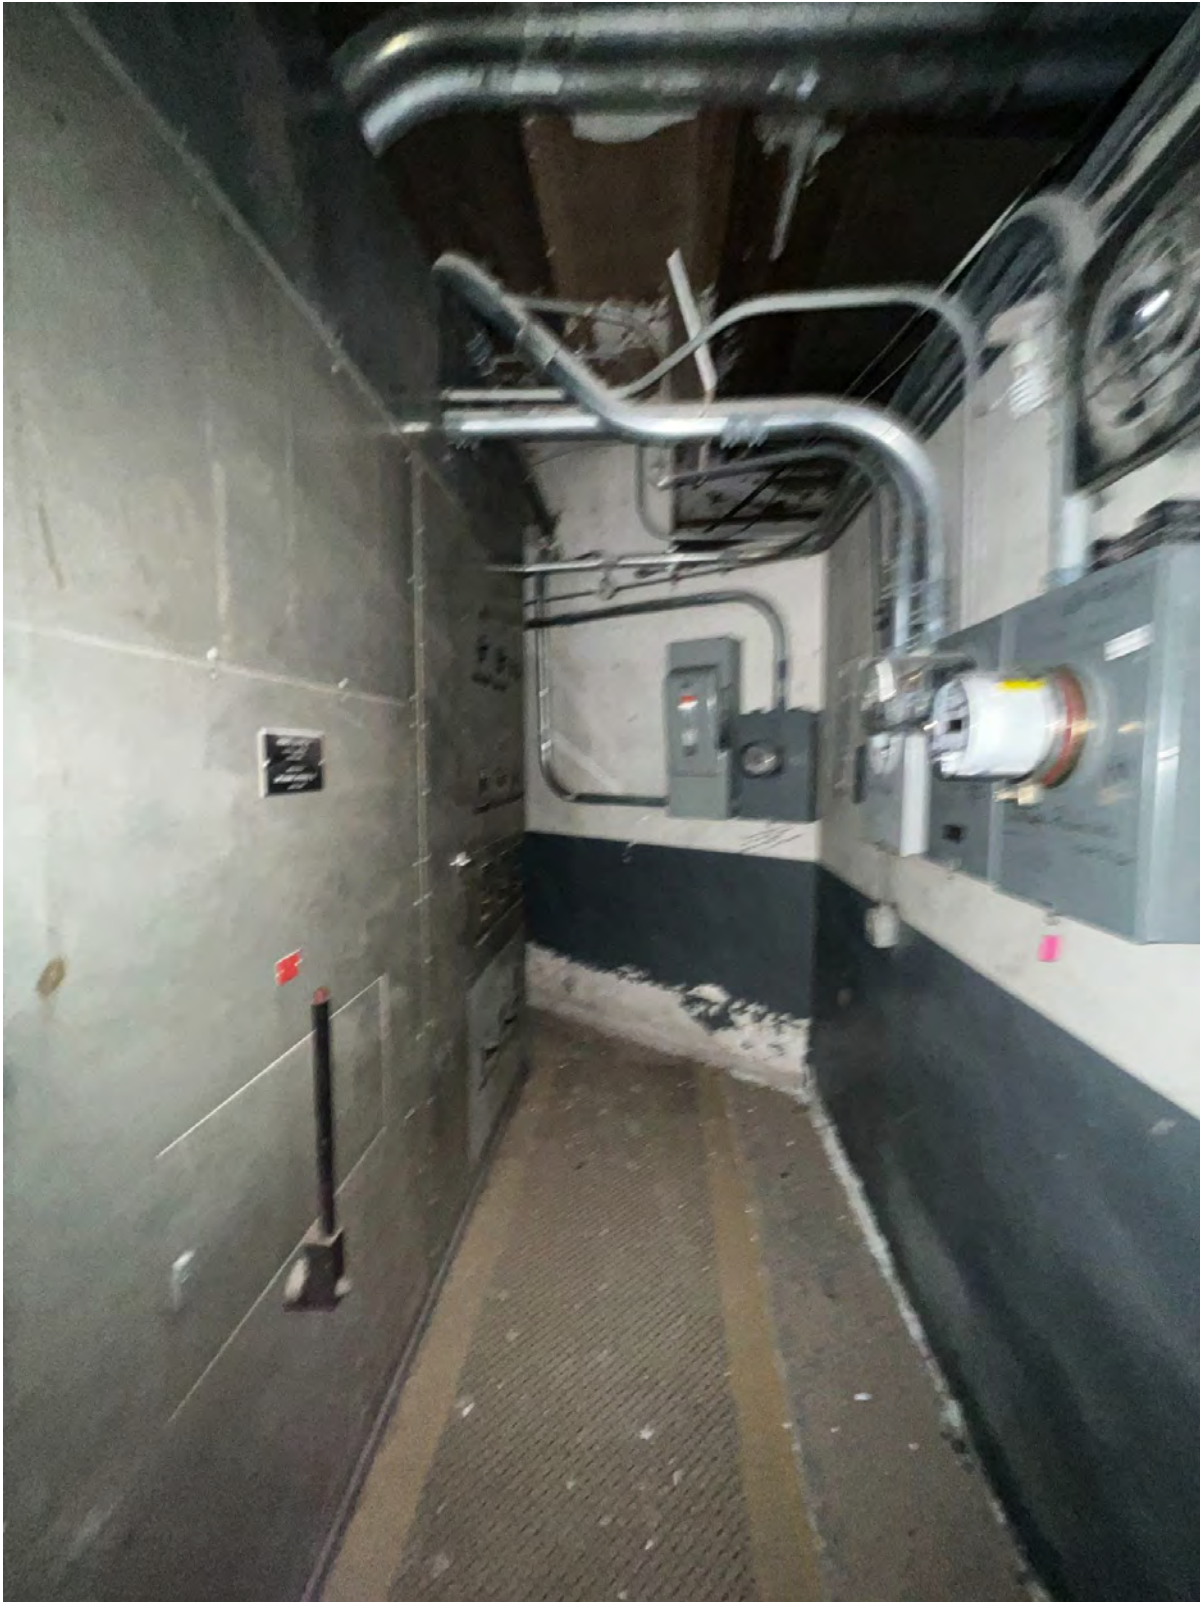
Sub-basement: Existing 120/208v switchboard

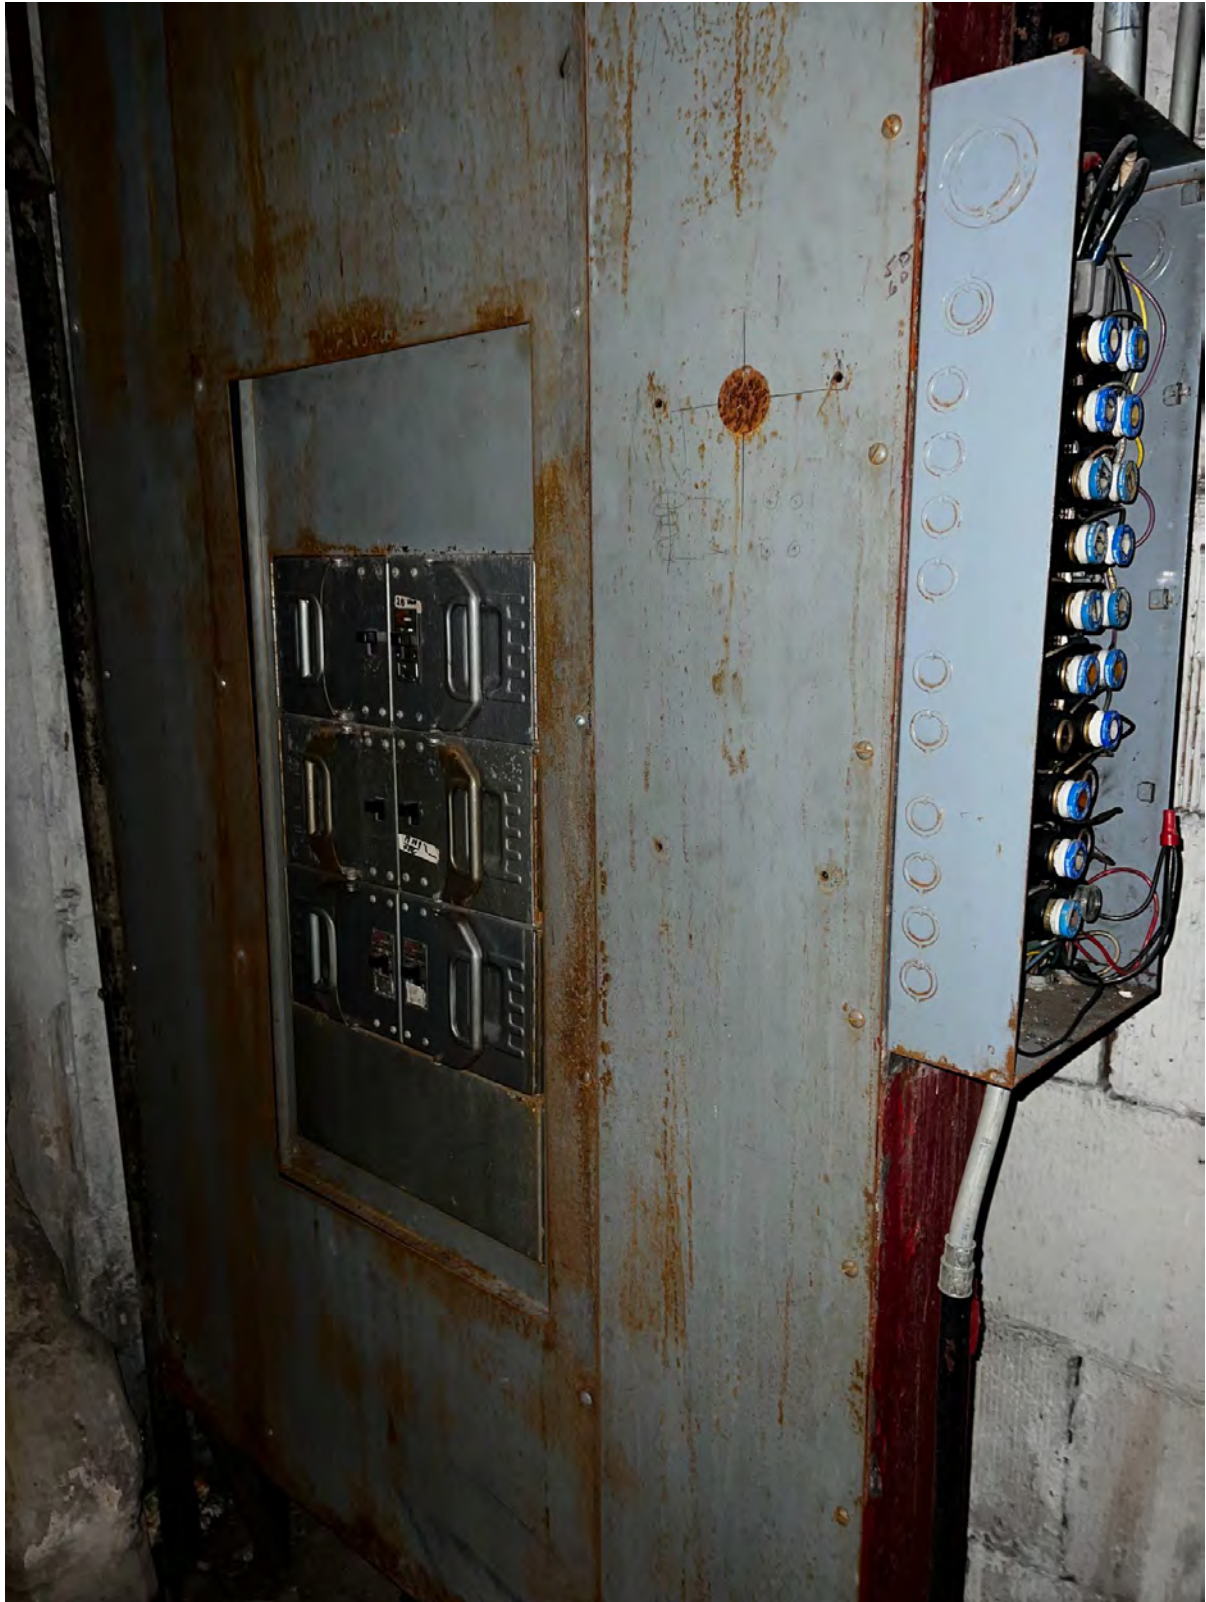
Sub-basement: Outdated panelboard with corrosion on exterior and missing covers.

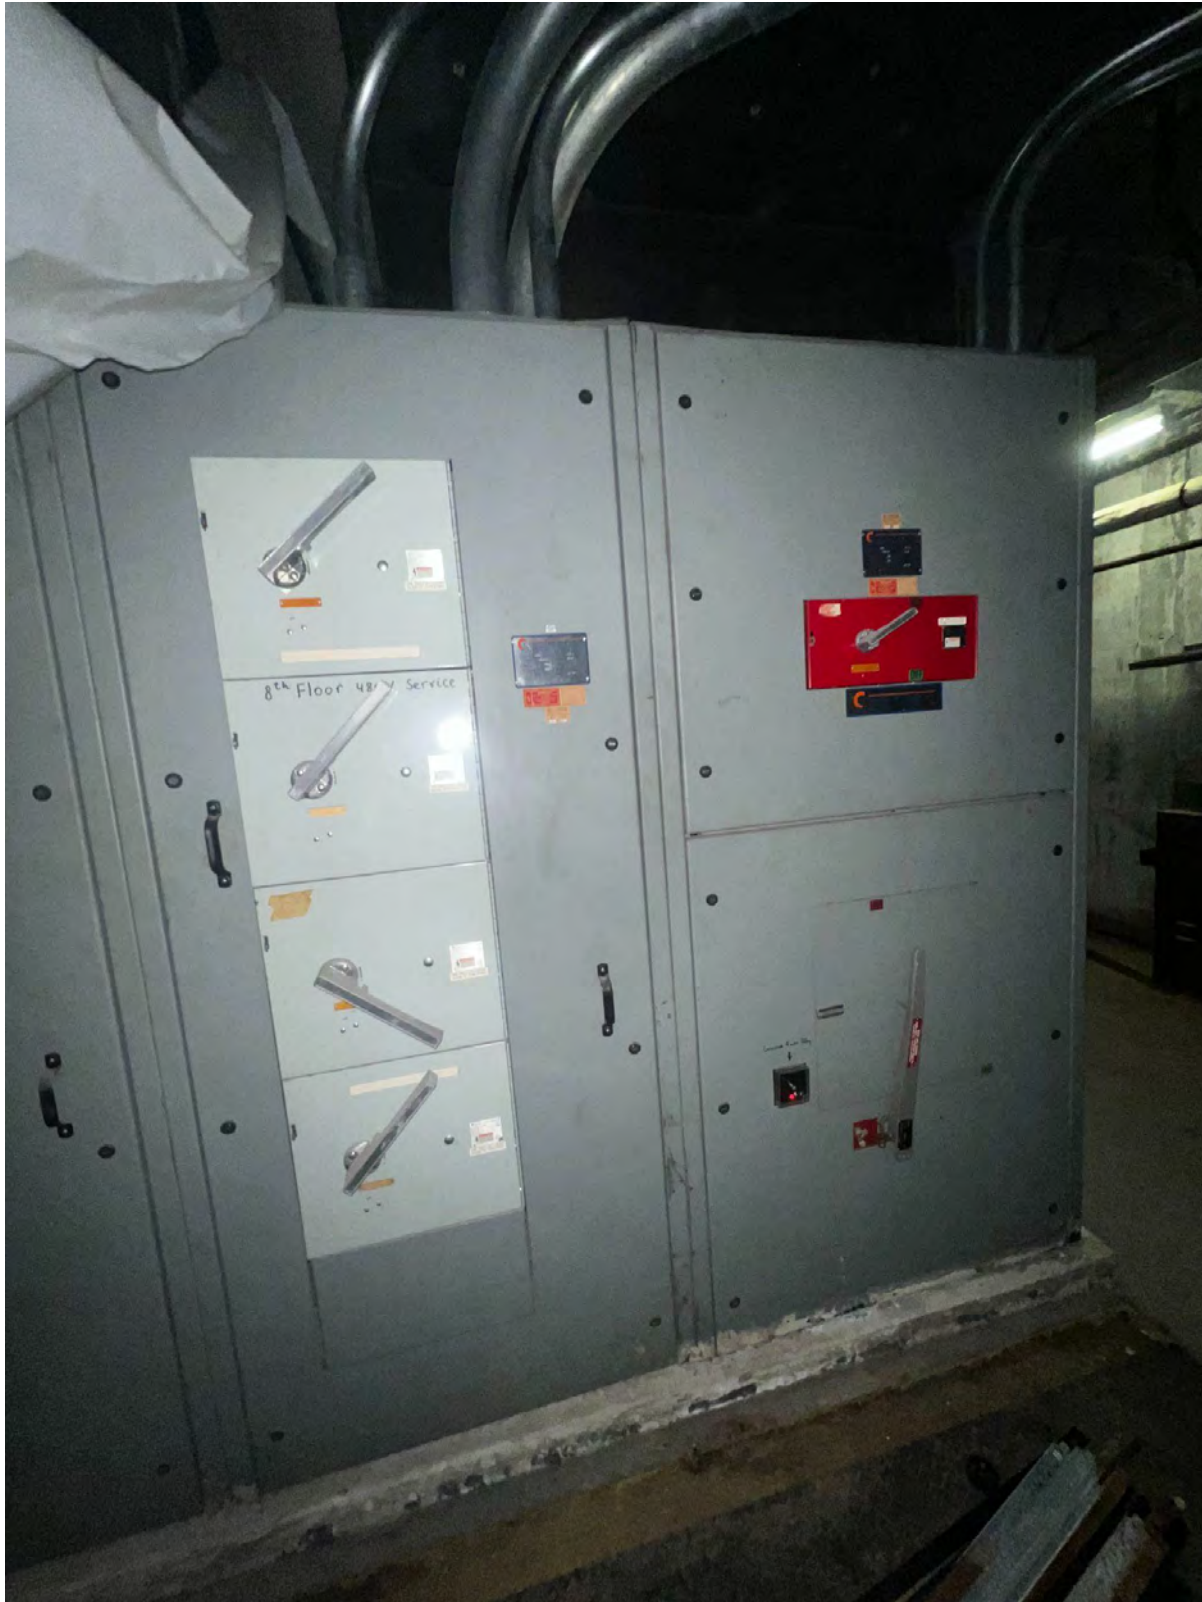
Sub Basement: Existing 480v switchboard

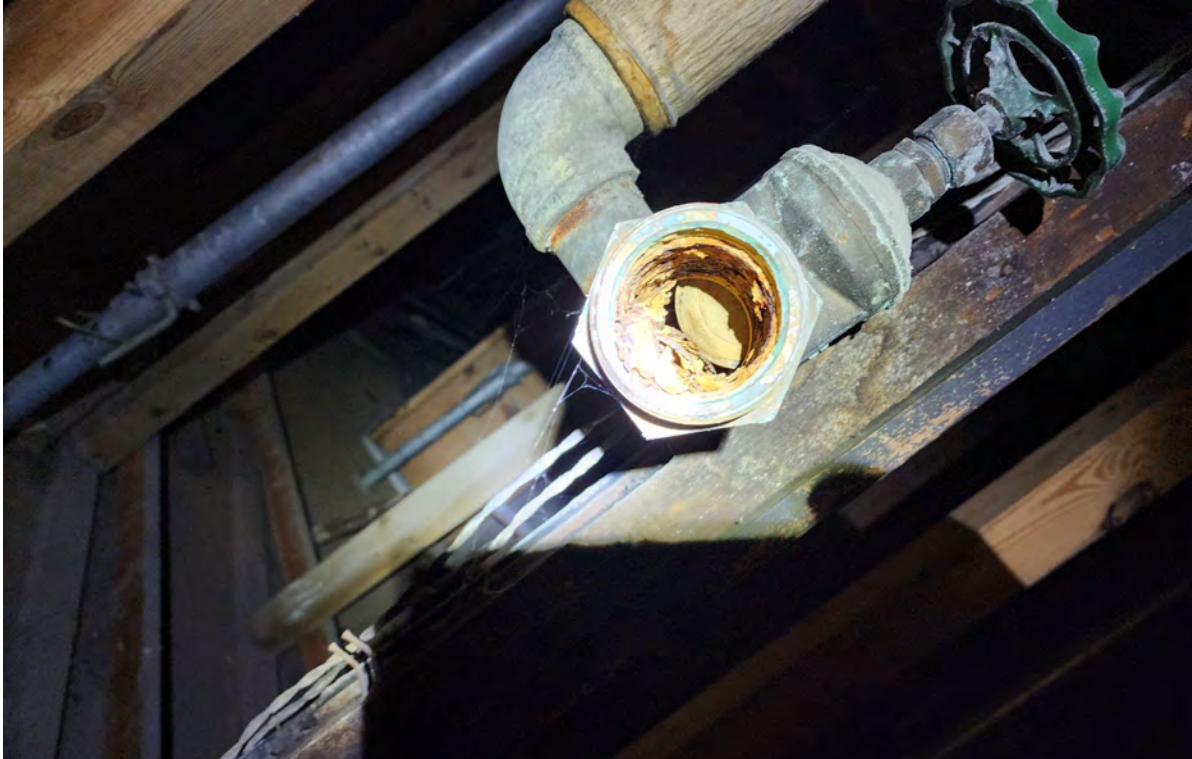
Basement Level: Abandoned domestic water piping - corrosion inside the pipe.

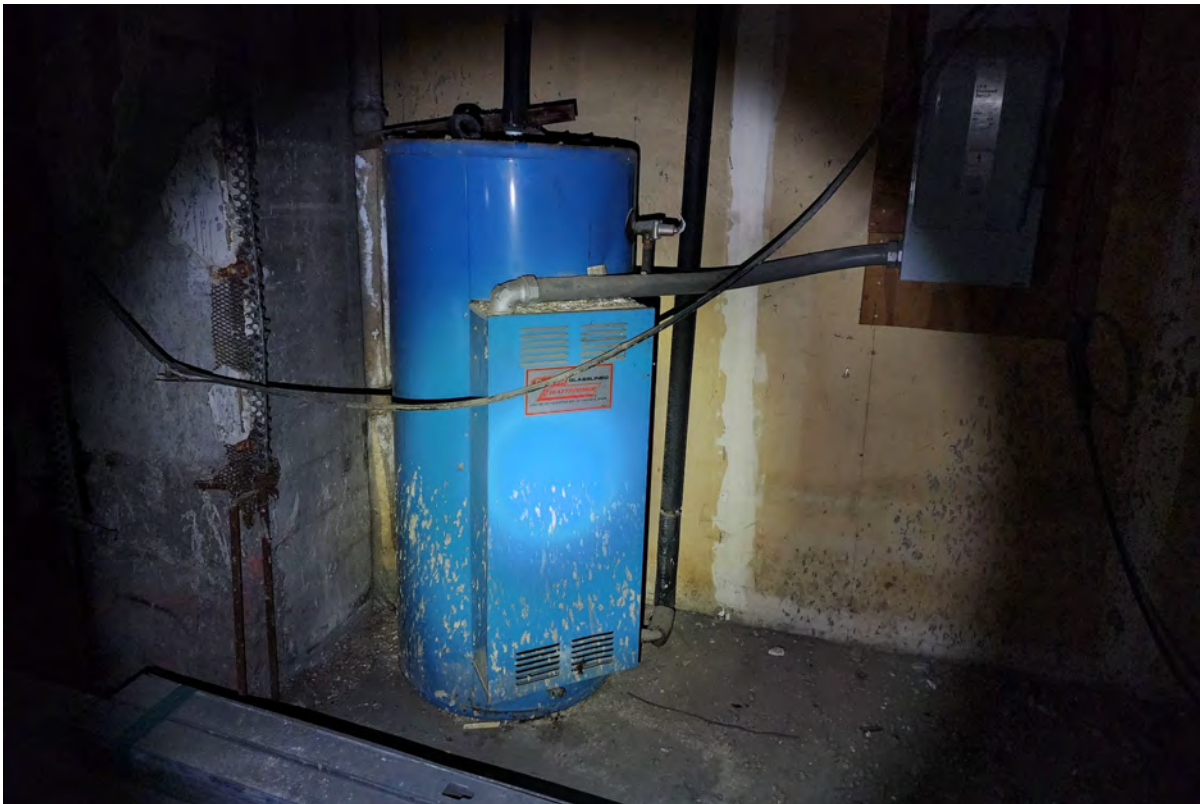
Basement Level: Tank-type Electric Water Heater.

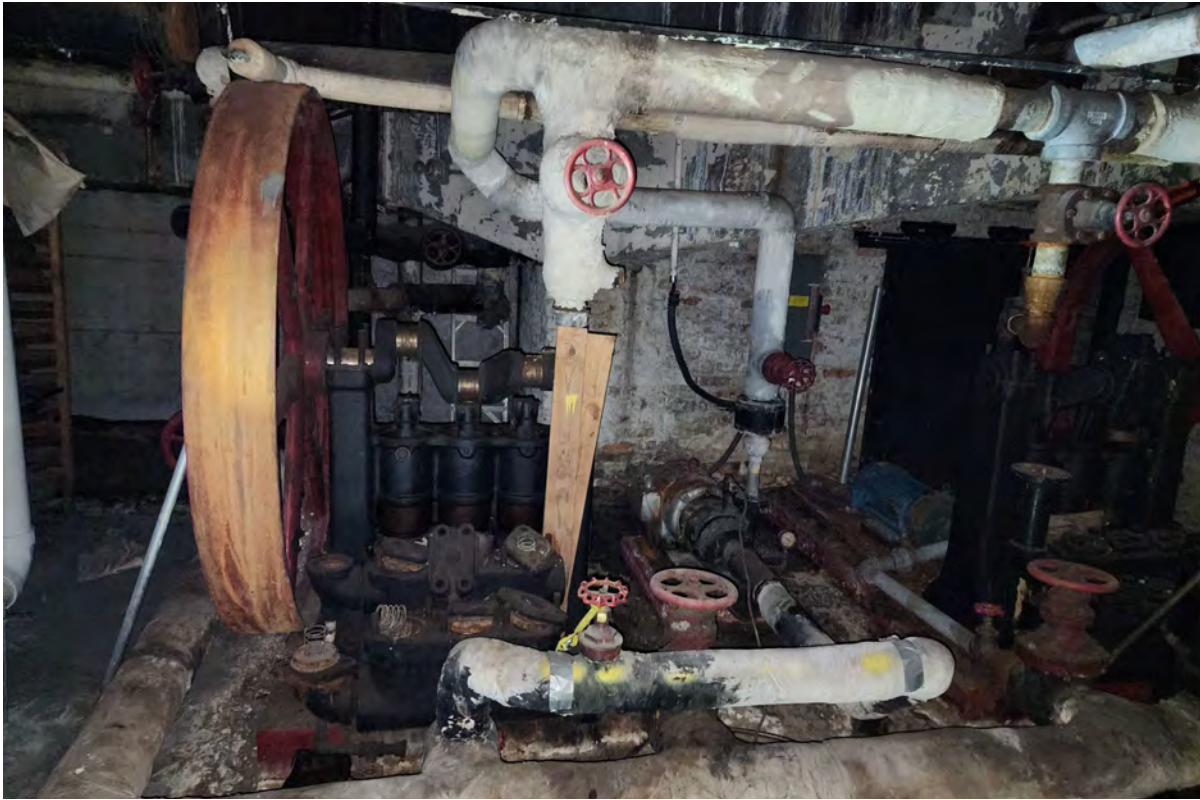
Basement Level: Fire Pump
Basement Level: Drainage piping with damaged insulation.

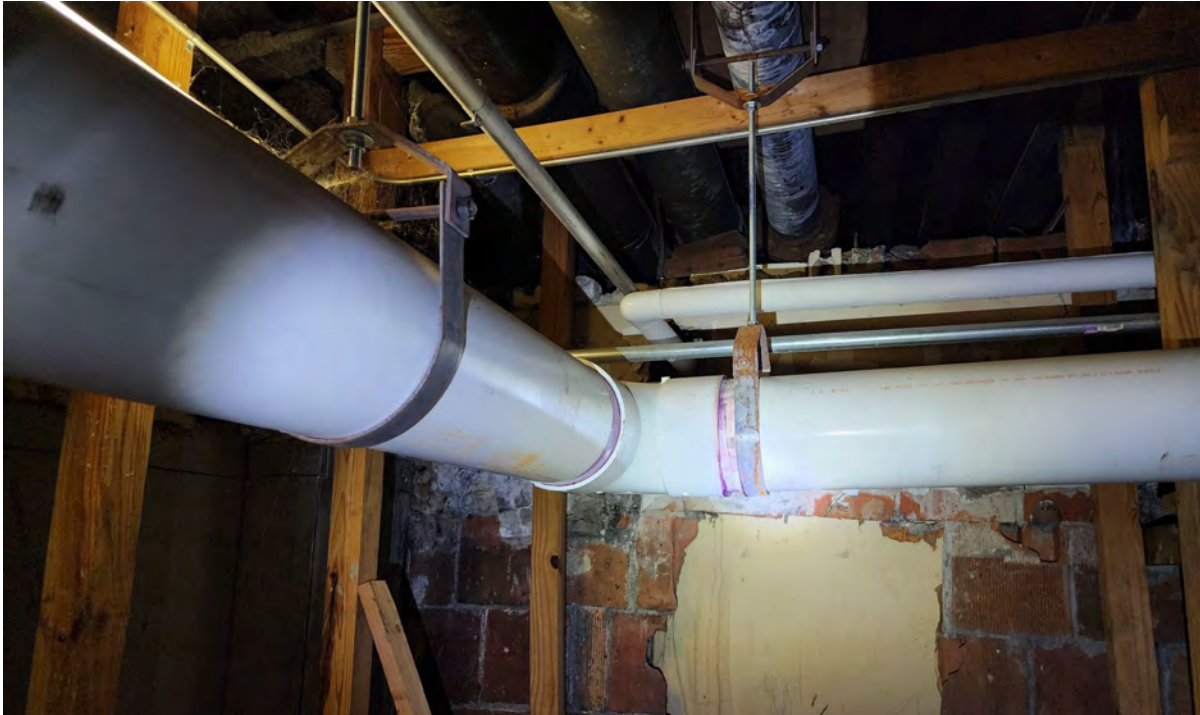
Basement Level: PVC piping that was installed to mitigate pipe leaks. The pipe material is not code compliant or does not meet the requirements listed in GSA's P-100 document.

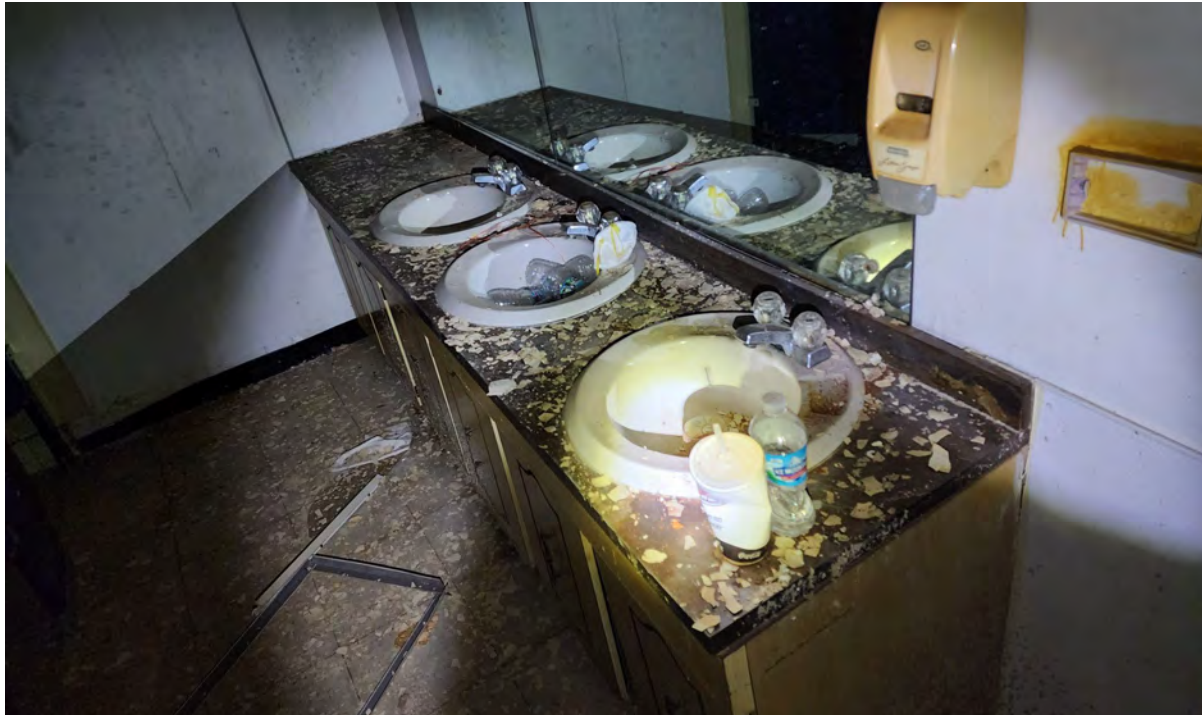
2nd floor restroom - Lavatory fixtures.

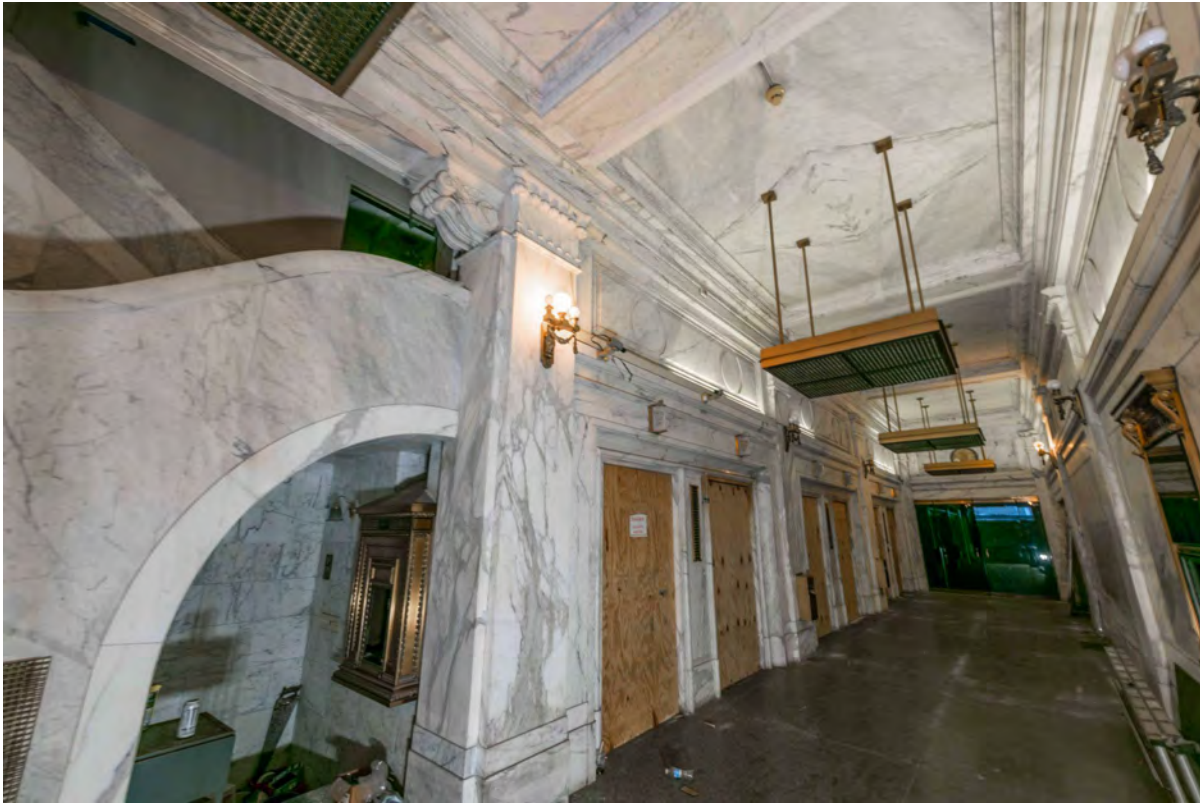
1st Floor Main Lobby Looking West
