San Ysidro Port of Entry Expansion Project San Diego, CA

Section 106 Consultation

October 2008

Relocation Study

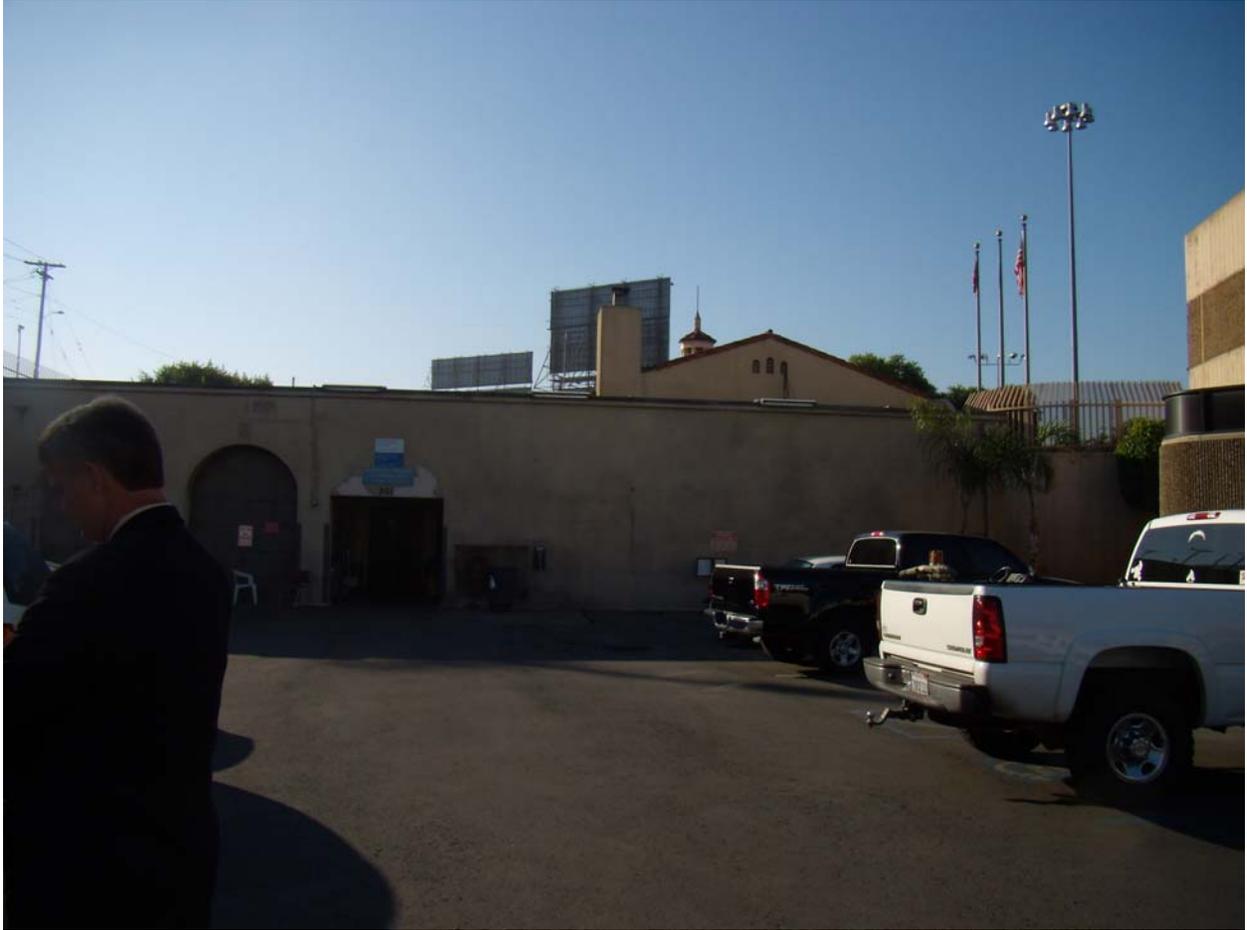
Figure 7 – North (U.S.) entrance to old U.S. Custom House. Note defensive wall connecting old Custom House to Main Building at right.

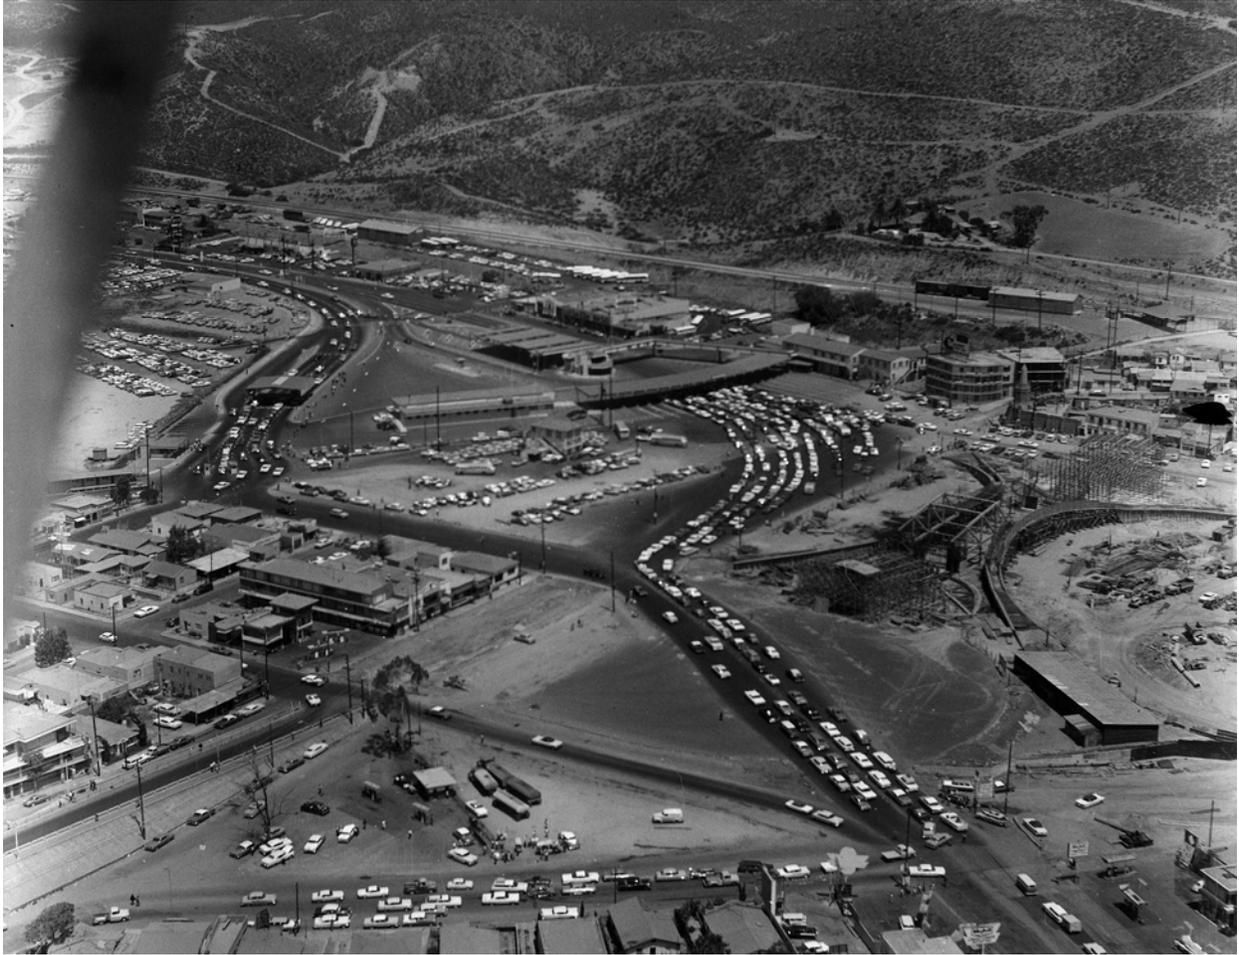
Figure 10 – View of expanded port of entry, 1964. Note old U.S. Custom House to the right of the vehicle lanes, with porte cochere removed. A new custom house (constructed in 1960, now demolished) is to the left of the vehicle lanes.

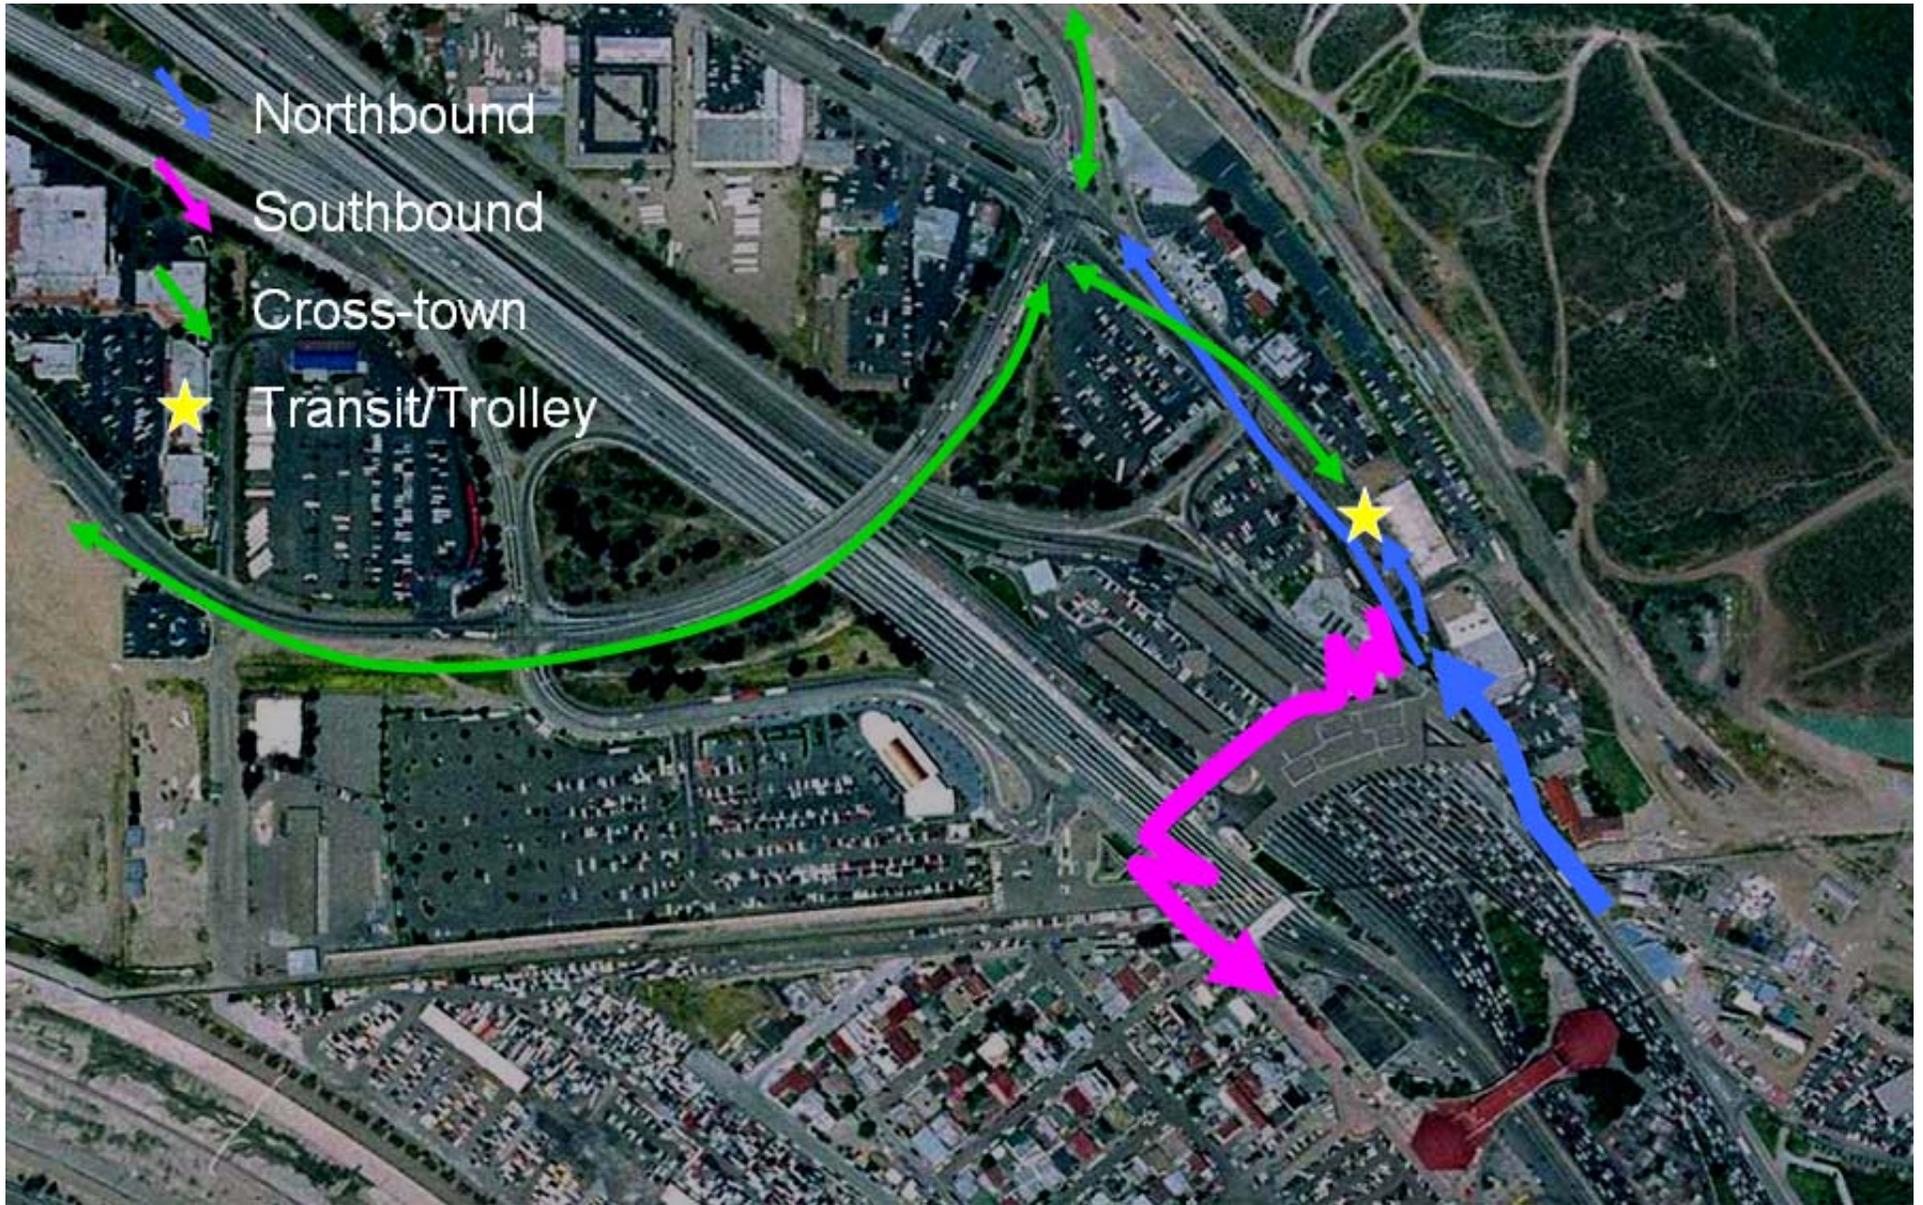
Figure 17 – Existing pedestrian access at the San Ysidro POE

- The San Ysidro Community Relations Committee requested additional southbound pedestrian accommodation at the east side of the POE, and this has been integrated into the project master plan (Fig 17-18). Northbound pedestrian flow is already located at the east side of the project site, and the addition of southbound pedestrian flow at this location causes potential conflict between northbound and southbound pedestrians. The project team has proposed demolition of the old U.S. Custom House in order to accommodate both northbound and southbound pedestrian access. The old U.S. Custom House is listed on the National Register of Historic Places. We have applied the Criteria of Adverse Effect found in 36 CFR §800.5 and determined this undertaking will have an adverse effect to historic properties.

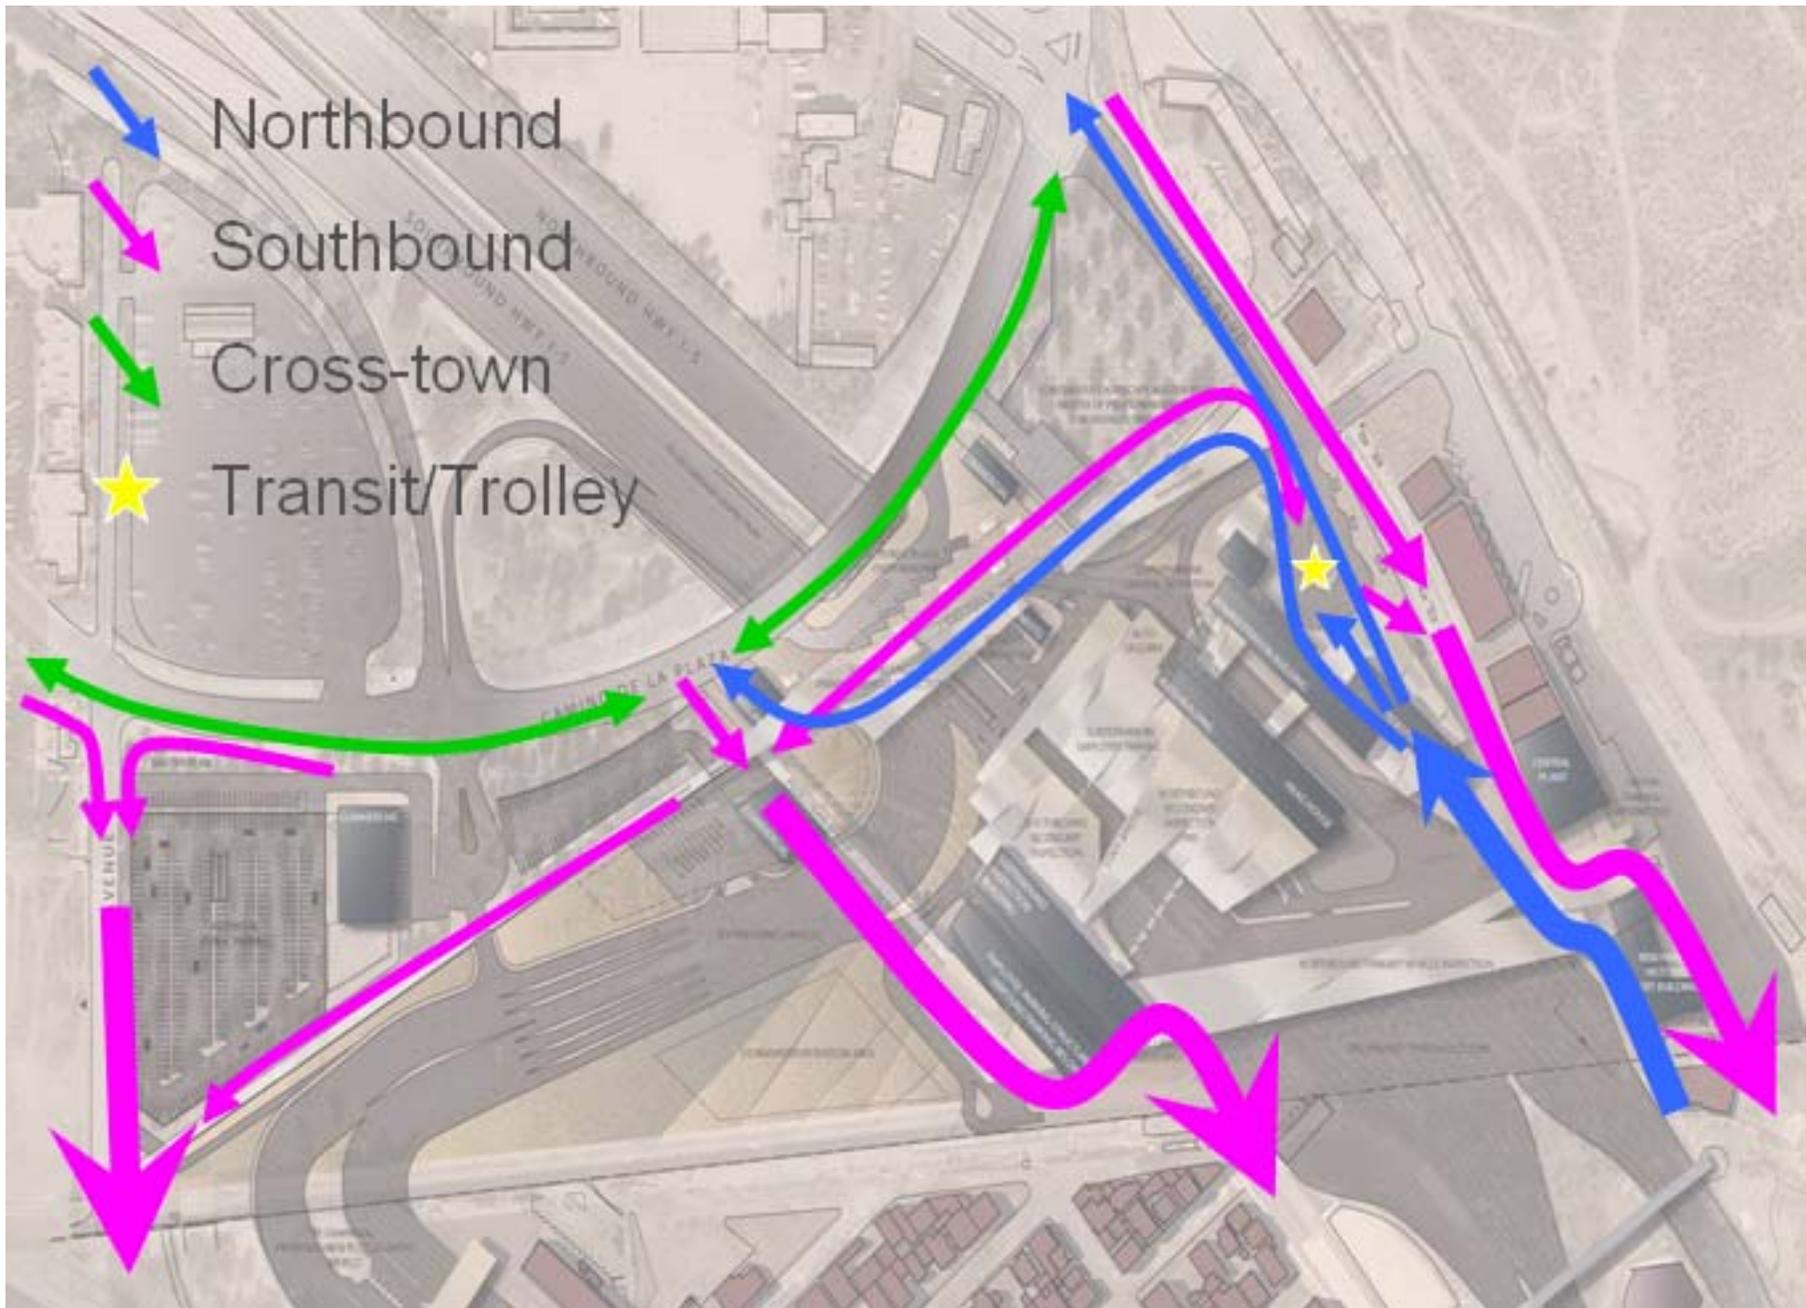
Figure 18 – Proposed pedestrian access at the San Ysidro POE. Note conflict of northbound and southbound pedestrians at right.

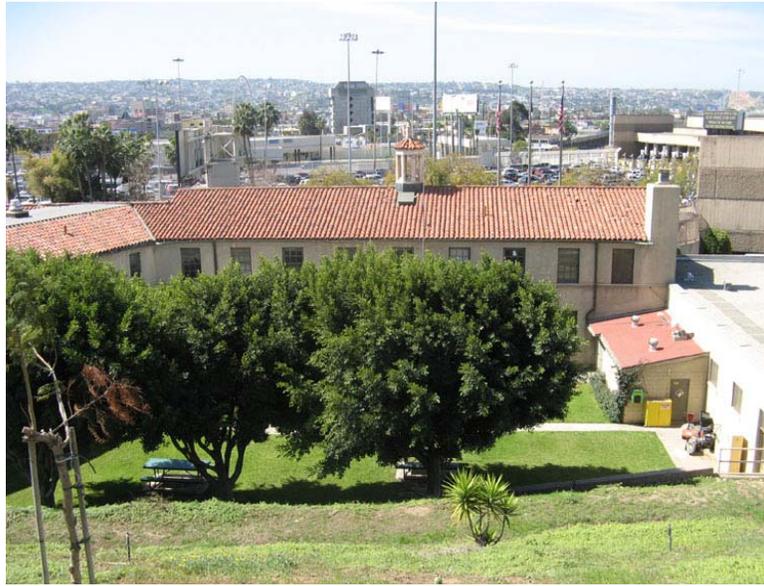
Figure 3: Photo exhibiting east (rear) façade of the Central Wing, fronting the proposed Option 1 site.

Architectural terra cotta with a mottled, yellow-buff glaze is used at the window sills, copula, and decorative ornament on the building. Small amounts of painted wood trim are present at the windows, eave trim, and window surrounds. The primary window type is 6-over-6 double hung wood sash. The building is topped with a cap and pan clay tile roof in a Mission red color.

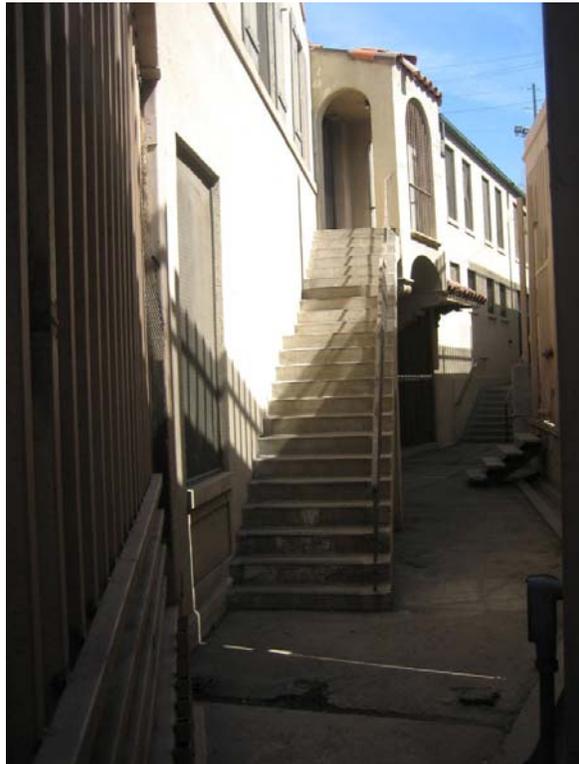
Figure 5: South façade, restricted view due to proximity of border fence.

The southern wing (Figure 5) is two-stories tall and contains office space and extends from the central wing at a 110 degree angle (in plan). As with the central wing, this wing has a crawlspace below providing access to utility lines and services. The architectural detail of the south wing matches that of the central wing, with subtle variations in the form and massing. The roof matches the central wing in material quality, with red clay tile featuring copper gutters and downspouts being the dominant technique. In an effort to create a hierarchical massing, the “ridge” of the south wing was lowered by having a central, low-sloped (flat) roof, giving a slight “mansard” affect. Flat-seamed copper roofing is present at the low sloped portion of the roof. The south wing also exhibits a slight half-story elevation change, with differing finish floor elevations connected by a series of internal and external steps accommodating this variation.

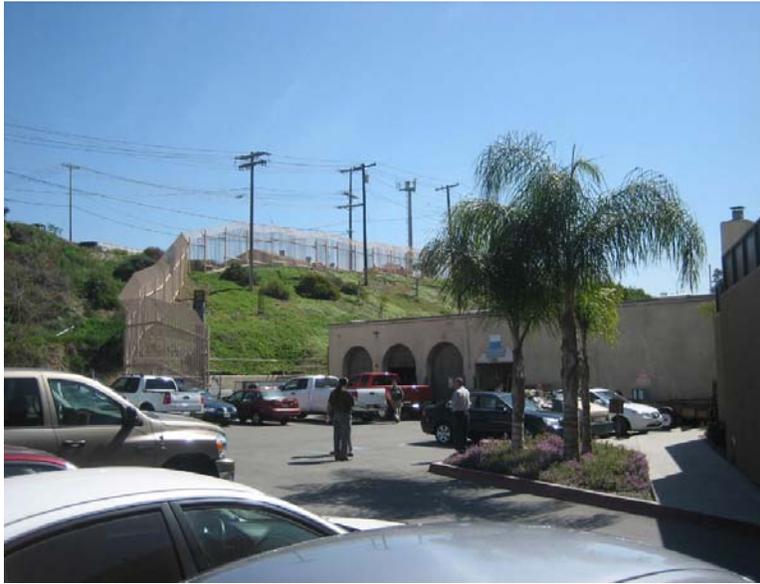
Figure 6: North façade, fronting parking lot.

The northern or garage wing (Figure 6) contains the utility area, is only one-story high, and extends at a more traditional 90 degree angle from the central wing. This utility space varies in construction technique from the adjoining central and south wings, as the unreinforced brick masonry walls bear on a slab poured on-grade. A flat roof is supported by dimensional lumber joists. This area appears to have had numerous interior and exterior alterations, reflecting the utilitarian nature of this wing.

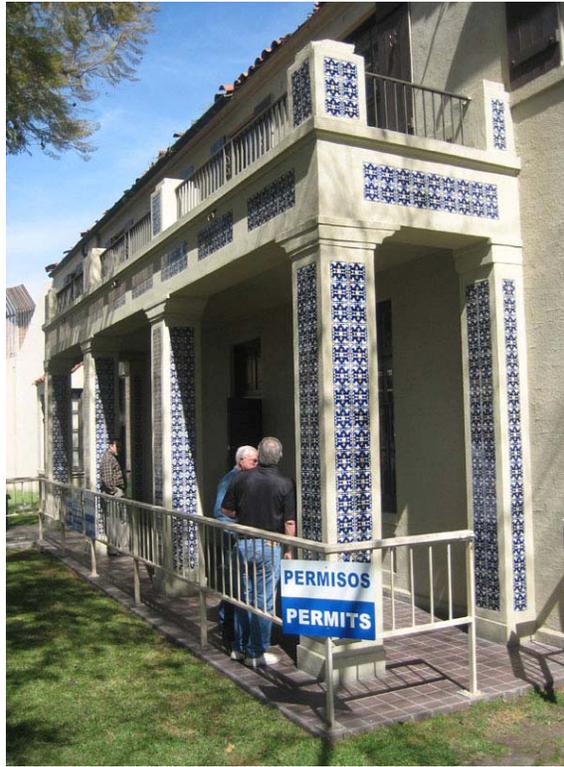
Figure 7: Existing porte-cochere constructed in the early 1970s.

The original canopy or porte-cochre was constructed out of reinforced concrete and was significantly larger than the extant canopy. The new porch, constructed in 1975, reflects the same general design of the original with slight variations in materials craftsmanship. The existing canopy is a concrete frame, with rough sand finished stucco and decorative glazed ceramic tile inlays (see Figure 7).

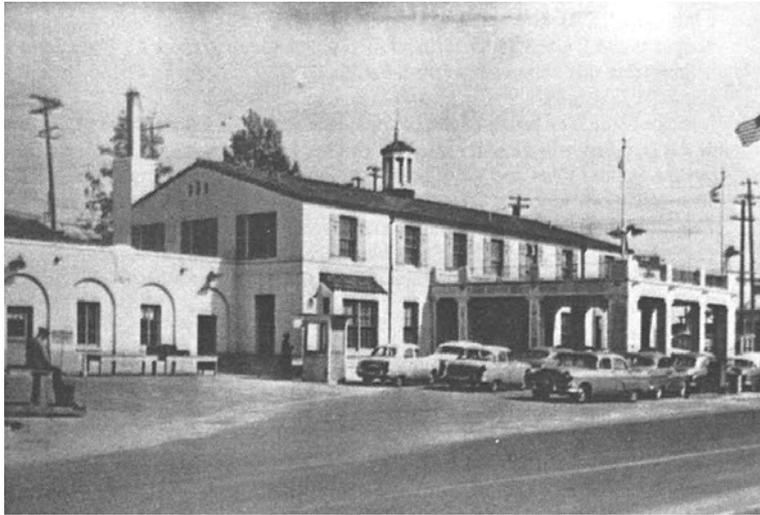
Figure 8: Historic view ca. 1954. Note original canopy and openness of the site.

The building's surroundings and landscape have been significantly altered since 1930, with only the topography remaining consistent. The building originally occupied an open landscape, providing a "pastoral" feel to the building. Yet, the area of San Ysidro has become more urbanized with the increasing amount of traffic. Due to this need to increase flow across the border, as well as added security measures, the building has been increasingly restricted in its extant setting.

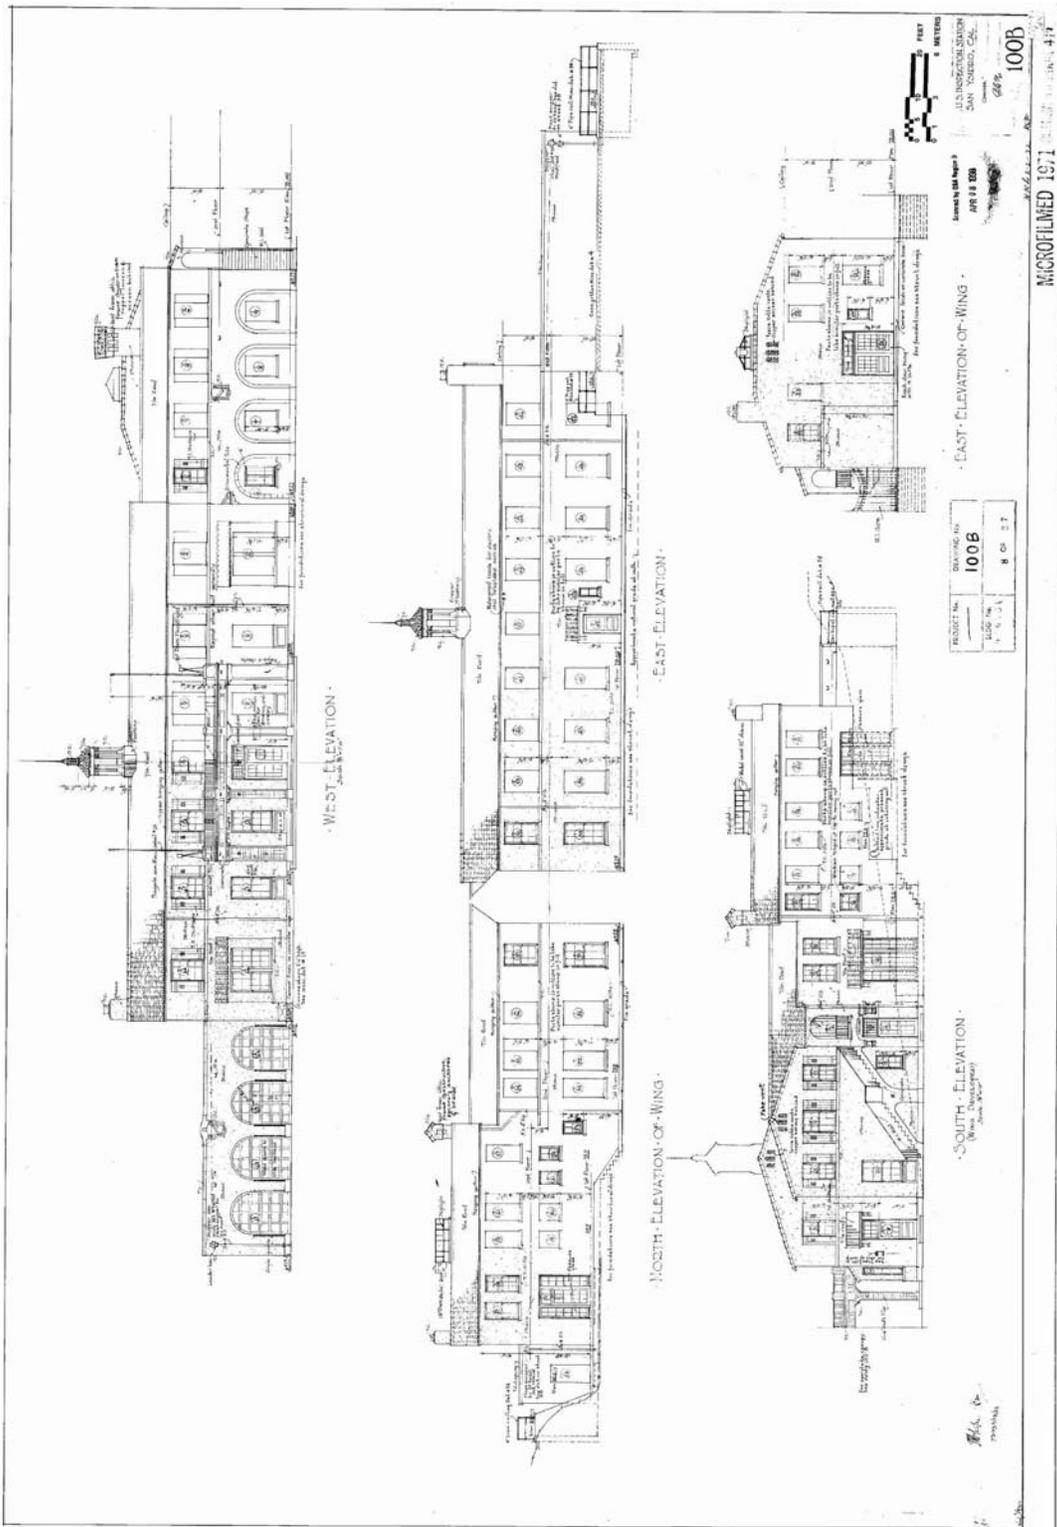
⁵ Historic Elevations, original construction drawings.

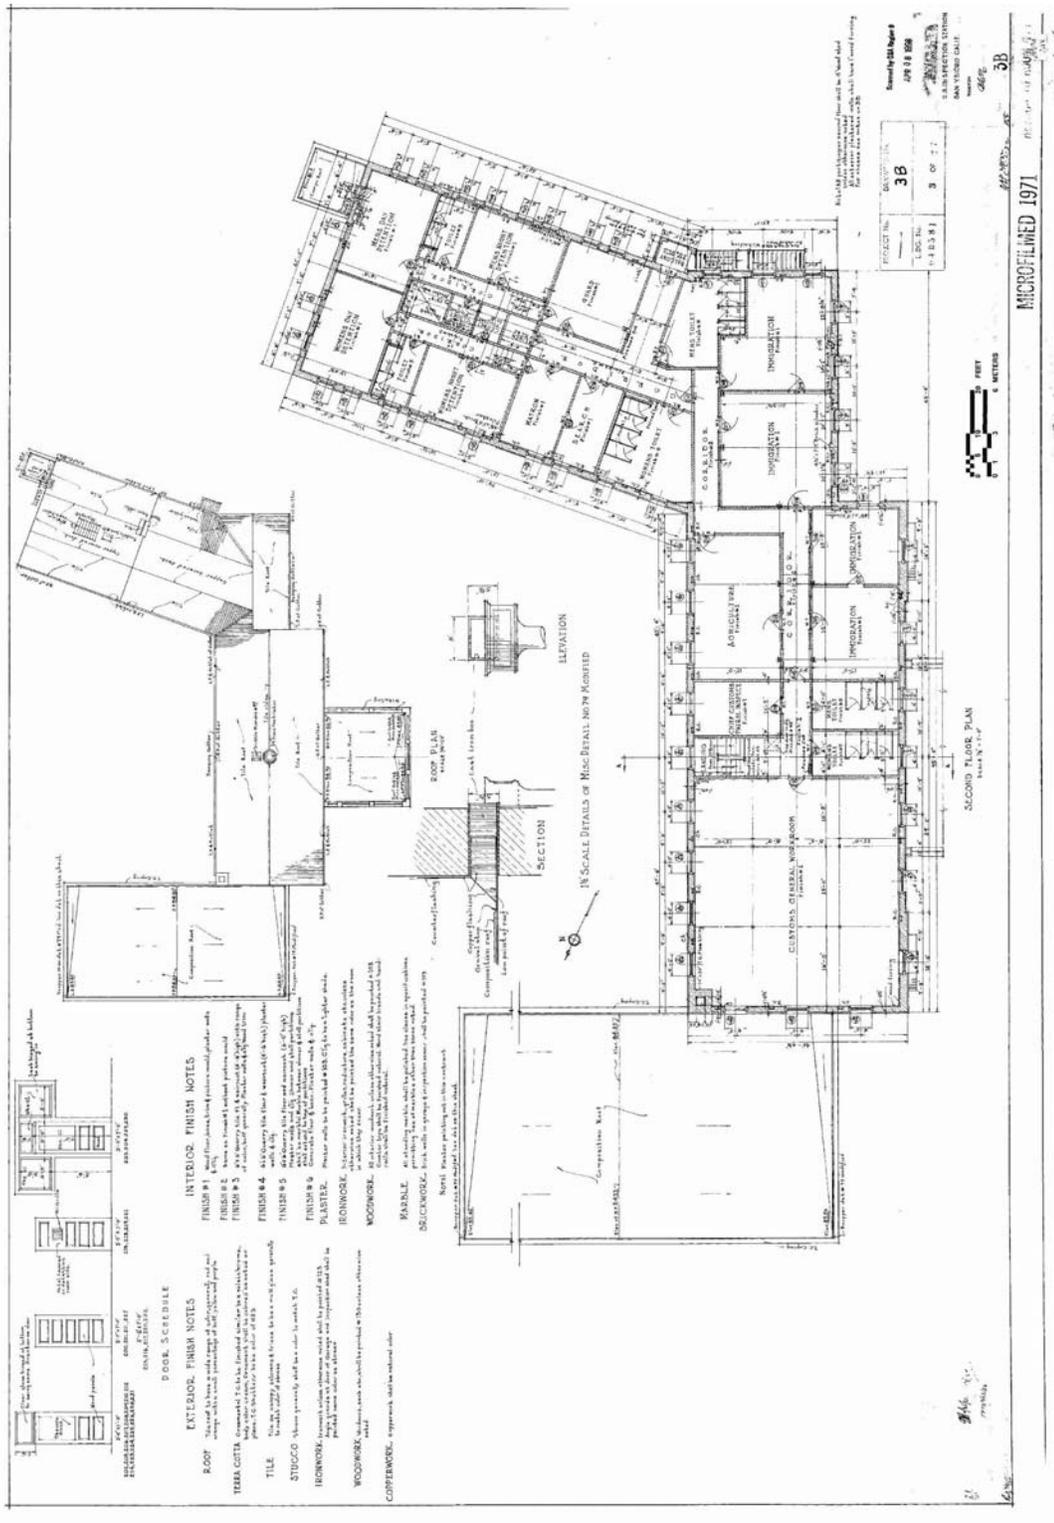
⁶ Historic Plans, original construction drawings of second floor.

The historic San Ysidro Border Station is an approximately 20,500 square foot building that occupies a U-shaped footprint (as shown in Appendix A, Sheet 1 - Original Building Plan). The Spanish Colonial Revival style building can be broken into five distinct components: Central Wing, South Wing, North Wing, Canopy, and Eastern Additions. The components are described as follows:

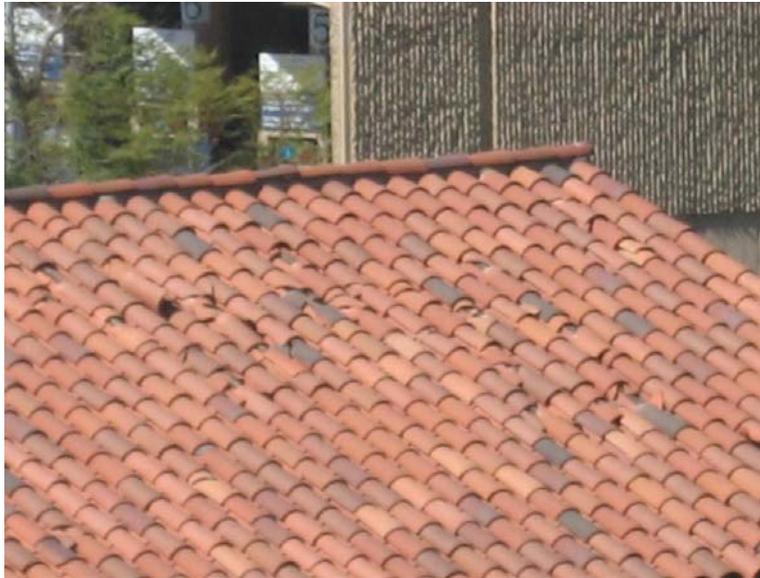
- Clay roof tiles are broken, cracked and loose in a number of locations. Site representatives reported that this was due to illegal aliens climbing the border fence and running across the building's roof(s).

Figure 9: Existing damage to cap and pan roof.

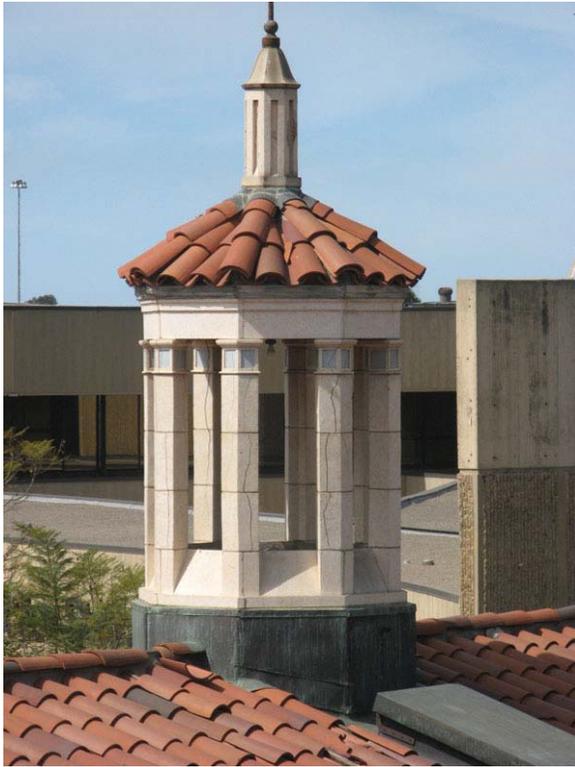
- Similarly, the building's copper gutters and downspouts are dented, displaced, warped, or missing.
- Improper drainage from the damaged gutters and downspouts has led to some deterioration of the exterior cement plaster stucco.
- The terra cotta at the cupola is cracked and spalled. The patterns of deterioration are consistent with corrosion-related expansion of embedded steel elements in the terra cotta assembly.

Figure 10: Existing cracking in terra cotta assemblies.

- Terra cotta support brackets at the south elevation stair balcony are also cracked.
- A textured coating has been applied to the building exterior stucco (and other elements, such as conduit). The coating has failed in a number of areas and appears to be holding moisture within the cement plaster stucco.
- Wood window sills and sashes appear to suffer from ultraviolet light degradation.

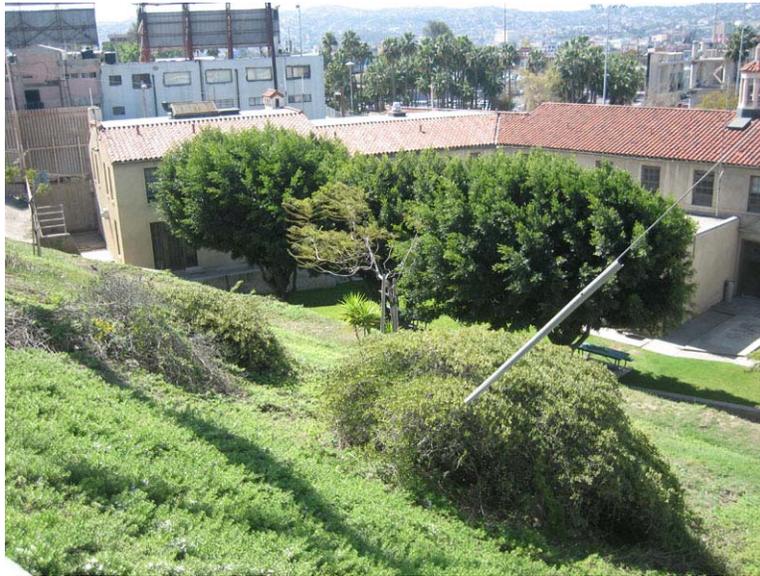
Figure 11: Option 1 site.

Option 1 represents the relocation of the old Custom House to a new site approximately 45 ft. to the east (behind) and 6 ft. above the existing site (See Figures 11-12). As presented by RDC, the primary goal of relocation to this site is maximization of available land in front of the historic building for potential use as a pre-security public plaza. This plaza, forming the eastern edge of the adjacent vehicular entry, would serve as a gathering node for both the northbound and southbound pedestrian traffic. Relocation to this site represents a focused benefit intended to maximize the available space for this plaza.

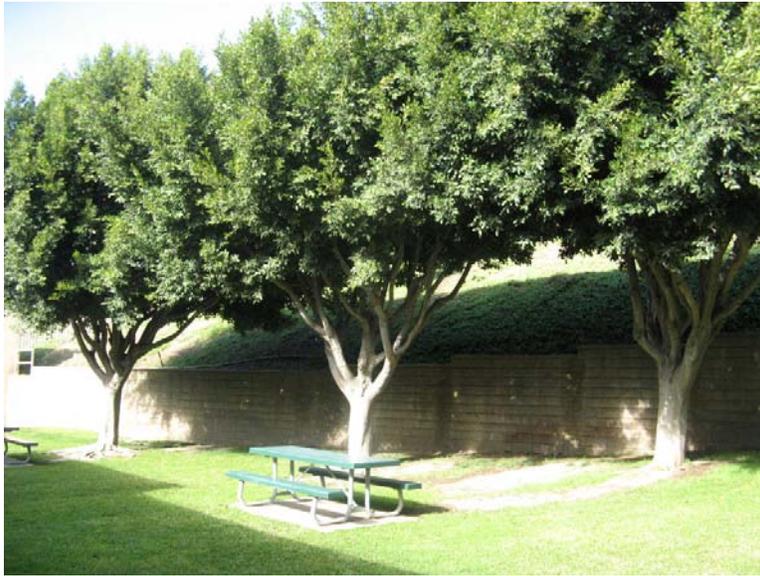
Figure 12: Existing landscape and topography impacted by relocation to Option 1.

It was the determination of the project team that, although a greater move of up to 50 ft. is potentially viable, the 45 ft. mark represents the maximum feasible acquisition of usable square footage from the existing slope east of the site. The potential site bounds are thus defined by the retaining and topographic needs of the steeply sloping hillside to the east, the easement of the electrical transmission lines approximately halfway up the eastern hillside, an existing incinerator north of the proposed site, and the existing border fence fronting the south facade. (See Board 2, Relocation Option 1, for further analysis of the site boundary and potential constraints.)

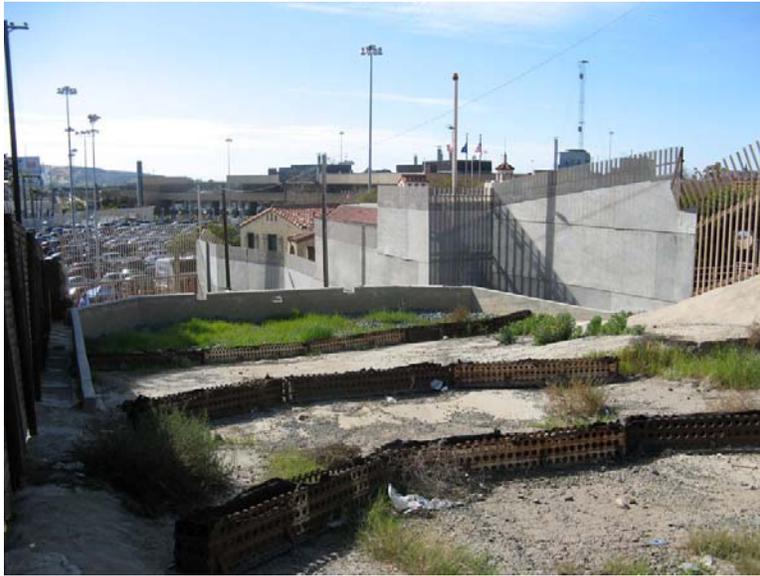
Figure 13: Drainage culvert, forming border crossing buffer zone between United States and Mexican border fences.

- The extant electrical transmission lines approximately halfway up the existing slope.
- The easement of the transmission lines currently owned and operated by S.D. G&E. The easement will not be impacted by the relocation as it forms the eastern edge of the relocation site.
- Establishing positive drainage from the proposed terraced slope will likely involve the installation of sub-grade drainage systems channeling runoff to the catchment basin located south of the existing building.

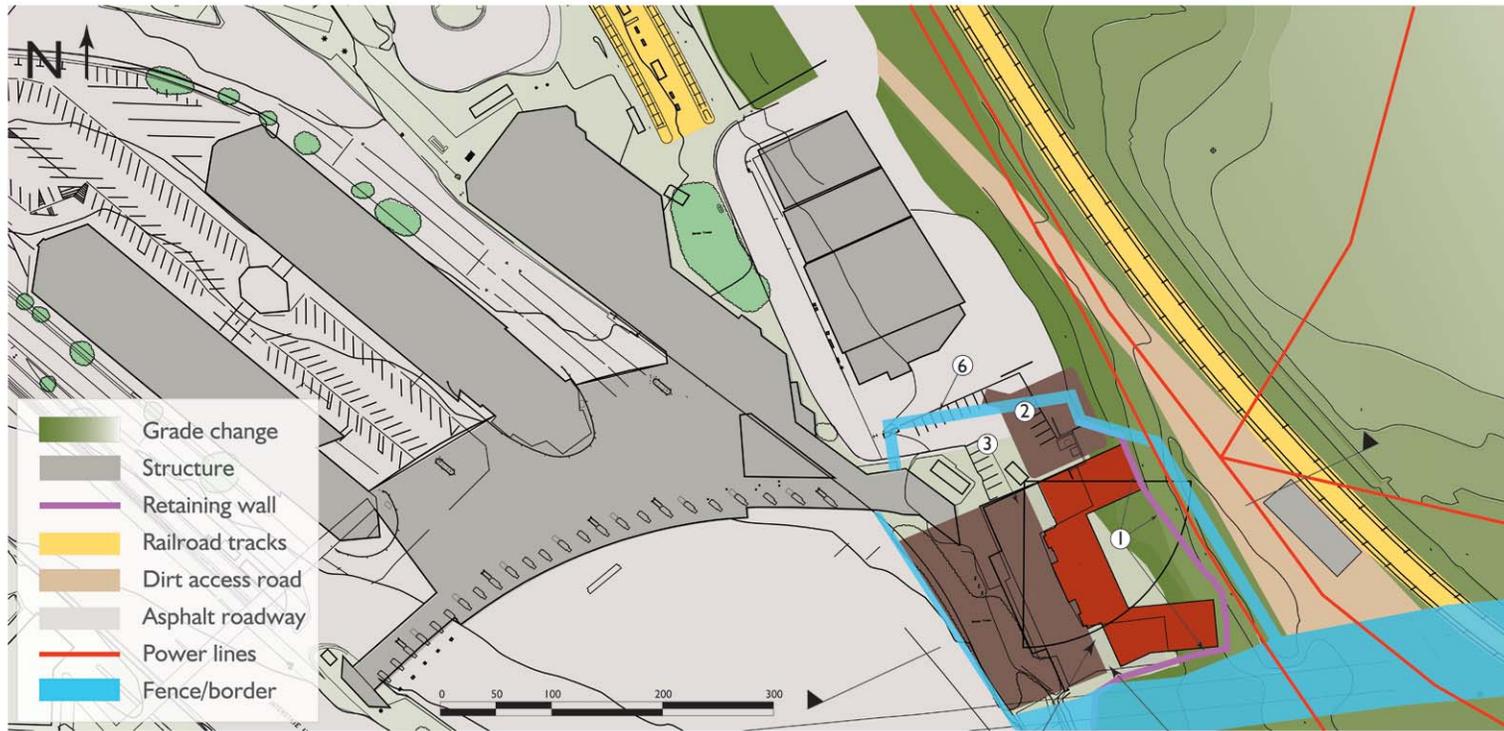
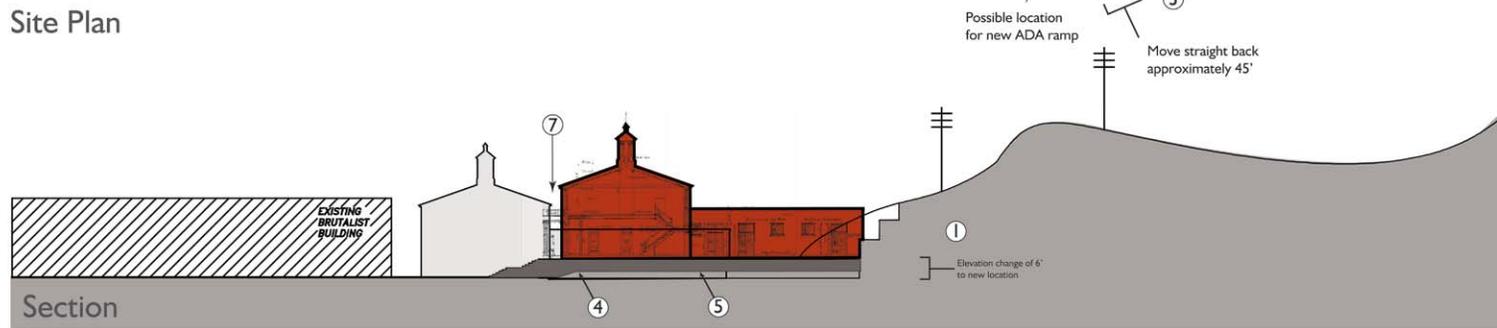
RELOCATION OPTION #1

Site Plan

Section

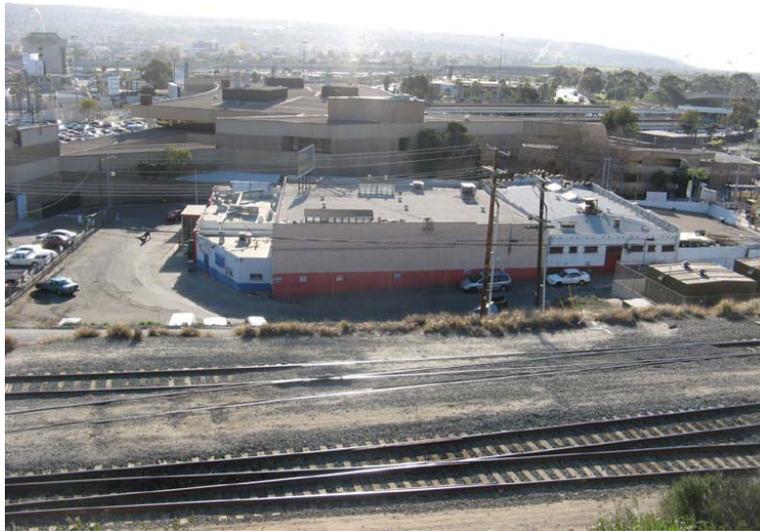
Figure 14: Existing structures at Option 2. The potentially historic Art Deco building is third from the left of the group (white rear façade).

Option 2 entails relocation of the old Custom House to a site approximately 270 ft. northwest of the existing location (See Figures 14-16). The potential site is bounded to the north by an art deco building potentially eligible for local historic significance and to the west by the existing 1960s border station. An extant building, approximately 13,000 sq. ft. supporting both a retail function as well as a Greyhound Bus facility, is currently located on the proposed site. This building would be demolished as part of this relocation option.

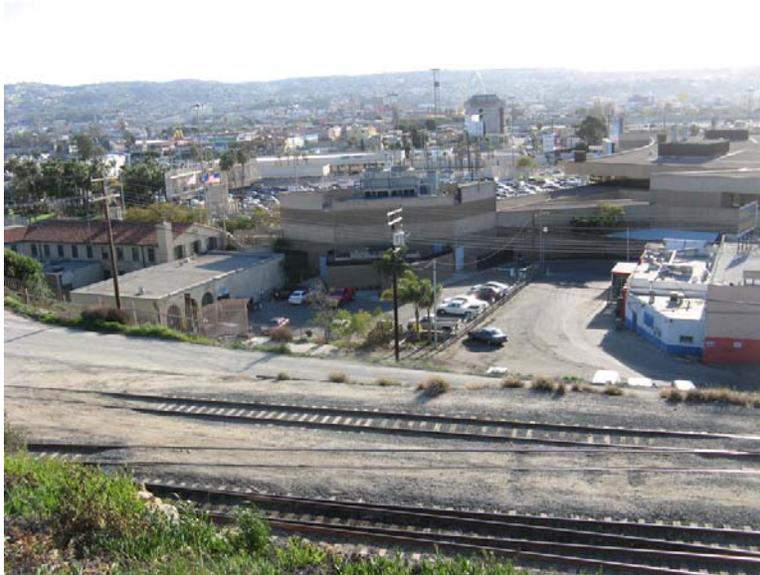
Figure 16: Potential move route of Option 2.

Note: The subsurface soil condition is unknown for this relocation. Although no significant challenges are present above grade, the soil may not be capable of bearing the weight of the building during the move. Additional study must be preformed to analyze the potential needs for surface compaction of the move route.

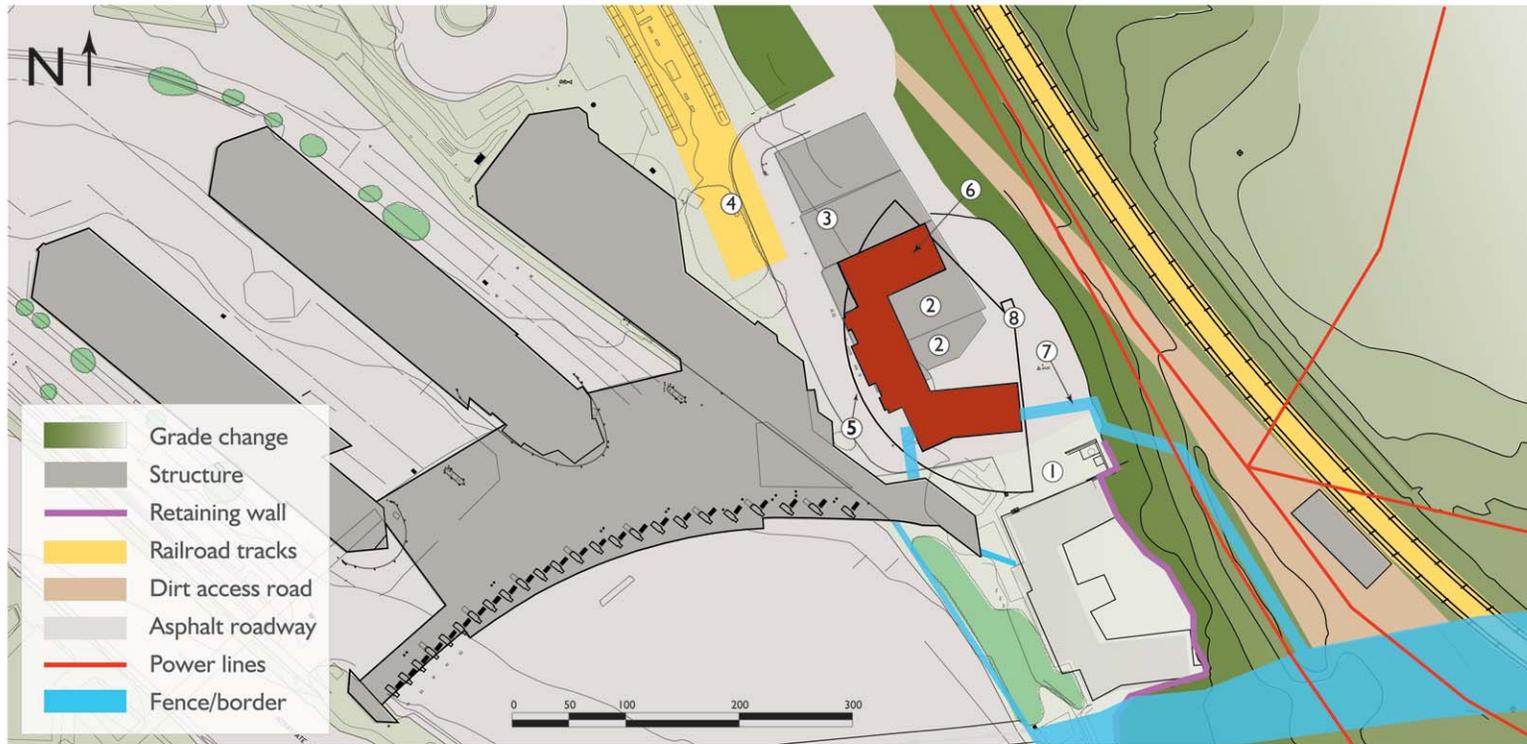
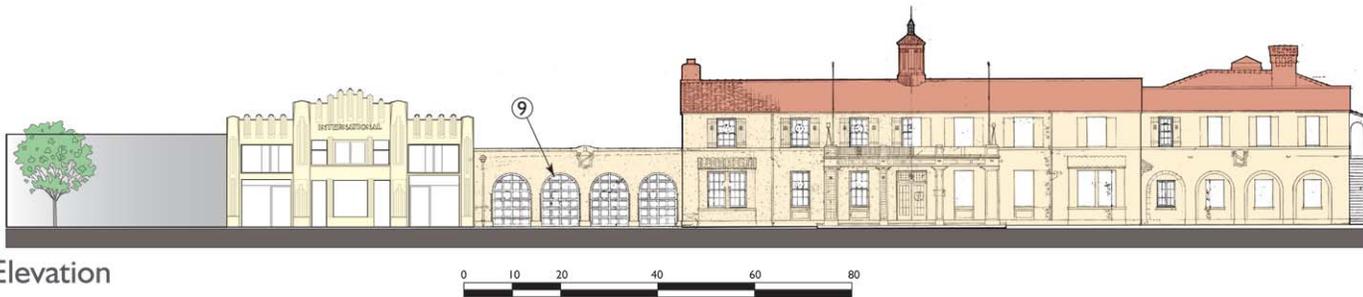
RELOCATION OPTION #2

Site Plan

Elevation

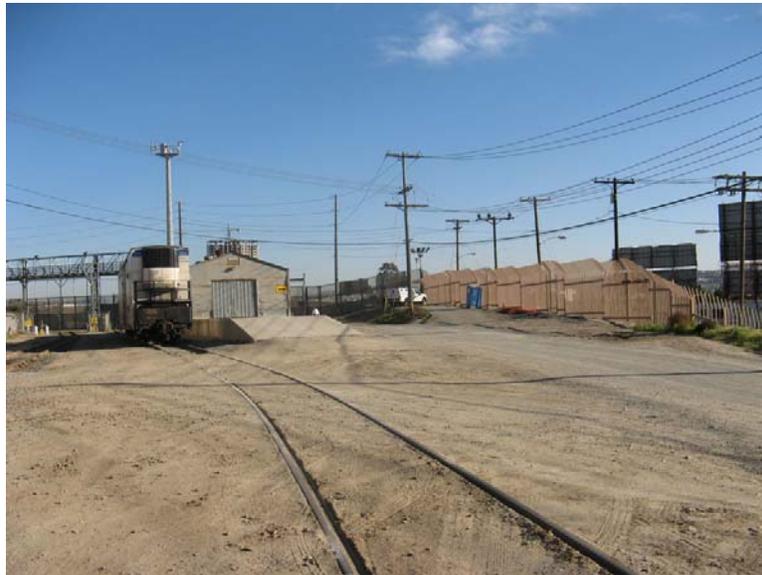
Figure 17: Option 3 site. Note significant infrastructure including power lines and railroad tracks.

Option 3 represents the relocation of the old Custom House to a site approximately 168 ft. behind, and 43.9 ft. above, the current location (See Figures 17-18). The proposed site consists of a plateau established for the extant railroad tracks and freight inspection building. This location would be the most visible, iconic location proposed; however it is also the most difficult for relocation and reprogramming. This site occupies an area bounded by Union Pacific Rail Road tracks to the east, border fence to the south, and the existing slope to the west (see Board 3, Relocation Option 3).

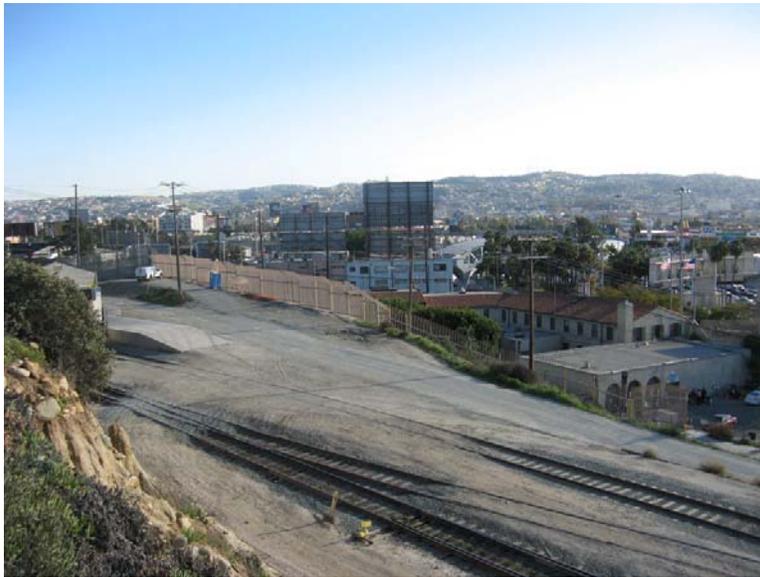
Figure 18: Note elevation change between current location and Option 3 site.

For the purpose of this study, the Option 3 site is assumed to be under full control and ownership of the GSA. Although land acquisition is not covered under the scope of this study, significant easement rights controlled by both SDG&E and the Union Pacific Railroad may impede further development of this option. Additionally, for code consideration, continuing the existing occupancy is assumed.
