San Ysidro Port of Entry Expansion Project San Diego, CA

Section 106 Consultation

October 2008

Relocation Study

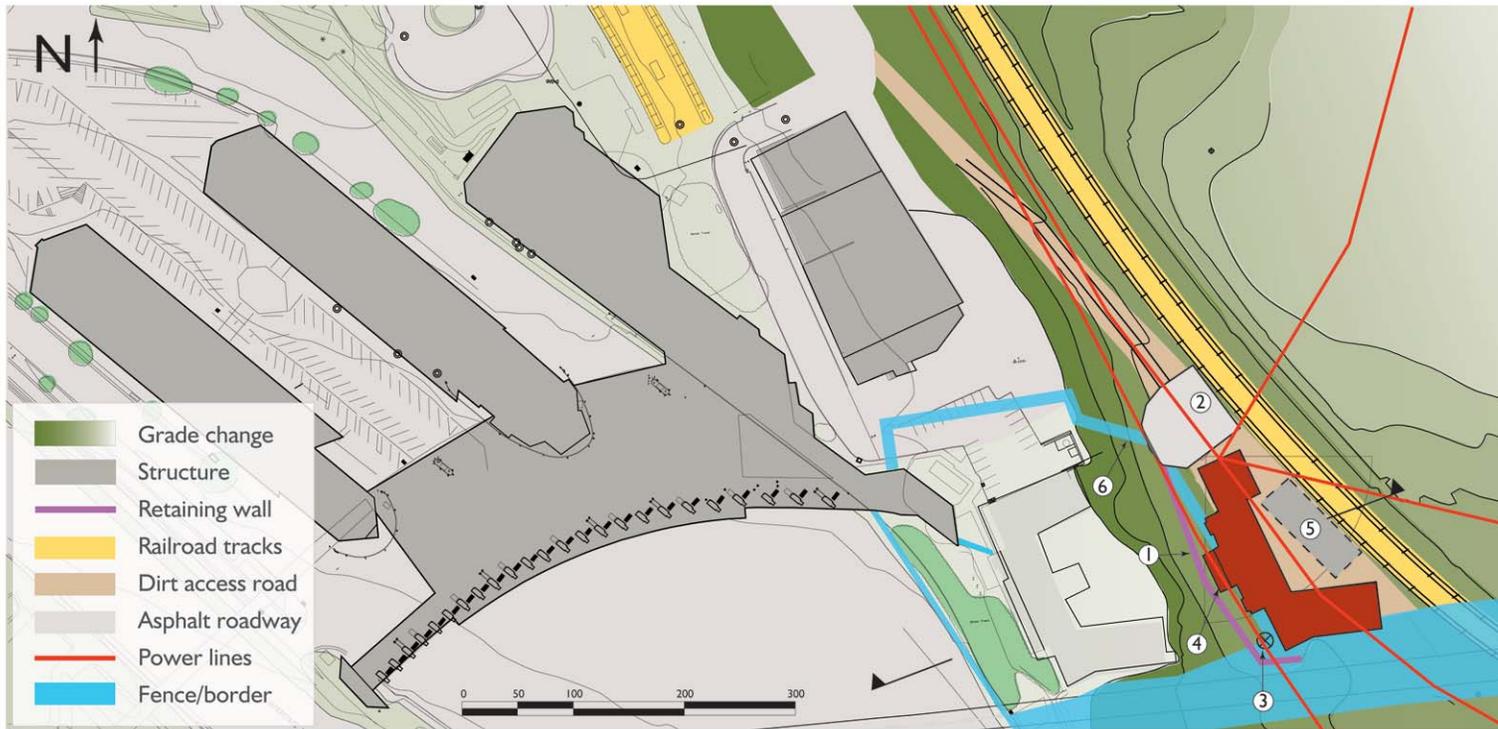
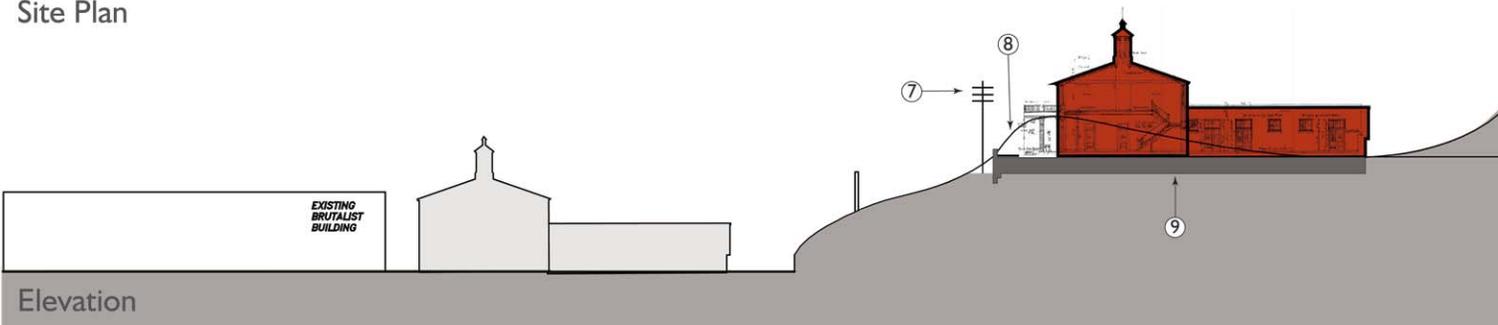
RELOCATION OPTION #3

Site Plan

Elevation

- Significant amounts of earth-work necessary.
- Significant earthwork involved in lifting and sliding the building into the site.
- Difficulty in moving the power lines, railroad tracks, and fencing.
- Complicated and expensive move.
- It may be necessary to shut the power lines down for a significant amount of time. DMJM believes these lines to be a power source for the trolley.
- Significant code concerns involving fire truck access, ADA access and parking, and site parking/regrading.
- Potential difficulty in fronting the rail tracks.
- Demolition of North Wing may be necessary.
