**Draft
Environmental Assessment
for
Department of Veterans Affairs
Mental Health Facility
Tampa, Florida**

January 2021

Prepared for:
GSA Region 4

Prepared by:
Potomac-Hudson Engineering, Inc.

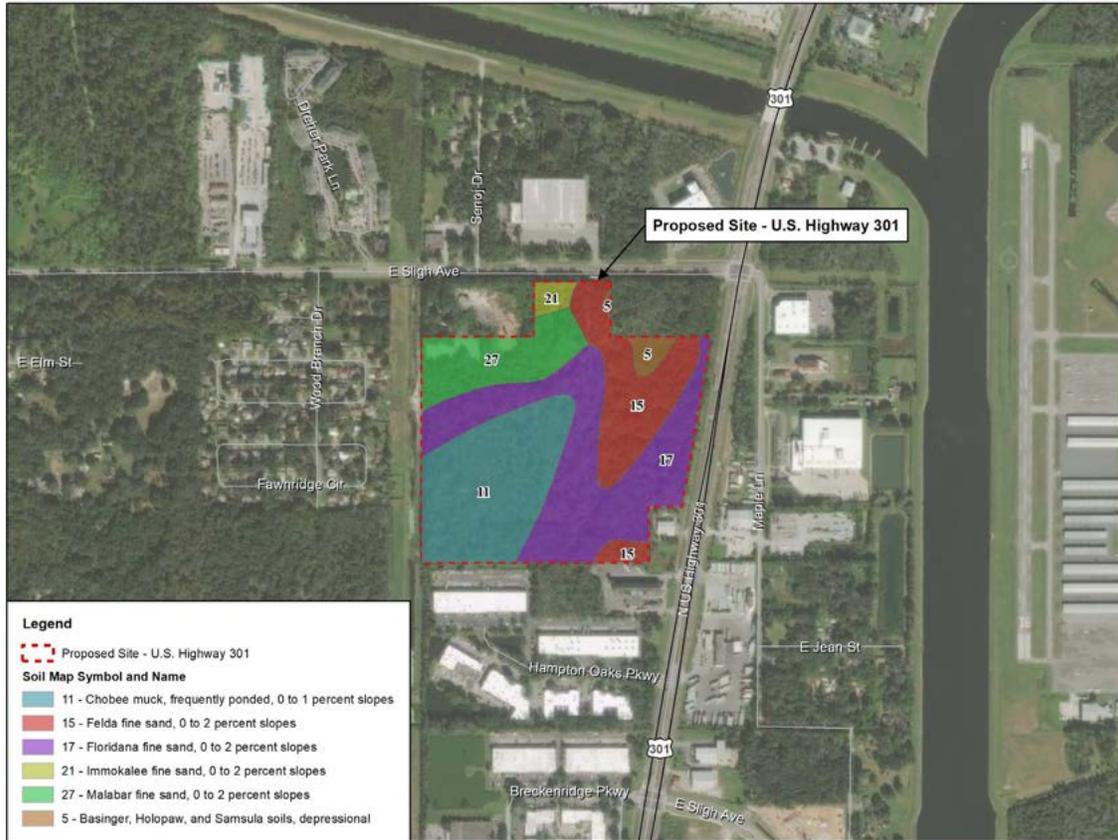
Figure 3.4-3. U.S. Highway 301 Soil Map

Site Alternative	Soil Profile for Site
Temple Terrace (Alternative 1)	The extreme western portion of the site contains soils of the Tavares-Millhopper complex, while the remainder of the site contains Candle Fine Sand (see Figure 3.4-1).
Bearss Avenue (Alternative 2)	A majority of the site soils is characterized by Zolfo Fine Sand. A small north-central portion of the site contains St. Johns Fine Sand, and a small south-central portion of the site contains Malbar Fine Sand. Additionally a small area of Arents occurs in the southeastern portion of the site. See Figure 3.4-2 for locations of these soil types at this site.
U.S. Highway 301 (Alternative 3)	Six soil types occur at the site including (from greatest to least coverage): Floridana Fine Sand, Chobee Muck; Felda Fine Sand; Malabar Fine Sand; Immokalee Fine Sand; and the Basinger, Holopaw and Samsula soils. See Figure 3.4-3 for locations of these soil types at this site.

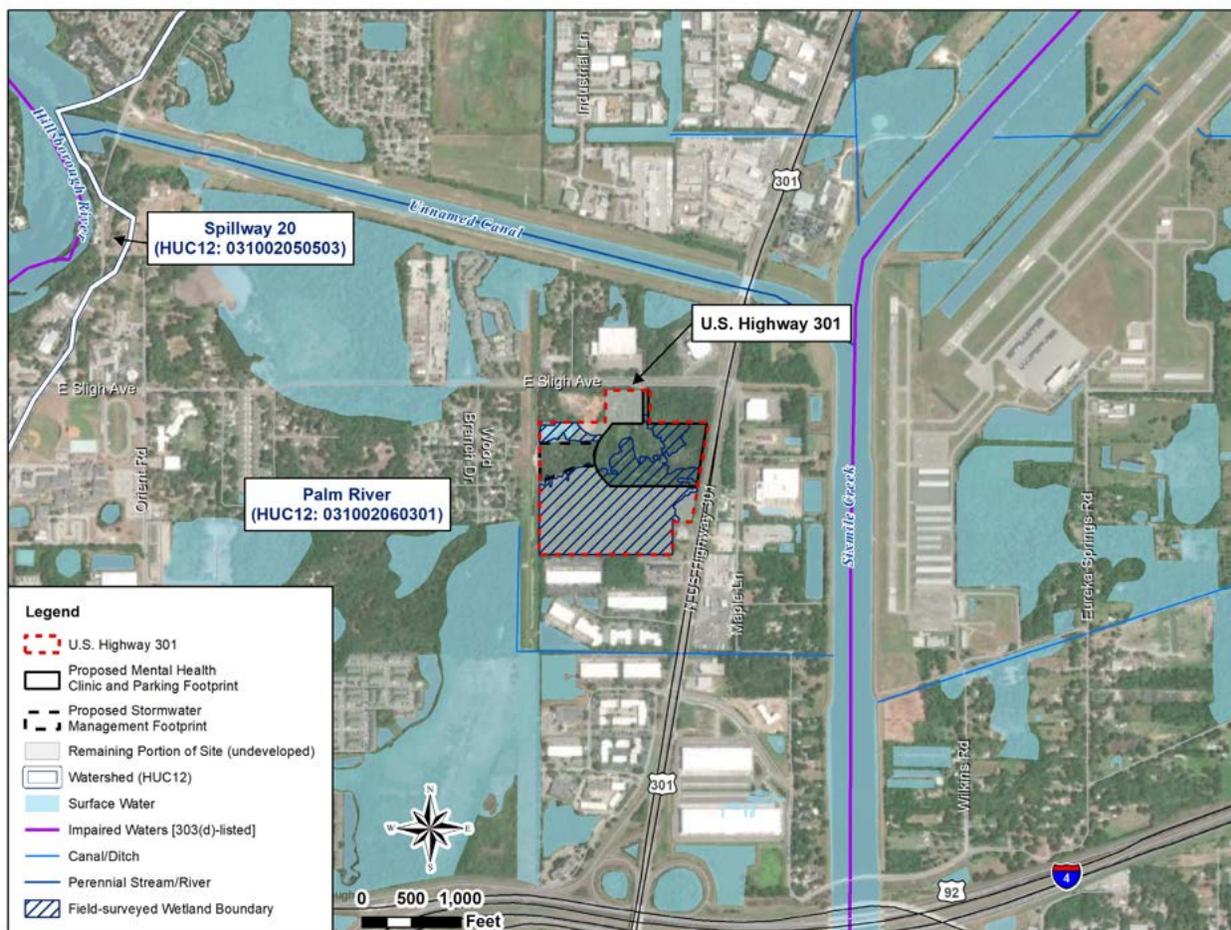
Figure 3.5-1. U.S. Highway 301 Site Wetland Boundary

According to the Biological Resources Assessment (see Appendix C), a large portion of the U.S. Highway 301 site may qualify as federal and state jurisdictional wetlands. Potentially jurisdictional areas include approximately 29.7 acres in the southern half of the site, an existing pond and adjacent low area (2 acres) in the northwest corner of the property, and a 2.5-acre area on the northeast portion of the property. A formal delineation of wetland boundaries would be required to determine the full extent of jurisdictional wetlands at the U.S. Highway 301 site. Figure 3.5-1 depicts the potential wetland boundary observed during the U.S. Highway 301 site visit.

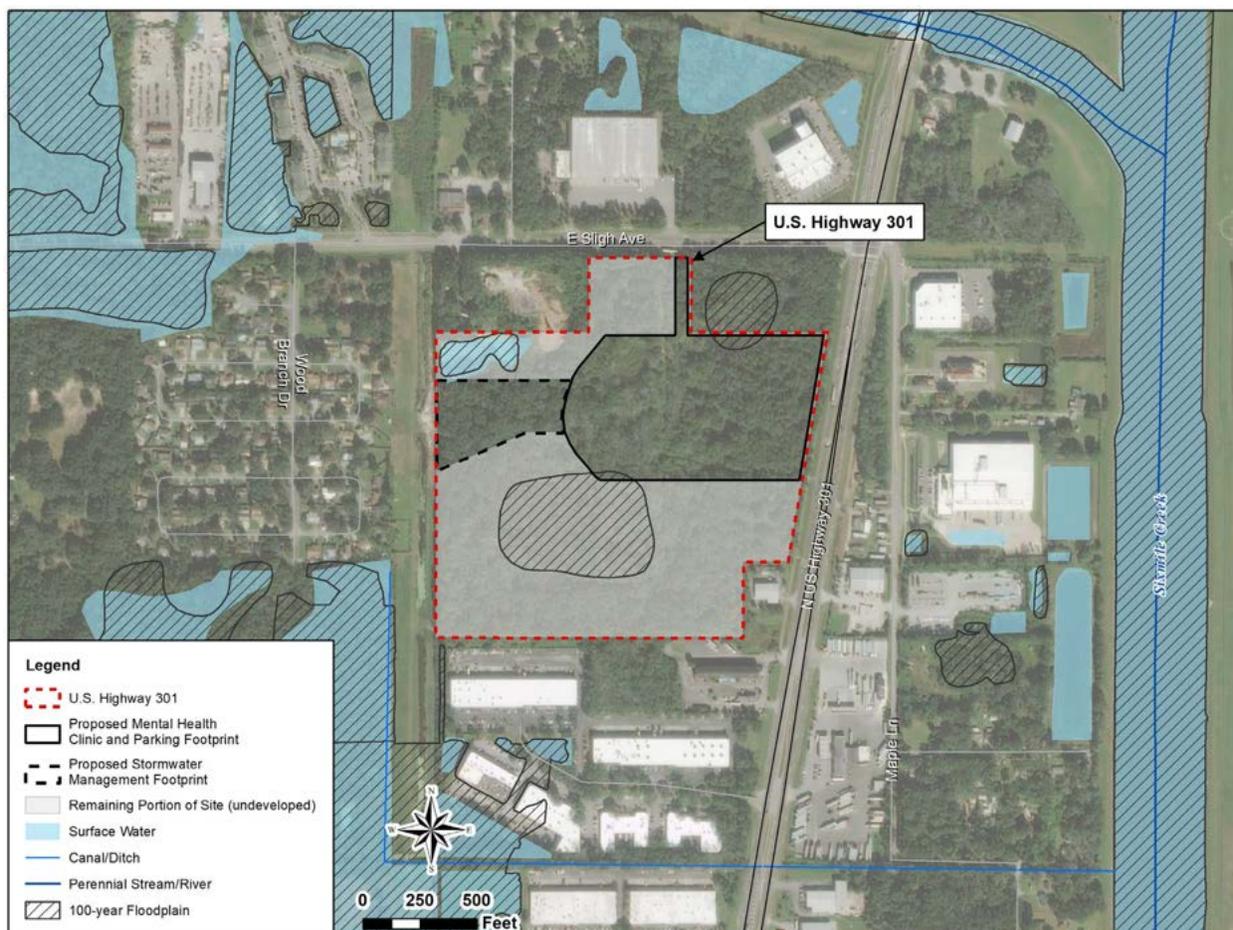
Figure 3.5-2. 100-year Floodplain at the U.S. Highway 301 Alternative Site

No portion of the Temple Terrace or Bearss Avenue sites are located within the 100-year floodplain (FEMA 2013). At the Bearss Avenue site, the mapped 100-year floodplain is located directly north of the Bearss Avenue Site, encompassing Sinclair Hills Road along the northern boundary of the site and areas to the north of Sinclair Hills Road. Approximately 7.5 acres of the U.S. Highway 301 site is located within the regulated 100-year floodplain, and therefore, has a 1 percent annual chance of flooding. The floodplains at this site are associated with three features located in the northwest, northeast, and central portions of the site (see Figure 3.5-2). Of the 7.5 acres, approximately 15,000 square feet (0.34 acre) occurs at the edge of the proposed development footprint.

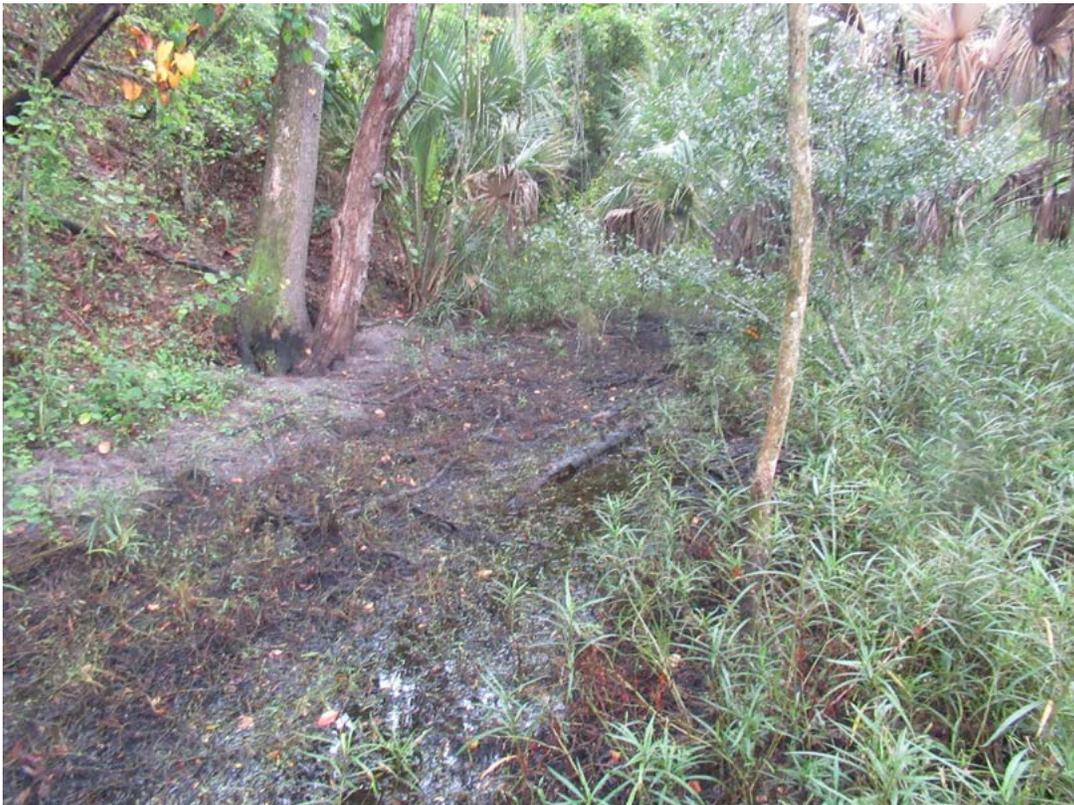
Photo 4: View of ditch on west side of site.

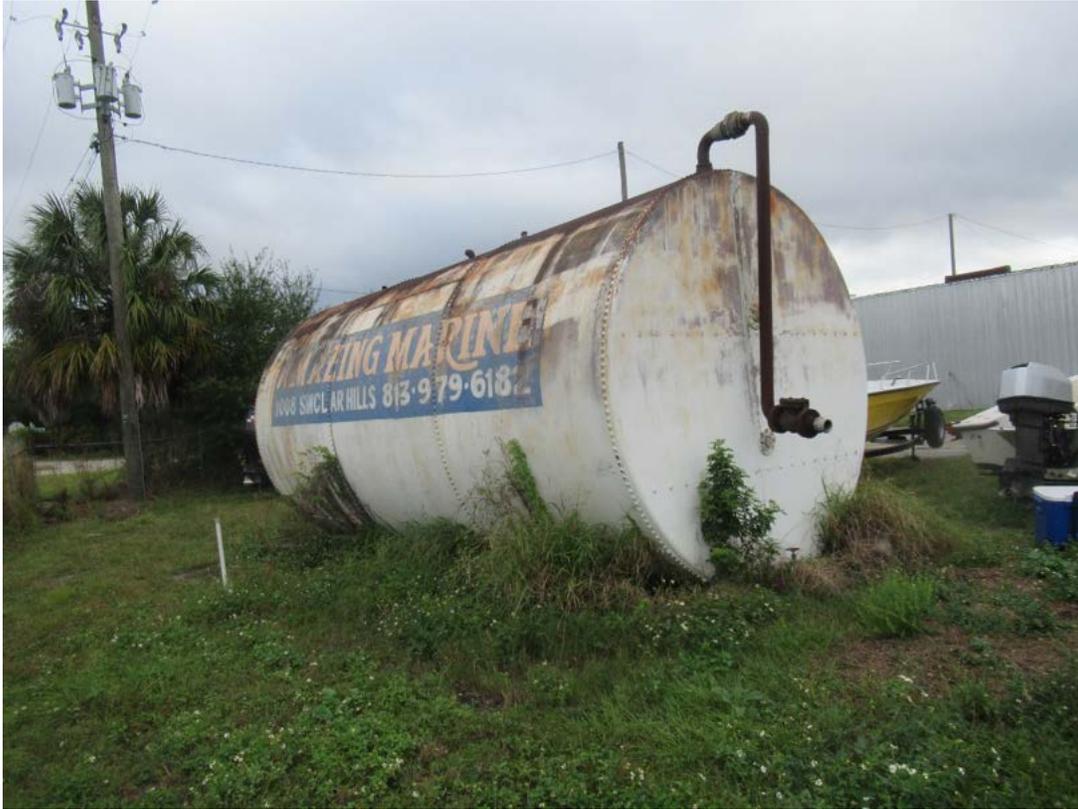
Photo 1: 5,000-gallon Bunker C oil AST at Amazing Marine.

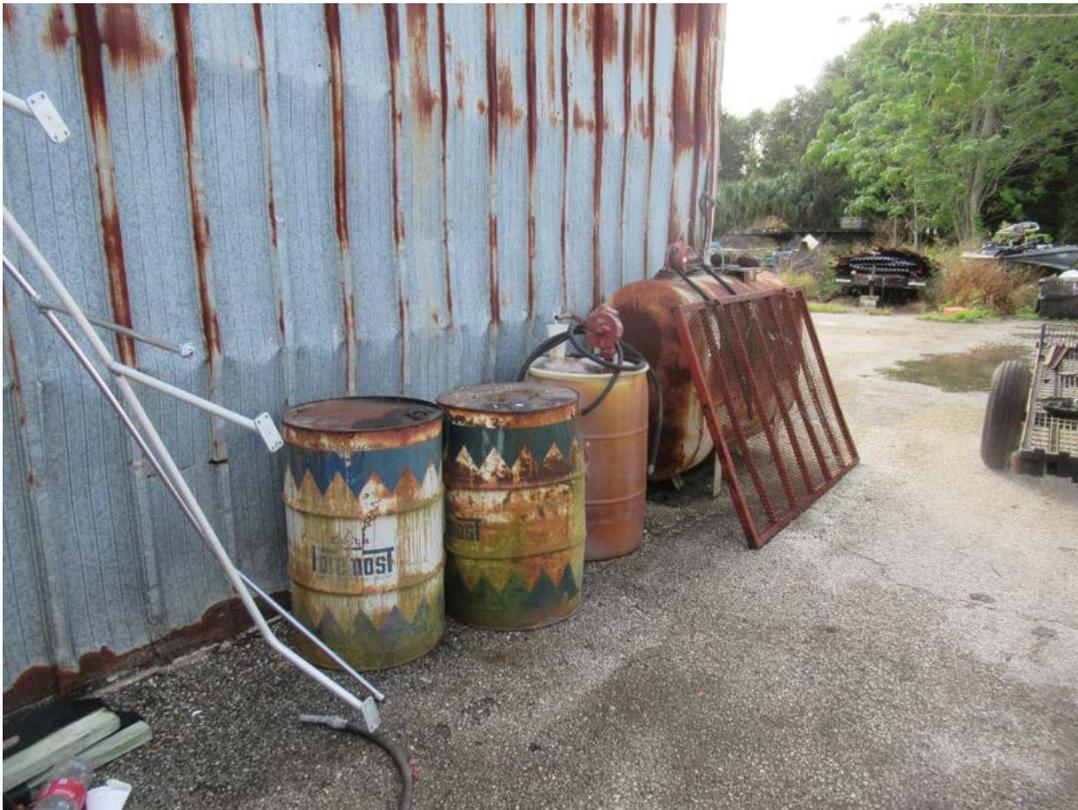
Photo 2: 110-gallon oil AST and drums at Amazing Marine.

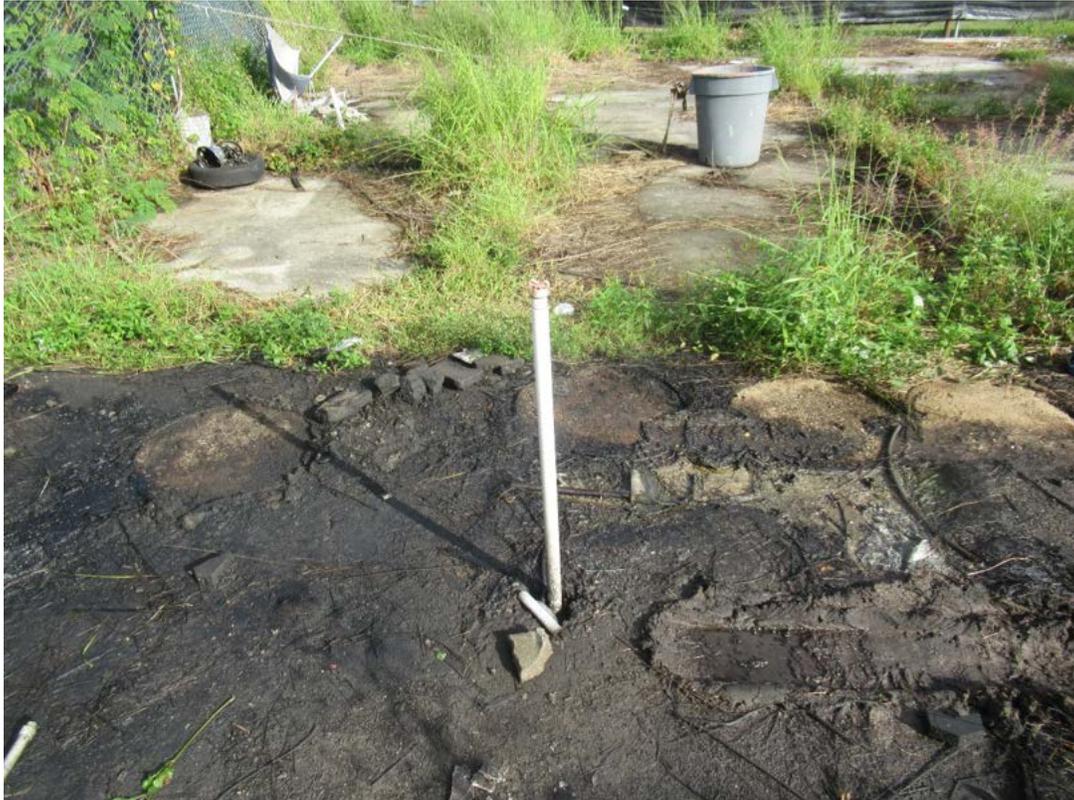
Photo 3: One of 3 temporary well points at Amazing Marine. Note stained ground surface.

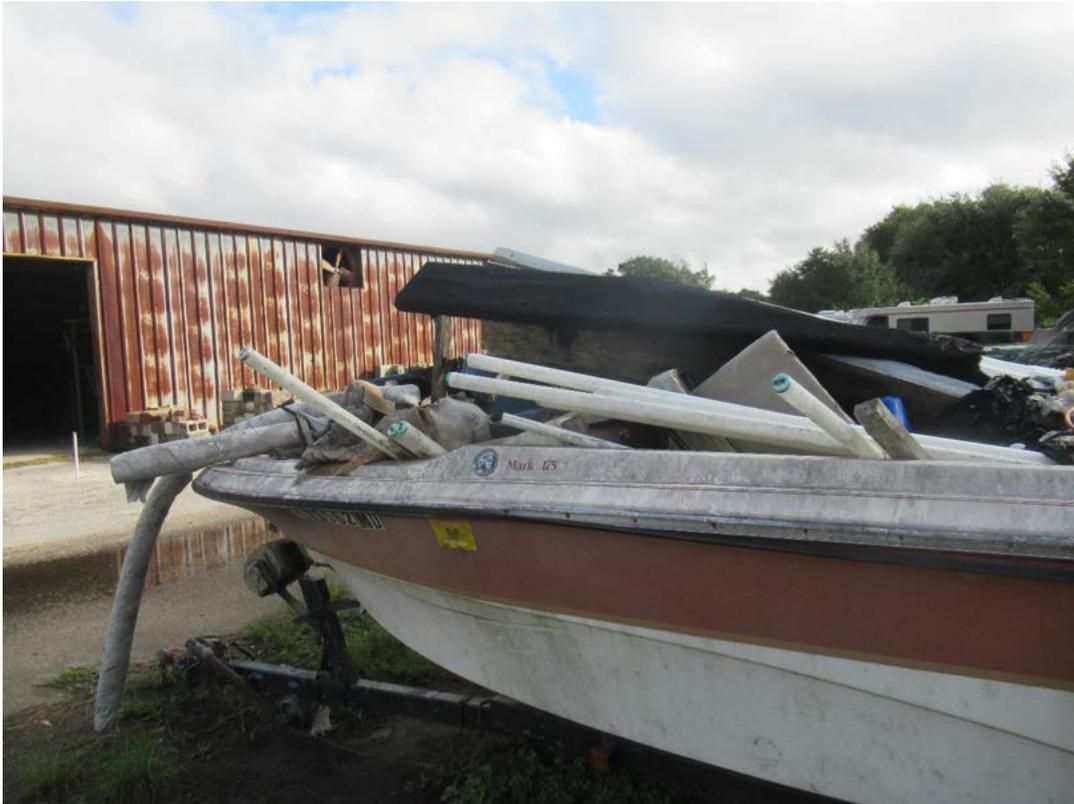
Photo 7: Waste/broken mercury-containing bulbs improperly stored at Amazing Marine.

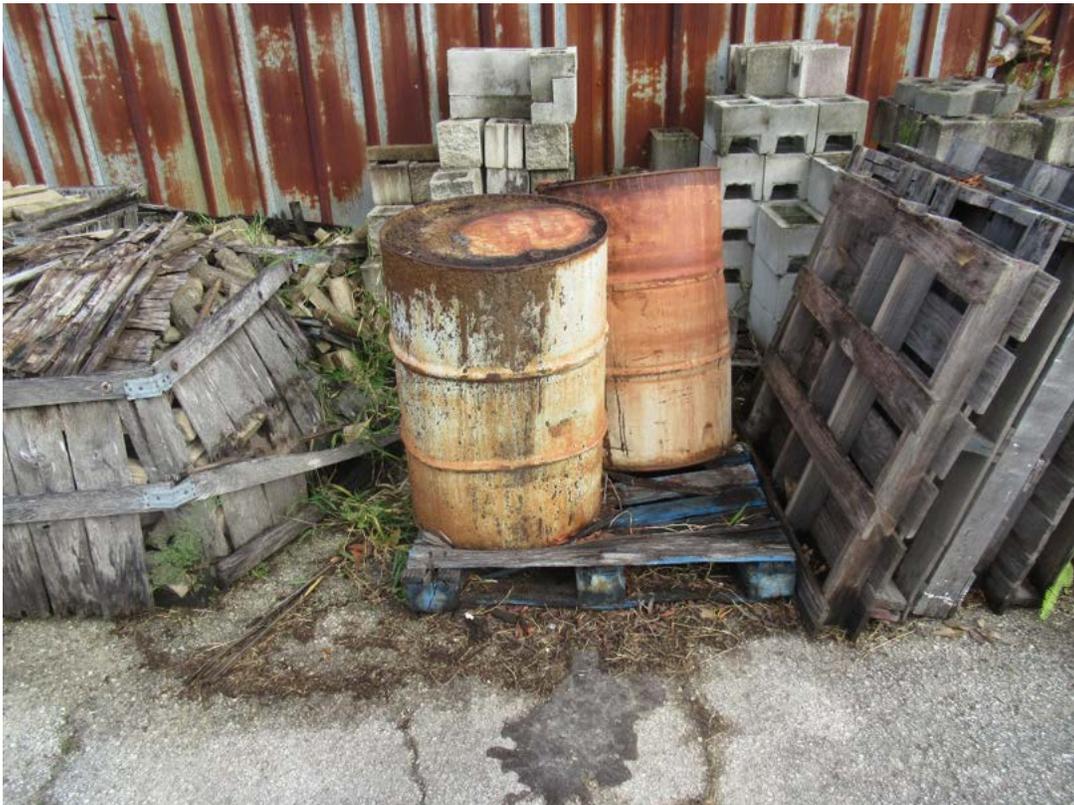
Photo 8: Typical old, damaged, and/or rusted drums observed across the Amazing Marine property.

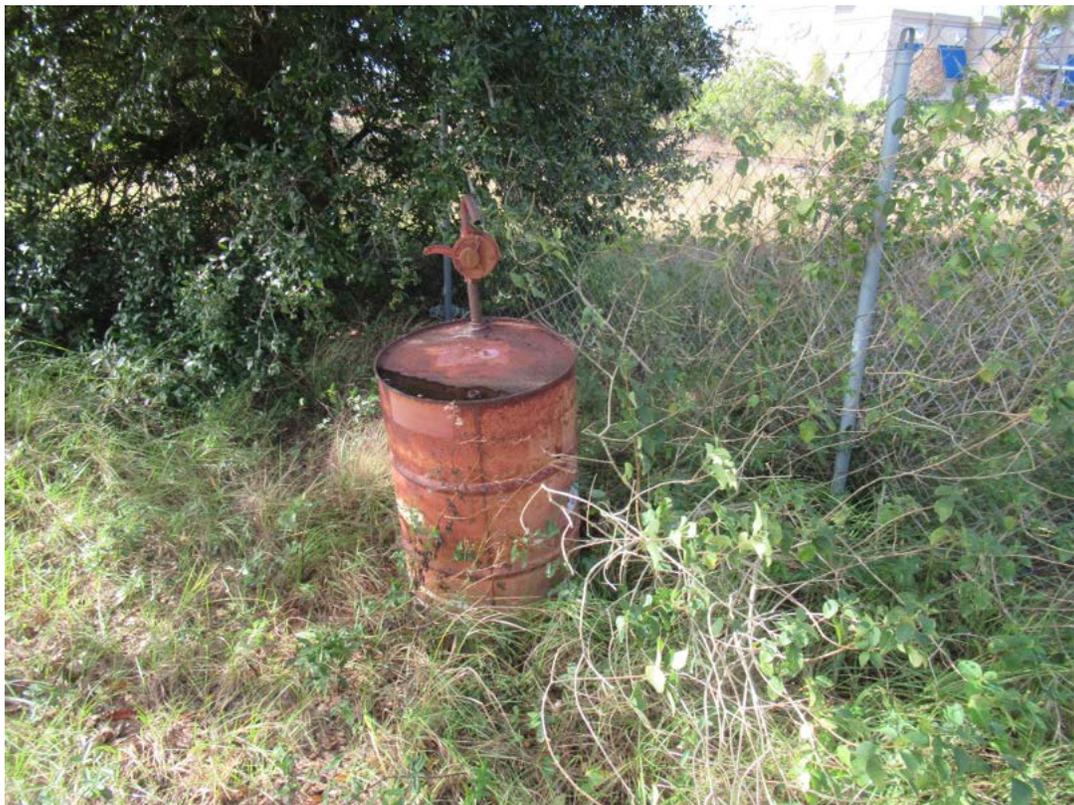
Photo 14: Abandoned 55-gallon drum on far west side of Golf Grove site.

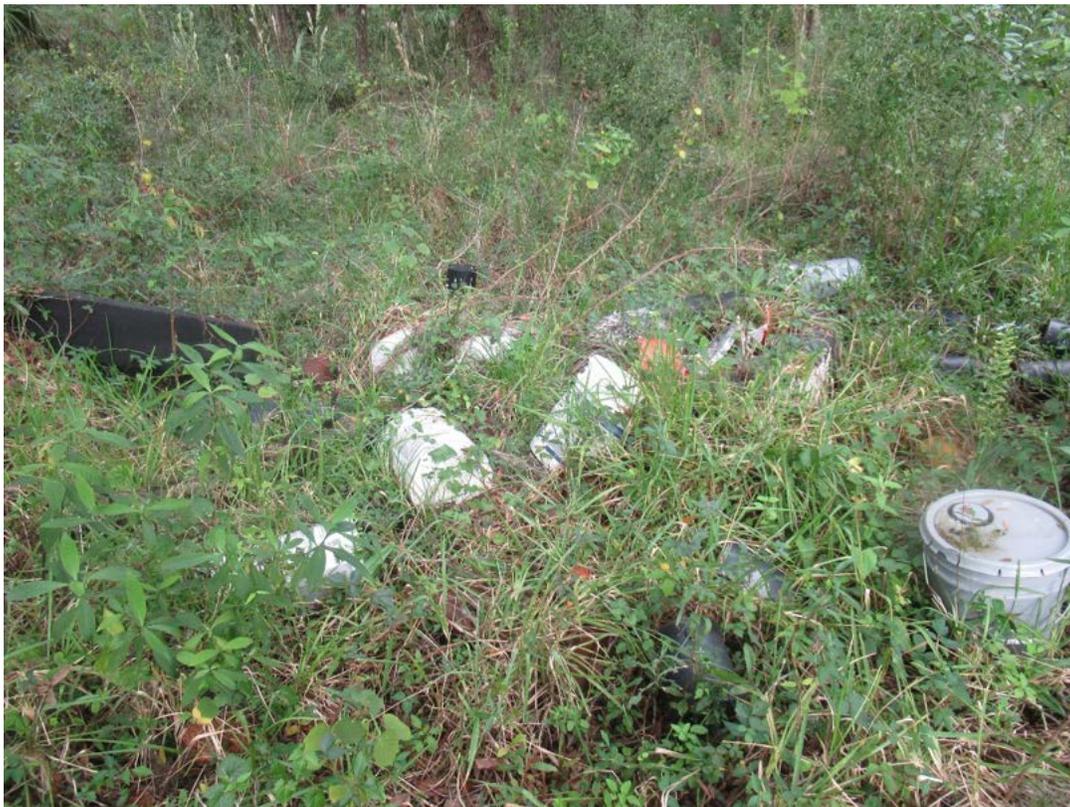
Photo 6: Area of debris and waste, including cans of paints.

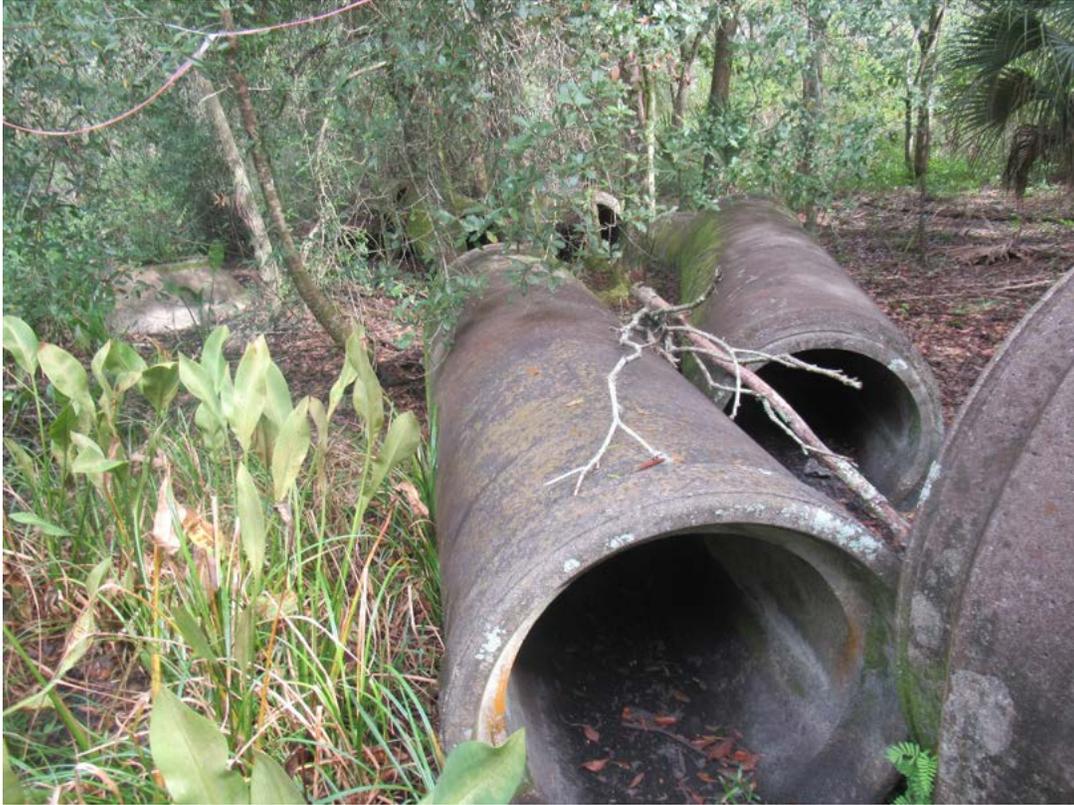
Photo 7: View of large-diameter concrete pipes onsite.

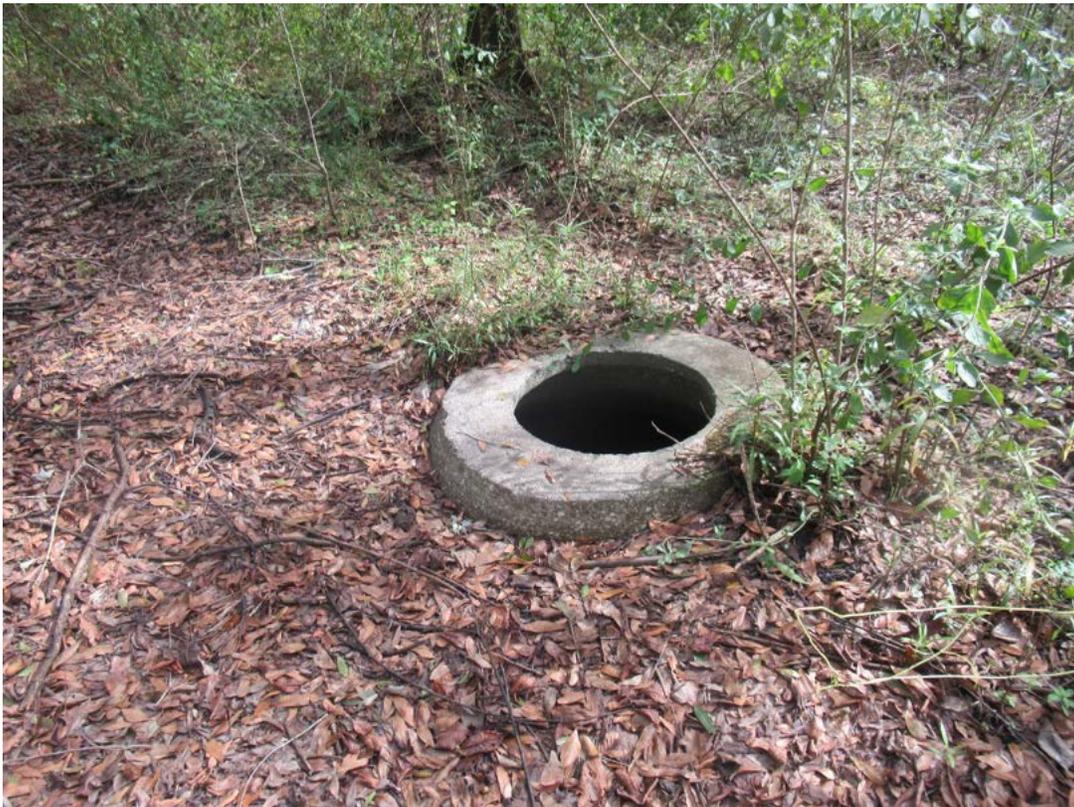
Photo 8: View of one of two storm drains observed onsite.
