Living in a High-Performance Green Building: The Story of EPA's Region 8 Headquarters

June 2013

U.S. General Services Administration
Office of Federal High-Performance Green Buildings

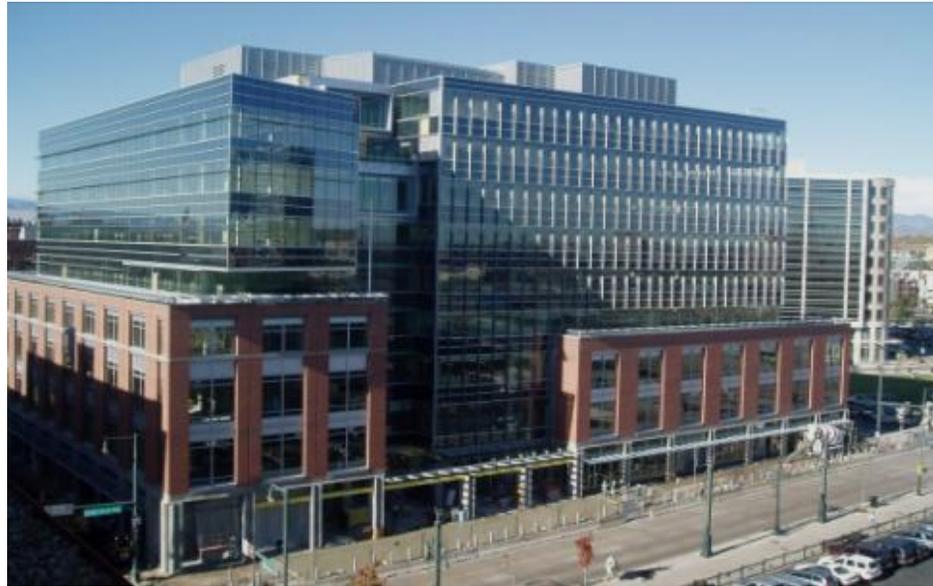
Figure 2-1. Wynkoop Building—EPA Region 8 Headquarters

This privately owned building is at a prominent intersection on the 16th Street Mall, a bustling pedestrian avenue (Figure 2-1). The 9-story building includes retail space on the first floor, a fitness center, conference center, library, break rooms on each floor, a data center, and a records center. Two transit hubs are within a 3-block radius. The facility was designed and built through a design-build public-private partnership, incorporating sustainability elements developed jointly by GSA (the government lessor) and EPA (the tenant agency). The building uses energy and water efficiently and showcases environmentally preferable building materials and design. The private operator and federal tenant use coordinated environmental management systems to track and manage facility environmental performance and monitor progress in meeting federal high-performance building requirements.

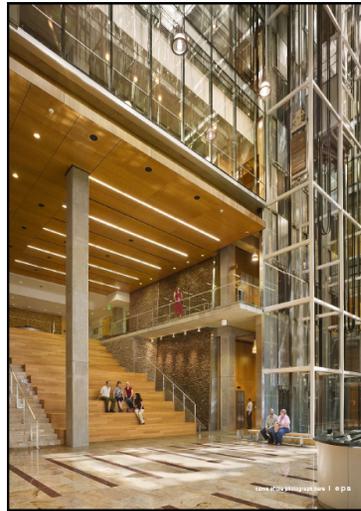
Figure 4-2. Wynkoop Building Atrium

The central atrium raised issues about how best to direct light down to the bottom of the atrium while protecting the upper levels from heat and glare. During the competition phase, the team included a faceted reflector on the roof, to ensure that some cost for a reflector would be carried in the construction budget. ZGF then explored a number of options for cost-effective interior reflectors that would direct light into the interior. They built a physical model of the atrium, and of different reflector options, and studied them using the heliodon at the University of Oregon's energy studies laboratory.

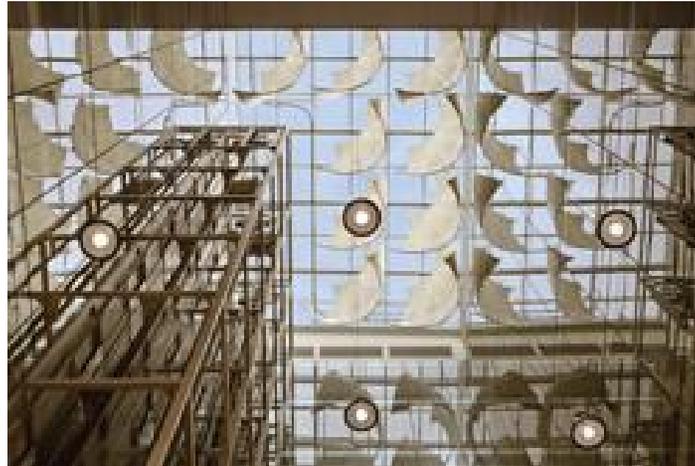
Figure 4-3. Fabric Sails in the Atrium to Help Direct Daylight

ZGF contacted tensile structure companies for fabrication, but their bids were very high, and there was concern that solar radiation would degrade elastic in the proposed fabric. ZGF then approached a sailmaker in the Portland, OR, area about fabricating the sails, and a Denver-based theatrical rigging company for information on installation and maintenance. ZGF printed a cutting pattern from its computer model, from which the sailmaker created a scale model. The bids for fabrication and installation from these two sources fell within the allowable budget, allowing the sails to remain in the project. (For more information see “Atrium Daylight Control System,” *Architect Magazine*, September 1, 2007; and “The Butterfly Effect,” Holly Richmond, *Greendesign.com*, May/June 2009. Links to both articles appear in [Appendix B.](#))

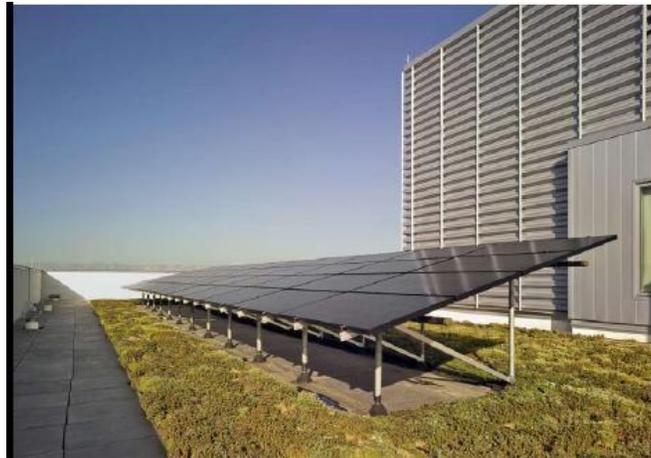
Figure 4-4. Photovoltaic System on Southeast Corner

Colorado law requires utilities to allow customers to install renewable energy systems on their properties and sell the generated energy to the utility servicing that property (“net metering”). EPA installed a 48-panel, 10 kilowatt (kW) PV system on the southeast corner of the 9th floor as a demonstration feature for building tours (Figure 4-4). According to the tour script, the system generates enough electricity to power three to five energy-efficient homes. However, the PV array does not make a meaningful contribution to the building’s energy use. EPA purchases green power certificates to support renewable energy sources.⁴

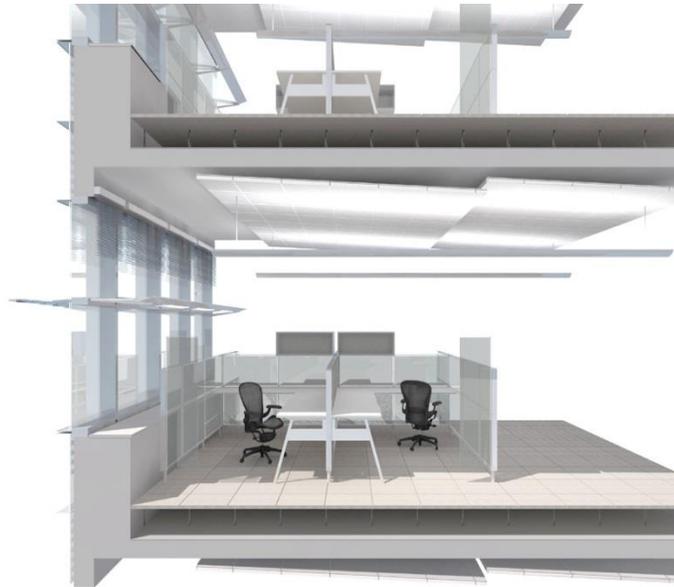
Figure 4-5. Under-Floor Air Delivery System

Floors 1–3 use a traditional overhead-delivery HVAC system. Floors 4–9 (office spaces) are conditioned through a UFAD system (Figure 4-5). Under-floor systems offer several advantages:

- ◆ The cool supply air does not need to be forced down to the occupants from the ceiling, through ambient rising warm air, so the system needs less pressure than a traditional overhead system. This allows smaller fans to be used throughout, and smaller fans use less energy.
- ◆ Supply air coming up from the floor does not get mixed as much as supply air from an overhead system, so the air does not need to be cooled as much. In this building, UFAD supply air is typically cooled to 62–65°F, whereas supply air from an overhead system might be cooled to 55–58°F.
- ◆ Supply ports (diffusers) can be easily relocated to accommodate office reconfigurations or respond to tenant comfort needs (Figure 4-6). Air flow from the diffusers can be easily manipulated by tenants, which allows for some degree of individual temperature control.

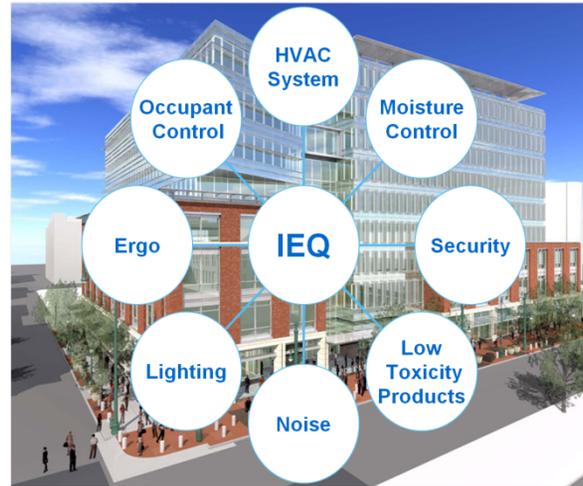
Figure 6-1. Integrated Components of IEQ

As illustrated in Figure 6-1, IEQ consists of complex interrelated elements that must be considered together in designing a sustainable facility. The following is a summary of the IEQ goals for the Wynkoop building:

The IEQ research that addressed these goals included human factors research (a web-based survey and functionality analysis), and measurement of physical conditions such as acoustics, UFAD, thermal conditions, air quality, and daylighting. The results of that research are discussed in [Chapter 7](#).

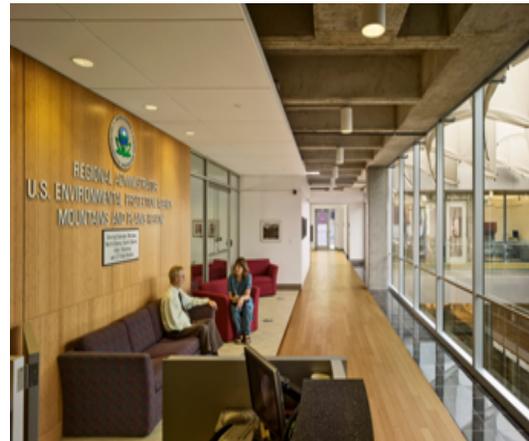
Figure 6-2. Direct Line of Sight to Windows in Regularly Occupied Spaces

The project met requirements for daylighting and views by designing building and workstation layouts so that occupants have a direct line of site to windows in 90 percent of the regularly occupied spaces. Credits were denied with a request to submit larger scale floor plans indicating interior and exterior glazing, solid walls, and room names and numbers.

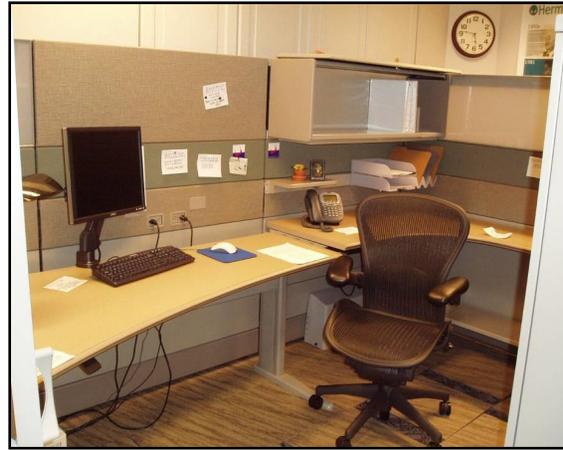
Figure 6-3. Typical Workstation Layout

Well-designed workspaces improve employee health and productivity and reduce “churn” costs for building managers.³⁰ A team of EPA employees managed procurement for workstations and chairs. Three highly ergonomic, adjustable chair models were selected by the team. Employees were able to select their chair during 3 days of “hands-on/seats-on” tryouts, during which vendor representatives were present to answer questions and make adjustments. The chairs also contain high recycled content (from 30 to 66 percent) and were designed to be recycled themselves.

A number of ergonomic and environmental attributes were specified in the workstation procurement:

- ◆ Adjustable-height computer work surfaces allow people to stand or sit at a comfortable working height. Adjustable monitor arms enable people to optimally position computer screens.

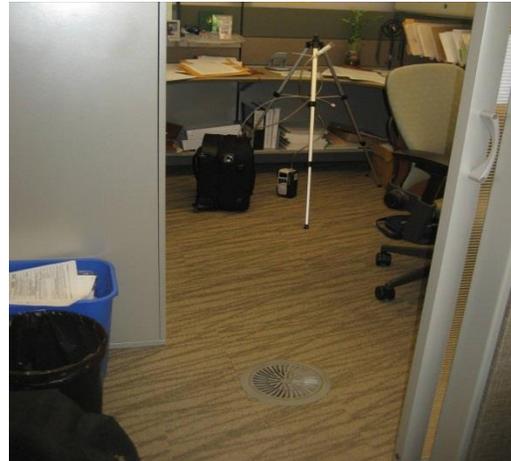
Figure 8-2. Office Sampling Location with SVOC Sampler

Data collected during field sampling included continuous measurements of CO₂, ozone, PM₁₀ (particulate matter with an aerodynamic diameter of less than 10 microns), temperature, relative humidity, atmospheric pressure, and sound level. In addition, integrated samples were collected to quantify concentrations of fungal spores, VOCs and SVOCs. A portable instrumentation package (Figure 8-1) measured conditions in the sampling locations described above (Figure 8-2).

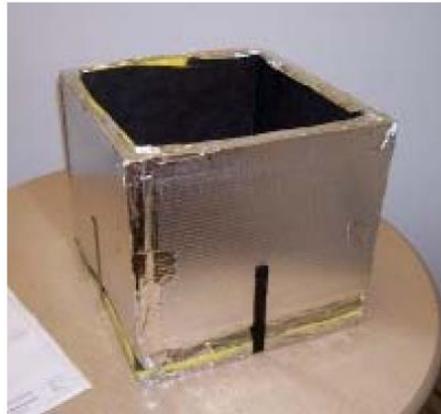
Figure 8-10. Experimental Boot for Air Grille

Experimental boots were constructed and installed directly under all air grilles in the test area (Figure 8-10). To complete the setup, it was necessary to alter the equalization and power levels of the test area speakers. The equipment layout of the original installation did not lend itself to separating the selected test area, so a temporary amplifier and equalizer with integral masking noise generator was installed and temporarily connected to all speakers in the test area (Figure 8-11). The masking levels were measured in cubicles throughout the test area.

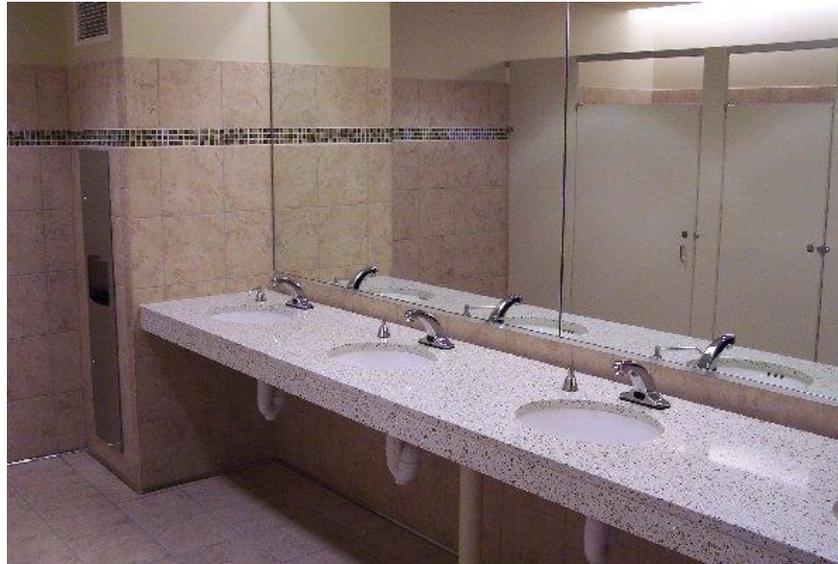
Figure 9-1. IceStone Countertops Installed in Bathrooms

Indoor air quality was a high priority; the SFO specified ventilation performance metrics and a variety of source control strategies to consider. The SFO highlighted cost-effective use of environmentally preferable products⁴⁴ and identified some specific types that were applicable, such as for landscaping, insulation, acoustical ceiling tiles, wallboard, ceramic tile, toilet partitions, bathroom paper products, and carpet. An example was the restroom countertops made of IceStone (Figure 9-1), a composite material consisting of recycled glass and concrete (Figure 9-2).

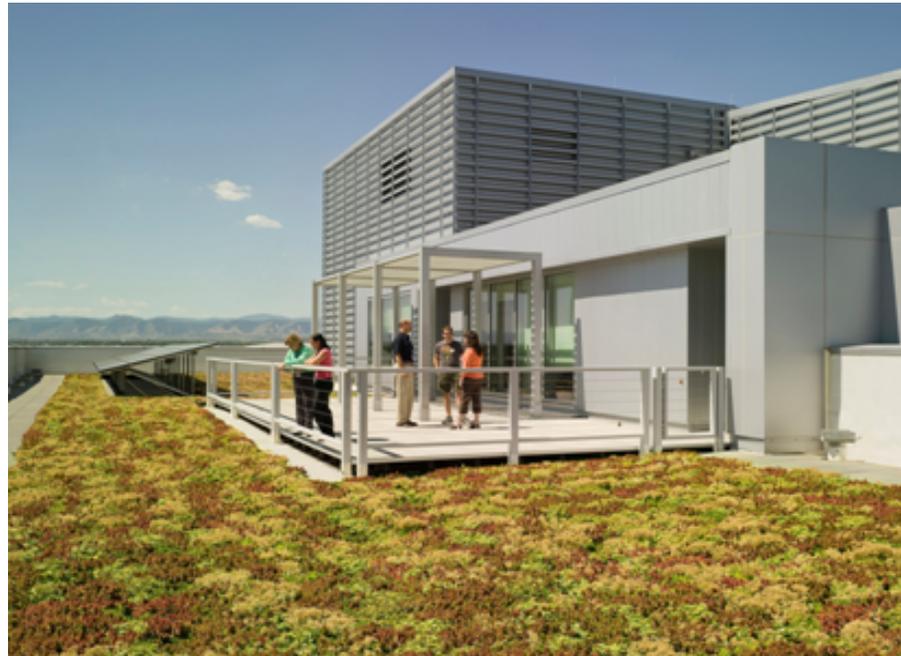
Figure 10-1. Vegetated Roof

This chapter focuses on the design goals for a vegetated roof (Figure 10-1) and the roof's sustainability performance. This was the first planned installation of this type of vegetated roof system in a North American high-mountain desert eco-region. As such, it was subject to extensive investigation, from the best types of plantings to use to its performance for stormwater retention and its effects on the building energy performance.

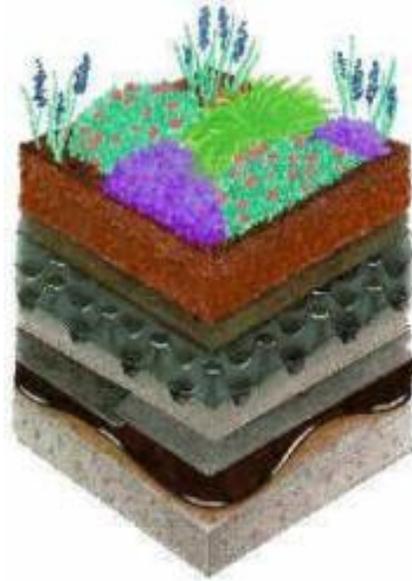
Figure 10-2. Vegetated Roof Layers

Some changes were made to the roof assembly to accommodate this system. The building's roof is an EPDM membrane with a high-emissivity acrylic coating; the membrane was changed from 60 mil to 90 mil, a fleece protection mat was added to protect the membrane from friction, and the warranty was extended from 10 to 15 years. Recycled rubber pavers provide walking paths around the perimeter of the modular systems for use by maintenance personnel.

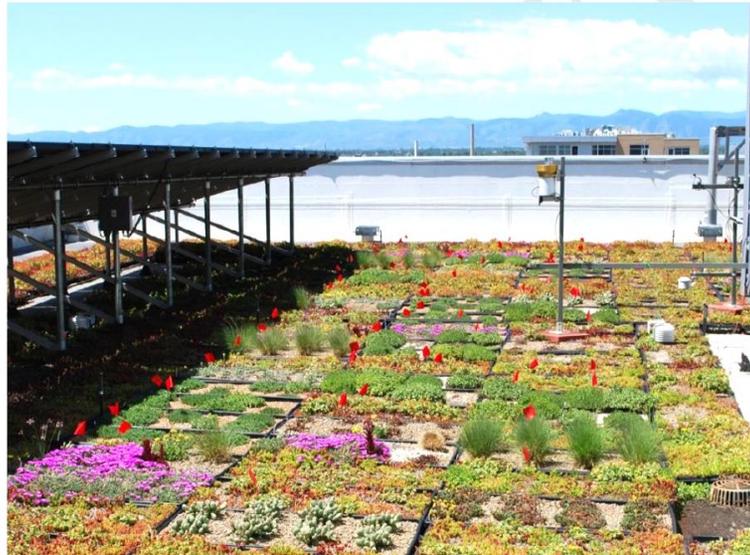
Figure 10-3. Solar Panels Shade Portions of Vegetated Roof

Photovoltaic Array Added to the Roof- Photovoltaic panels were initially removed from the roof design due to a lack of funding. However, Opus decided to install the support structure fittings for the panels in case EPA should decide to install them in the future. Later in construction, when EPA decided to install a 10 kW array of PV panels over the vegetated roof, Opus resisted. The untested configuration was a risk, and negotiations were necessary to release Opus from liability if the shade from the PVs were to kill the vegetated roof (Figure 10-3).

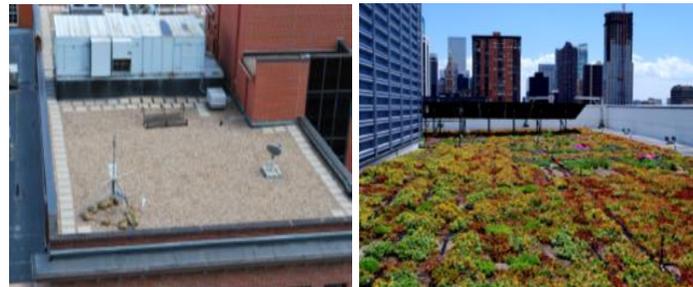
Figure 10-4. Control Roof (Left) and Vegetated Roof

The conventional (control) roof is located on an extensively renovated, LEED Gold Certified historic building located across the street from the EPA facility (Figure 10-4). The control roof is a low-slope dark EPDM membrane roof topped with gravel ballast (about 1.5 inch or 3.8 cm). Concrete pavers border the perimeter of the roof. The roof membrane is overlain in most areas with a single layer of gravel, with the membrane visible through the porous gravel. The study site is located in the north corner.

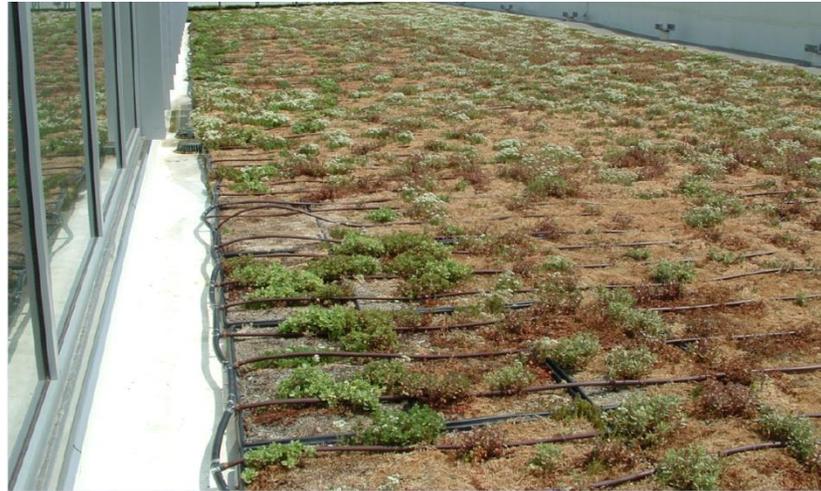
Figure 10-7. Drip Irrigation of Vegetated Roof with Emitters Spaced at 12 Inches

For 2009 the targeted irrigation application rate was 0.5 inch per week, and for 2010 the targeted irrigation application rate was 0.25 inch per week. However, according to sub-meter readings, the actual application rate was more on the order of 0.75 inch per week during the growing season. It is estimated that over the duration of the study, 125,000 to 150,000 gallons of water/year were used for irrigation.
