MARIPOSA LAND PORT OF ENTRY ANALYSIS AND RECOMMENDATIONS FOR SITE SYSTEMS

February 2018

Prepared by:
Conservation Design Forum
Landscape Architecture Foundation

Client:
U.S. General Services Administration

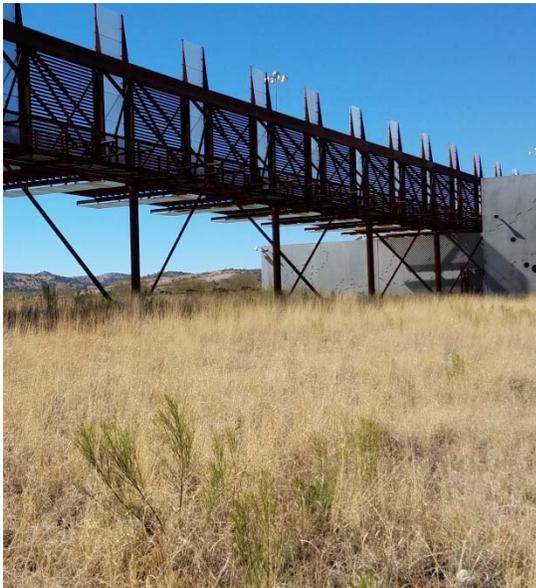
The image to the right is a site plan for the Mariposa Land Port of Entry. The drought tolerant zones are shown in red and the enhanced planting zones are shown in blue. The image below shows an example of the plantings found in drought tolerant zones.
