COESAM/PD-E-96-007

**HISTORIC ARCHITECTURAL INVENTORY SURVEY
AND
DETERMINATION OF ELIGIBILITY:**

**Pedricktown Support Facility
Pedricktown, New Jersey**

Prepared by Laura V. Trieschmann
and Kathryn A. Gettings

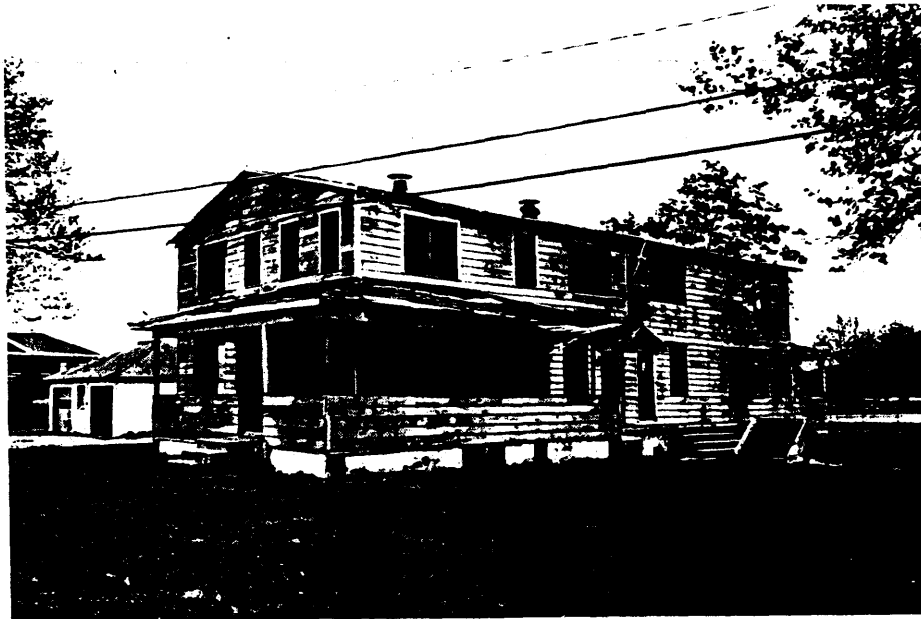
Negative File No. A 3-5

considered to be a permanent housing facility, and was subsequently relocated and altered to provide additional living quarters. In its present condition, however, the building has no integrity, having been moved, stripped of original interior and exterior ornament, and rehabilitated on numerous occasions. Yet, it is intact in form and retains a high level of association with the Pedricktown Support Facility. Therefore, Building 120 has been determined to be a non-contributing resource to the historic context.

ORIGINAL USE: Officers' Housing **PRESENT USE:** Vacant
PHYSICAL CONDITION: Excellent Good Fair Poor XXX
REGISTER ELIGIBILITY: YES POSSIBLE NO XXX **DISTRICT**
THREATS TO SITE: Roads Development Zoning
Deterioration XXX No Threat Other

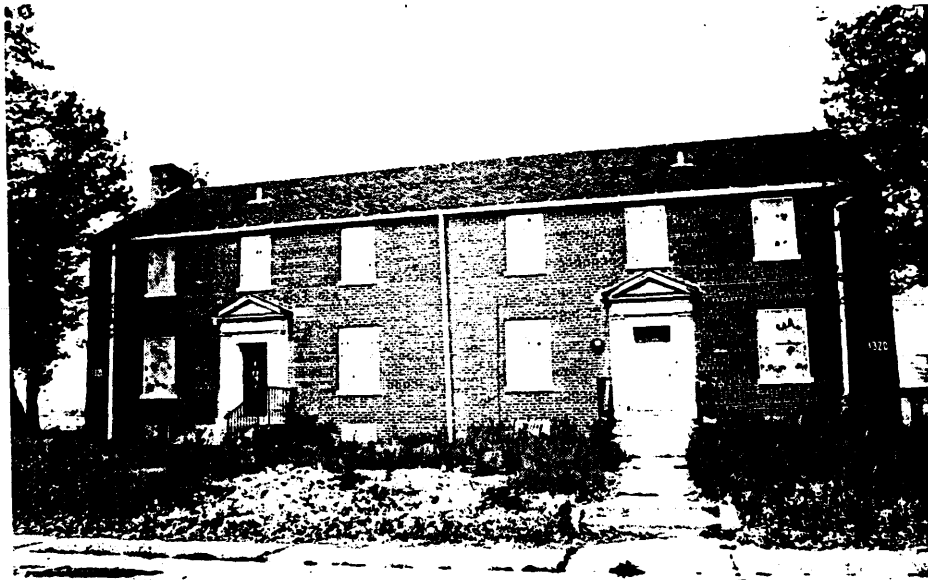
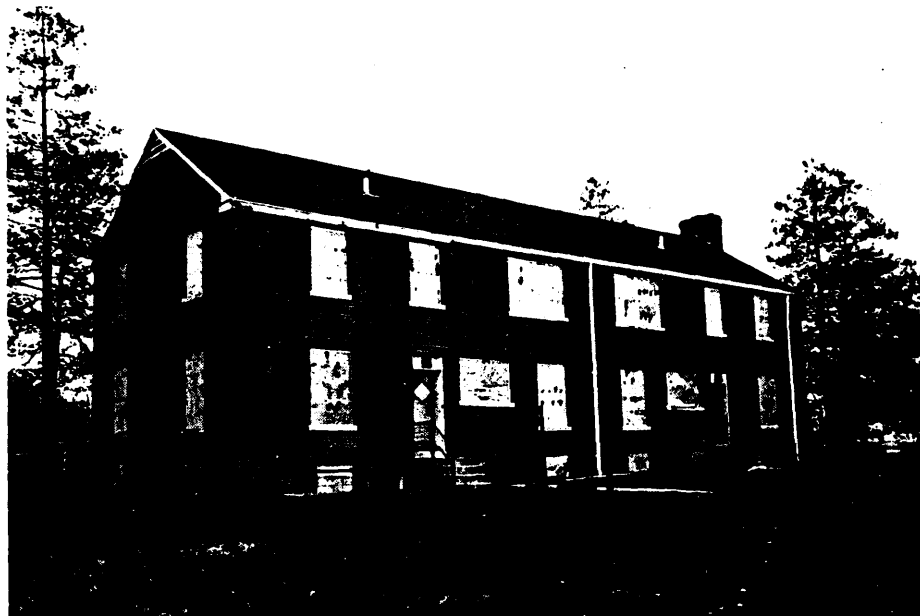
Negative File No. A 8-9

ORIGINAL USE: Double Company Officers' Housing **PRESENT USE:** Vacant
PHYSICAL CONDITION: Excellent ___ Good ___ Fair XXX Poor ___
REGISTER ELIGIBILITY: YES ___ POSSIBLE NO XXX **DISTRICT** ___
THREATS TO SITE: Roads ___ Development ___ Zoning ___
Deterioration XXX No Threat ___ Other ___

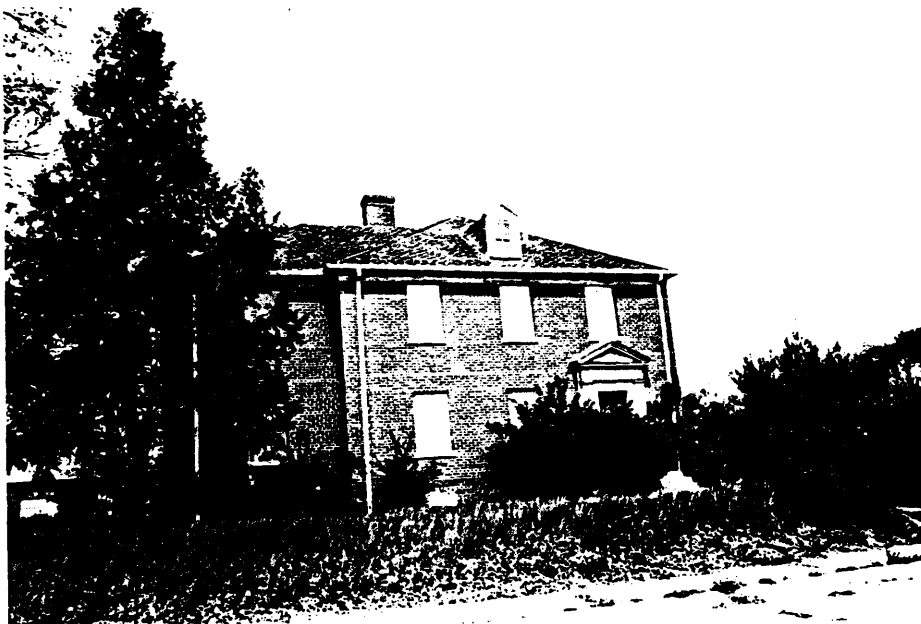
Negative File No. A 10-11

ORIGINAL USE: Single Company Officers' Housing **PRESENT USE:** Vacant
PHYSICAL CONDITION: Excellent___ Good___ Fair XXX Poor___
REGISTER ELIGIBILITY: YES___ POSSIBLE___ NO XXX DISTRICT___
THREATS TO SITE: Roads___ Development___ Zoning___
Deterioration XXX No Threat___ Other___

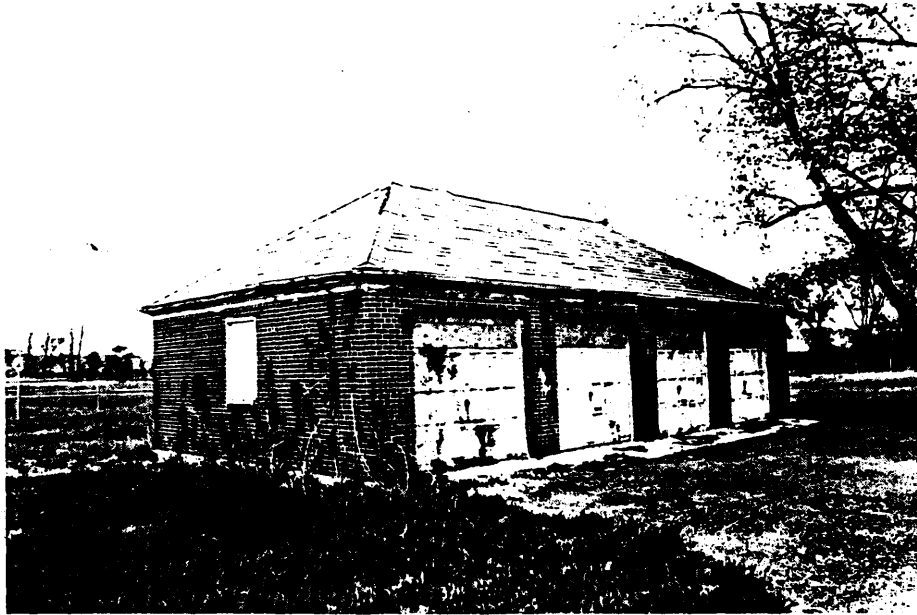
Negative File No. A 12

The building is located between Garrison and Central roads at Service Road. It is sited at the northeast side of the road adjacent to the small residential area. The site of the ordnance magazines is located to the west.

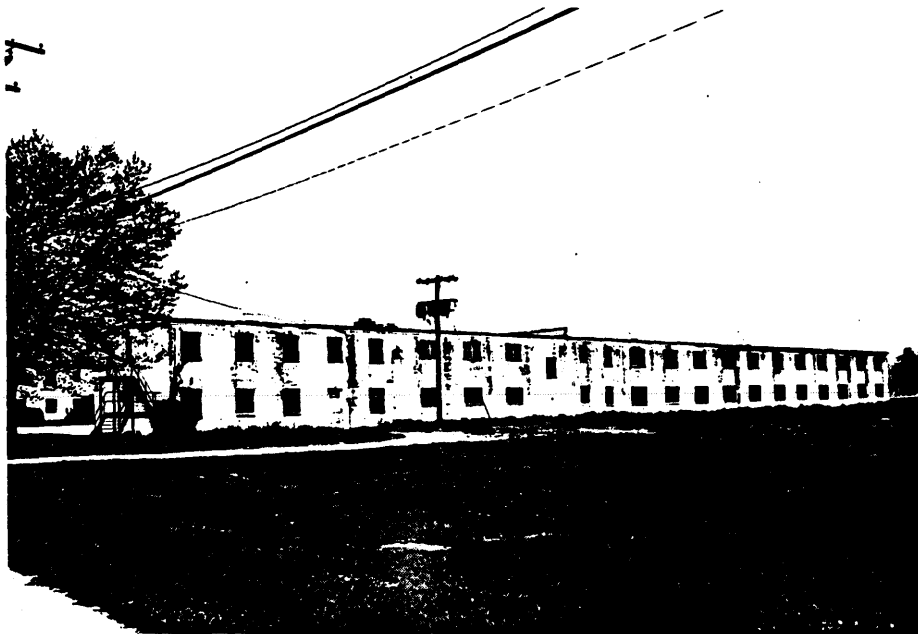
Negative File No. A 18-20

The building is located on the north side of Artillery Avenue, fronting on a concrete paved parking lot. The site of the ordnance magazines is located to the north.

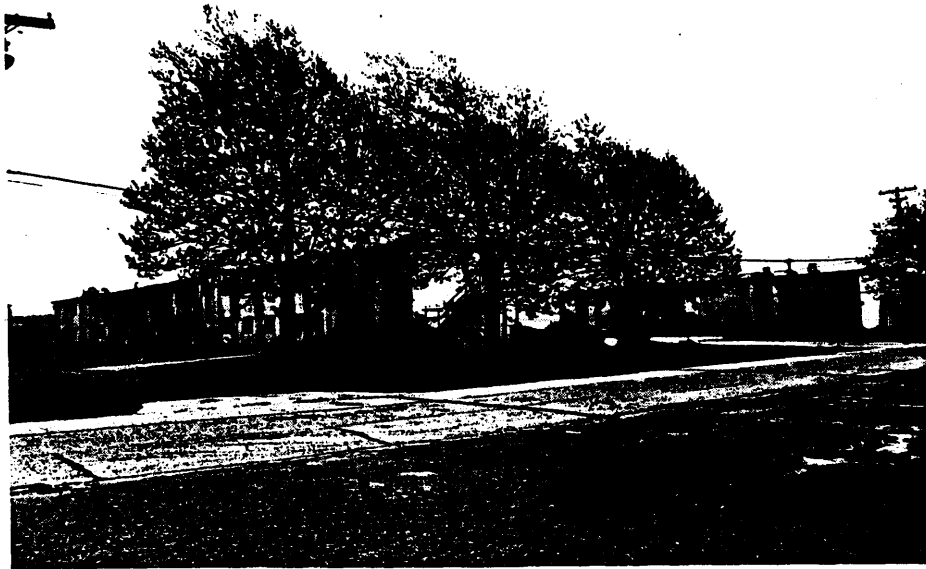
Negative File No. A 18-20

The building is located on the north side of Artillery Avenue, fronting on a concrete paved parking lot. The site of the ordnance magazines is located to the north.

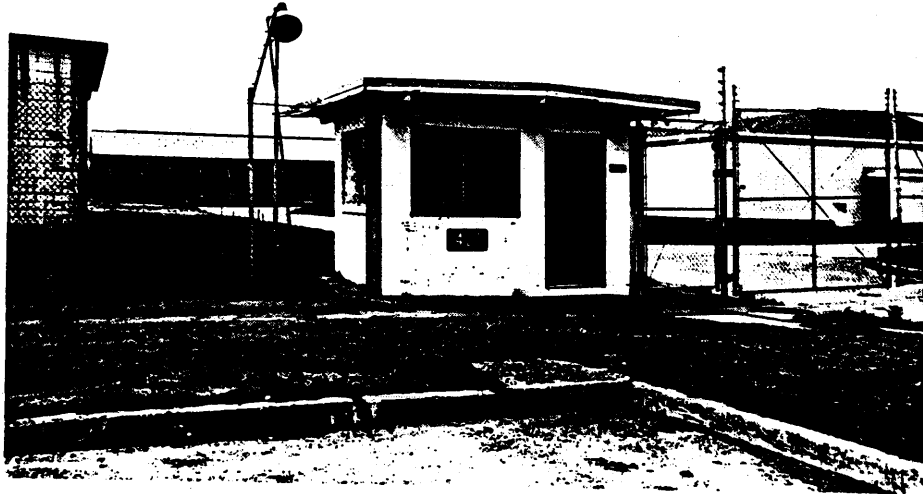
Negative File No. A 23

The building is located on the south side of Artillery Avenue along Delaware Road. Serving as a sentry booth for the restricted missile command area, the building is edged by a tall metal fence with barbed wiring. The entry gate to the area is set to the west of the building. Parking is to the northeast.

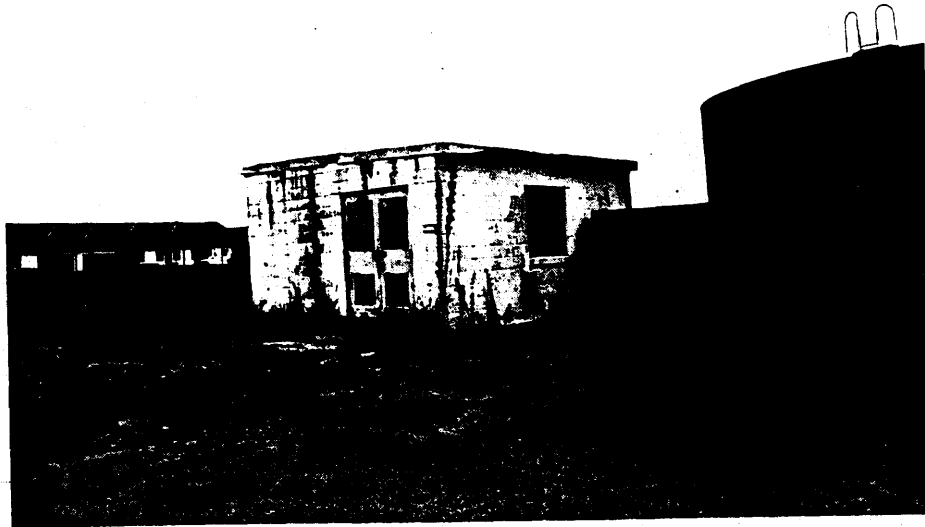
Negative File No. A 30-31

The building is located within the restricted area devoted to the missile command center.

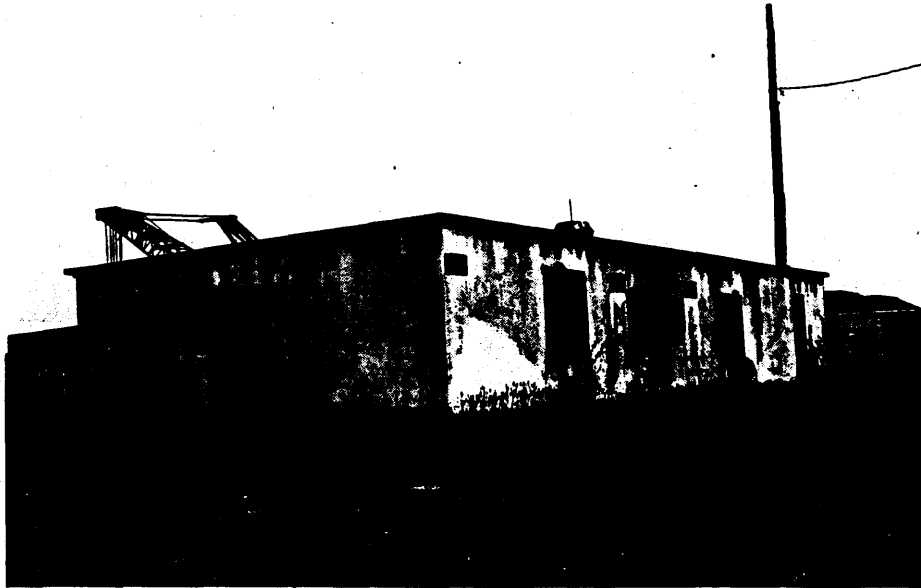
Negative File No. A 34

The building is located along the northeast side of Railroad Avenue, to the west of the restricted area.

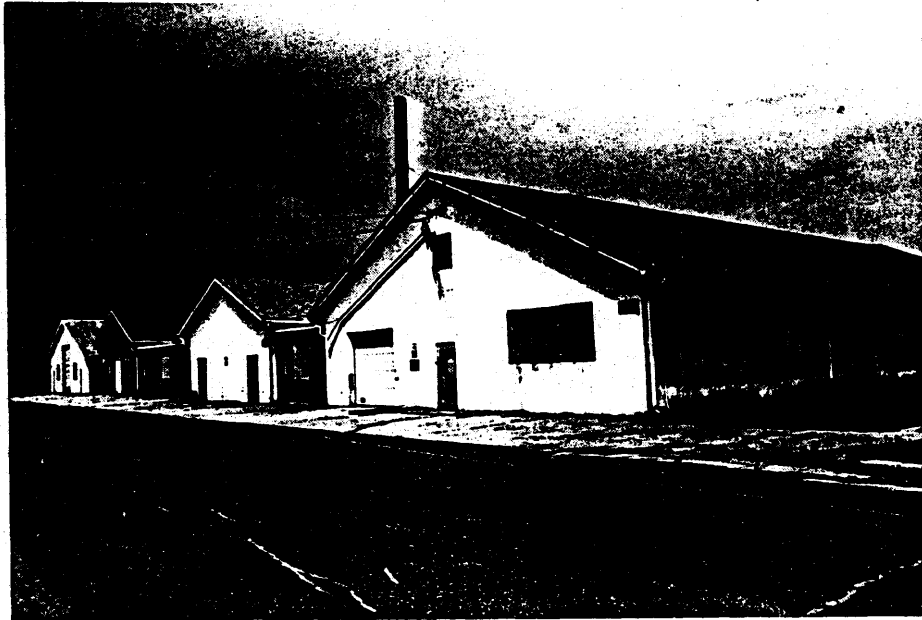
Negative File No. A 35-36; B 9 and 26

The building is located along the northeast side of Railroad Avenue, to the west of the restricted area.

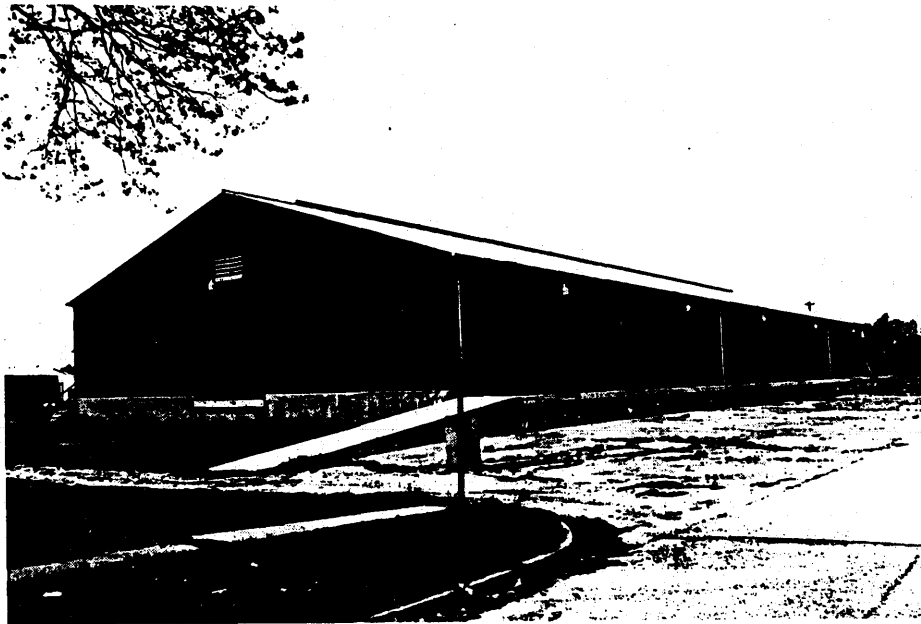
Negative File No. A 22

The building is located along the southwest side of Artillery Avenue at its intersection with West Road. It is sited to the northwest of the restricted area.

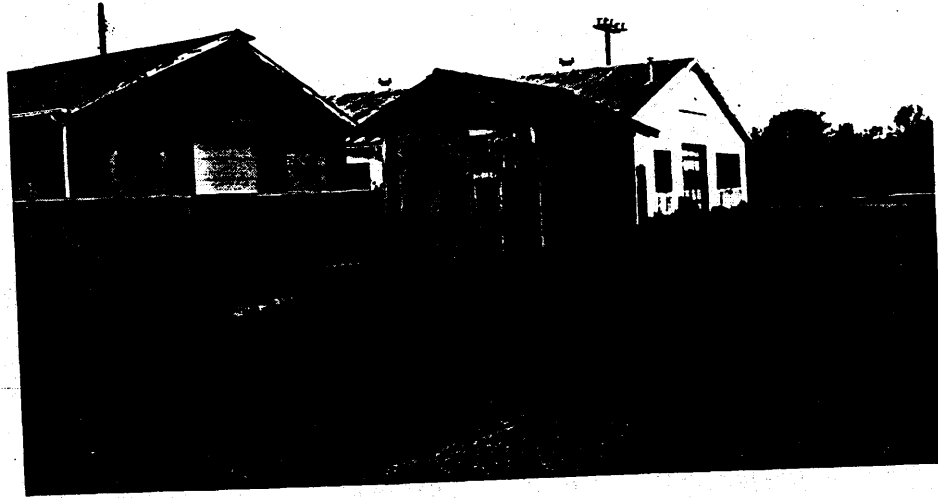
Negative File No. B 10

The building is located along the southwest side of Railroad Avenue, to the west of the restricted area.
