FINAL REPORT

ENVIRONMENTAL BASELINE SURVEY REPORT

**Camp Pedricktown, Reserve Enclave
Oldmans Township, New Jersey**

May 2003

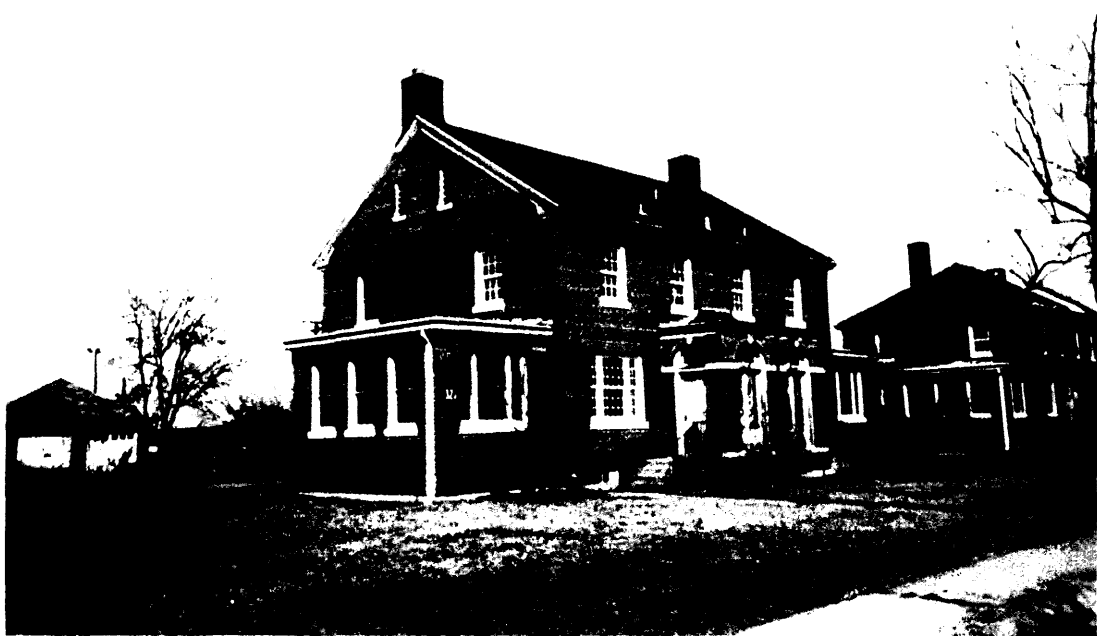
Photo B-4. Building 278 (Center), Building 277 (Right), and Building 288 (Garage to Left),
Looking Northeast

During the site reconnaissance, three family housing units (Buildings 276, 277, and 278), four associated detached garages (Buildings 285, 286, 287, and 288), and one enlisted personnel barracks (Building 273) were observed at the Reserve Enclave. None of the housing units appears to be occupied. The presence of lead-based paint in all these buildings was confirmed in a survey that included a sampling and analysis effort. Asbestos may be present in these units as well.

A lead-based paint survey and surface soil sampling investigation was conducted at housing units and associated garages at Camp Pedricktown, including Reserve Enclave buildings 276, 277, 278, 286, 287, and 288. The investigation found that lead-based paint was present on both interior and exterior surfaces, as well as in surface soil within 20 feet of the building foundations. Surface soil within 3 feet of the foundation exceeded NJDEP action levels.
