Prepared for the US General Services Administration

By Dan Howett, P.E.
Oak Ridge National Laboratory

January 2015

Catalyst-Based Nonchemical Water Treatment System Frank E. Moss US Courthouse Salt Lake City, Utah

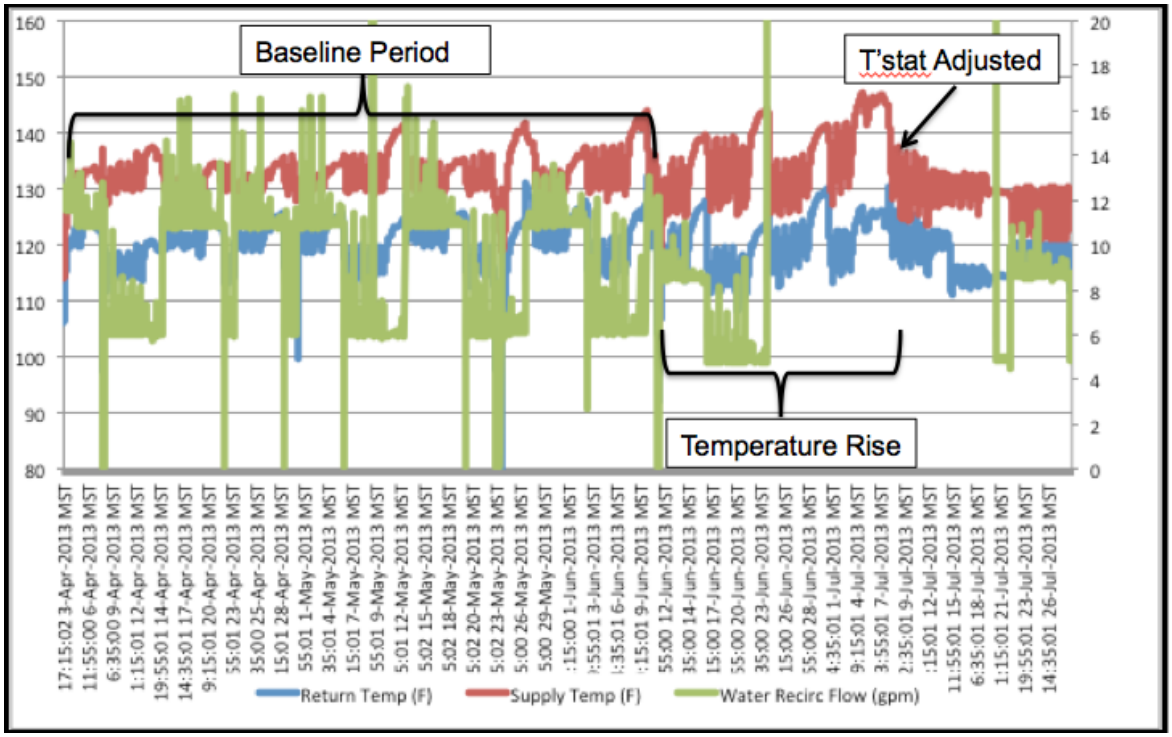
Figure 10. Graph Showing Water Heating System Temperature Trends Over Time.

In early July 2013, site operations personnel observed that the temperature of the domestic water heating system had risen to almost 150°F. At this point they felt that it was too hot for safe use in the facility, so on July 12 they adjusted the thermostat to its next lowest setting. After checking the temperature trends of the system, personnel determined from the data that the temperature rise began at the same time that the catalyst-based NCWT device had been installed (Figure 10). It should be noted that the electric heating elements, in their efforts to maintain the temperature set point, remained energized 24 hours a day, even over weekends. This constant state of being energized was required because the elements were so caked with calcite, which was acting as an insulator and impeding heat energy from easily transferring from the element to the water.

After the thermostat was adjusted, temperature in the system went back down to around 130°F, where it was supposed to be. Data from the electrical meter on the heater noted that at this point the heating elements began to cycle off when the temperature reached its set point. Figure 11 is a graph of the electric current showing it cycling off during the night and on weekends when usage is low.

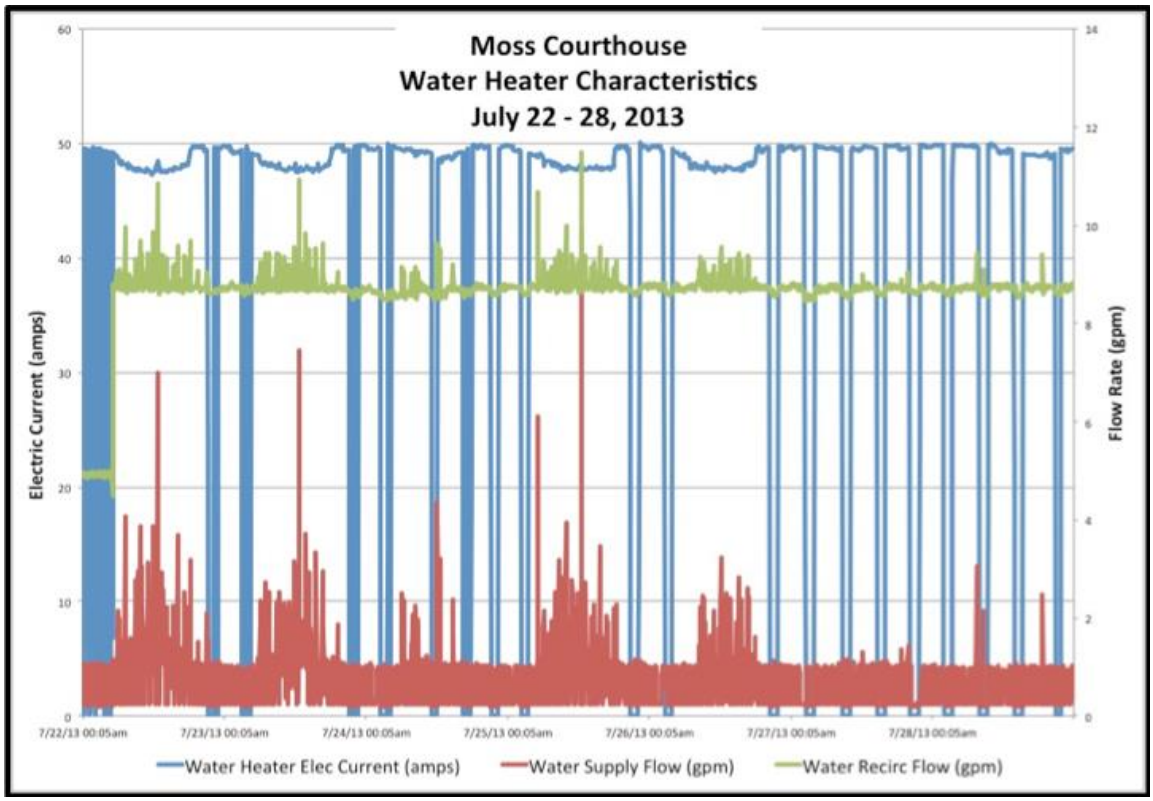
Figure 11. Graph Showing Electric Current and Water Flow Rates.

The manufacturer's recommended flow rates are consistent with what was measured in the above graph. Please note that the step changes in flow rates are caused when the two circulating pumps alternate between each other. One pumps at about 6 gpm, the other around 11 gpm (Figure 10). It should be noted that a set of flow rate data was lost due to meter failure. However, discussions with site operations personnel plus analysis of data before and after the meter failure gave the evaluation team confidence that there were no variations in the building operating characteristics during the gap in data.

After scrutinizing the data, ORNL researchers concluded that it appeared that more heat was being transferred from the heating element into the water. The only thing that could have allowed this to happen is a reduced buildup of calcium on the heating elements.

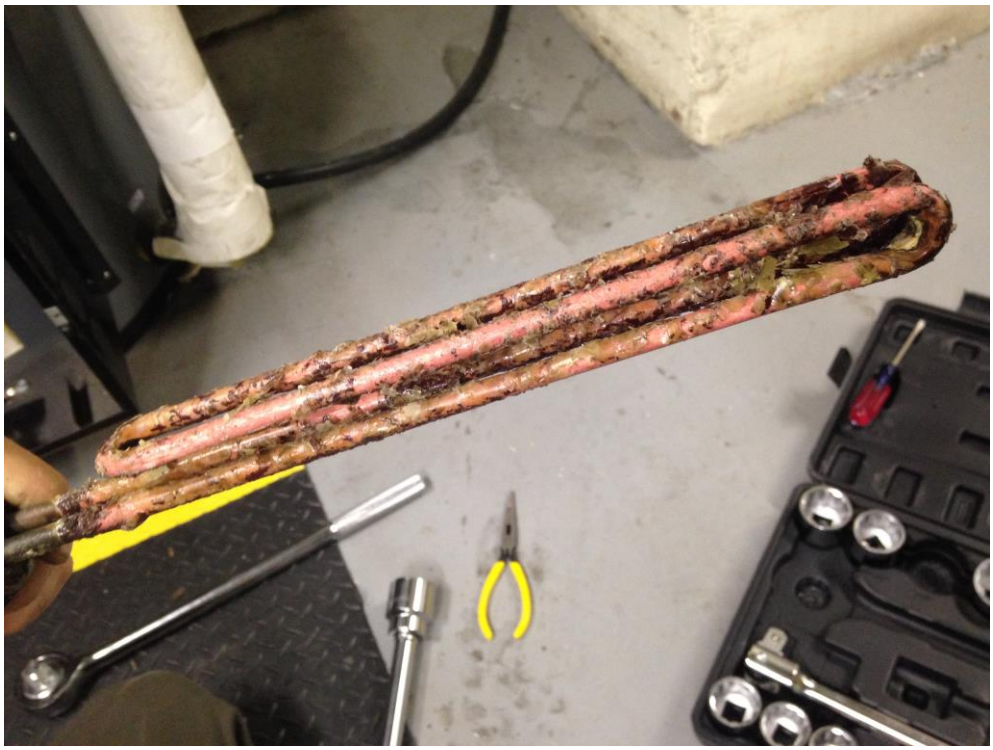
Figure 13. One of the Six Elements Examined in November 2014.

On November 20, 2014, the project team had the opportunity to reconvene at the site to evaluate the technology's long-term effectiveness after 17 months of continuous operation. During this period, no heating elements had failed.

The tank was drained and heating elements removed for evaluation. There was some calcite on each element, similar to what was found in the July 2013 evaluation. However, the elements were mostly clean and in good condition. Figure 13 shows a typical element.

The team did note that there was a small collection of soft material that looked like calcite in the tank's bottom. The technology's vendor was contacted and asked about this observation. The vendor's response follows.

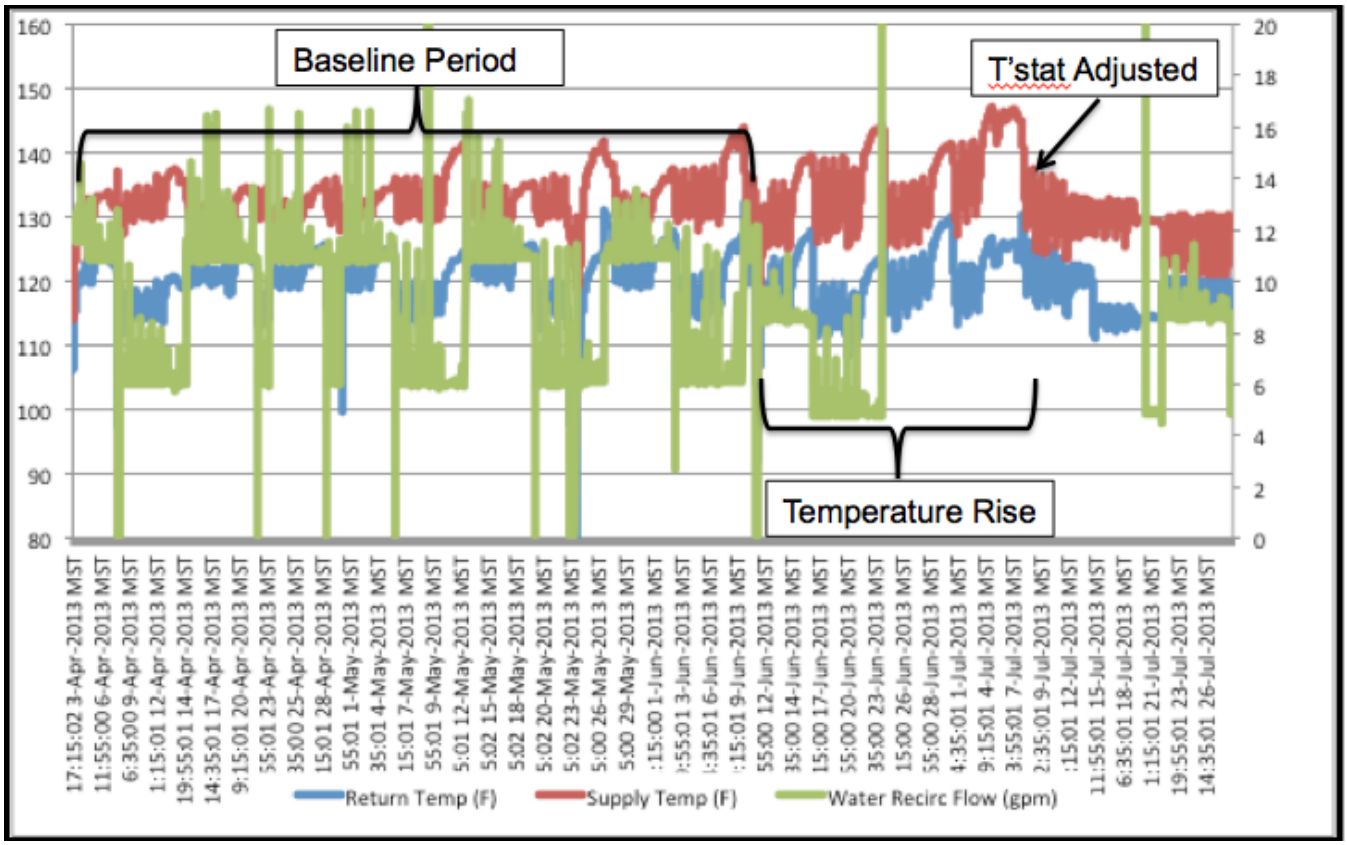
The following is an enlarged image of Figure 10 from the main body of the report. It is being shown here for clarity's sake.
