Potomac Annex:  
Buildings 1 & 3-7

Historic Structures Report, Corrected Final Submission  
 General Services Administration Project Control Number: 44007  
 September 9, 1997  
 VOLUME 2 OF 2

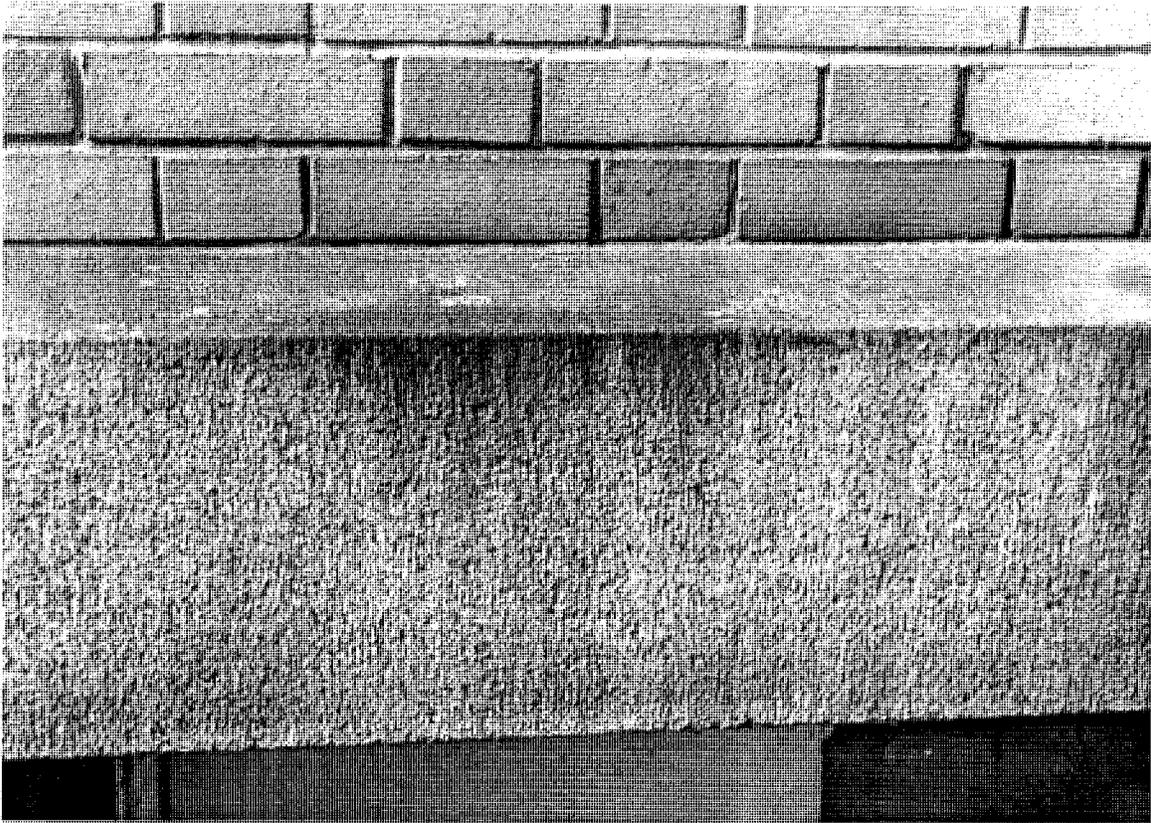
Figure 1-21

Granite and cast stone form the water table which surrounds the building at the base of the first floor. These elements - like the granite keystones - are generally in good condition but are lightly to heavily soiled. However, the joints between juxtaposed stones are open or have been filled with caulk (Figure 1-20). The bed joints and the top horizontal joints for the granite water table are generally open. Run-off from window air conditioners has stained the granite (Figure 1-21).

Location: East Elevation of Building 1 at near North Entrance

Cause of Problem: Run-off from window air conditioners

Suggested Remedy: Poultice with iron-chelating agent

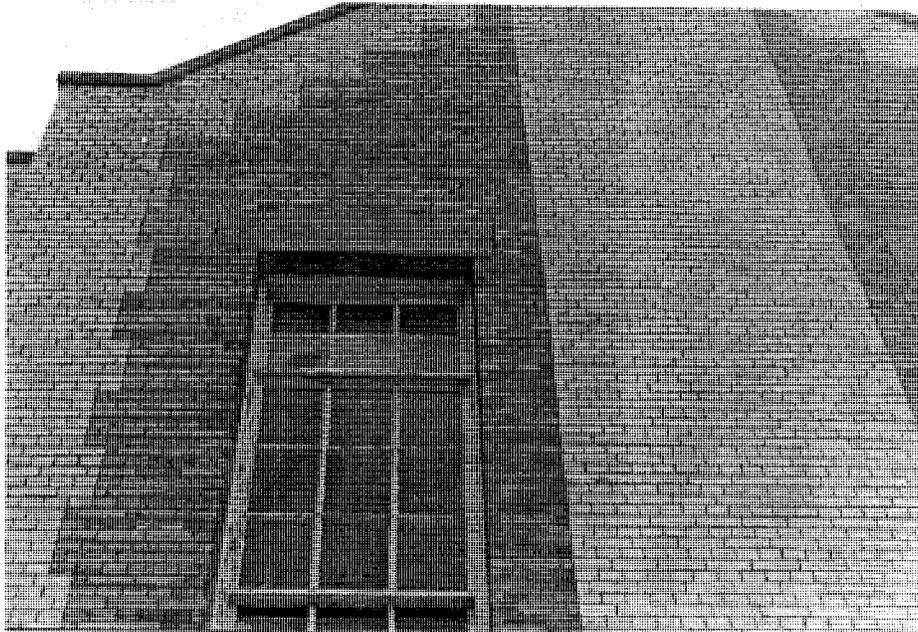
Figure 3-1

The buff brick is soiled moderately and selectively giving it a mottled appearance (Figure 3-1). This brick exhibits a crazed and cracked outer skin which entraps much of the soiling (Figure 3-2). Minor graffiti and bitumen deposits are found on this brick (Figure 3-3). The removal of window grates at the basement level damaged some of the brick (Figure 3-4).

Location: West Elevation of Building 3 on West Pavilion

Cause of Problem: Atmospheric pollution

Suggested Remedy: The buff brick will not clean by conventional or unconventional methods (see also Chapter VIII. *Materials Cleaning Analysis*)

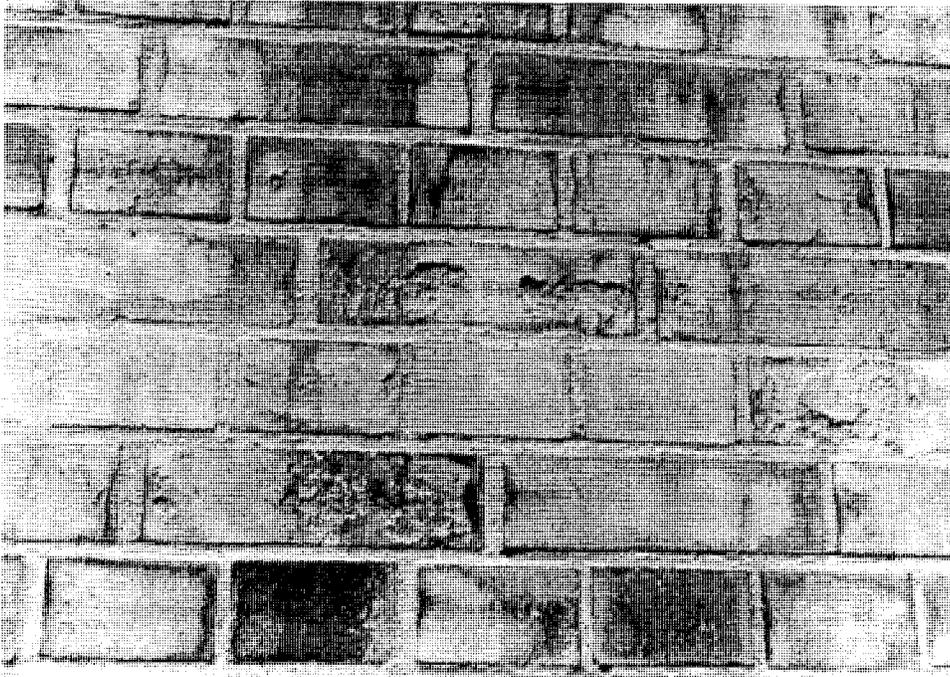
Figure 3-2

Location: North Elevation of Building 3 near West Pavilion

Cause of Problem: Unknown but may be poorly fabricated brick

Suggested Remedy: There is no remedy other than replacement of all buff brick

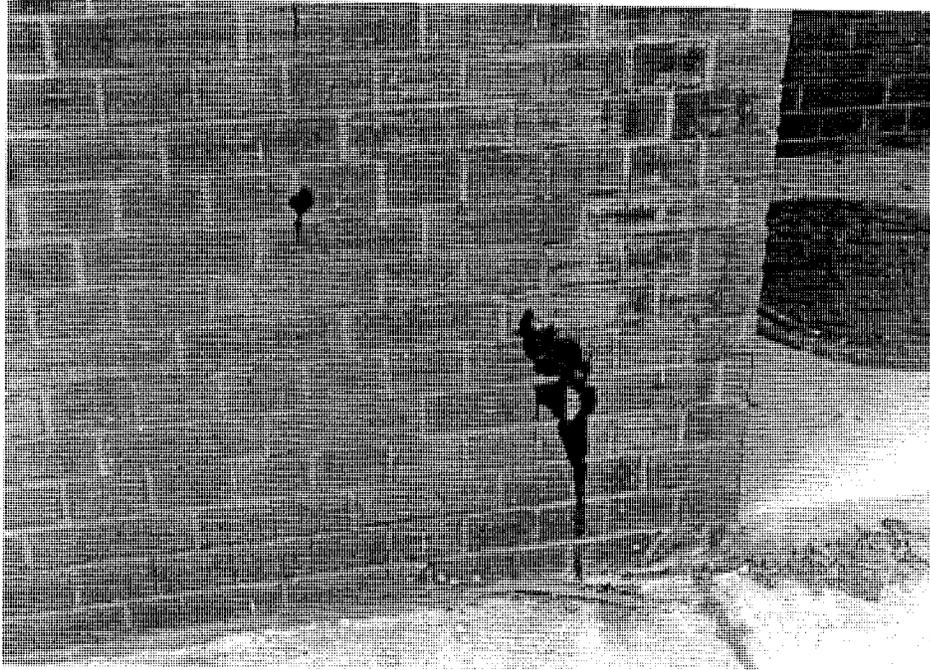
Figure 3-3

Location: North Elevation of Building 3 near West Pavilion

Cause of Problem: Poorly executed maintenance procedures

Suggested Remedy: Remove with solvent poultice (details are discussed in Chapter VIII. *Materials Cleaning Analysis*)

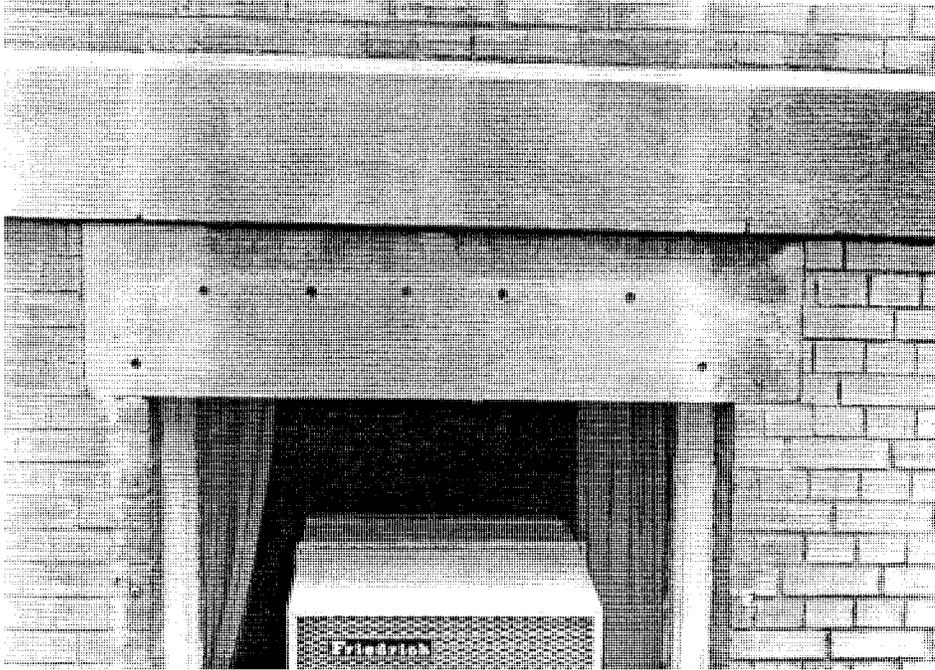
Figure 3-4

Location: South Elevation of Building 3 on East Pavilion

Cause of Problem: Installation of window grates

Suggested Remedy: Remove inserts and fill all holes

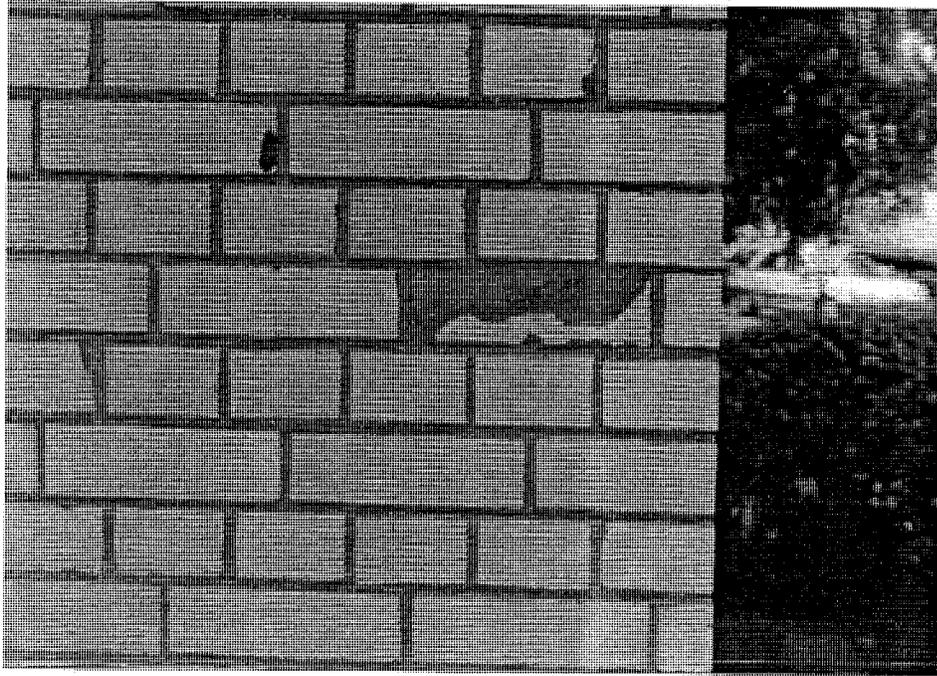
Figure 3-5

The white glazed brick, like the buff brick, is selectively damaged but to a much lesser extent (Figure 3-5). The areas of loss comprise about twenty percent of the total surface area of this brick.

Location: East Elevation of Building 3 on West Pavilion

Cause of Problem: Unknown but may be freezing water or impact damage

Suggested Remedy: Replace with matching brick and mortar

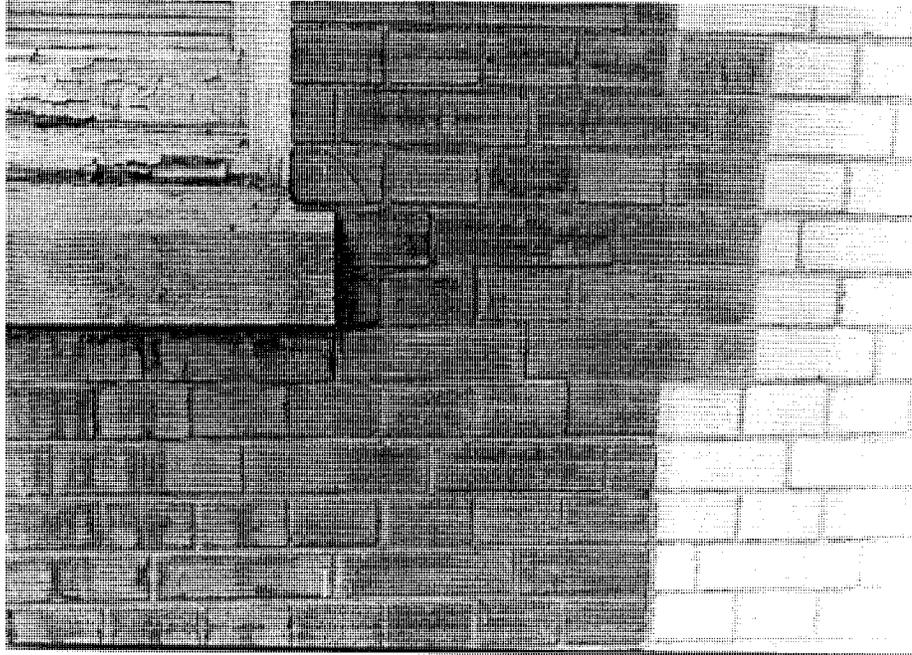
Figure 3-6

Stress cracks and open joints are found on Building 3 in association with the vertical or head joints of the limestone water table (Figure 3-6). Stress cracks and open joints have been caulked

Location: East Elevation of Building 3 on East Pavilion

Cause of Problem: Freezing water in open joints and/or rusting of iron anchors

Suggested Remedy: Remove brickwork and assess for rusting iron anchors. If anchors are rusted they should be replaced with stainless steel anchors; brick should then be replaced to match existing texture, color and size and reset in mortar to match surrounding pointing in color, texture, and profile.

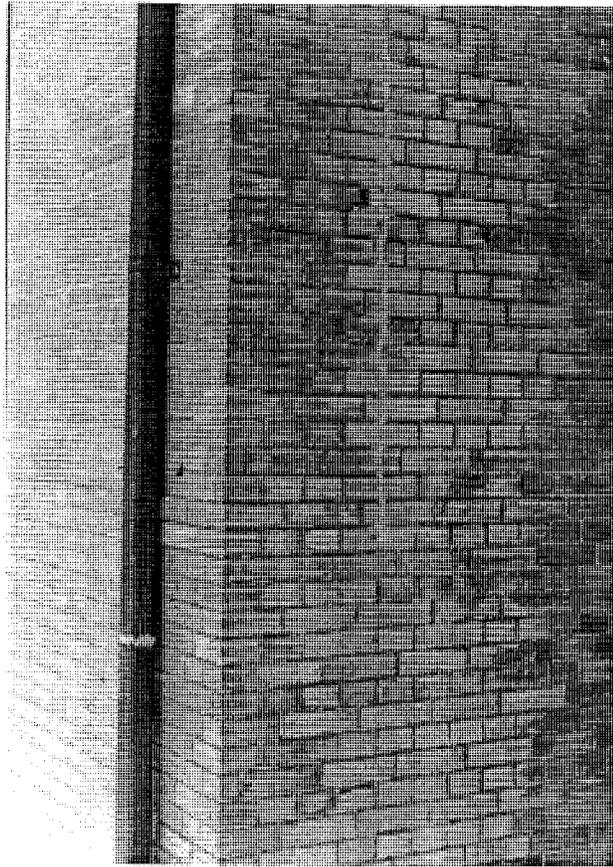
Figure 3-7

Location: South Elevation of Building 3 at West Corner

Cause of Problem: Unknown but possibly differential heat stress

Suggested Remedy: Remove brickwork and replaced to match existing texture, color and size and reset in mortar to match surrounding pointing in color, texture, and profile

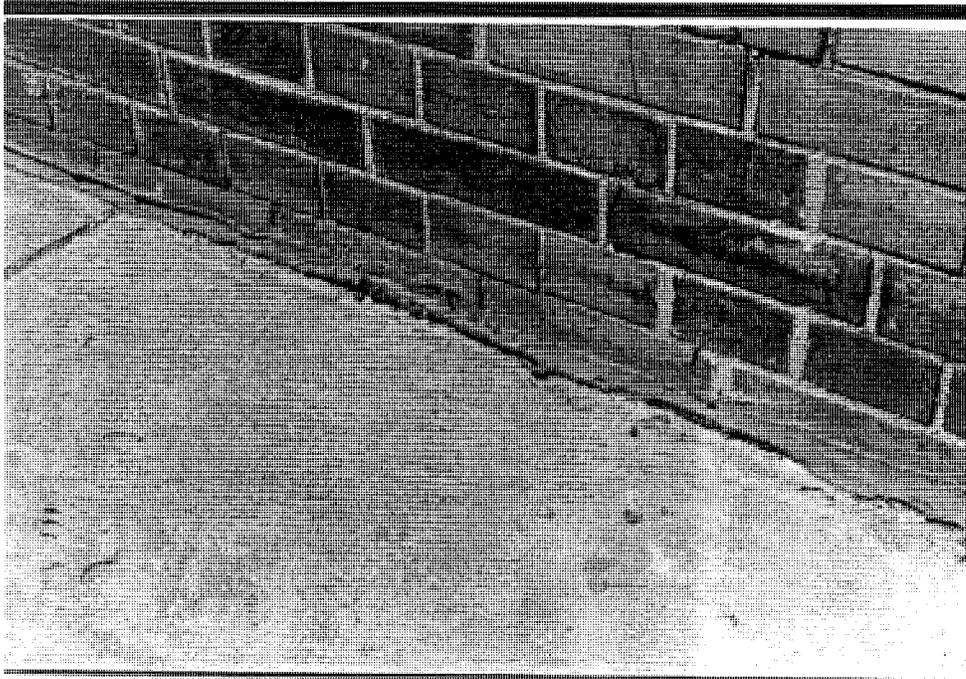
Figure 3-8

at the basement level (Figure 3-7). Caulk repairs are also seen at grade for open joints between brick and concrete sidewalks (Figure 3-8).

Location: East Elevation West Pavilion on North Side of Building 3

Cause of Problem: Improper maintenance

Suggested Remedy: Remove caulk and repoint with mortar

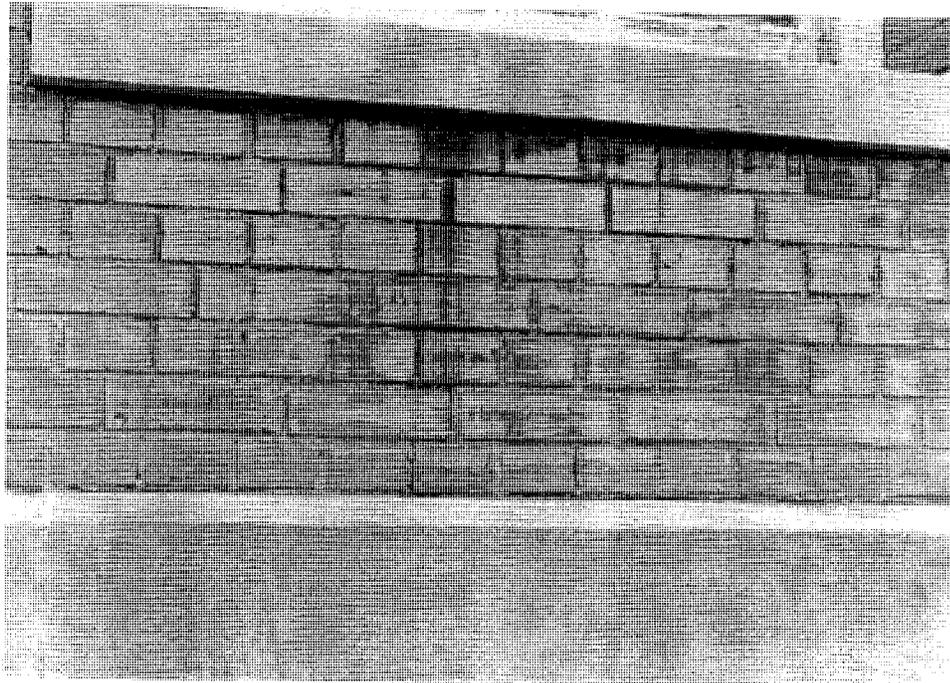
Figure 3-9

Location: South Elevation of Building on East Pavilion

Cause of Problem: Atmospheric pollution

Suggested Remedy: Water misting cleaning (for details see Chapter VIII. *Materials Cleaning Analysis*)

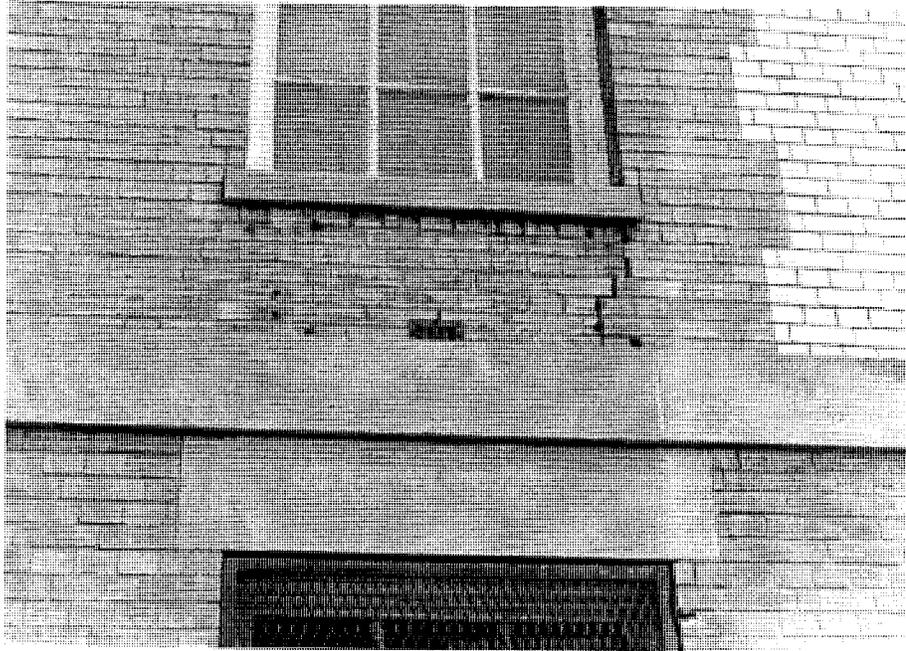
Figure 3-10

Location: South Elevation of Building 3 on West Pavilion

Cause of Problem: Freezing water in open joints and/or rusting iron anchors in window sills.

Suggested Remedy: Remove brickwork and assess for rusting iron anchors. If anchors are rusted they should be replaced with stainless steel anchors; brick should then be replaced to match existing texture, color and size and reset in mortar to match surrounding pointing in color, texture, and profile.

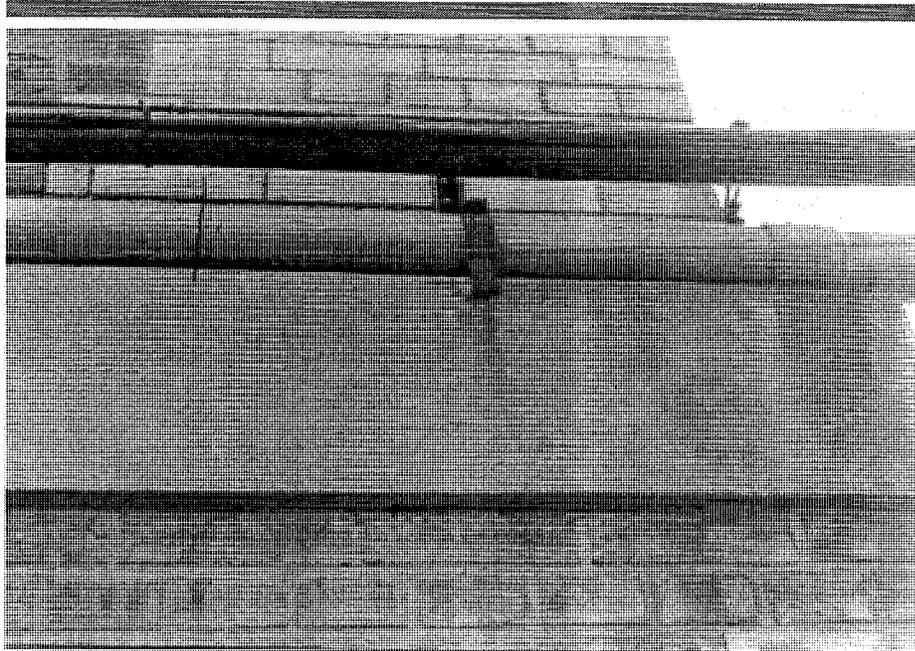
Figure 3-11

Metal brackets supporting the power lines have rusted and stained the limestone water table (Figure 3-11). In addition, the window air conditioning units have stained this water table as well as some of the limestone window sills (Figure 3-12). During the most recent campaign of repainting of the woodwork, paint has been splattered on the limestone elements. Limestone elements near parking areas or areas of vehicular exhibit percussive damage (Figure 3-13).

Location: North Elevation of Building 3 on West Pavilion

Cause of Problem: Rusting iron attachments

Suggested Remedy: Remove stain with iron poultice (scrape and paint iron elements)

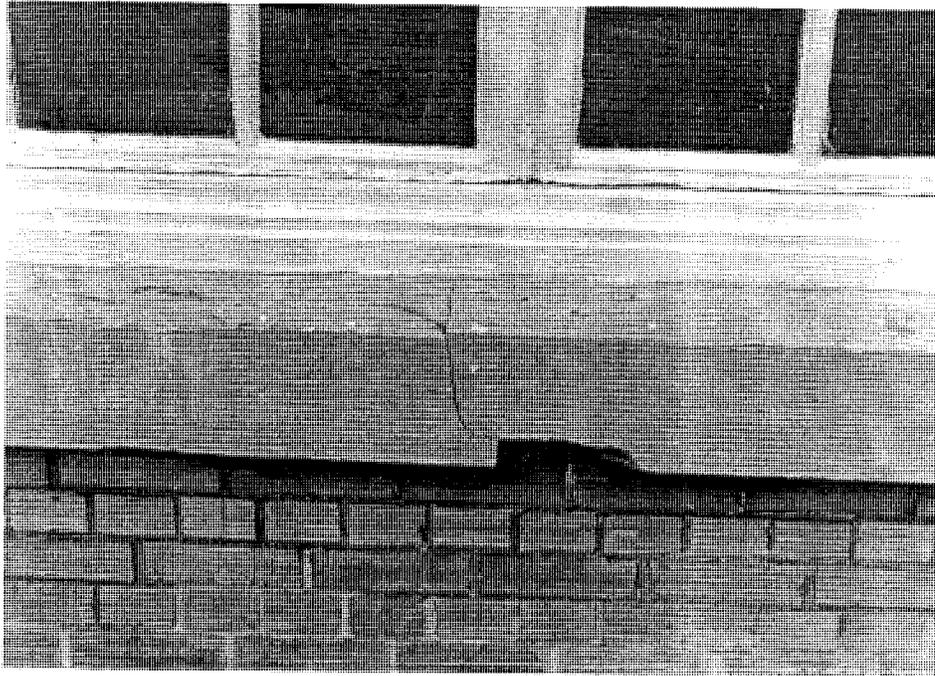
Figure 3-12

Location: West Elevation of Breezeway between Buildings 3 & 4

Cause of Problem: Impact from vehicles

Suggested Remedy: Repair with patching mortar

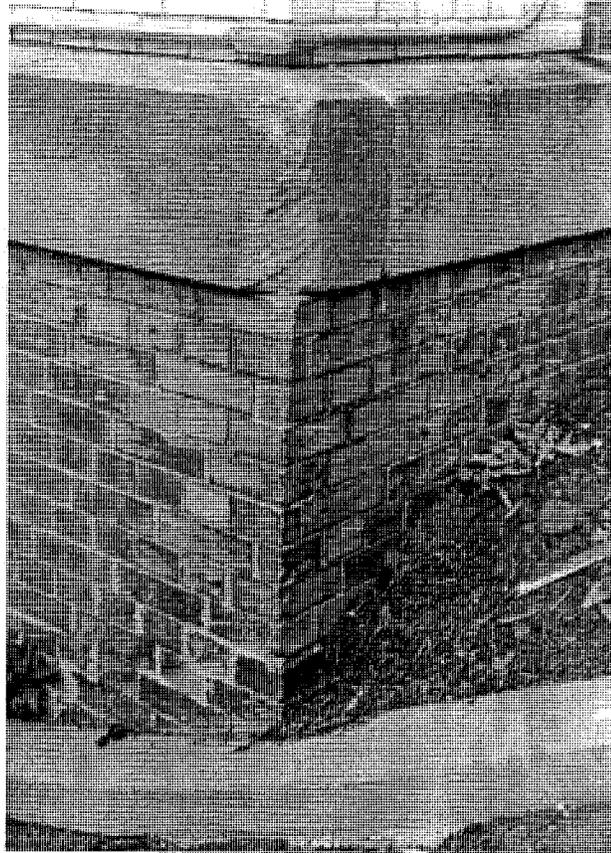
Figure 3-13

Location: East Elevation of Building 3 on South Corner of East Pavilion

Cause of Problem: Impact from vehicles

Suggested Remedy: Repair with patching mortar

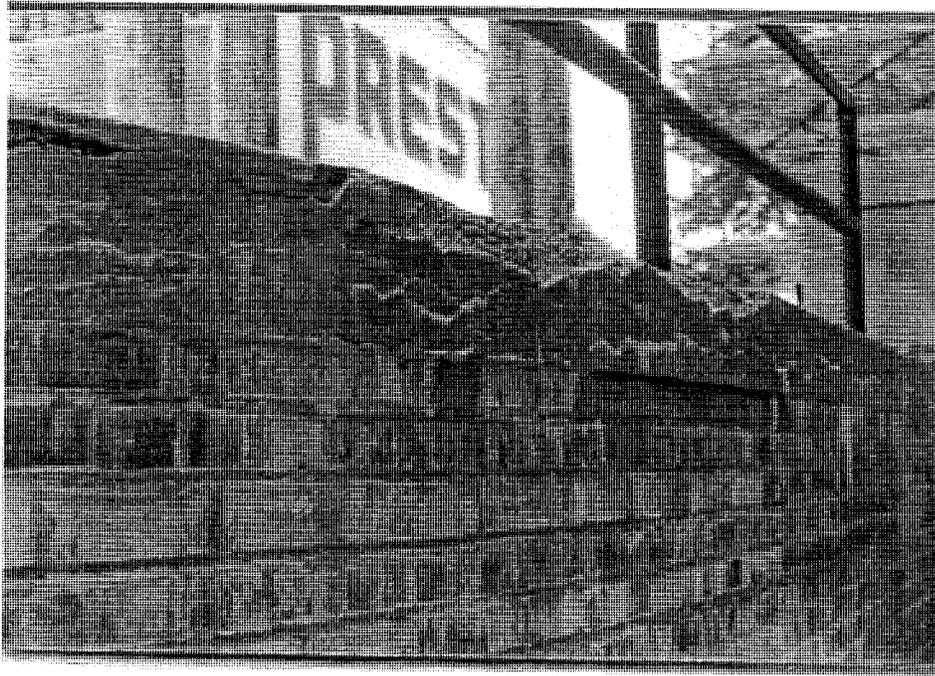
Figure 3-15

Location: North Elevation of Building 3 in Central Areaway

Cause of Problem: Water infiltration and corroding iron railings

Suggested Remedy: Remove and replace with new concrete

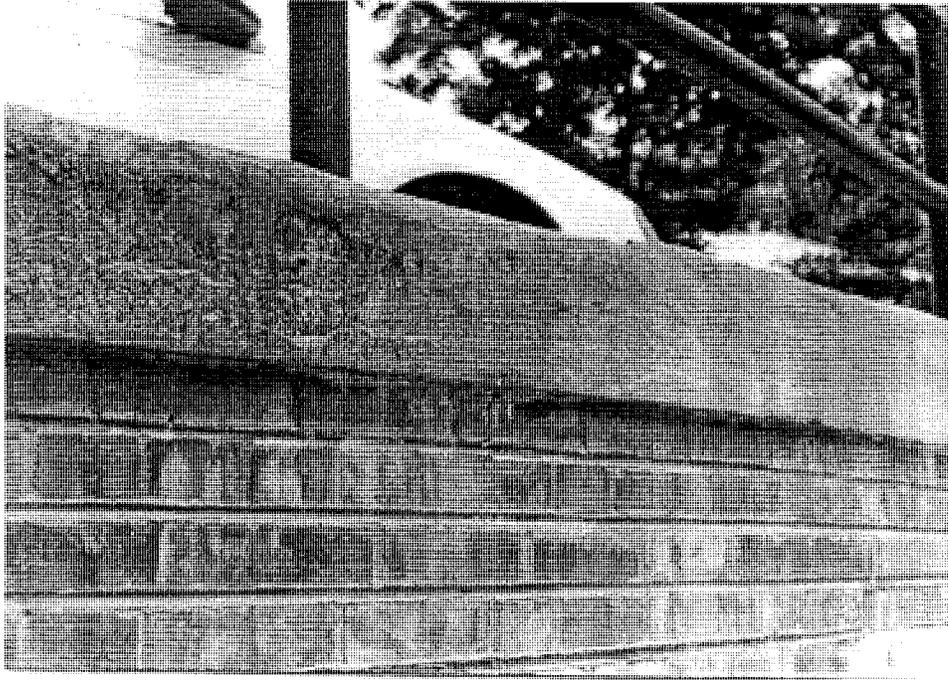
Figure 3-16

Location: North Elevation of Building 3 in Central Areaway

Cause of Problem: Improper and unsightly maintenance procedures

Suggested Remedy: Remove and replace with new concrete

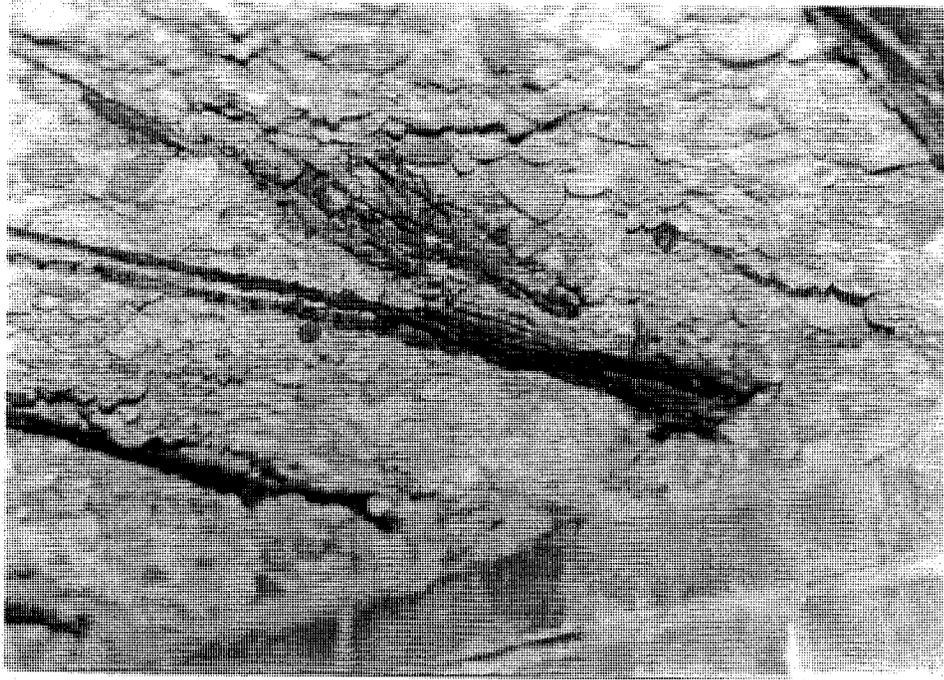
Figure 3-17

Location: North Elevation of Building 3 in Central Areaway

Cause of Problem: Water infiltration

Suggested Remedy: Demolish and rebuild

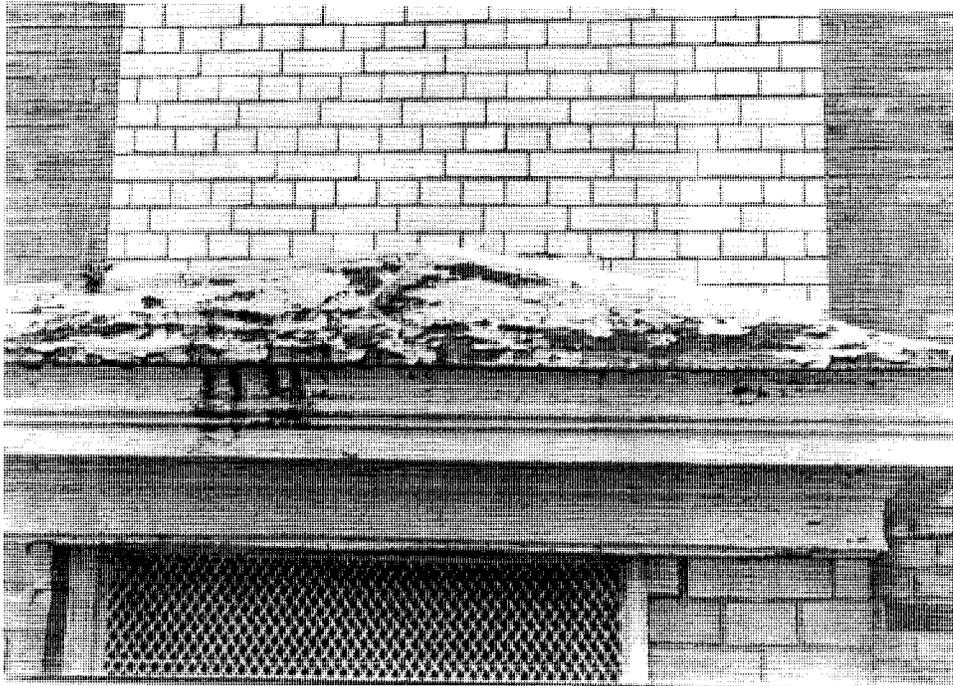
Figure 3-18

Tin roofs which have been painted show extensive loss and lack of adhesion of paint (Figure 3-18).

Location: East Elevation of Building 3 on East Pavilion

Cause of Problem: Inadequate maintenance

Suggested Remedy: Scrape, prime and paint

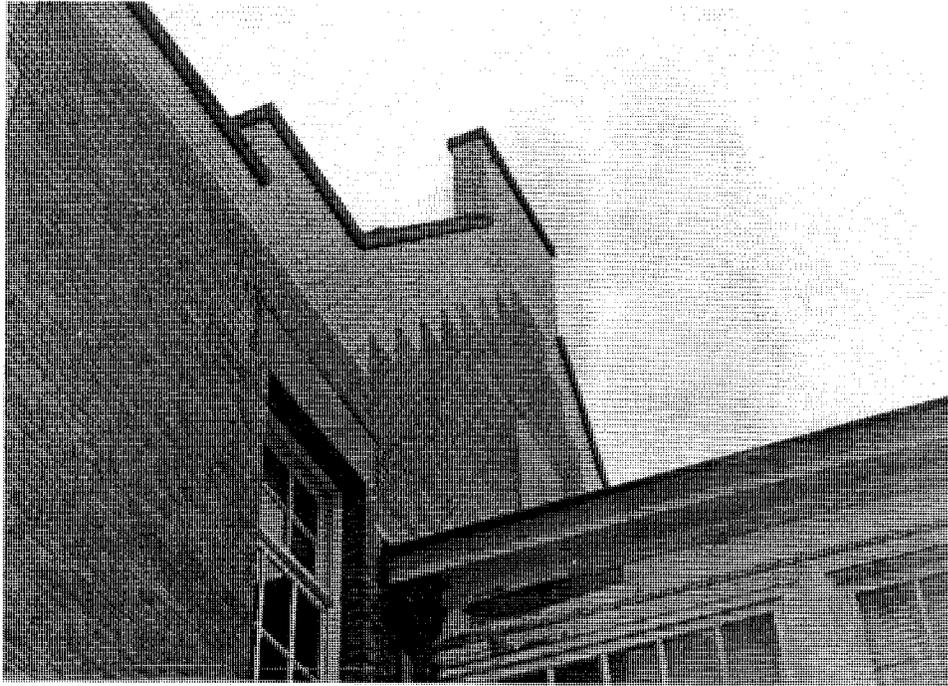
Figure 4-1

The buff brick is soiled moderately and selectively giving it a mottled appearance (Figure 4-1). This brick exhibits a crazed and cracked outer skin which entraps much of the soiling. Bitumen deposits are found on this brick (Figures 4-2 and 4-3).

Location: East Elevation of East Pavilion on Building 4

Cause of Problem: Atmospheric pollution

Suggested Remedy: The buff brick will not clean by conventional or unconventional methods (see also Chapter VIII).

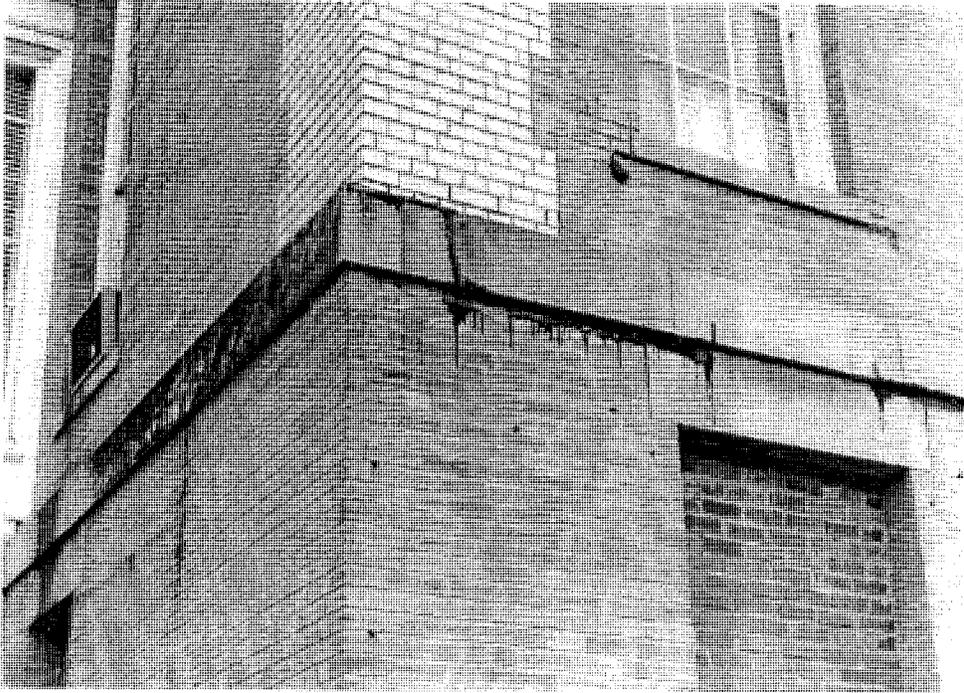
Figure 4-3

Location: South Elevation of Building 4 on East Pavilion

Cause of Problem: Poorly executed maintenance procedures

Suggested Remedy: Remove with solvent poultice (details are discussed in Chapter VIII, *Materials Cleaning Analysis*)

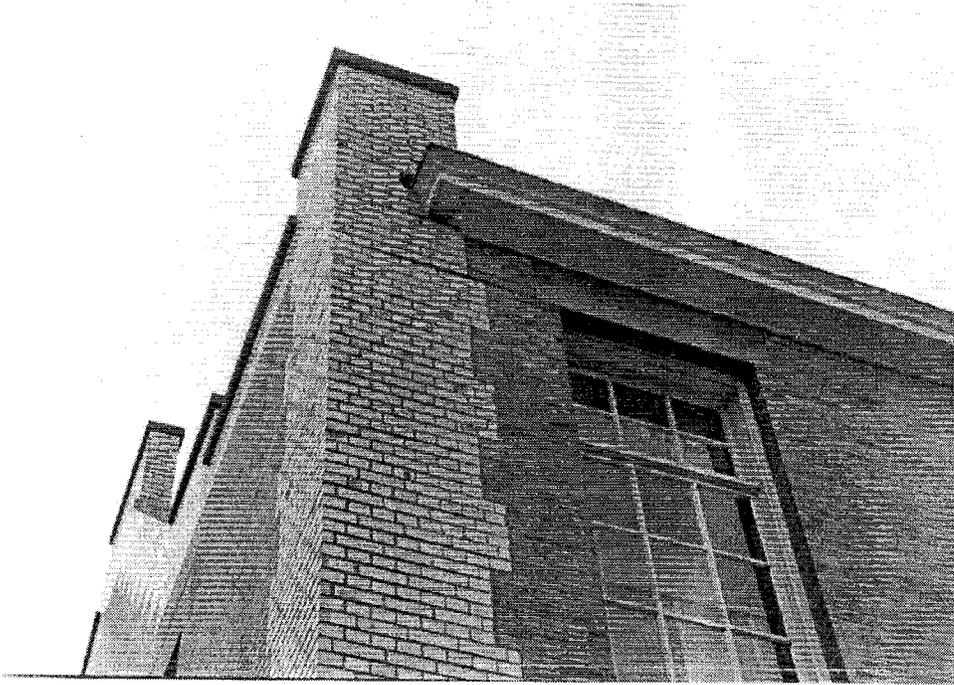
Figure 4-4

The white glazed brick, like the buff brick, is selectively damaged but to a much lesser extent (Figure 4-4). The areas of loss comprise about twenty percent of the total surface area of this brick.

Location: North Elevation of Building 4 on West Pavilion

Cause of Problem: Unknown but possibly freezing water or impact damage

Suggested Remedy: Replace with matching brick and mortar

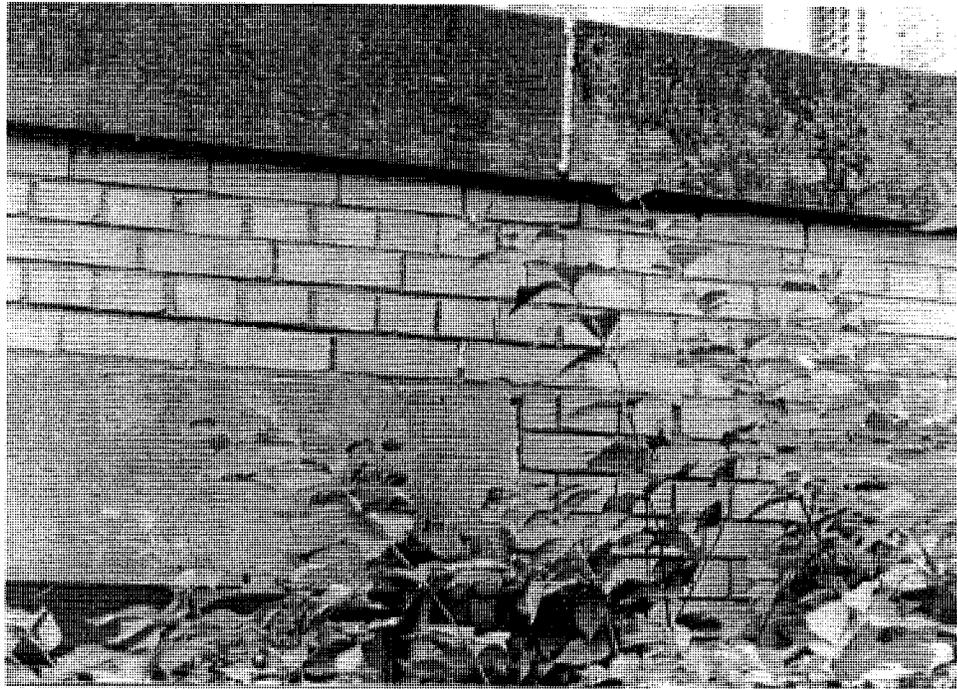
Figure 4-5

Stress cracks and open joints are found on Building 4 in association with the vertical or head joints of the limestone water table in the same way as on Building 3 (Figure 4-5).

Location: East Elevation of East Pavilion on Building 4

Cause of Problem: Freezing water in open joints and/or rusting of iron anchors

Suggested Remedy: Remove brickwork and assess for rusting iron anchors. If anchors are rusted they should be replaced with stainless steel anchors; brick should then be replaced to match existing texture, color and size and reset in mortar to match surrounding pointing in color, texture, and profile.

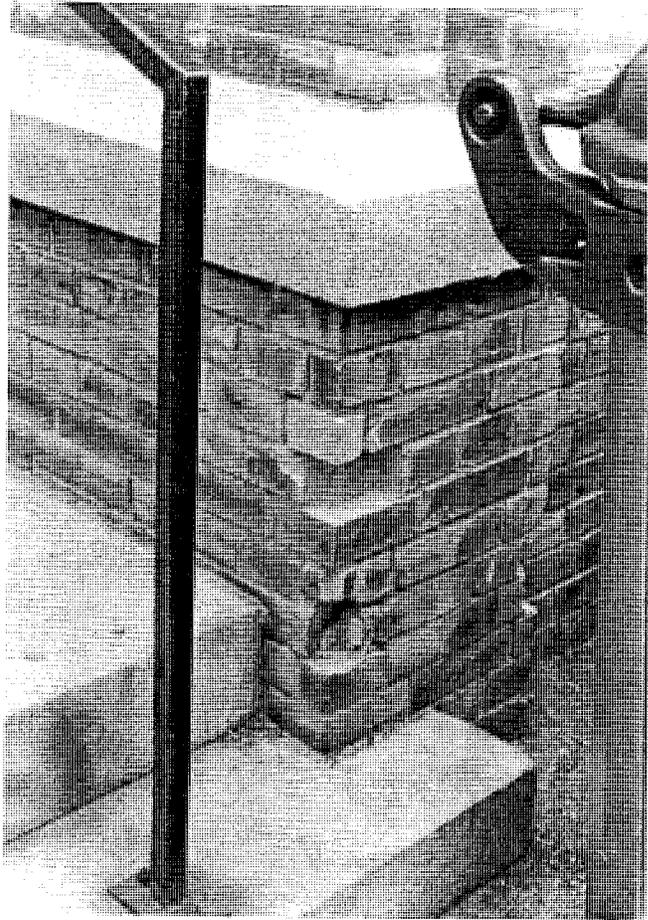
Figure 4-6

Brick has been dislodged and broken by impact at entryways (Figure 4-6).

Location: East Elevation of Building 3 on East Pavilion

Cause of Problem: Vehicular impact

Suggested Remedy: Remove damaged; brick should then be replaced to match existing texture, color and size and reset in mortar to match surrounding pointing in color, texture, and profile

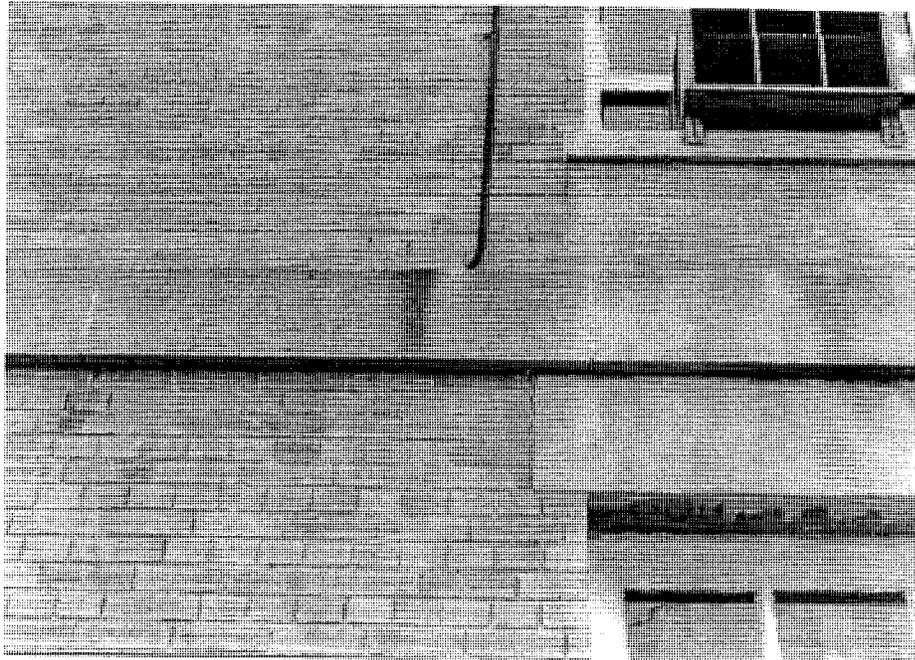
Figure 4-7

Location: North Elevation of Building 4 on West Pavilion

Cause of Problem: Atmospheric pollution

Suggested Remedy: Water misting cleaning (for details see Chapter VIII. *Materials Cleaning Analysis*)

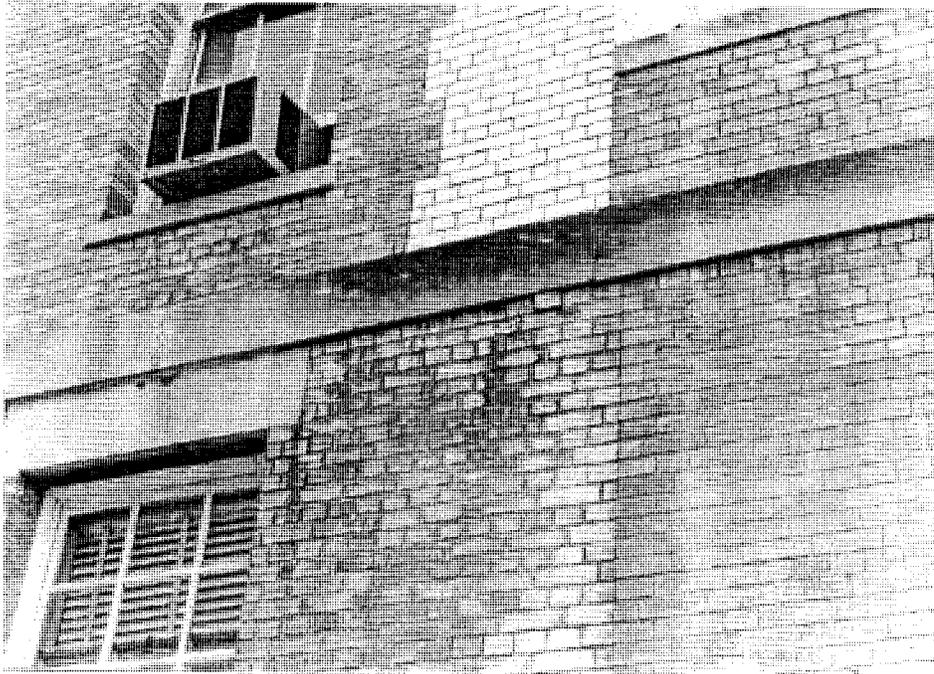
Figure 4-8

Limestone is used for capstones on the raked cornices, parapet walls, keystone and some window lintels, sills and belt courses (or water tables) on Building 4. All of these limestone elements shows signs of loss, but do not suffer from active granular disintegration or stress cracking. The light build up of gypsum and flyash appears to be confined to the window lintels and keystone and sills (Figure 4-7). The head joints in the water table and the joints of most of the limestone elements are open or have been repointed with visually or physically incompatible materials. Limestone elements are often soiled with biological growth (Figure 4-8).

Location: West Elevation of Building 4

Cause of Problem: Slow drying and overhanging trees

Suggested Remedy: Clean with power wash and detergent (for details see Chapter VIII. *Materials Cleaning Analysis*)

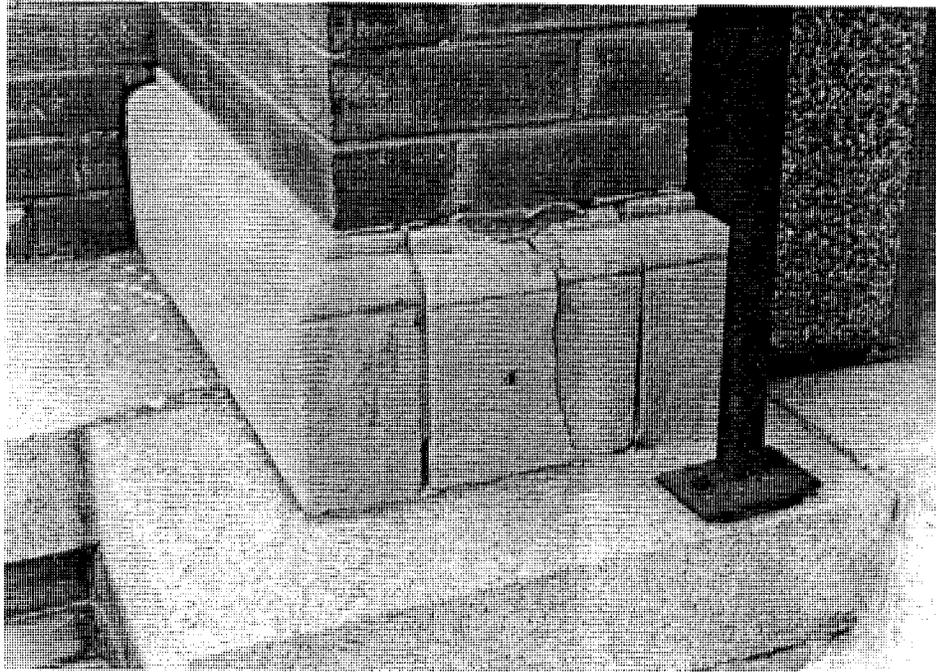
Figure 4-9

Damage has occurred to limestone elements both by impact from vehicles and by corrosion of iron anchors (Figures 4-9, 4-10, 4-11, 4-12). (Vehicular impact has also displaced granite capstones and corrosion has also cracked some nearby bricks.) Some previous repairs to limestone are unsightly (Figure 4-13).

Location: West Elevation of Building 4 on South Portico

Cause of Problem: Impact damage or corrosion of iron anchors

Suggested Remedy: Remove damaged limestone and assess anchors; replace with stainless steel if corroded and replace limestone with dutchman

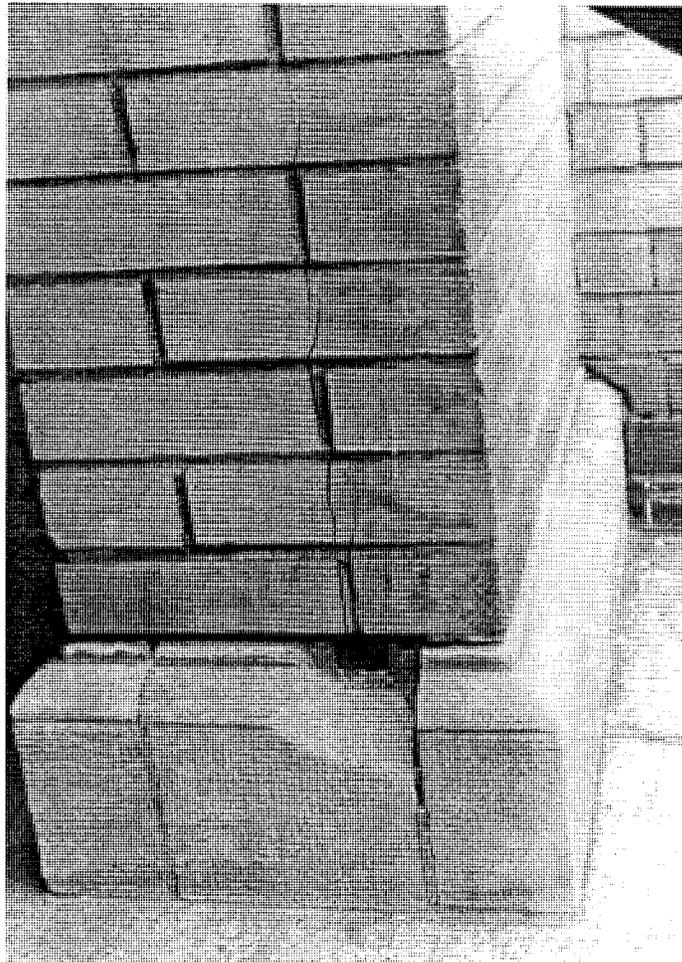
Figure 4-10

Location: South Elevation of Building 4 on South Portico

Cause of Problem: Corrosion of iron anchors

Suggested Remedy: Replace anchors with stainless steel and replace limestone with dutchman

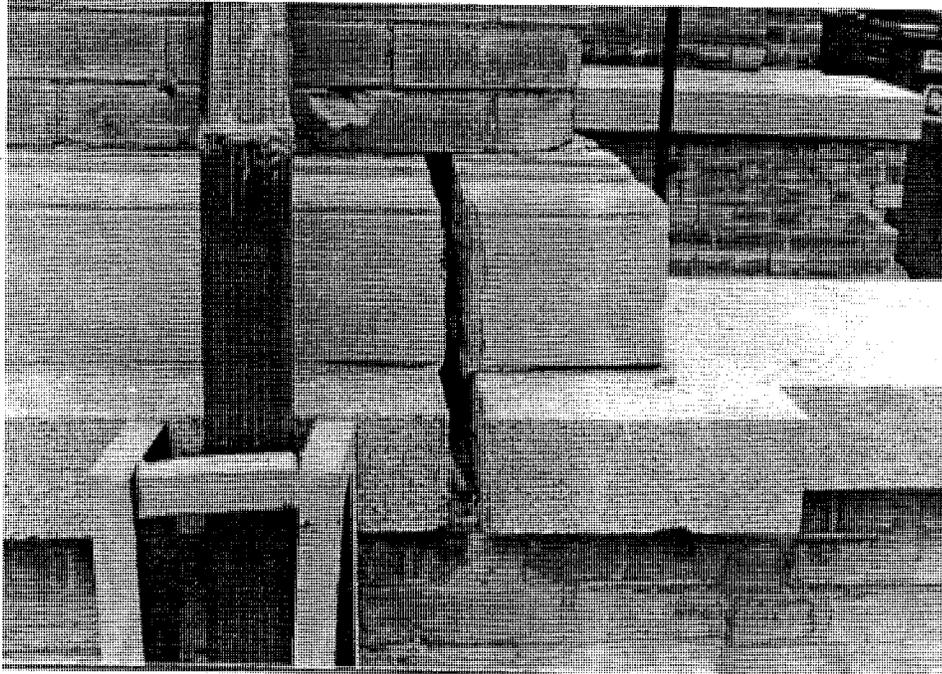
Figure 4-11

Location: South Elevation of Building 4 on South Portico

Cause of Problem: Vehicular impact

Suggested Remedy: Replace limestone with dutchman

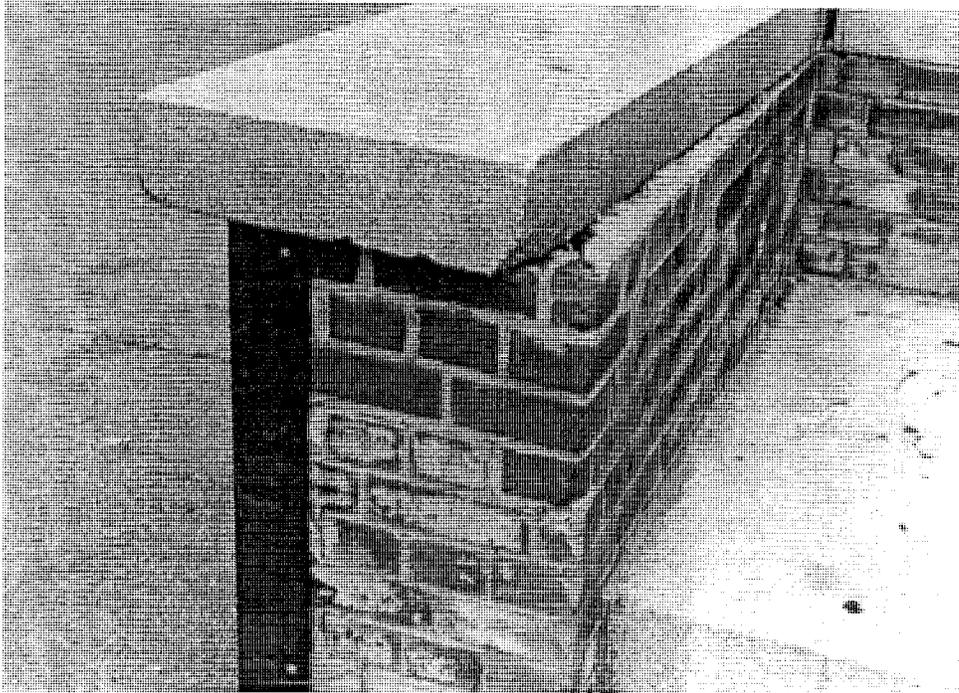
Figure 4-12

Location: South Elevation of Building 4 on South Portico

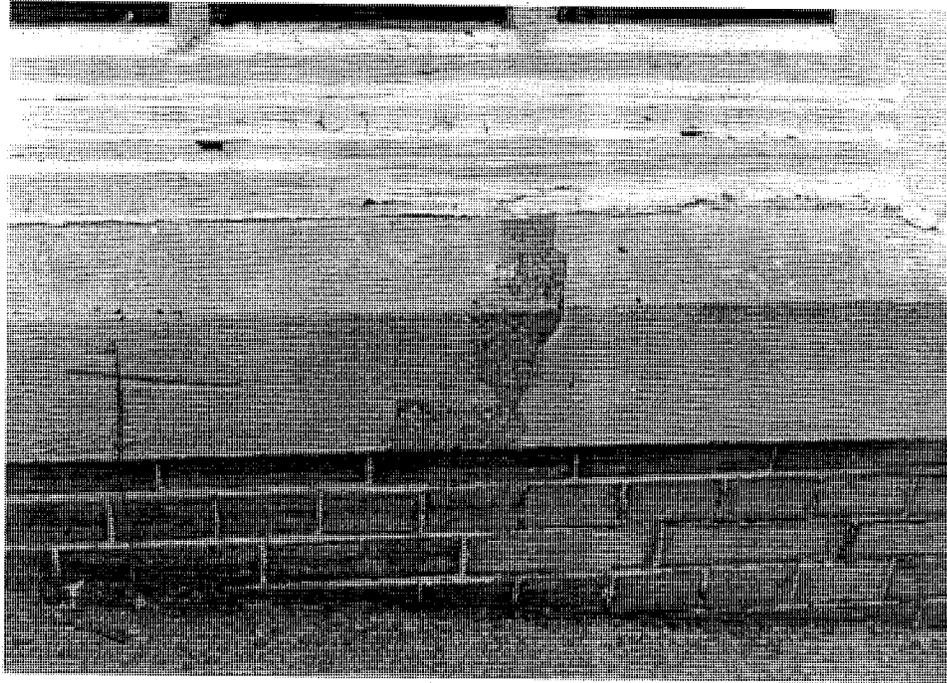
Figure 4-13

Location: West Elevation of Breezeway between Buildings 3 and 4

Problem: Damaged and repaired limestone

Cause of Problem: Improper choice of materials

Suggested Remedy: Remove and replace with better matching patching mortar

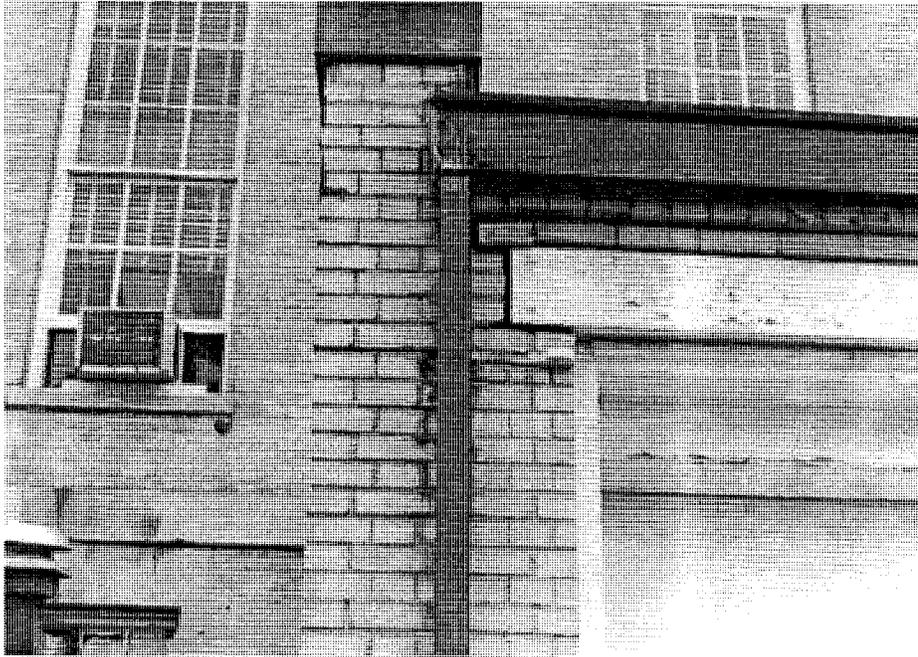
Figure 4-14

Location: South Elevation of Building 4 on Garage of East Pavilion

Cause of Problem: Water infiltration from poorly functioning gutter and leader

Suggested Remedy: Clear gutters and leaders; reset brick with proper mortar
