Potomac Annex:  
Buildings 1 & 3-7

Historic Structures Report, Corrected Final Submission  
 General Services Administration Project Control Number: 44007  
 September 9, 1997  
 VOLUME 2 OF 2

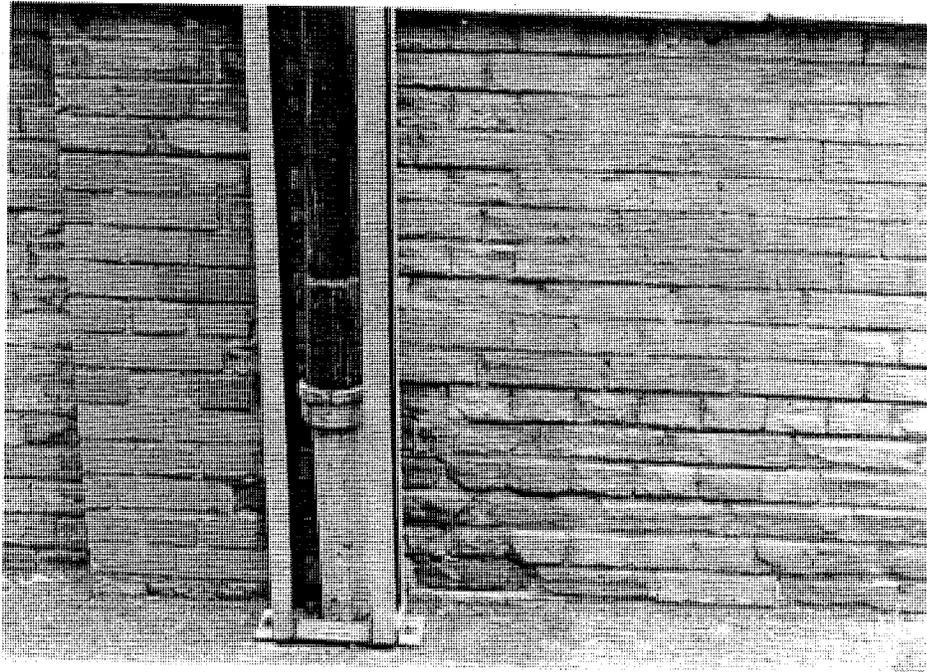
Figure 4-15

Location: South Elevation of Building 4 on South Portico

Problem: Damaged brick

Cause of Problem: Water infiltration from poorly functioning leader

Suggested Remedy: Clear leader

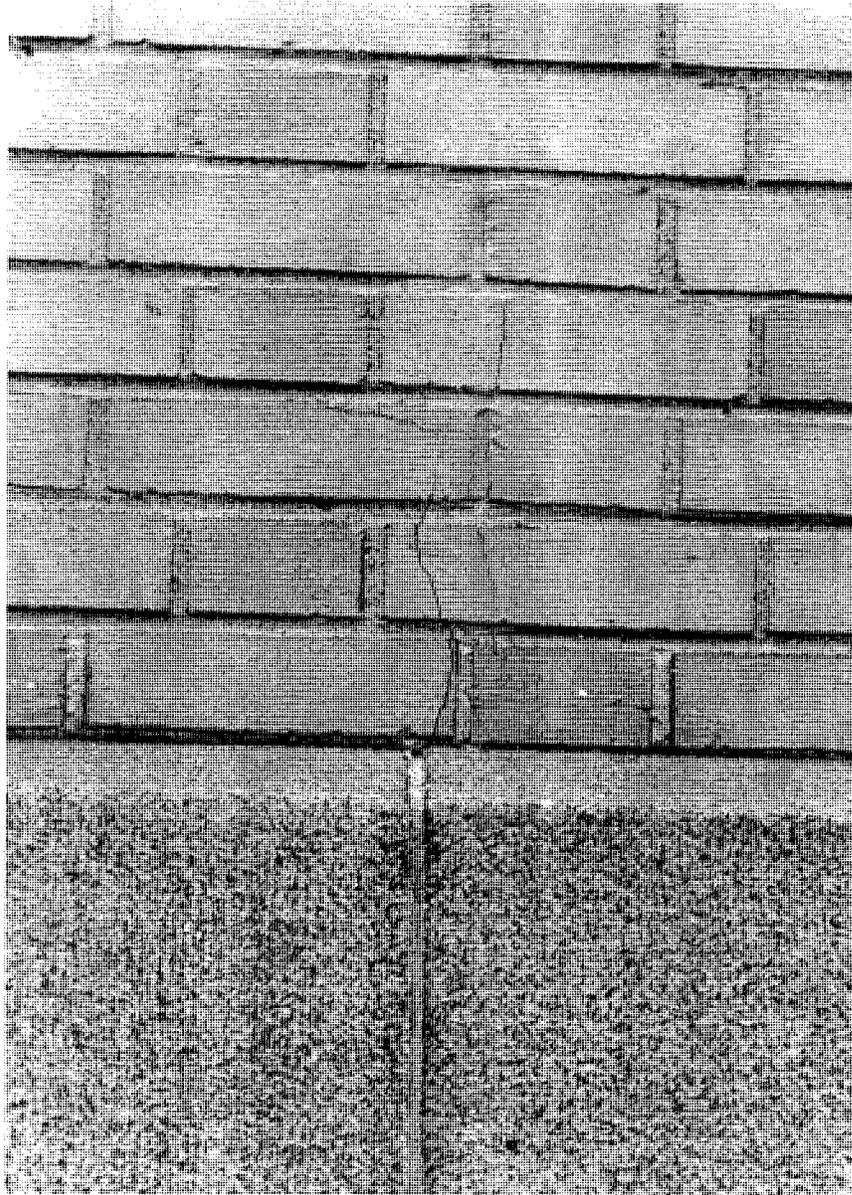
Figure 5-1

Location: North Elevation of Building 5 near West End

Problem: Stress cracks in brick and open mortar joints

Cause of Problem: Freezing water in open joints of water table and/or rusting iron anchors in window lintels and sills.

Suggested Remedy: Remove brickwork and assess for rusting iron anchors. If anchors are rusted they should be replaced with stainless steel anchors; brick should then be replaced to match existing texture, color and size and reset in mortar to match surrounding pointing in color, texture, and profile.

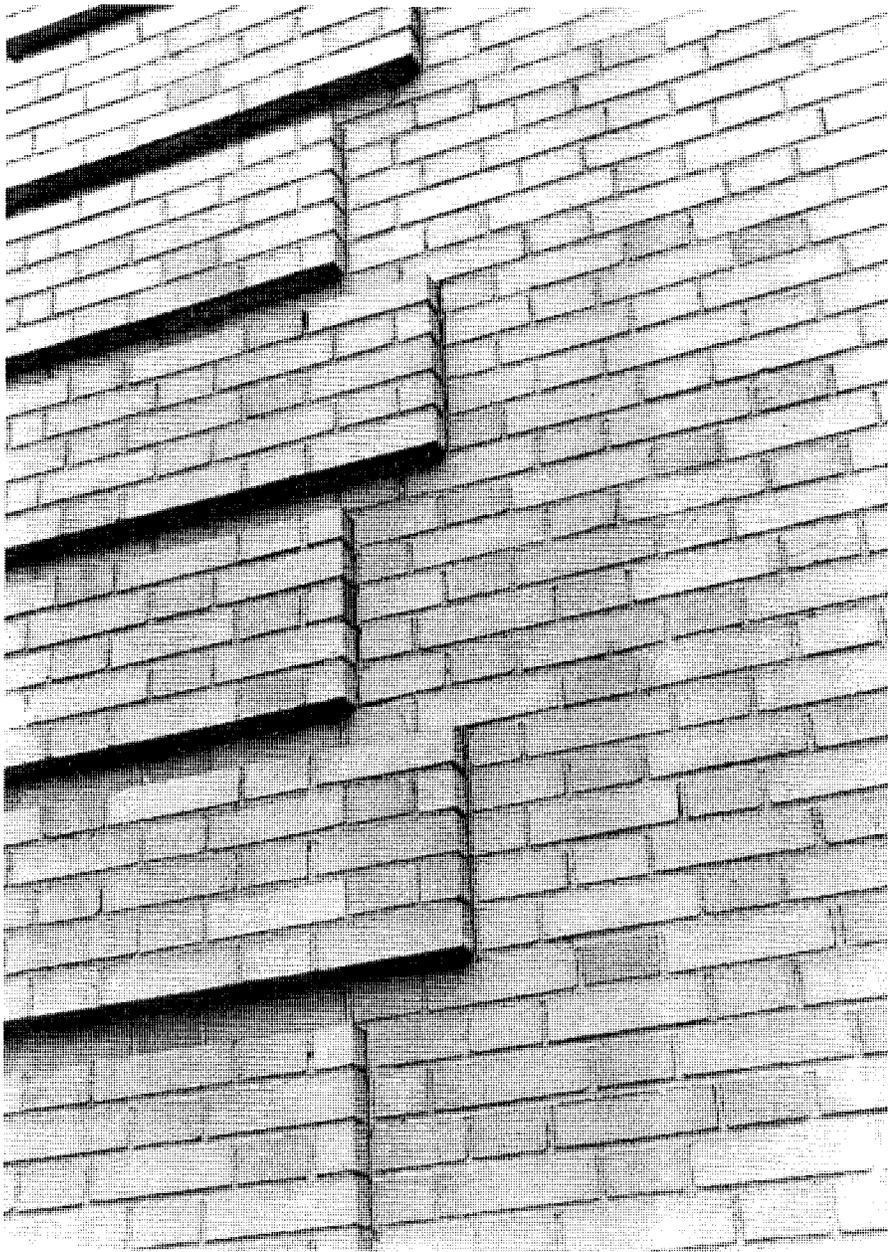
Figure 5-2

Location: East Elevation of Building 5 near South End

Cause of Problem: Freezing water in joints

Suggested Remedy: cut and point joints

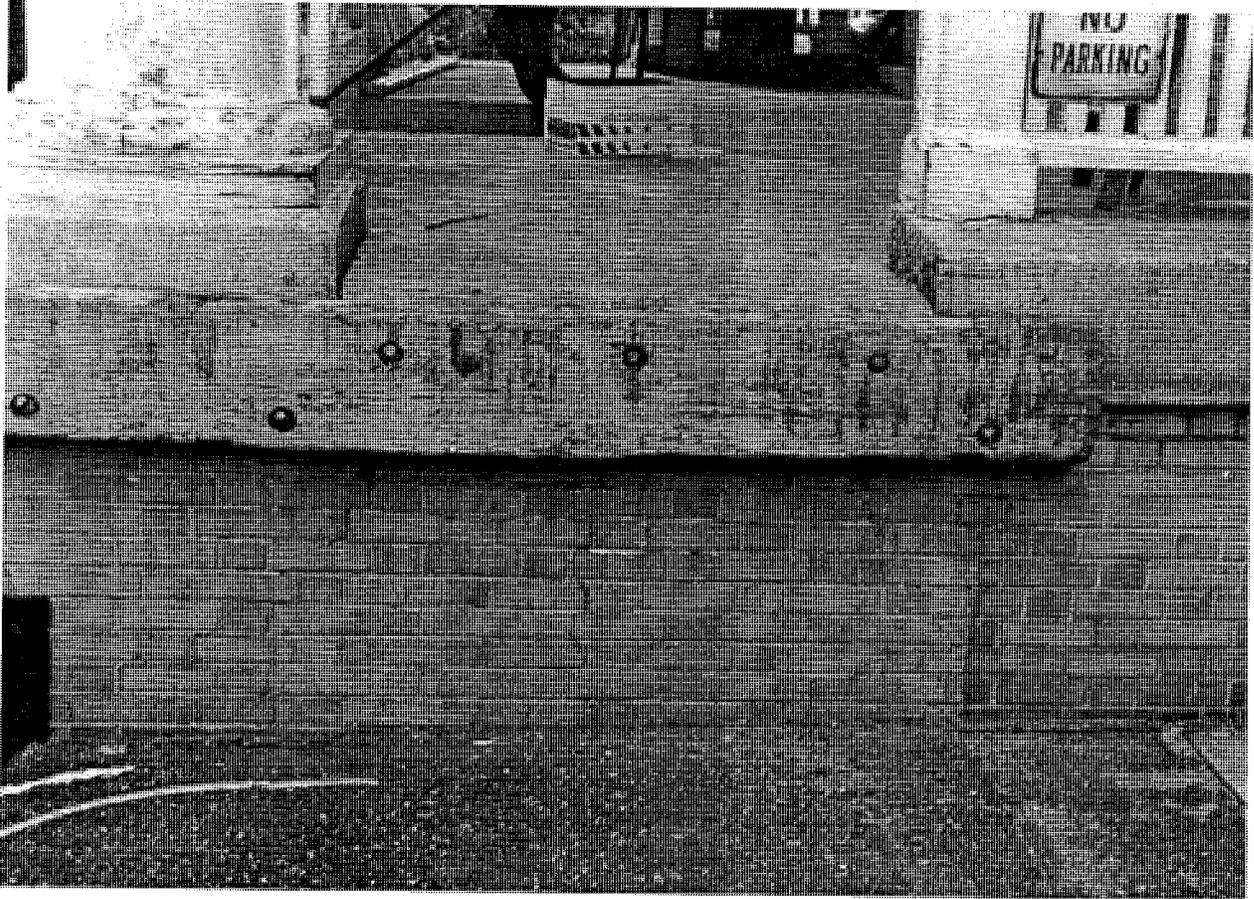
Figure 5-3

Location: North Elevation of Building 5 at West End of Porch

Problem: Open mortar joints and stress cracks in brick

Cause of Problem: Freezing water in joints; impact damage

Suggested Remedy: Brick should be removed and then replaced to match existing texture, color and size and reset in mortar to match surrounding pointing in color, texture, and profile

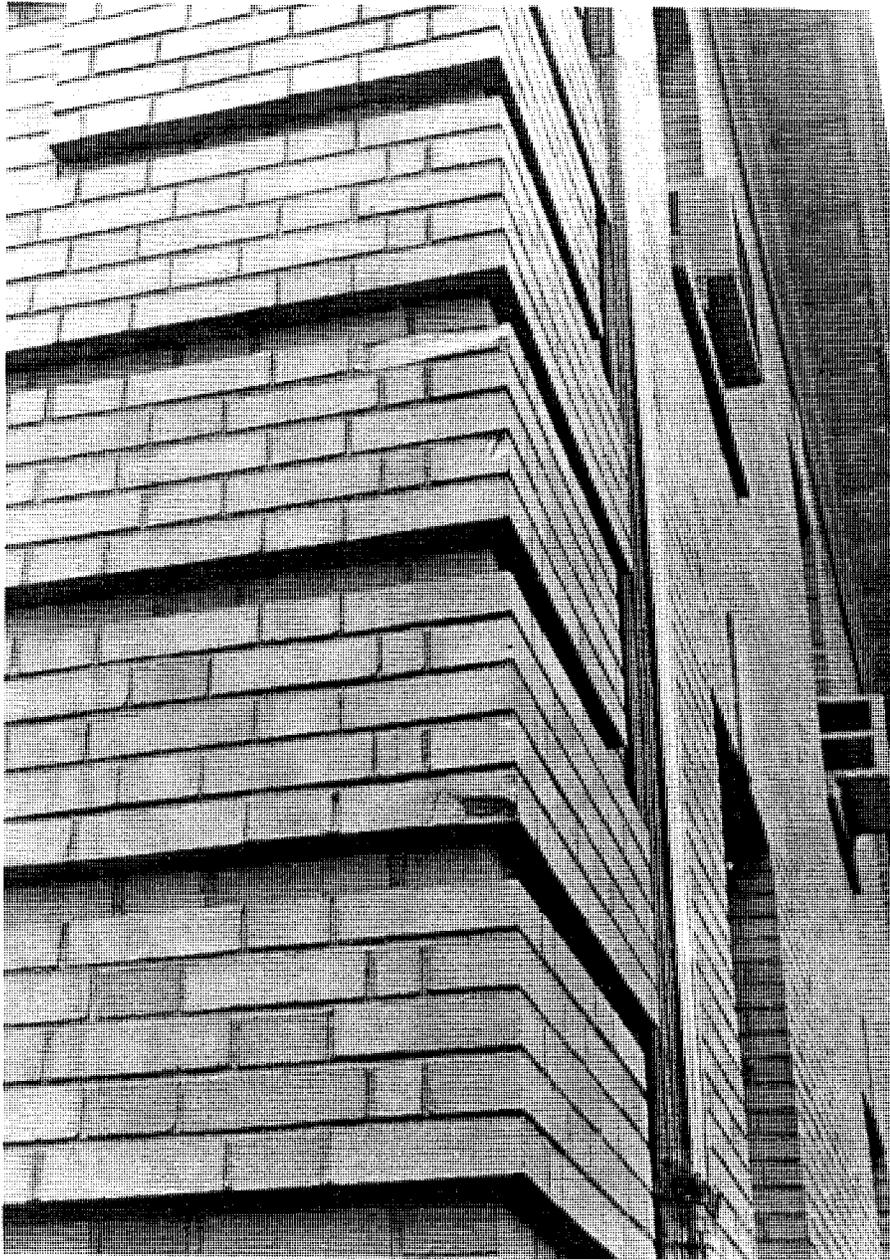
Figure 5-4

The northwest corner of Building 5 has damaged brick. (Figure 5-4).

Location: Northwest Corner of Building 5

Problem: Damage brick

Cause of Problem: Unknown but perhaps impact damage

Suggested Remedy: Brick should be removed and then replaced to match existing texture, color and size and reset in mortar to match surrounding pointing in color, texture, and profile

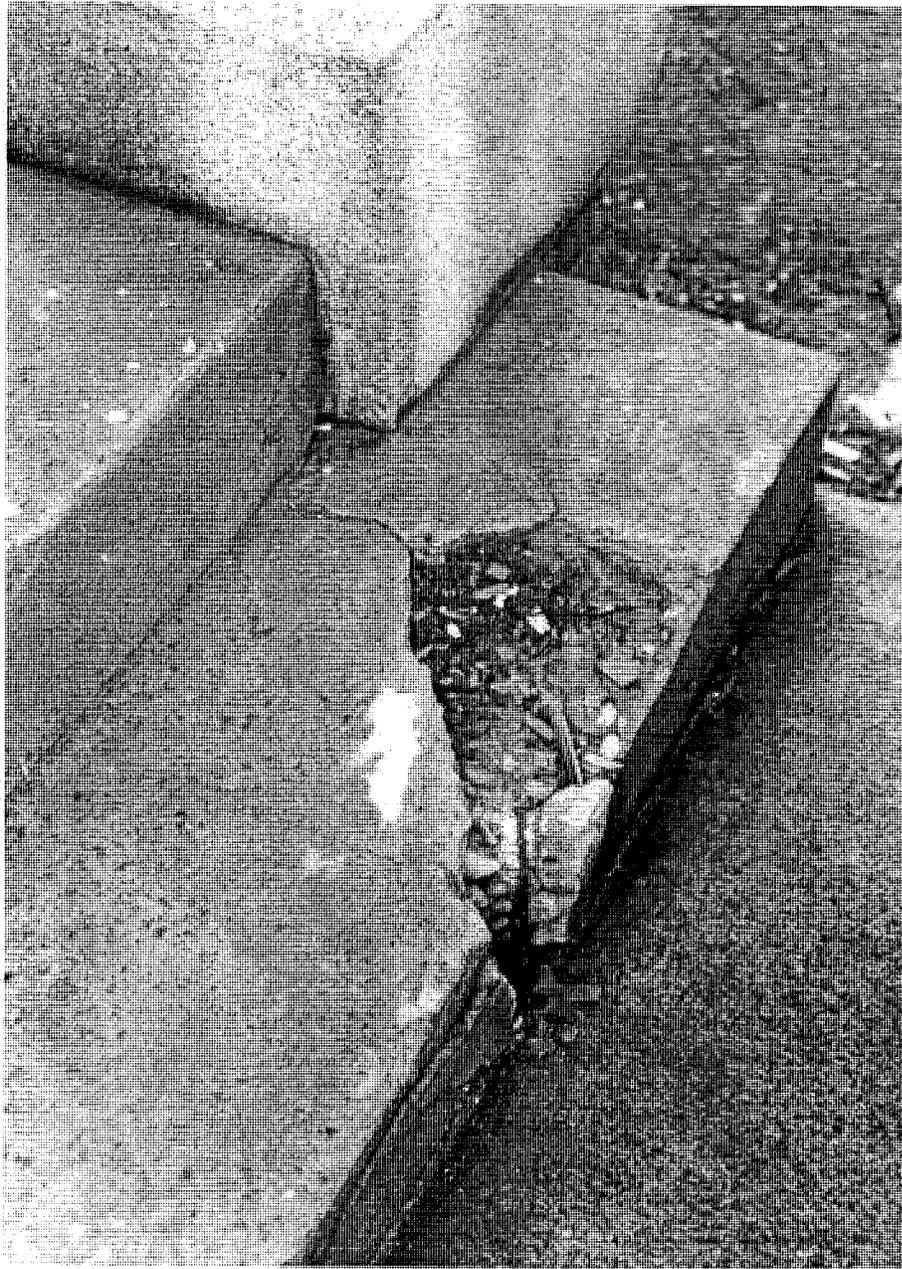
Figure 5-5

Location: West Elevation of Building 5 at Central Entryway

Problem: Damaged concrete

Cause of Problem: Water penetration and freezing

Suggested Remedy: Demolish and rebuild

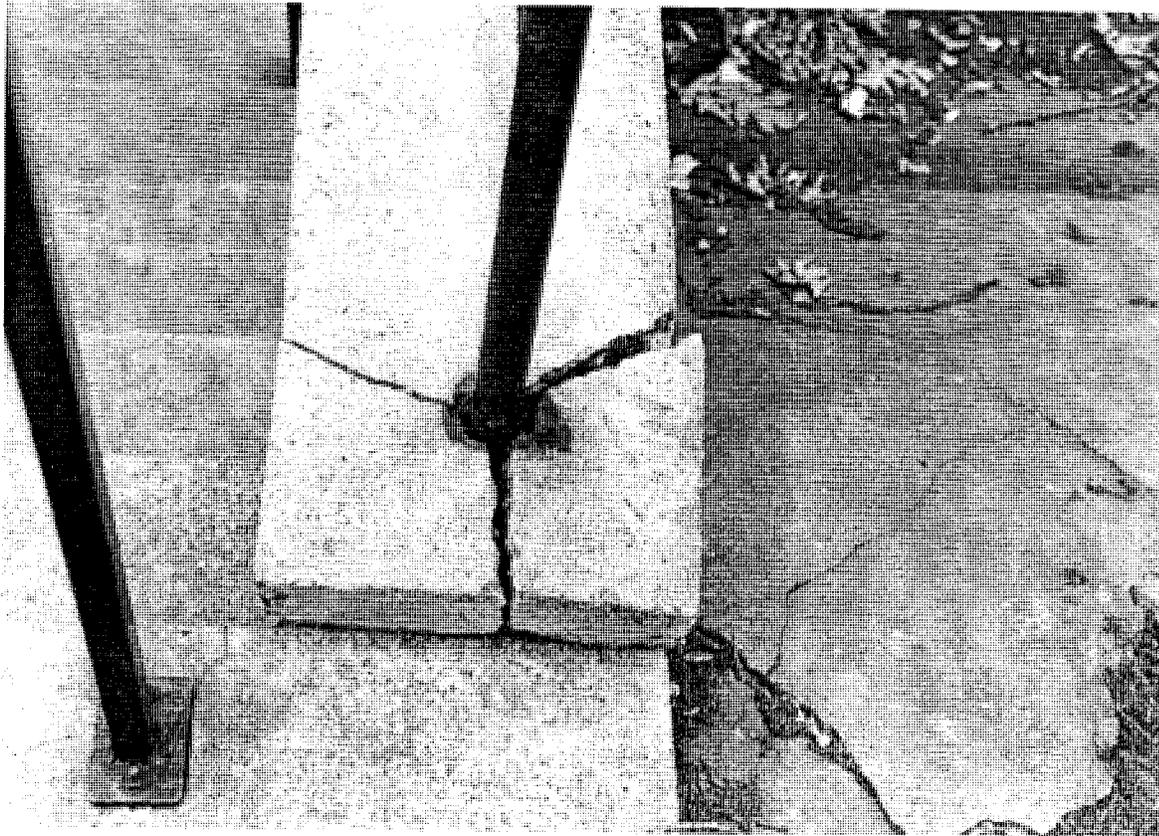
Figure 5-6

Location: West Elevation of Building 5 at Steps to Areaway

Problem: Damaged concrete

Cause of Problem: Water penetration and freezing; rusting of iron railings

Suggested Remedy: Demolish and rebuild

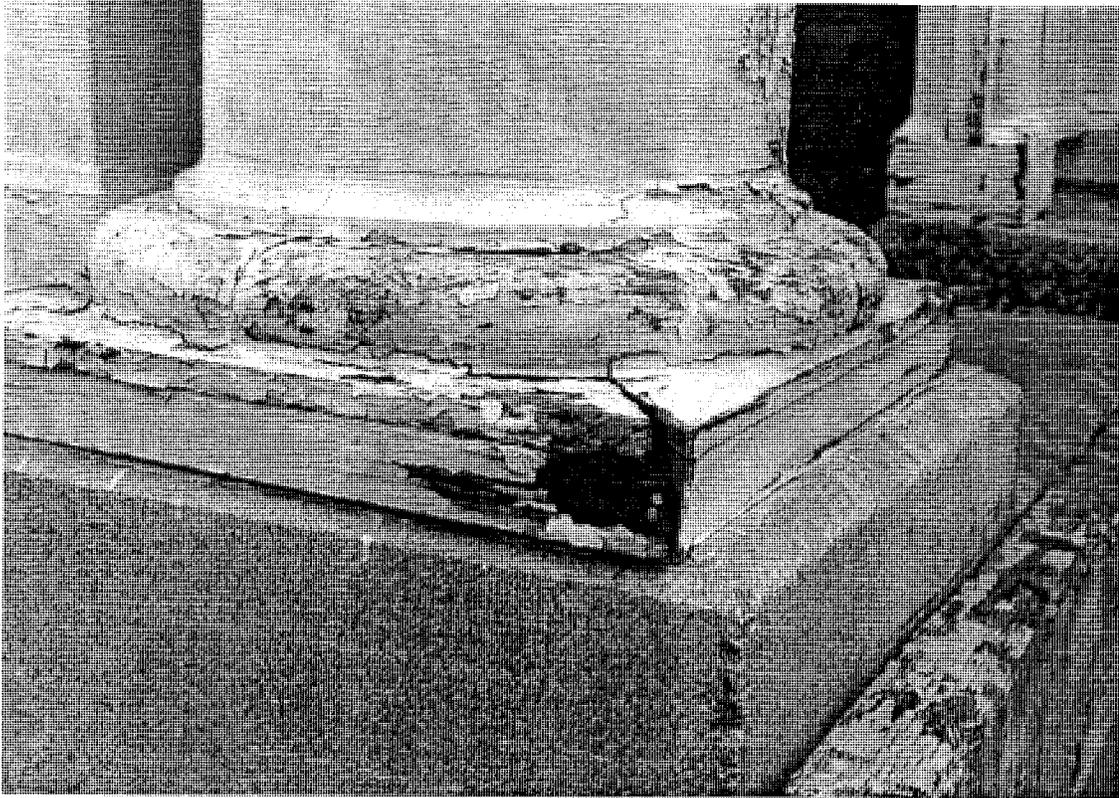
Figure 5-7

Location: North Elevation of Building 5 at Westernmost Column of Portico

Problem: Damaged wooden base

Cause of Problem: Water penetration and poor maintenance

Suggested Remedy: Remove rotted wood and replace with new elements

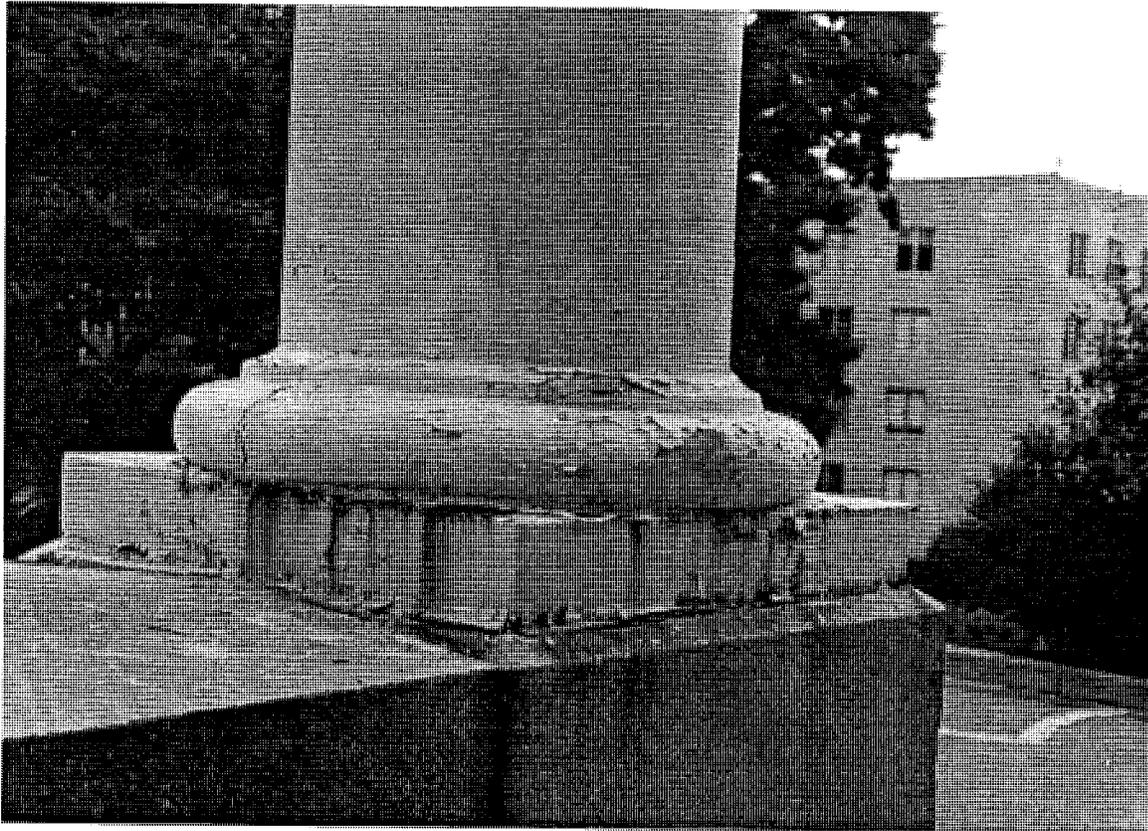
Figure 5-8

Location: North Elevation of Building 5 at Easternmost Column of Portico

Problem: Rusting of column leading to staining of granite

Cause of Problem: Water penetration of paint film and poor maintenance of paint

Suggested Remedy: Scrape and repaint column; poultice iron stain with chelating agent

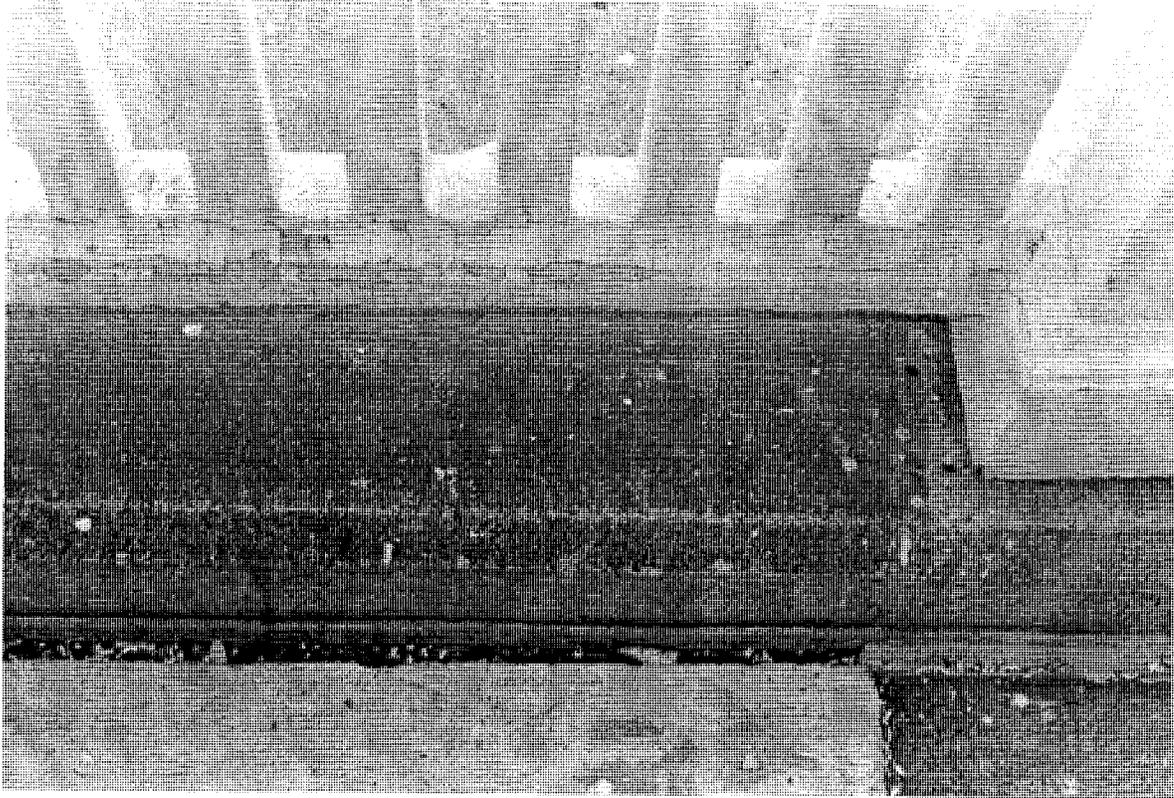
Figure 5-9

Location: North Elevation of Building 5 at Portico Balustrade

Cause of Problem: Atmospheric pollution

Suggested Remedy: Chemical cleaning (see Chapter VIII. Materials Cleaning Analysis for details)

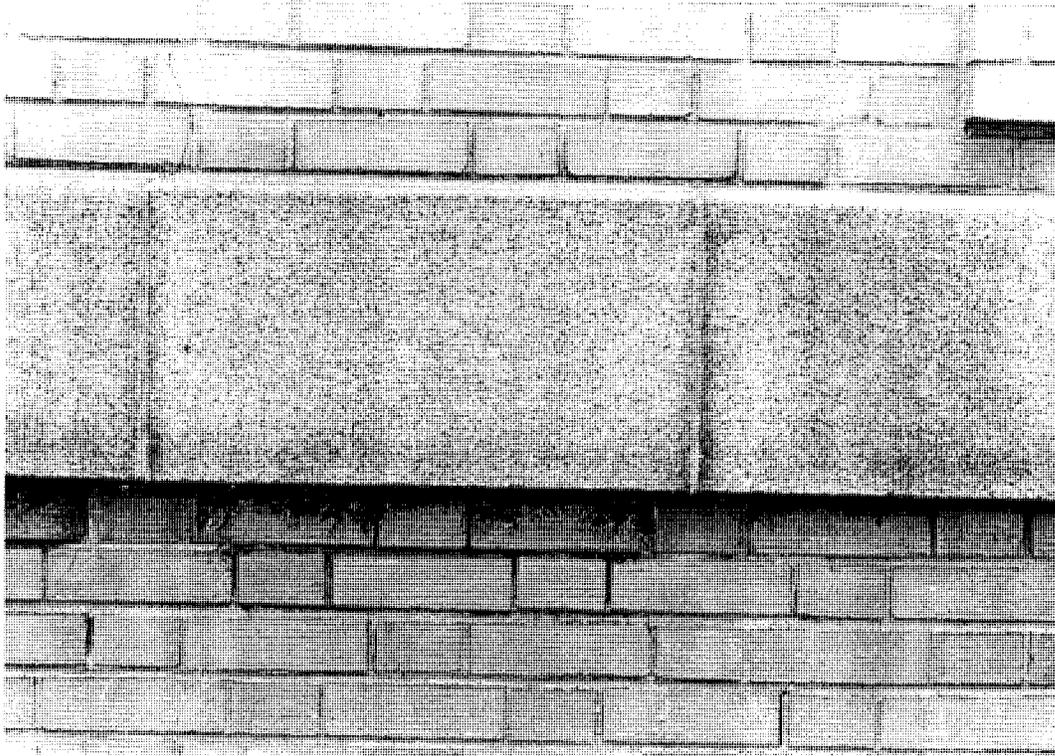
Figure 5-10

Location: North Elevation of Building 5 at West End

Cause of Problem: Susceptibility of vertical joints to water run-off; improper maintenance procedures

Suggested Remedy: Cut and point (see Chapter VII. Mortar Analysis for a discussion of replacement mortar)

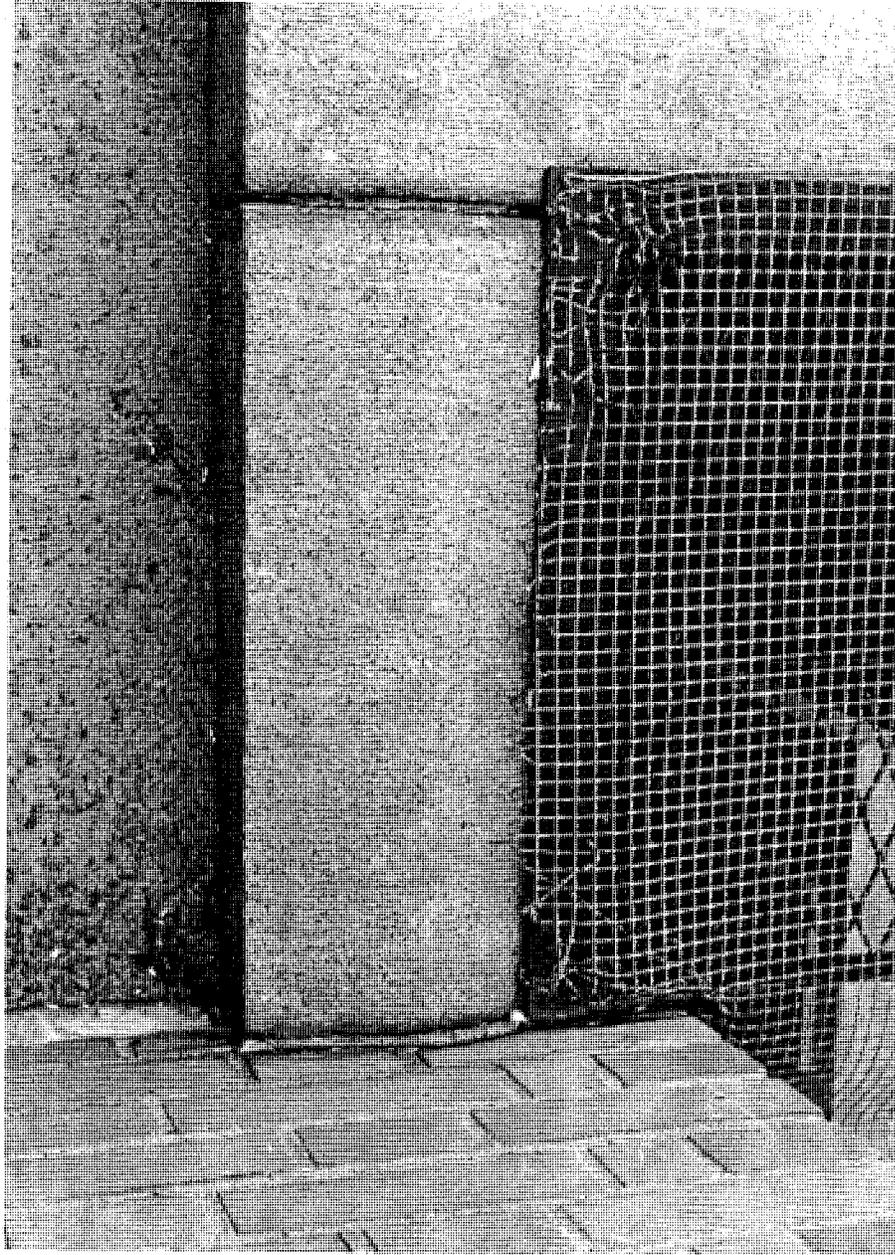
Figure 5-11

Location: West Elevation of Building 5 at North End

Cause of Problem: Susceptibility of vertical joints to water run-off; improper maintenance procedures

Suggested Remedy: Cut and point (see Chapter VII. Mortar Analysis for a discussion of replacement mortar)

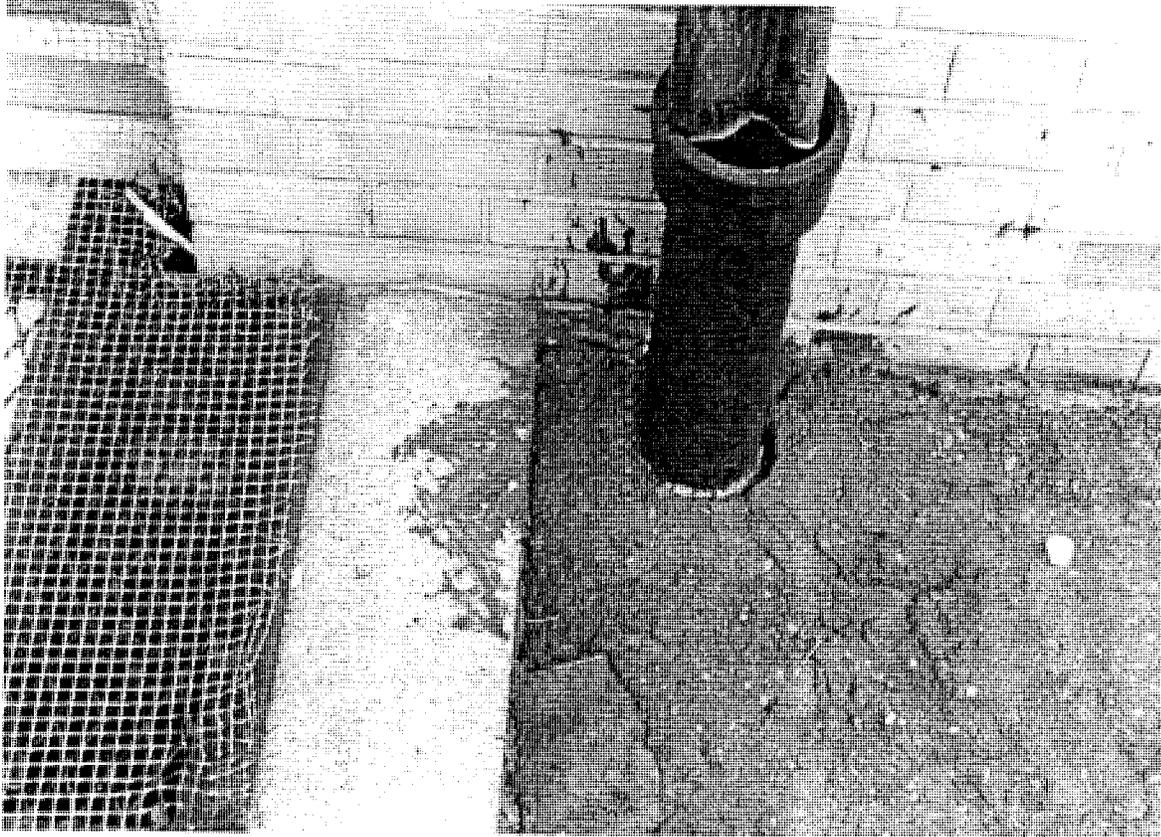
Figure 5-12

Location: West Elevation of Building 5 at North End

Cause of Problem: Sloppy application of waterproofing material for drain

Suggested Remedy: Poultice cleaning with solvent (see Chapter VIII. Materials Cleaning Analysis for details of treatment)

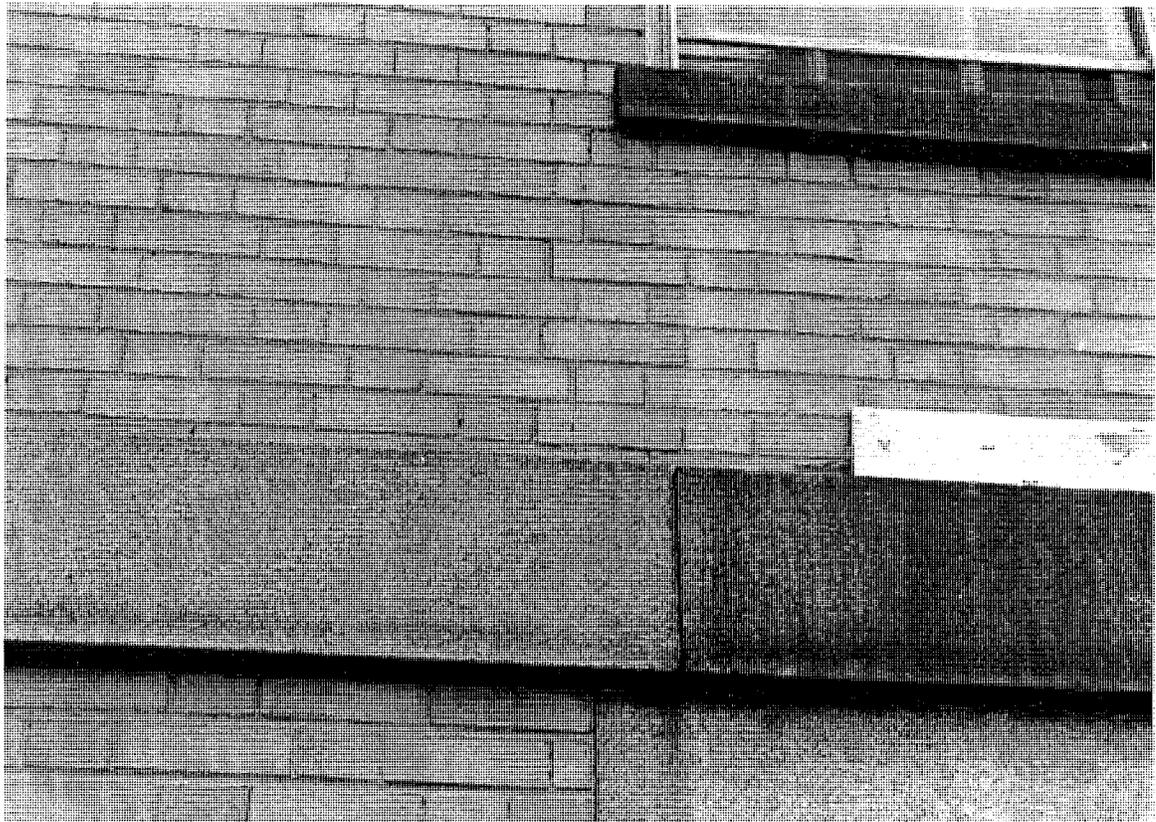
Figure 6-1

Location: North Elevation of Building 6 at West End

Problem: Stress cracks and open mortar joints

Cause of Problem: Freezing water in open joints of water table and/or rusting iron anchors in window lintels and sills.

Suggested Remedy: Remove brickwork and assess for rusting iron anchors. If anchors are rusted they should be replaced with stainless steel anchors; brick should then be replaced to match existing texture, color and size and reset in mortar to match surrounding pointing in color, texture, and profile

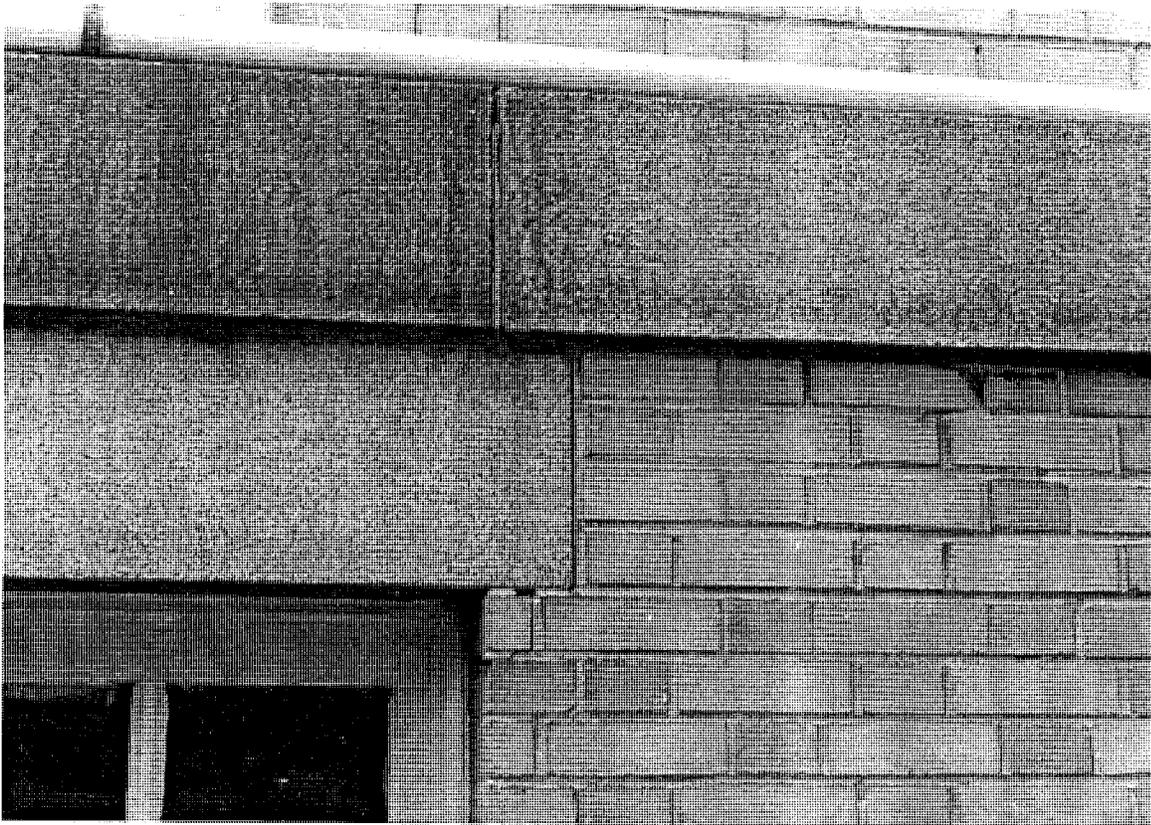
Figure 6-2

Location: North Elevation of Building 6 at West End

Problem: Stress cracks and open mortar joints

Cause of Problem: Freezing water in open joints of water table and/or rusting iron anchors in window lintels and sills.

Suggested Remedy: Remove brickwork and assess for rusting iron anchors. If anchors are rusted they should be replaced with stainless steel anchors; brick should then be replaced to match existing texture, color and size and reset in mortar to match surrounding pointing in color, texture, and profile.

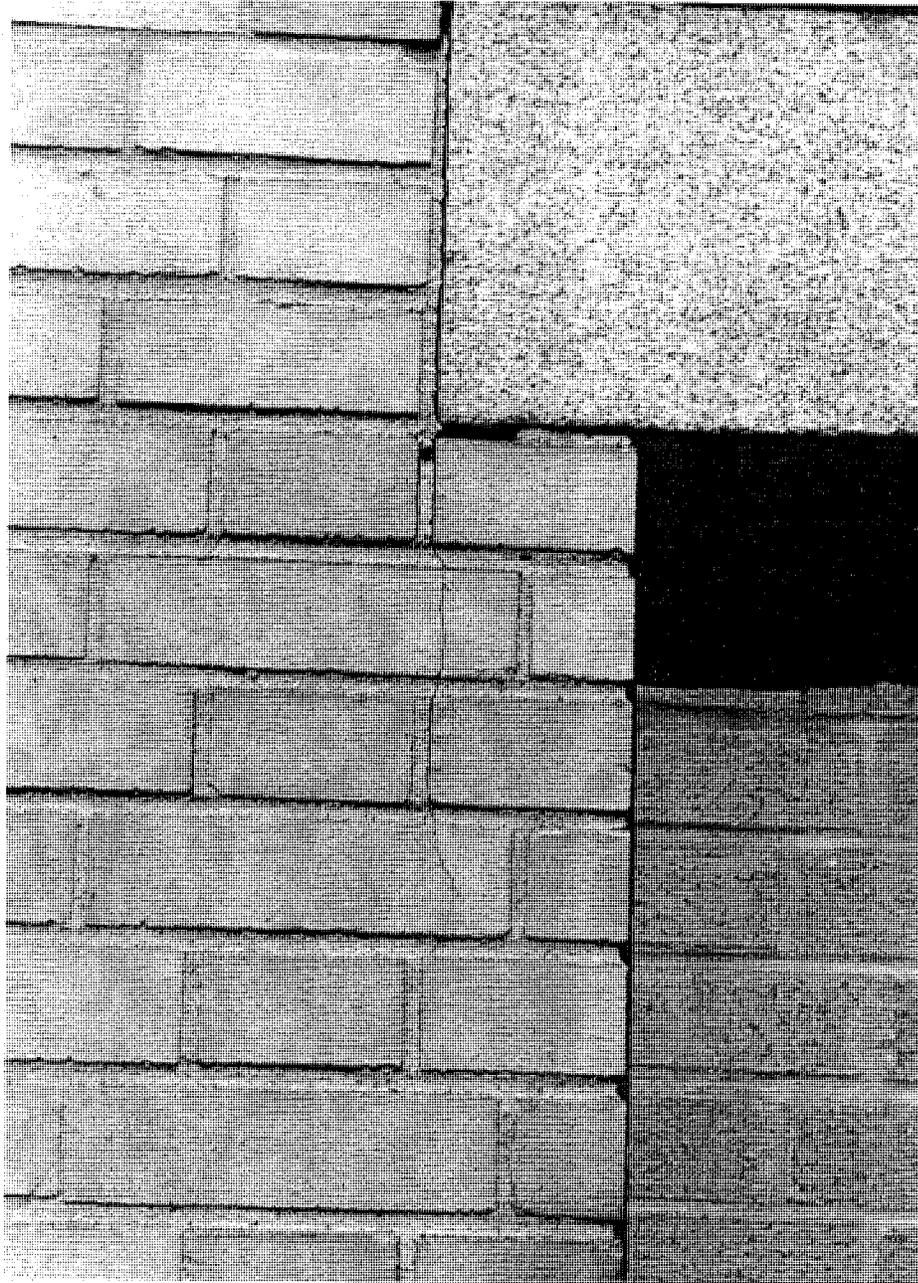
Figure 6-3

Location: East Elevation of Building 6 at North End

Problem: Stress cracks and open mortar joints

Cause of Problem: Freezing water in open joints of water table and/or rusting iron anchors in window lintels and sills.

Suggested Remedy: Remove brickwork and assess for rusting iron anchors. If anchors are rusted they should be replaced with stainless steel anchors; brick should then be replaced to match existing texture, color and size and reset in mortar to match surrounding pointing in color, texture, and profile.

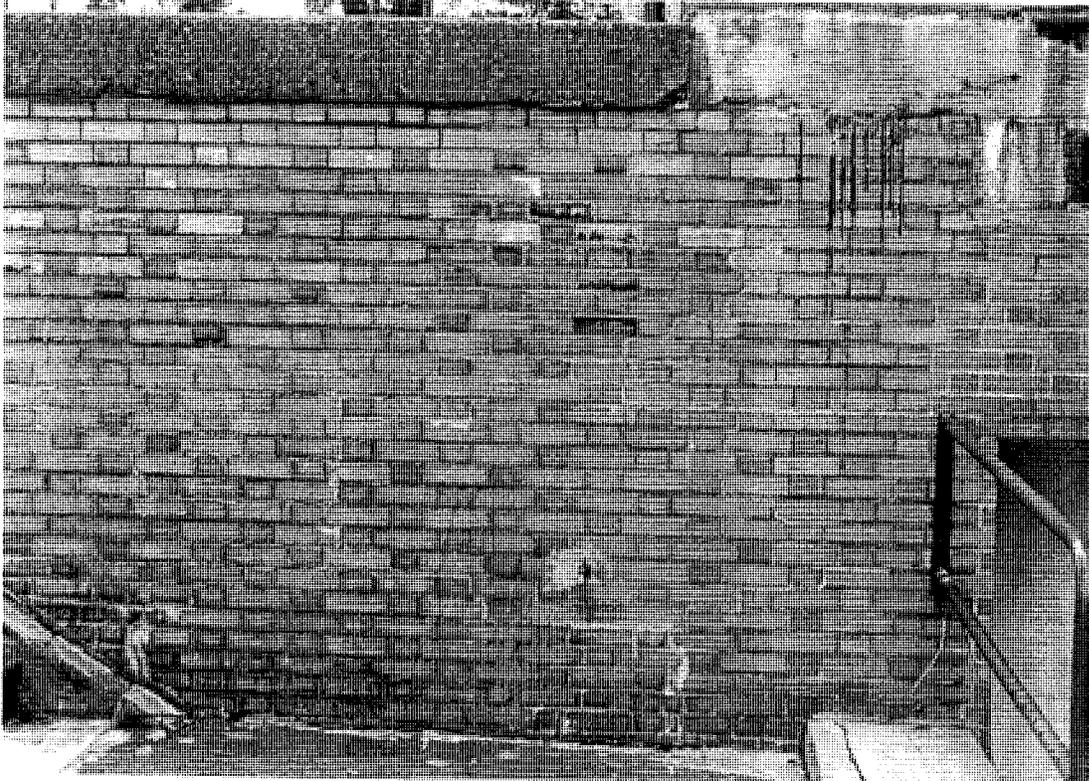
Figure 6-4

Location: West Wall of Entryway on North Elevation of Building 6

Cause of Problem: Water penetration through concrete slab

Suggested Remedy: Cut and point; waterproof concrete slab or replace concrete slab

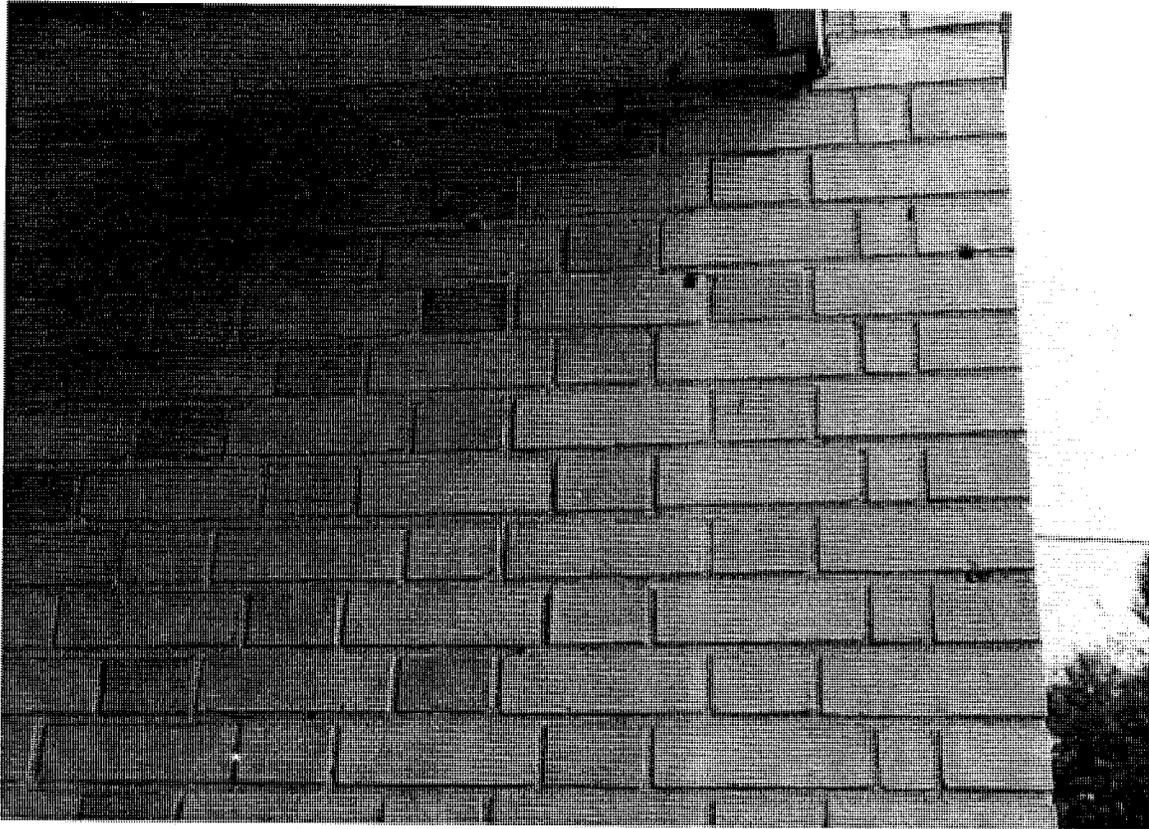
Figure 6-5

Location: South Elevation of Building 6 at East End

Problem: Damaged brick

Cause of Problem: Water penetration and freezing near metal anchors

Suggested Remedy: Remove anchors and fill with pointing mortar

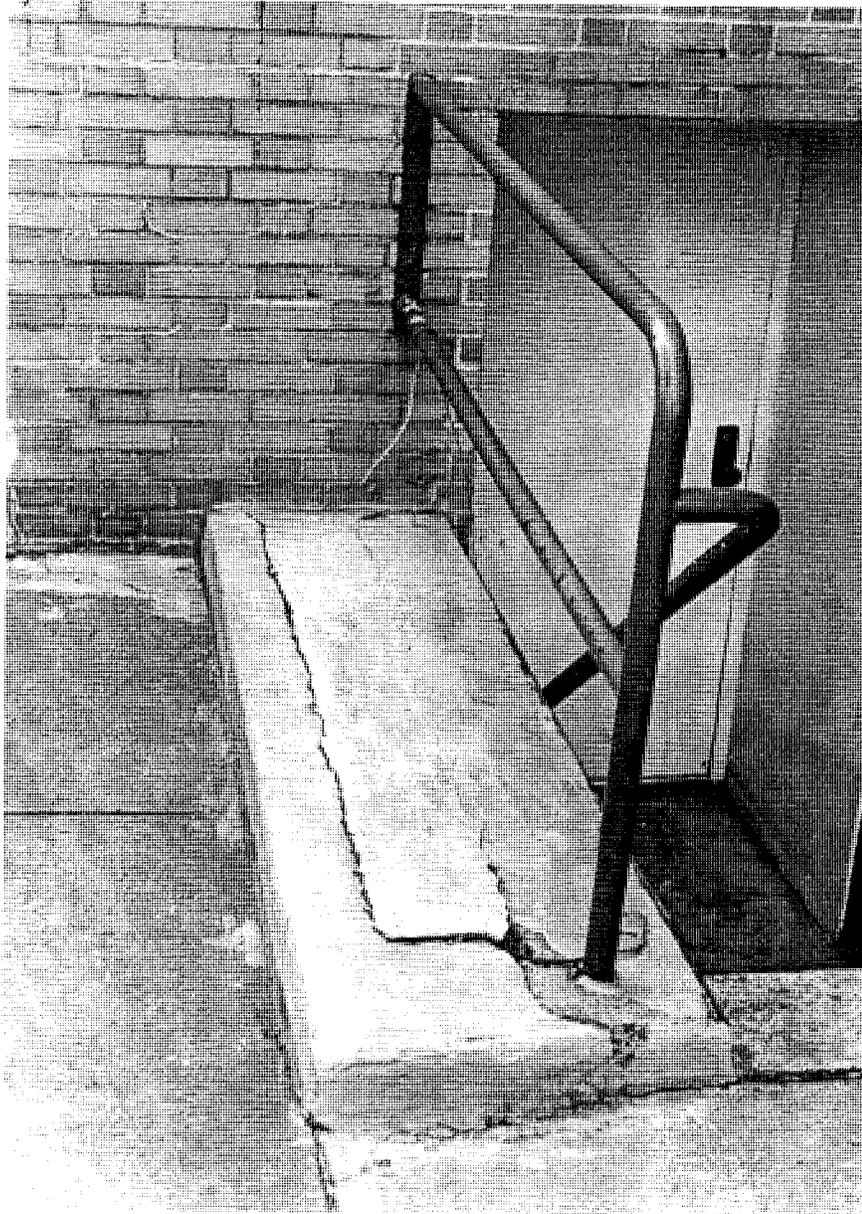
Figure 6-6

Iron railings are generally in good condition. They require periodic scraping and painting. Water entry at their bases has rusted some of the railings, causing damage to the concrete. (Figure 6-6).

Location: West Wall of Entryway on North Elevation of Building 6

Problem: Damaged concrete capstones

Cause of Problem: Water penetration and freezing; rusting of iron railings

Suggested Remedy: Demolish and rebuild

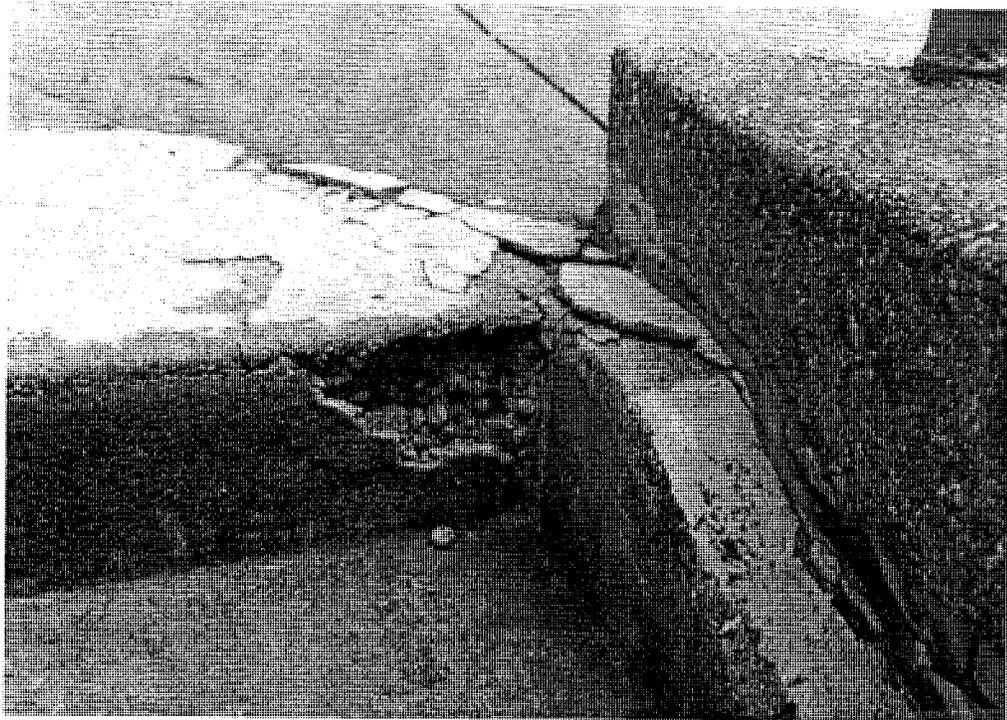
Figure 6-7

Location: West Side of Entryway on North Elevation of Building 6

Problem: Damaged concrete

Cause of Problem: Water penetration and freezing

Suggested Remedy: Demolish and rebuild

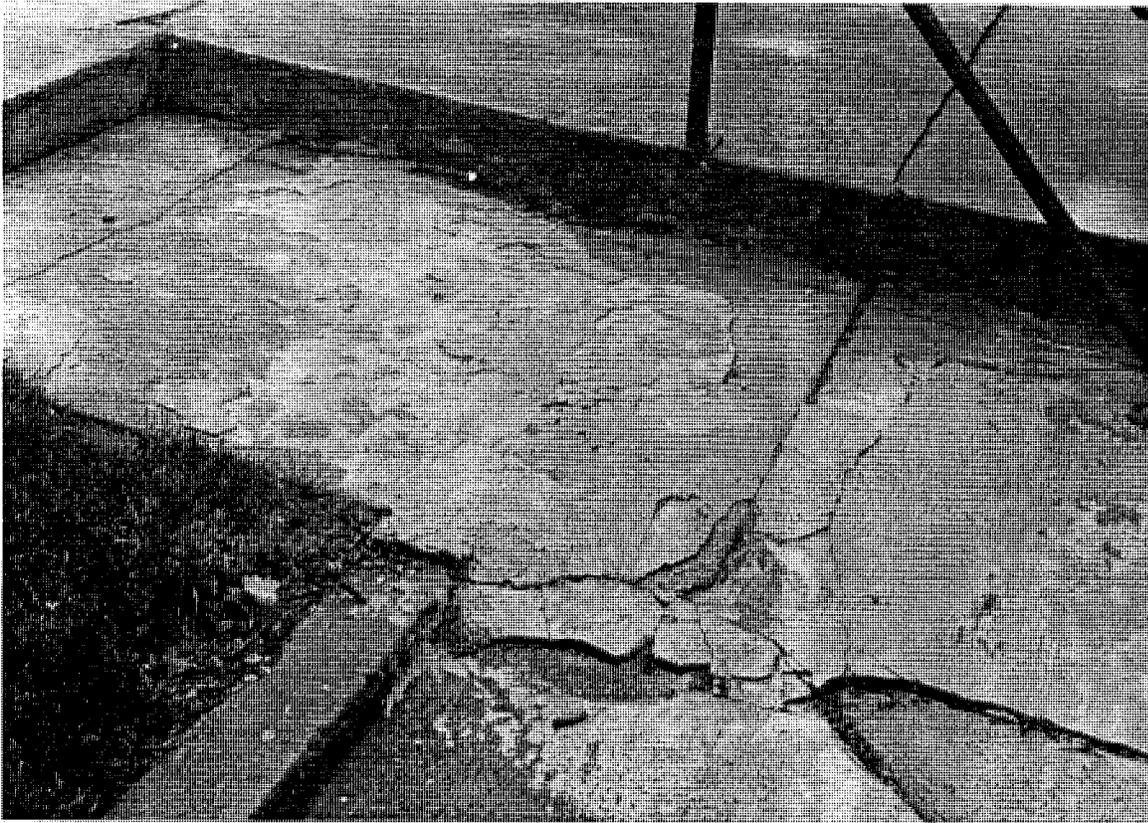
Figure 6-8

Location: West Wall of Entryway on North Elevation of Building 6

Problem: Damaged concrete

Cause of Problem: Water penetration and freezing

Suggested Remedy: Demolish and rebuild
