Potomac Annex:  
Buildings 1 & 3-7

Historic Structures Report, Corrected Final Submission  
 General Services Administration Project Control Number: 44007  
 September 9, 1997  
 VOLUME 2 OF 2

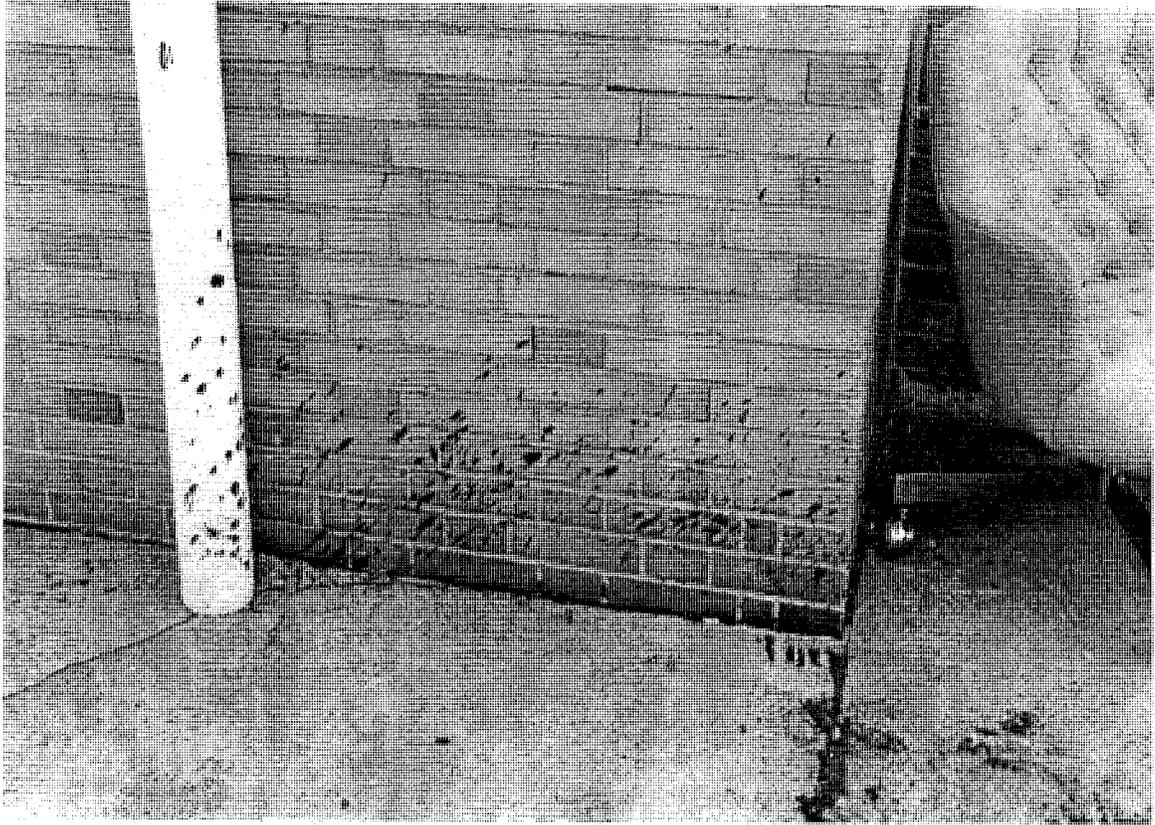
Figure 7-1

Yellow, unglazed brick is the primary construction material for Building 7. Overall the brick is in good condition while exhibiting light, superficial soiling. Bitumen has been spattered on the brickwork when waterproofing repairs were executed (Figure 7-1).

Location: West Elevation of Building 7 at South End

Cause of Problem: Poor maintenance procedures

Suggested Remedy: Poultice with solvents

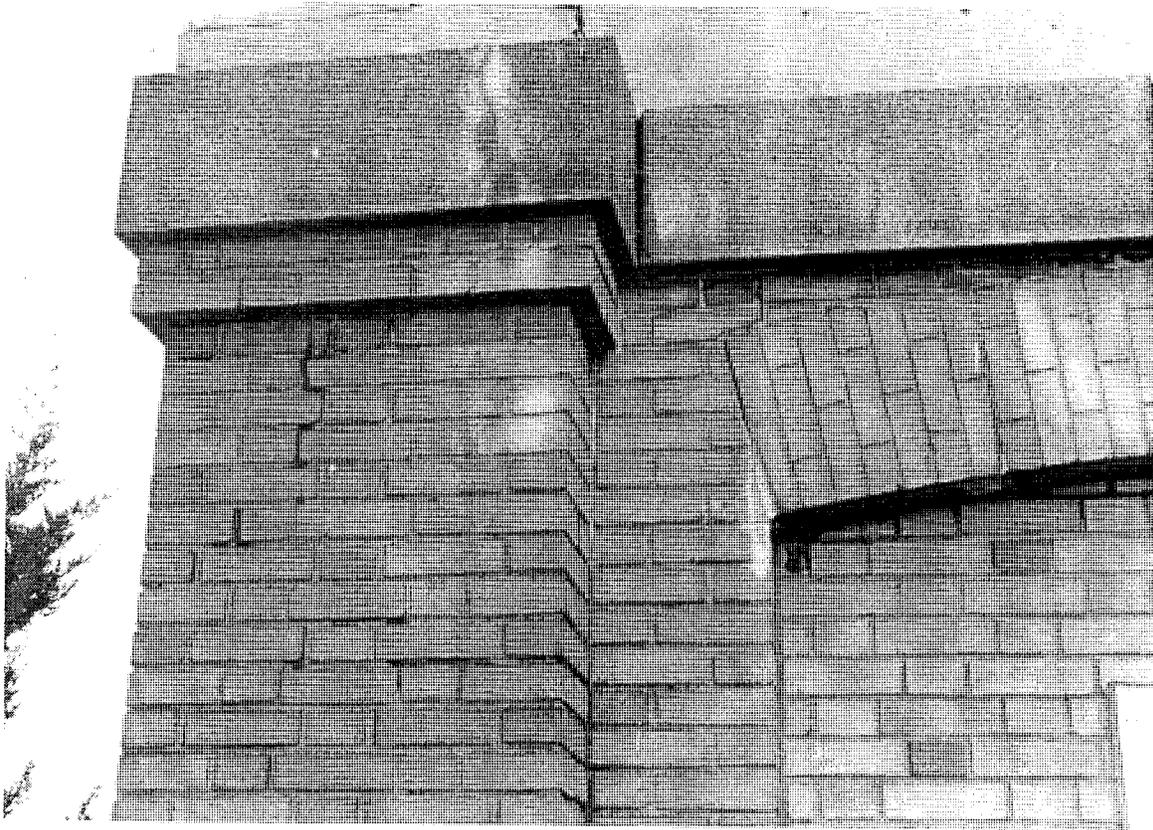
Figure 7-2

Location: South Elevation of Building 7 at West End

Cause of Problem: Water penetration and freezing

Suggested Remedy: Cut and point

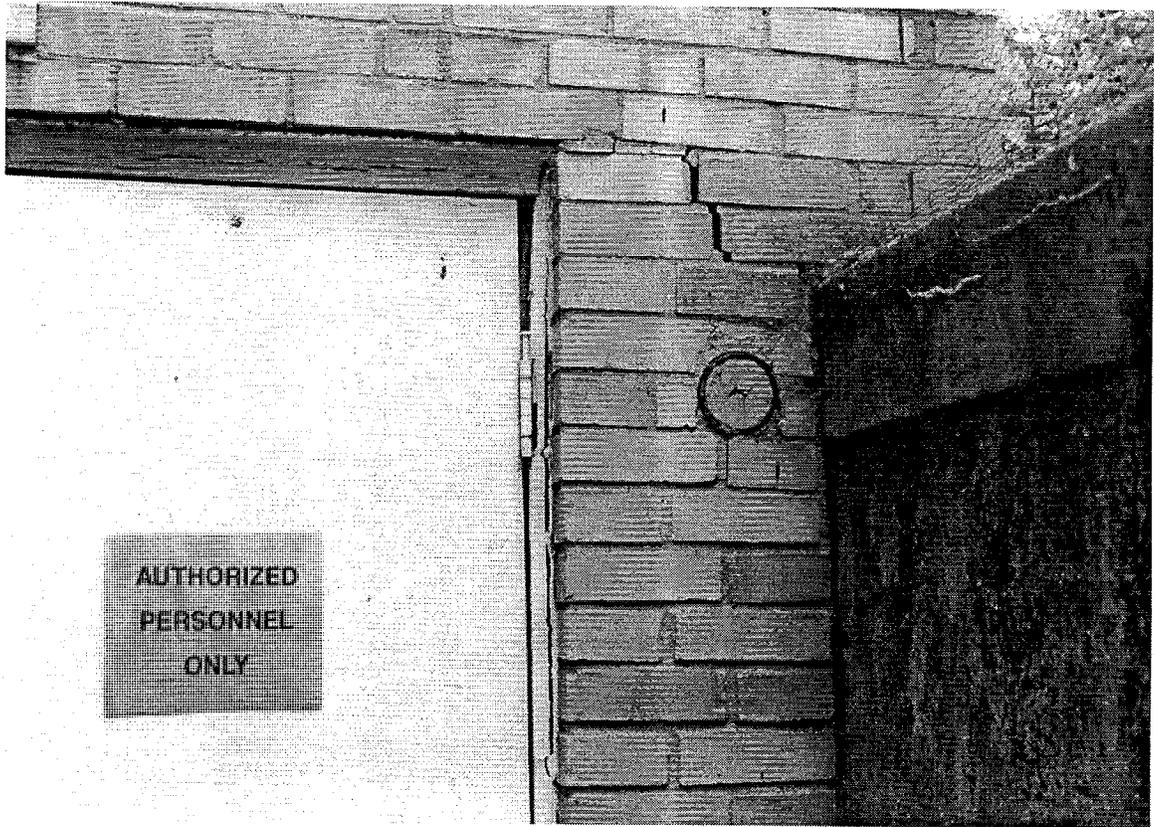
Figure 7-3

Stress cracks and open joints are found on Building 7 in association with the vertical or head joints of the granite water table. The stresses associated with the open joints transfer up and through the brick above, following the mortar joint pattern. Frequently they continue up to the first floor granite window sills. Articulated brick corners have consistently open joints where the corners meet the plane of the brick walls. These conditions are pervasive on all elevations. Semi-round brick arches also have open mortar joints (Figure 7-2). Brickwork near a concrete retaining wall contains open joints due to shifting of the concrete wall (Figure 7-3).

Location: North Side of Entryway on West Elevation of Building 7

Cause of Problem: Water penetration and freezing; rusting of door lintel

Suggested Remedy: Remove brick and assess condition of lintel; replace if necessary and reset brick with mortar to match existing in color, texture and profile

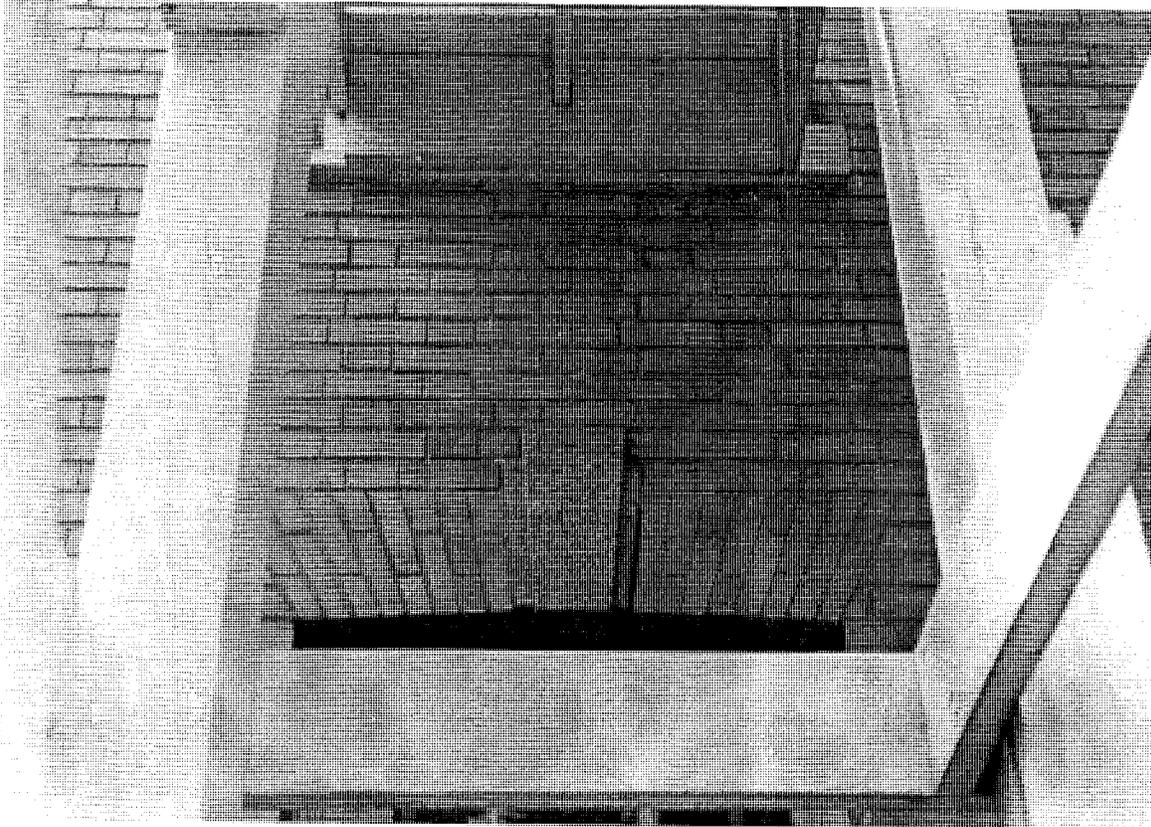
Figure 7-4

The head of the windows in Building 7 consist of wedged shaped brick voussoirs with granite keystones. The joints between the keystones and brick are consistently open as are the joints between the brick voussoir at each end of the window head trim and the surrounding brickwork of the wall (Figure 7-4).

Location: North Elevation of Building 7 in Central Area

Cause of Problem: Water penetration and freezing

Suggested Remedy: Cut and point

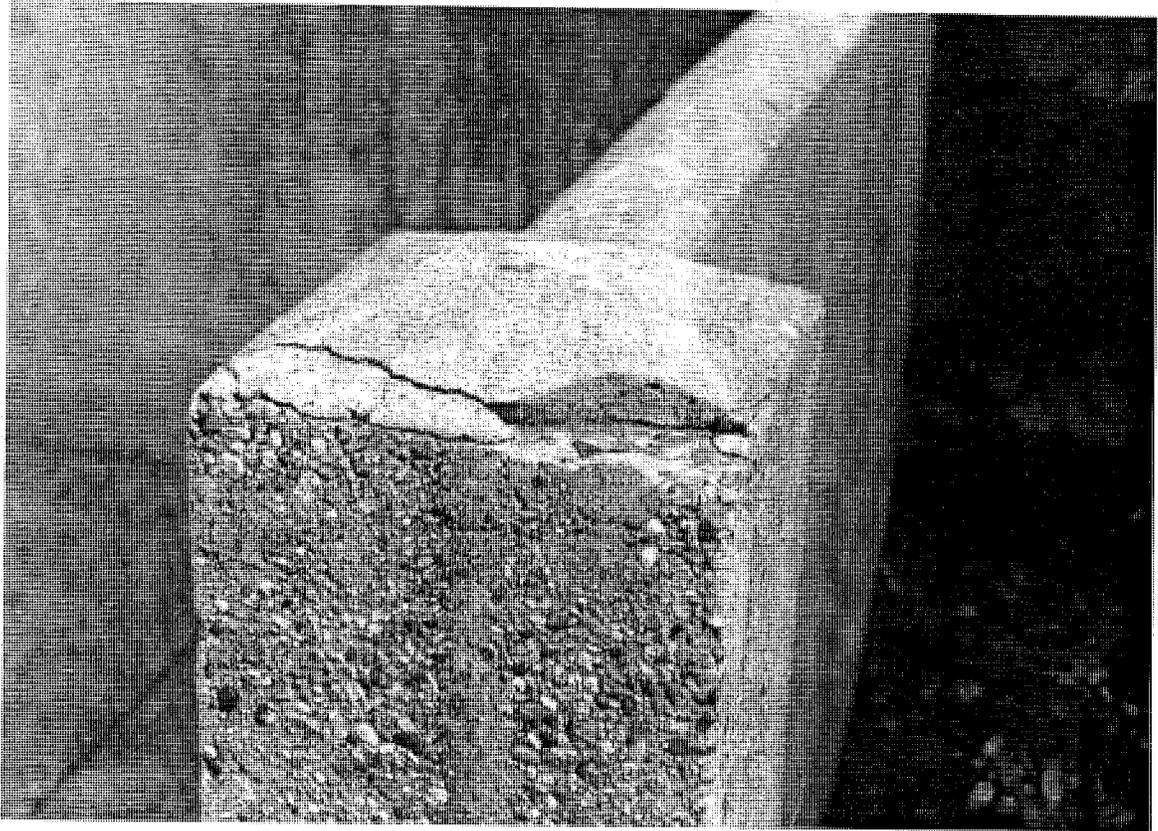
Figure 7-5

Concrete is used for the walkways and nearby walls as well as a retaining wall on Building 7. The tops of the walls associated with walkways have been repaired in the past, and these repairs are failing (Figure 7-5). Some concrete stucco is also failing where it has been directly applied to brickwork (Figure 7-6). A concrete retaining wall on the west elevation near the main entrance portico shows efflorescence and some bulging (Figure 7-7). Concrete bases for the piers under the entrance portico are damaged (Figure 7-8). Other sidewalk walls have damaged capstones (Figure 7-9).

Location: East Elevation of Building 7 at North End (patio wall)

Problem: Damaged concrete

Cause of Problem: Water penetration and freezing

Suggested Remedy: Repair with concrete patching material

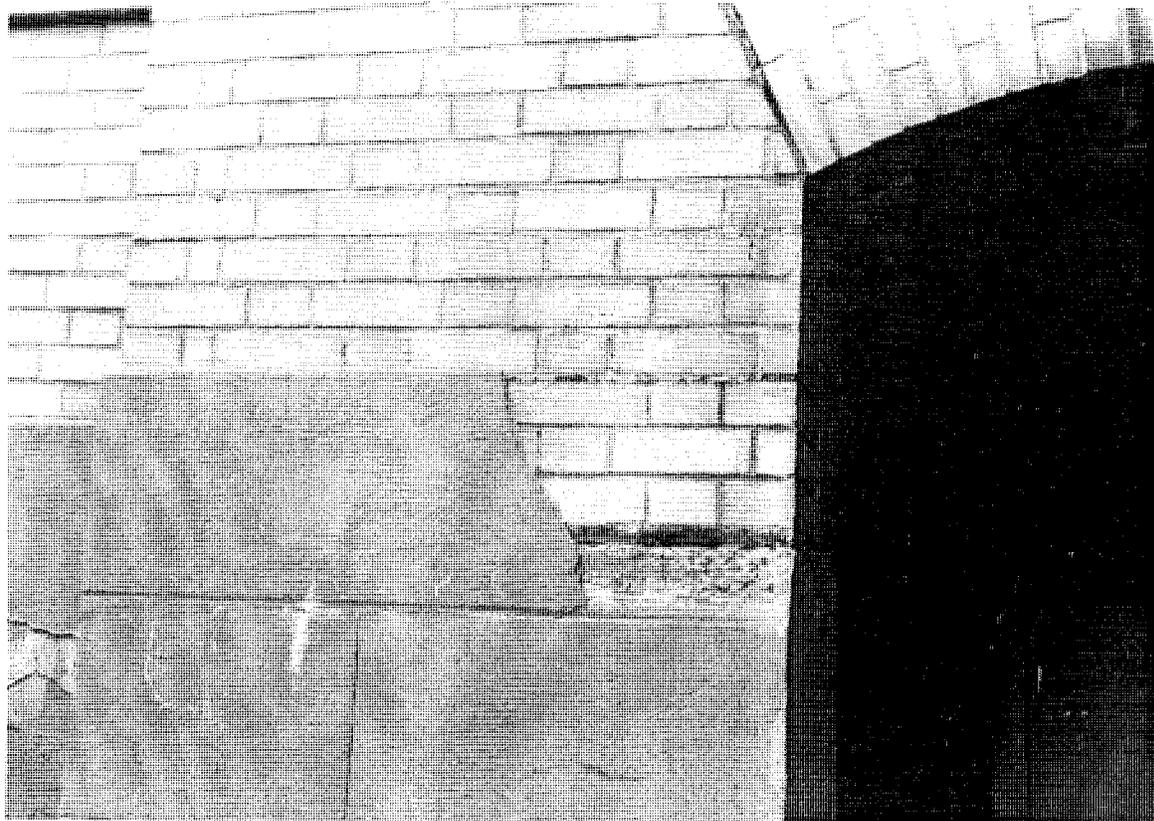
Figure 7-6

Location: South Elevation of Building 7 at West End

Problem: Damaged and failing stucco

Cause of Problem: Water penetration and freezing

Suggested Remedy: Repair with new stucco

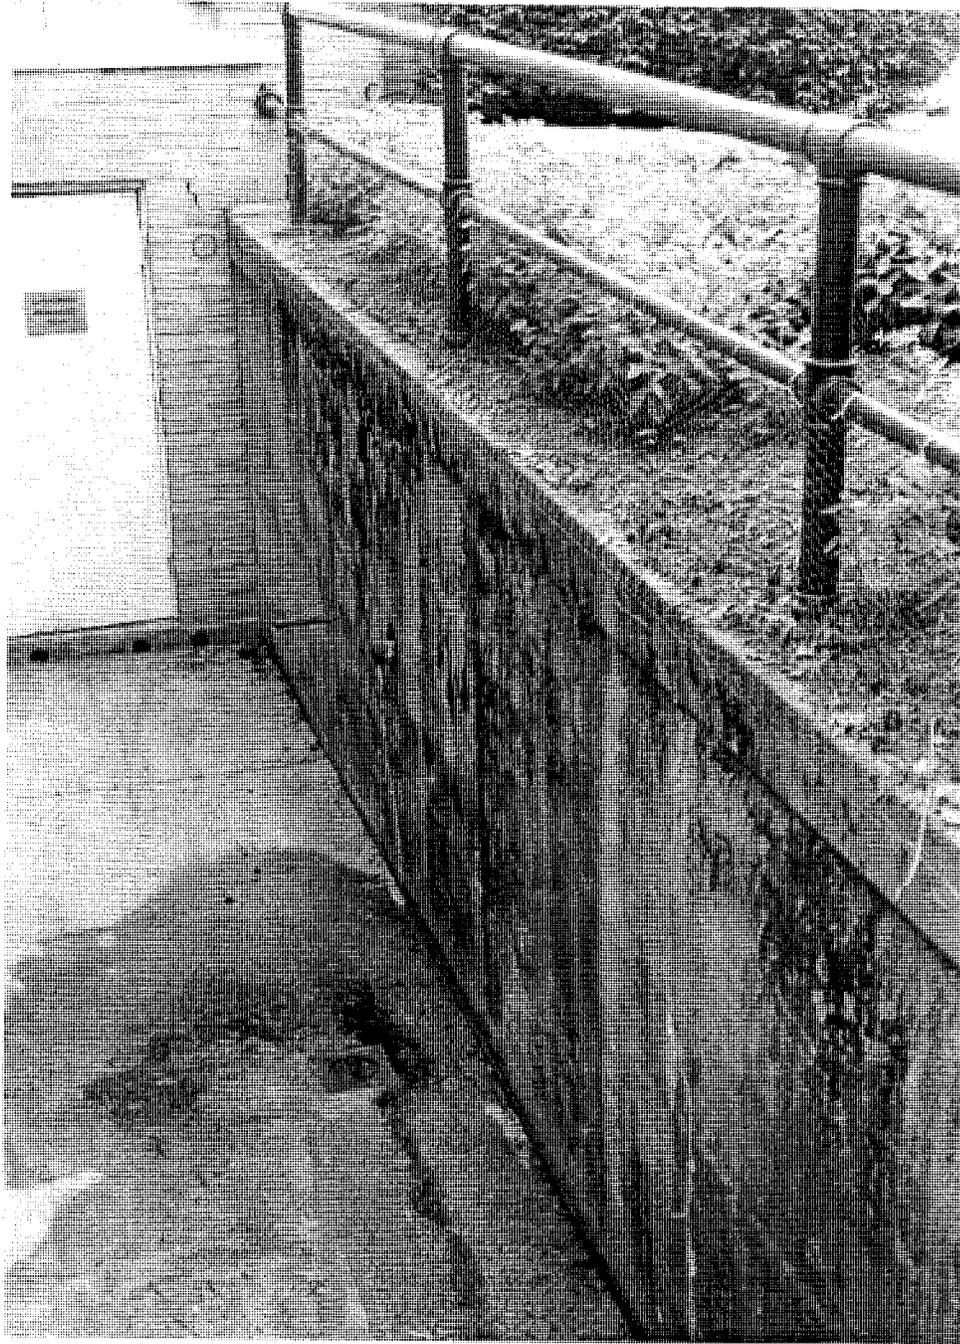
Figure 7-7

Location: West Elevation of Building 7 along North Areaway

Cause of Problem: Water penetration and freezing; pressure from soil

Suggested Remedy: Demolish and rebuild

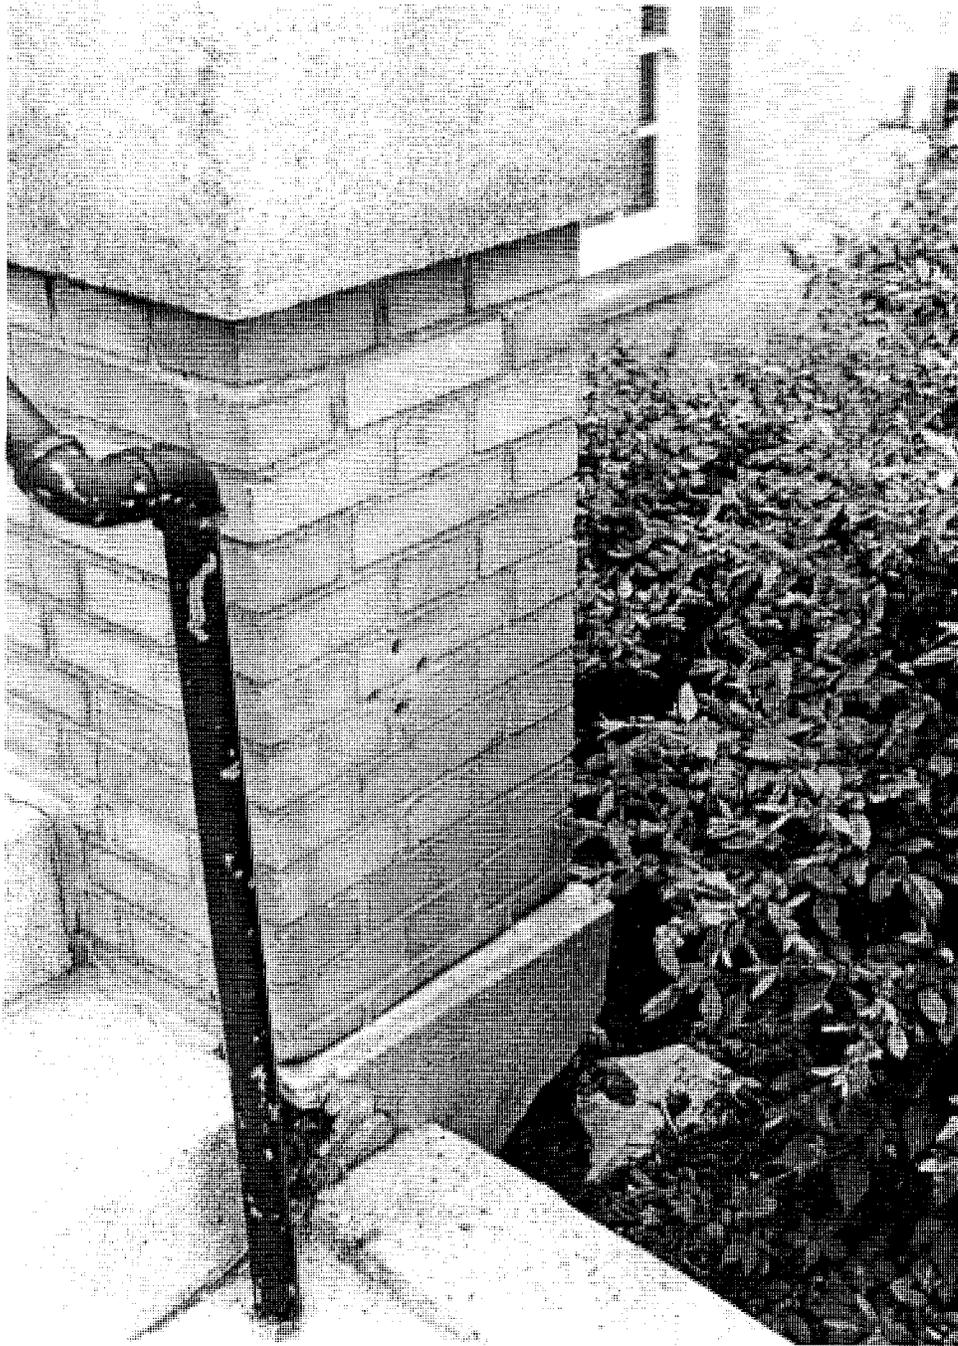
Figure 7-8

Location: West Elevation of Building 7 at Central Entryway

Problem: Damaged and deteriorating concrete piers

Cause of Problem: Water penetration and freezing

Suggested Remedy: Repair with concrete patching material

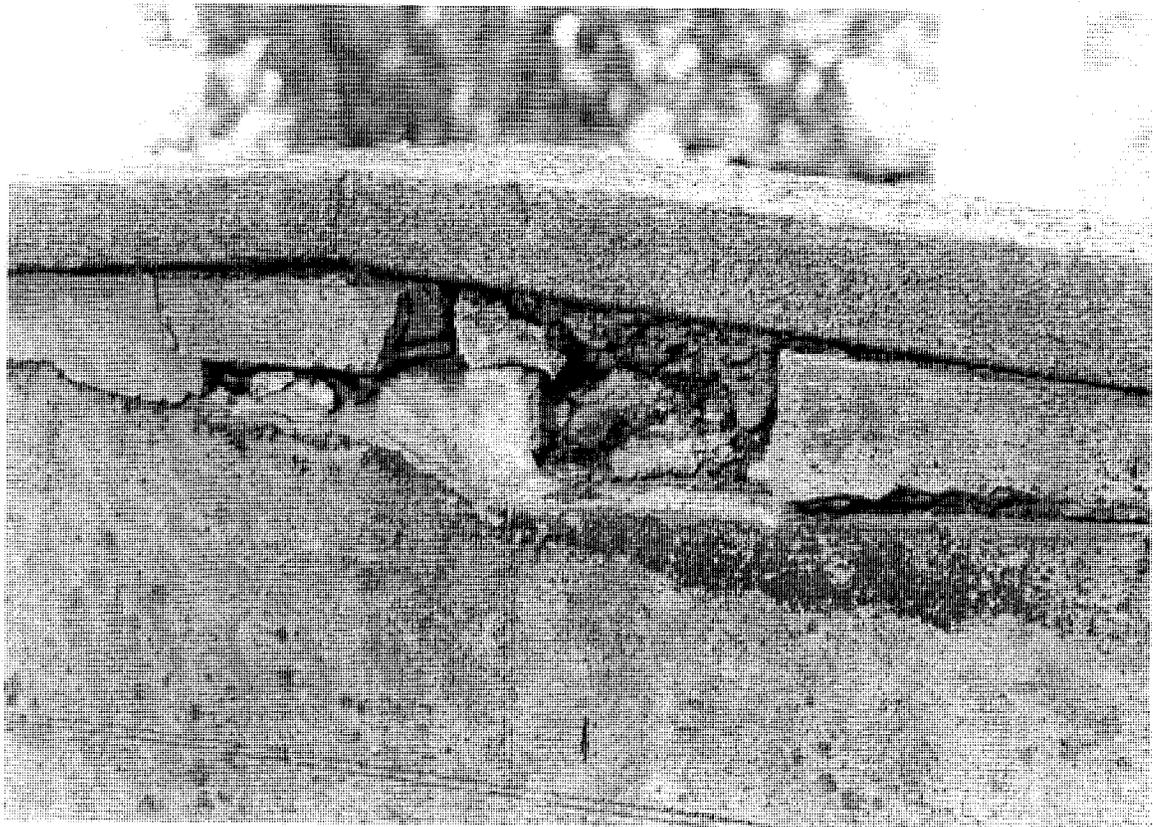
Figure 7-9

Location: North Elevation of Building 7 at West End (Walkway Wall)

Problem: Damaged and deteriorating concrete capstone

Cause of Problem: Water penetration and freezing

Suggested Remedy: Remove and replace

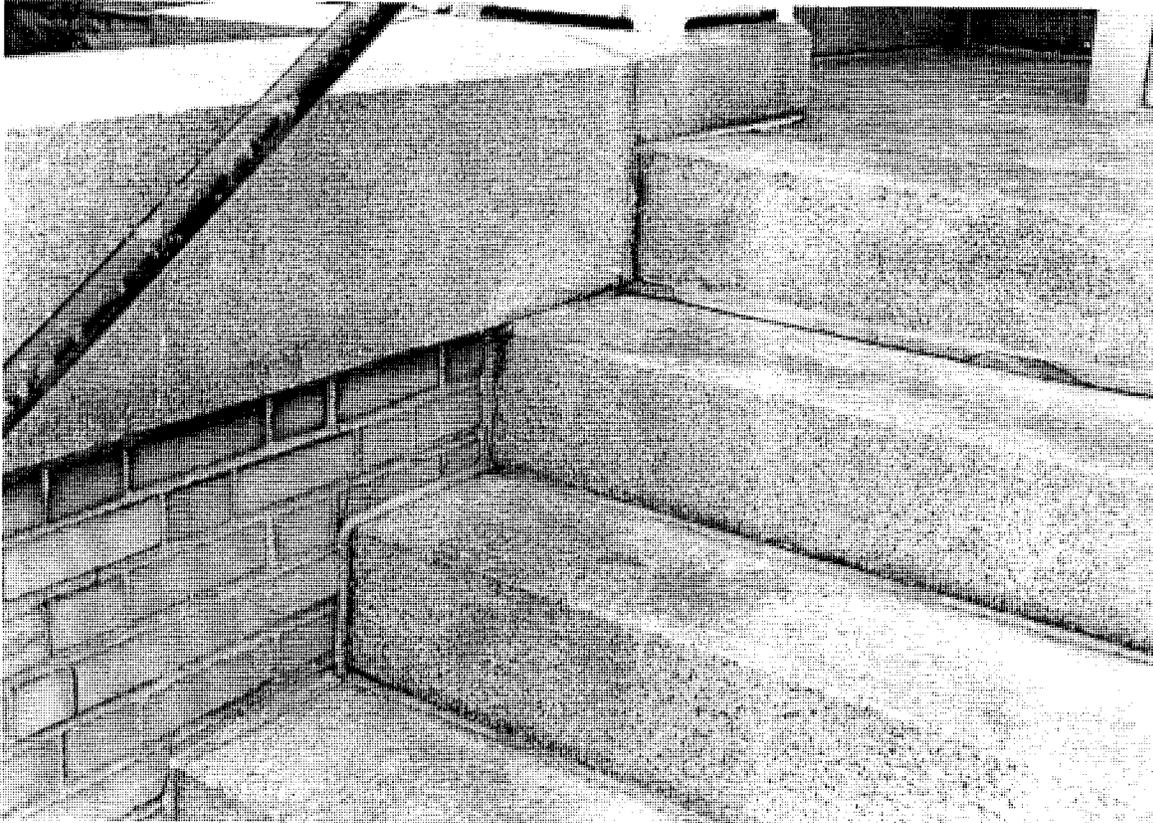
Figure 7-10

Granite forms the water table which surrounds the building at the base of the first floor. These elements - like the granite keystones - are generally in good condition but are soiled in a range from light to heavy. However, the joints between juxtaposed stones are open or have been filled with caulk. The bed joints and the top horizontal joints for the granite water table are generally open. Run-off from window air conditioners has stained some of the granite. Granite steps exhibit failing pointing and caulking (Figure 7-10).

Location: West Elevation of Building 7 at Central Entryway

Cause of Problem: Water penetration and freezing; improper maintenance procedures

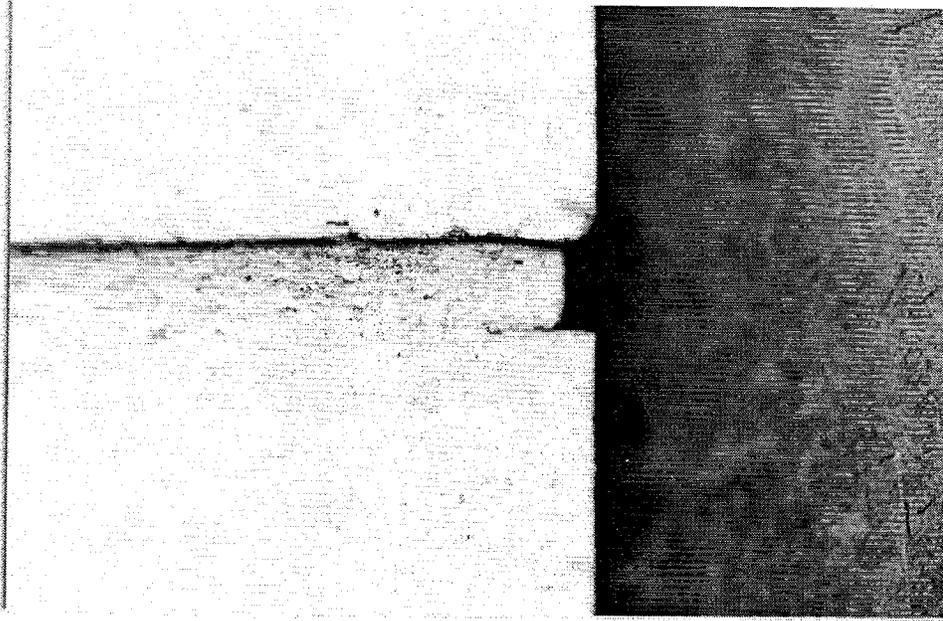
Figure 7-1

**Designation:** 1POTM (Figure 7-1)  
**Location:** Northeast corner of Building 1 at eye level  
**Integrity:** Appears to be original  
**Description:** White-grey with fine aggregate; some dark inclusions  
 Munsell Color Notation - Mortar: 5 Y 9/1

**Deterioration:** The mortar is in generally good condition and is well bonded except in step or stress cracks

Building 1 - Brick Pointing Mortar

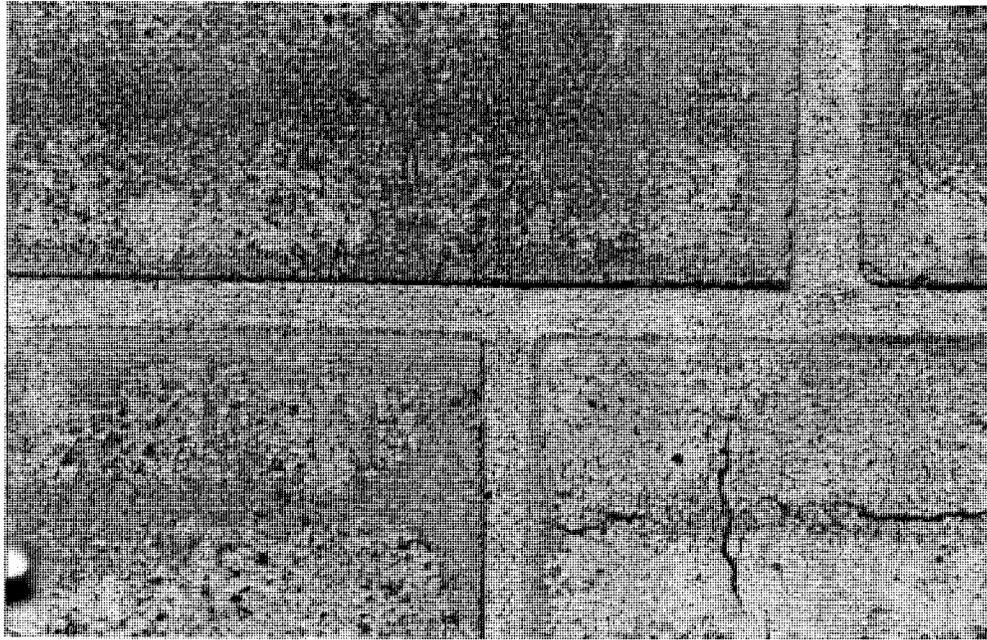
Figure 7-4

**Designation:** 3POTMWT (Figure 7-4)  
**Location:** Southeast corner of Building 3  
**Integrity:** Appears to be original  
**Description:** White-grey with fine to medium aggregate  
 Munsell Color Notation - Mortar: 5 Y 8.5/1

Building 3 - Limestone Pointing Mortar

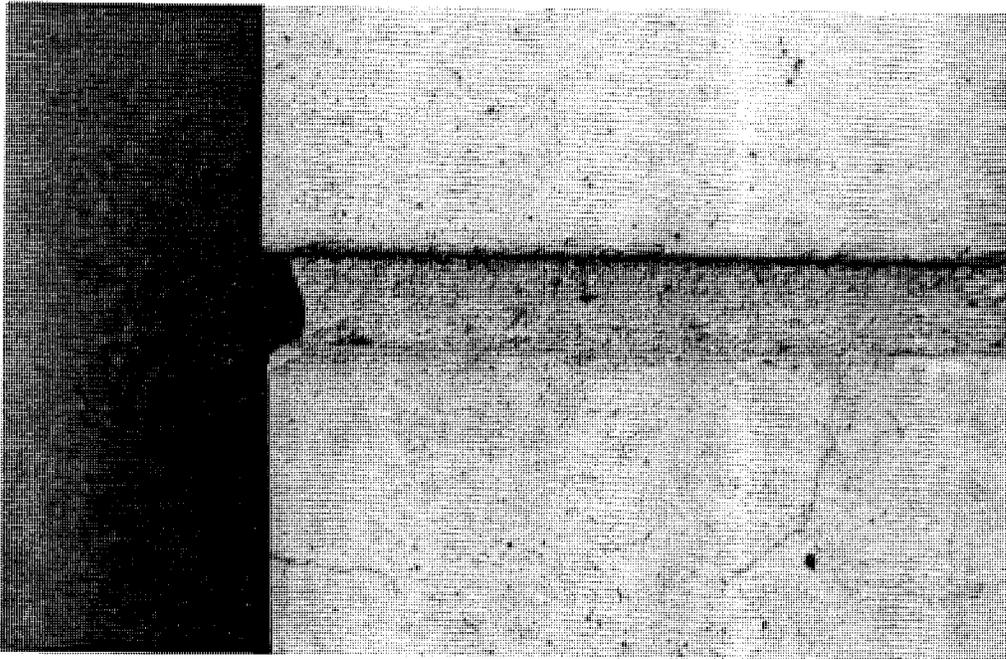
Figure 7-6

**Designation:** 4POTMWT (Figure 7-6)  
**Location:** Northwest corner of Building 4  
**Integrity:** Appears to be non-original  
**Description:** Tan with medium aggregate  
 Munsell Color Notation - Acid Insolubles: 2.5 Y 8.5/2

Building 4 - Limestone Pointing Mortar

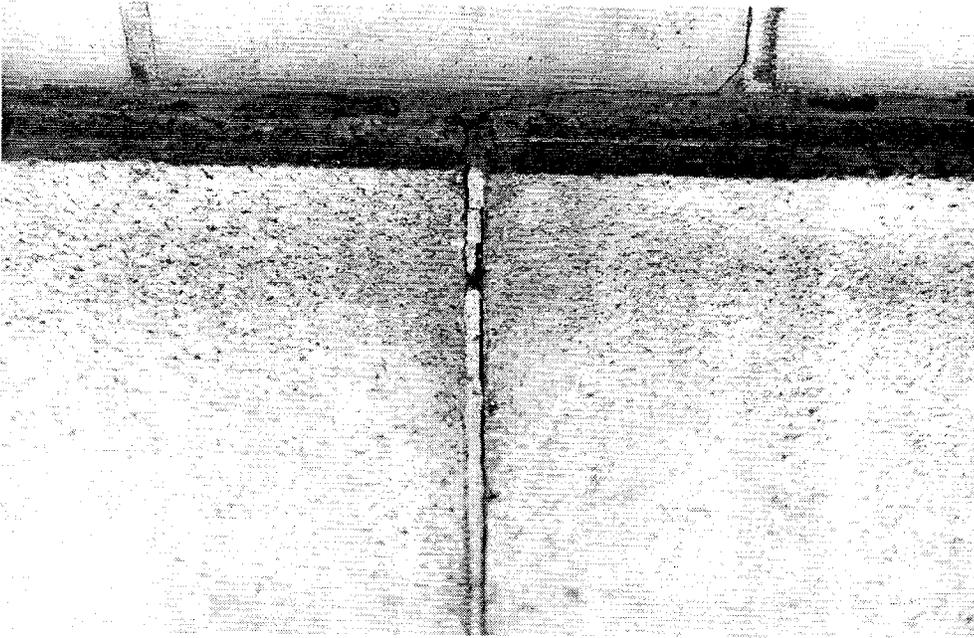
Figure 7-7

**Designation:** 5POTM (Figure 7-7)  
**Location:** Northeast corner of Building 5  
**Integrity:** Appears to be original  
**Description:** White-grey with fine aggregate and some dark inclusions  
 Munsell Color Notation - Mortar: 5 Y 9/1

Building 5 - Brick Pointing Mortar

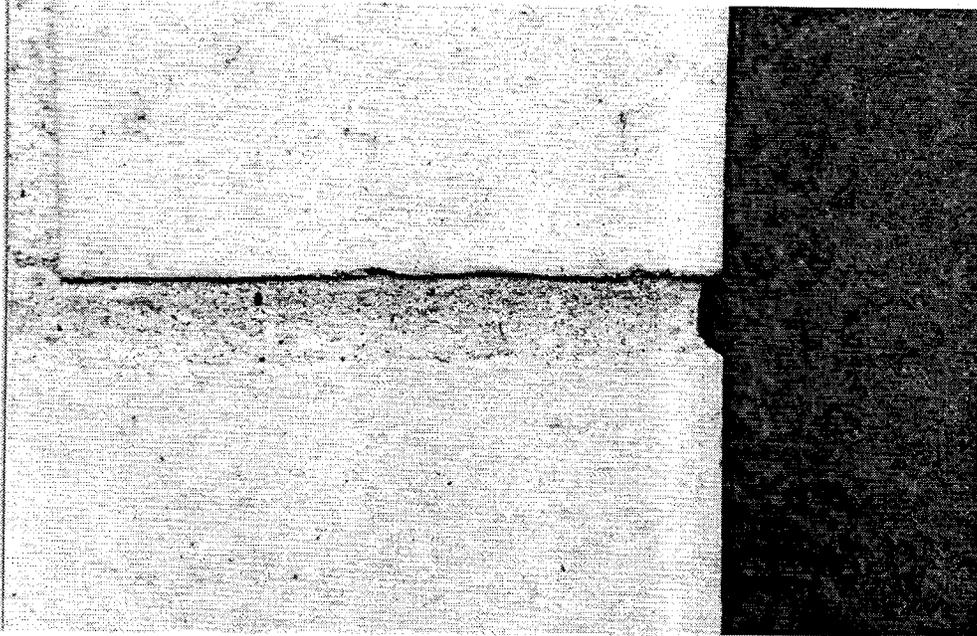
Figure 7-8

**Designation:** 5POTMWT (Figure 7-8)  
**Location:** Northeast corner of Building 5  
**Integrity:** Appears to be non-original  
**Description:** Tan with medium aggregate  
 Munsell Color Notation - Mortar: 5 Y 9/1

Building 5 - Granite Pointing Mortar

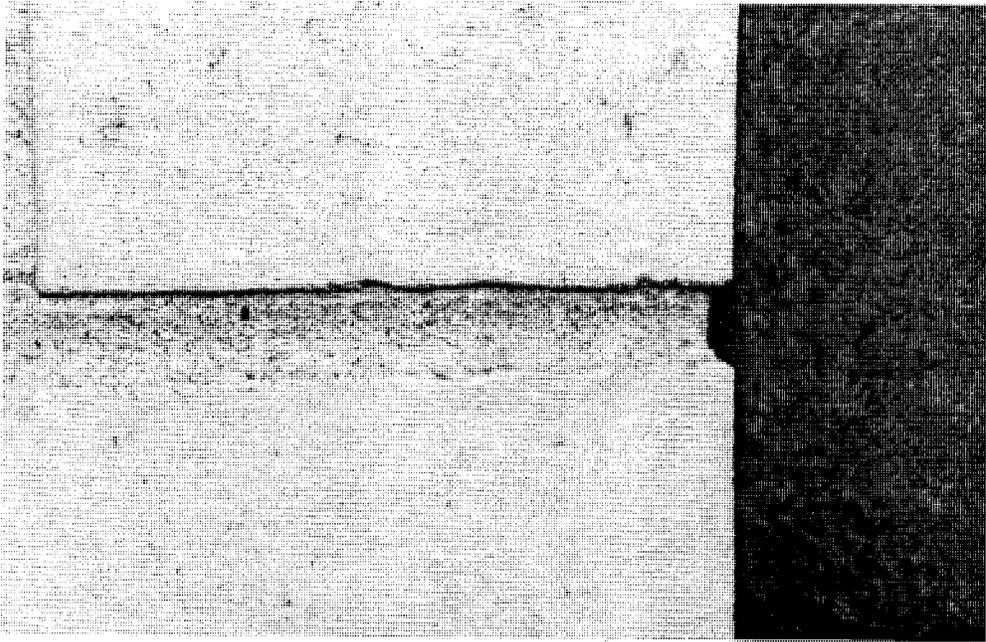
Figure 7-10

**Designation:** 6POTMWT (Figure 7-10)  
**Location:** North facade of Building 6, west of entrance, near first basement window  
**Integrity:** Appears to be non-original  
**Description:** Tan with medium aggregate  
 Munsell Color Notation - Mortar: 5 Y 9/1

Building 6 - Granite Pointing Mortar

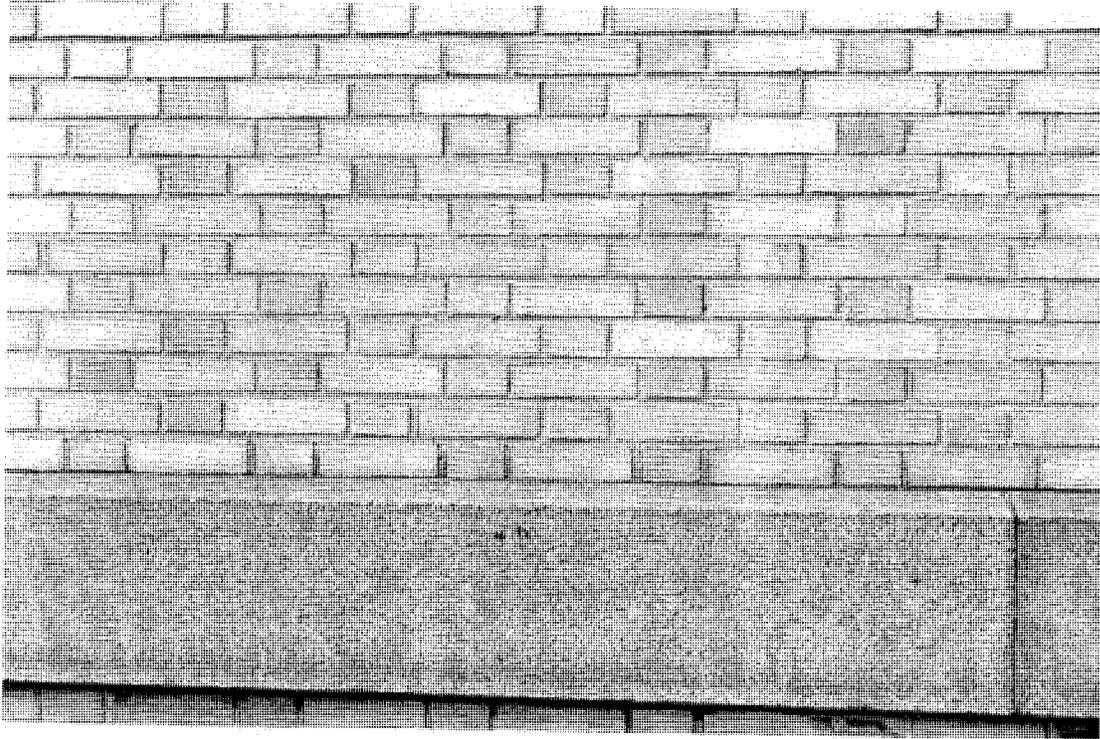
Figure 8-1

The brick and granite on Buildings 1, 5, 6 and 7 is only lightly soiled as seen here on the elevation of Building 1.

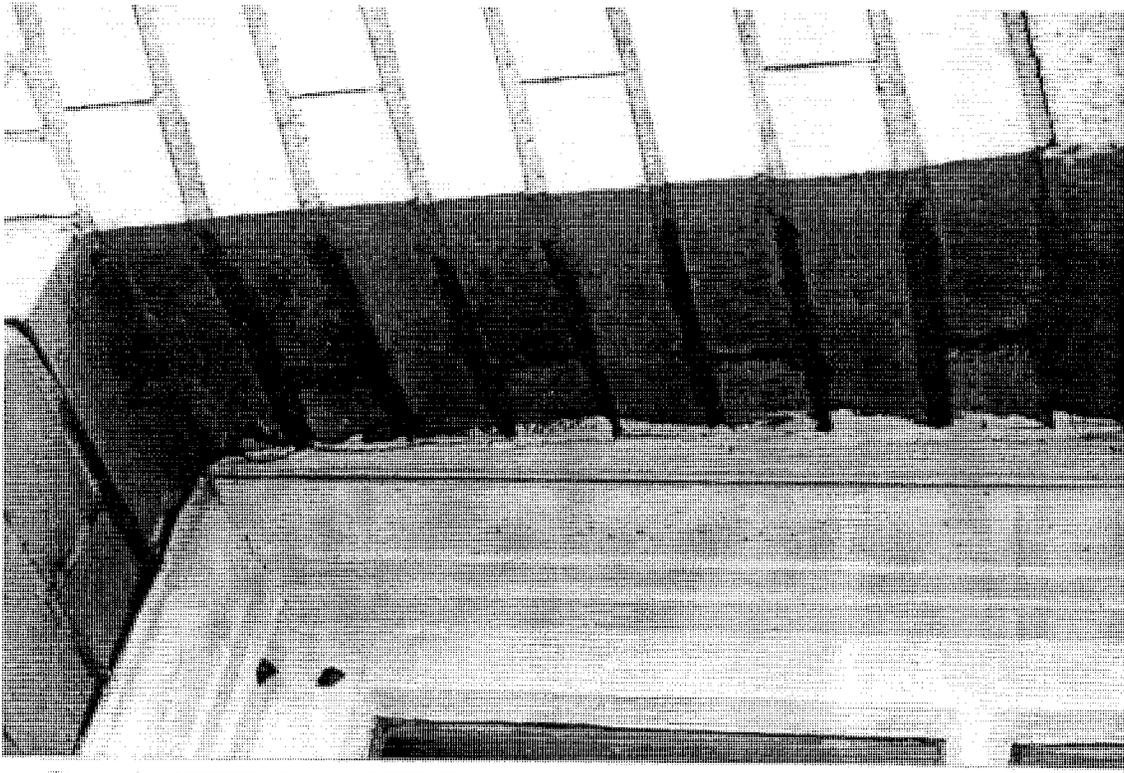
Figure 8-2

While these deposits are somewhat disfiguring, they are not, at this time, sufficient enough to cause damage to the brick or the granite. However, removal at this time may prevent future deterioration and the eventual need for more intrusive and potentially damaging cleaning methods.

Gypsum and flyash have deposited on the undersides of window lintels and sills as seen here on the elevation of Building 3.

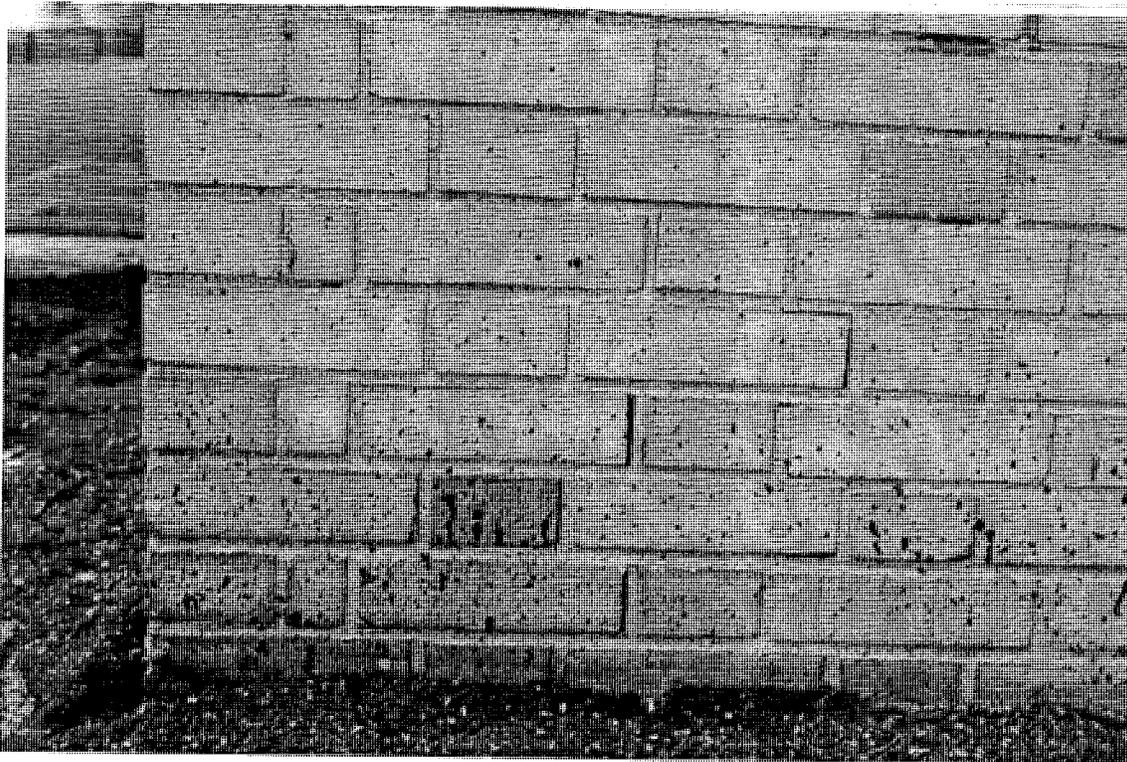
Figure 8-3

Bitumen-based materials have been accidentally splashed onto the brick and granite as seen here on the elevation of Building 7.

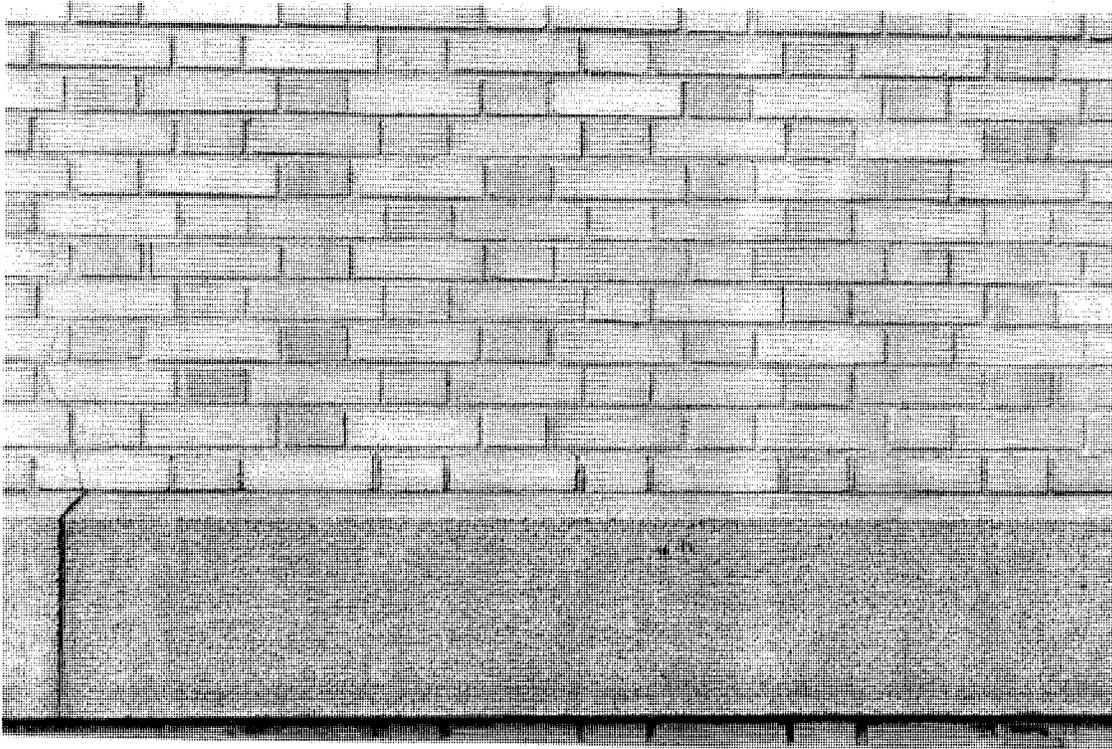
Figure 8-7

The condition of the granite can be seen in Figure 8-7. Two methods of cleaning were chosen: 1) Application of detergent (PROSOCO'S 1026) followed by low pressure power wash; 2) Application of alkaline pre-wash followed by an acid after-wash with low pressure power wash after each step. The conditions for each test are outlined below.

The granite water tables (as well as other granite elements) on Buildings 1, 5, 6 and 7 are lightly soiled as seen here on the east elevation of Building 5 before cleaning tests commenced.

The result of cleaning the light soiling of the granite with Method 1 is shown in Figure 8-8; no cleaning of the granite was achieved by this method. The results of Method 2 are documented in Figure 9. Good cleaning of the granite was achieved by this method; therefore the appearance resulting in the application of Method 2, as represented by Figure 8-9, is the recommended cleaning technique.

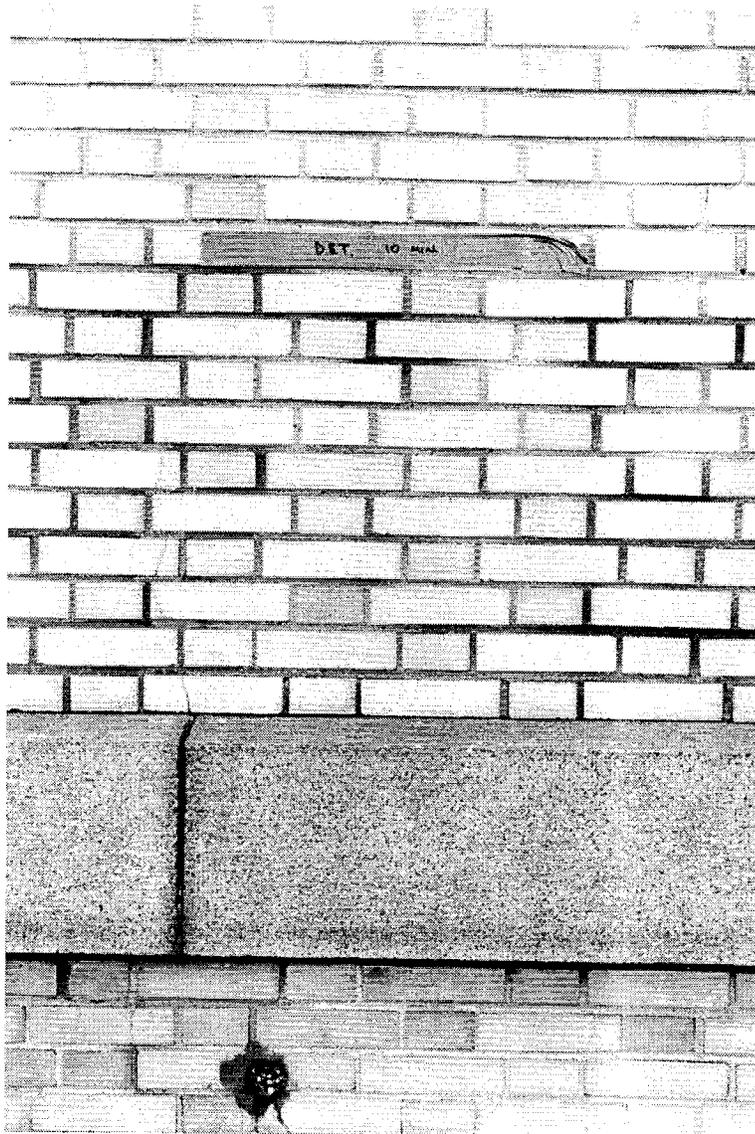
Figure 8-8

The detergent cleaning of the granite water table on the east elevation of Building 5 was unsuccessful.

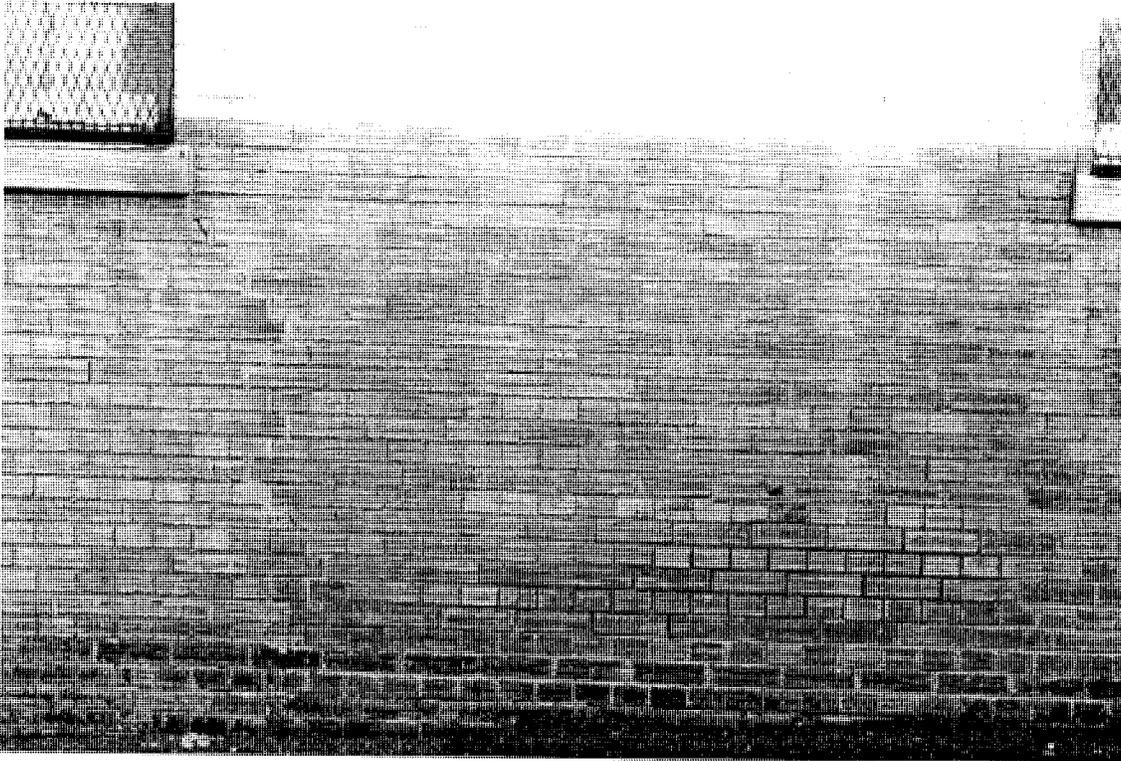
Figure 8-12

As can be seen in Figure 8-13 the soiling of the brick on Buildings 3 and 4 is heavier than that of Buildings 1, 3, 5, 6 and 7. Similar cleaning methods used on Building 6 have been tested on a representative area of Building 3.

The soiling of the brick on Building 3 and 4 is more severe than on Buildings 1, 5, 6 and 7 as seen here on the elevation of Building 3. The brick on Buildings 3 and 4 is also different from the brick on Building 1, 5, 6 and 7.

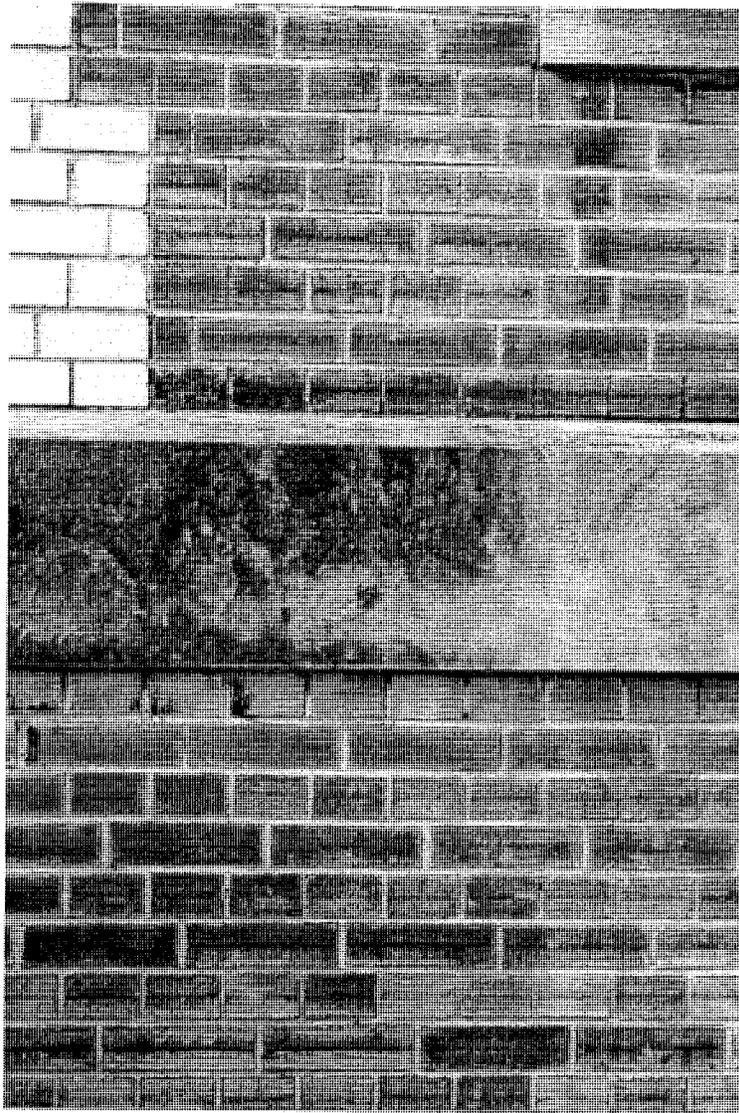
Figure 8-13

The water tables (and other decorative elements) on Buildings 3 and 4 are limestone. This limestone is moderately soiled as seen here on the elevation of Building 3.
