Potomac Annex:  
Buildings 1 & 3-7

Historic Structures Report, Corrected Final Submission  
 General Services Administration Project Control Number: 44007  
 September 9, 1997  
 VOLUME 2 OF 2

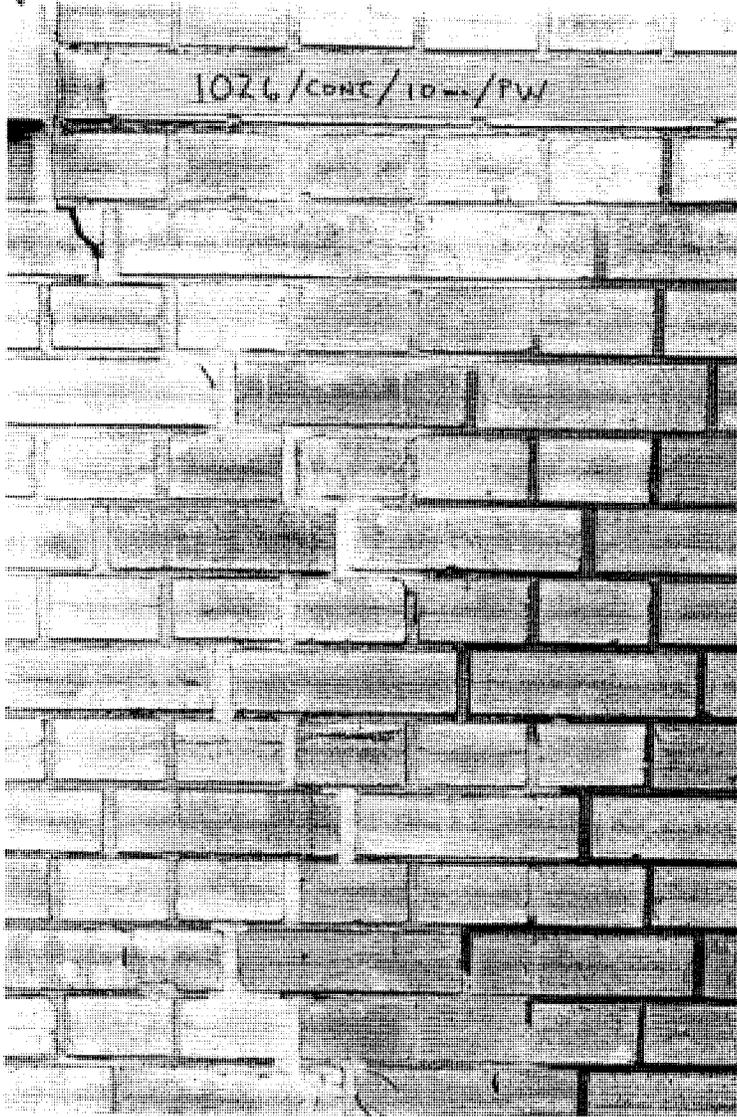
The result of cleaning the soiling of the brick with Method 2 is shown in Figure 8-15 (the before condition is seen on the middle-left side of Figure 12). No cleaning has been achieved by this method. The result of cleaning the soiling of the brick with Method 1 is shown in Figure 8-14 (the before condition is seen on the left side of Figure 8-12). No cleaning has been achieved by this method. The result of cleaning the soiling of the brick with Method 3 is shown in Figure 16 (the before condition is seen on the middle right side of Figure 8-12). No cleaning has been achieved by this method.

A cleaning test was executed with PROSOCO'S 1026 detergent on the brick of the south elevation of Building 3. No cleaning was achieved by this method (the left side of Figure 12 shows this area before cleaning).

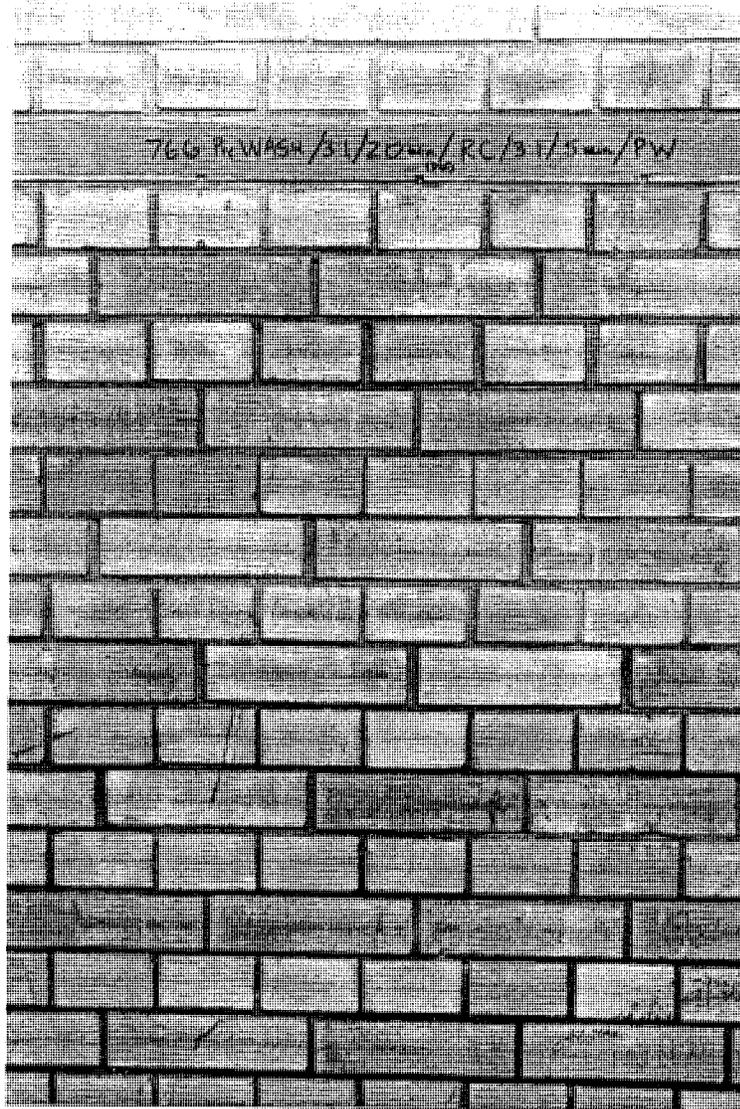
Figure 8-15

Cleaning tests on the brick of Building 3 were also executed with an alkaline pre-wash/acid after-wash system. The results shown here on the south elevation of Building 3 indicate that no cleaning was achieved by this method.

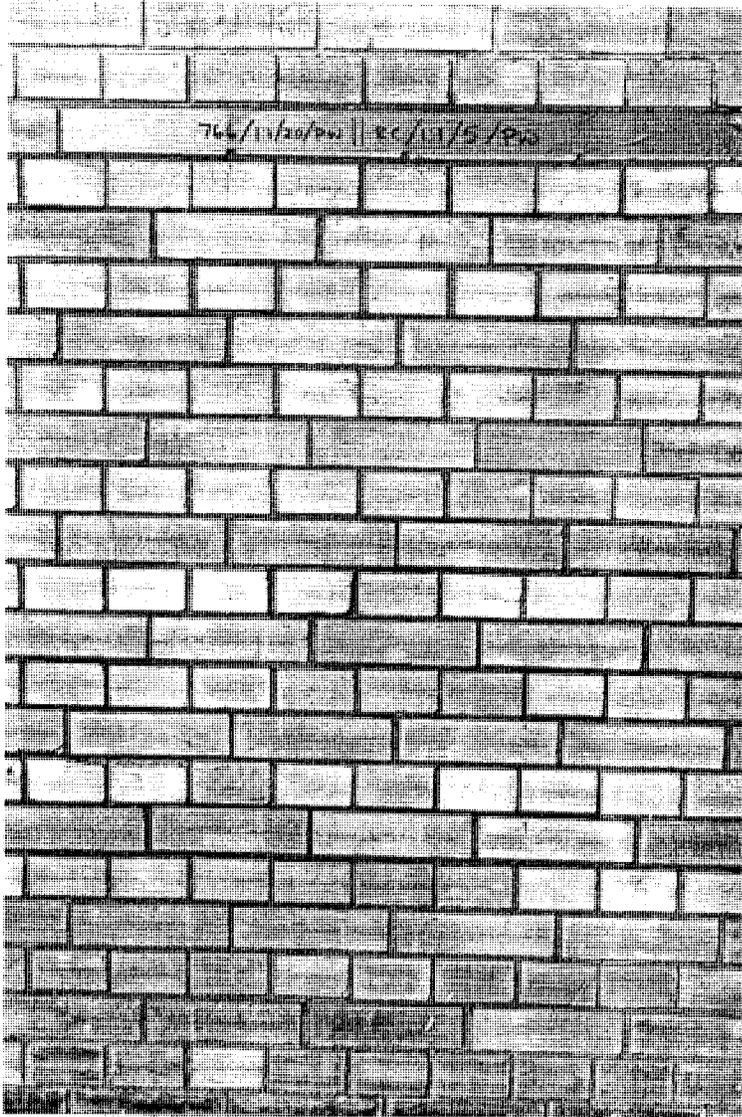
Figure 8-16

Cleaning tests were executed on the brick of Building 3 using increased concentrations in the alkaline pre-wash/acid after-wash system. Again, no cleaning was achieved as shown here on the south elevation of Building 3.

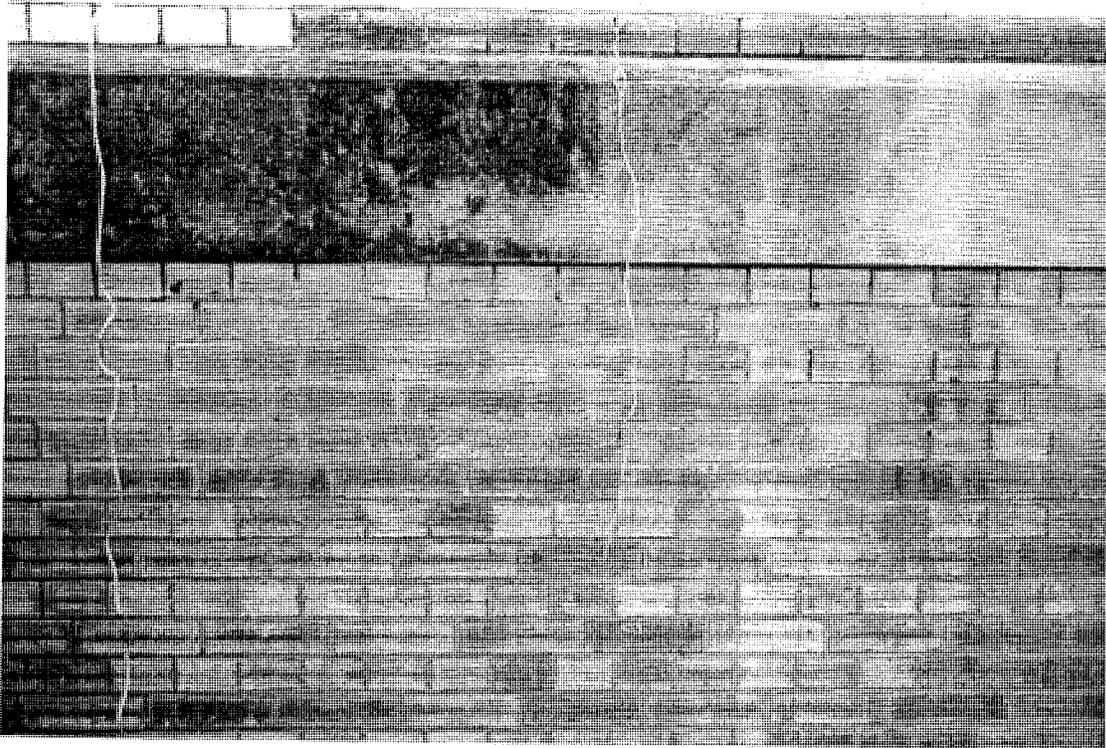
Figure 8-17

A section of the brickwork on the east elevation of Building 4 was cleaned with the water misting method. On the lower left the brick (and the limestone water table) can be seen before cleaning.

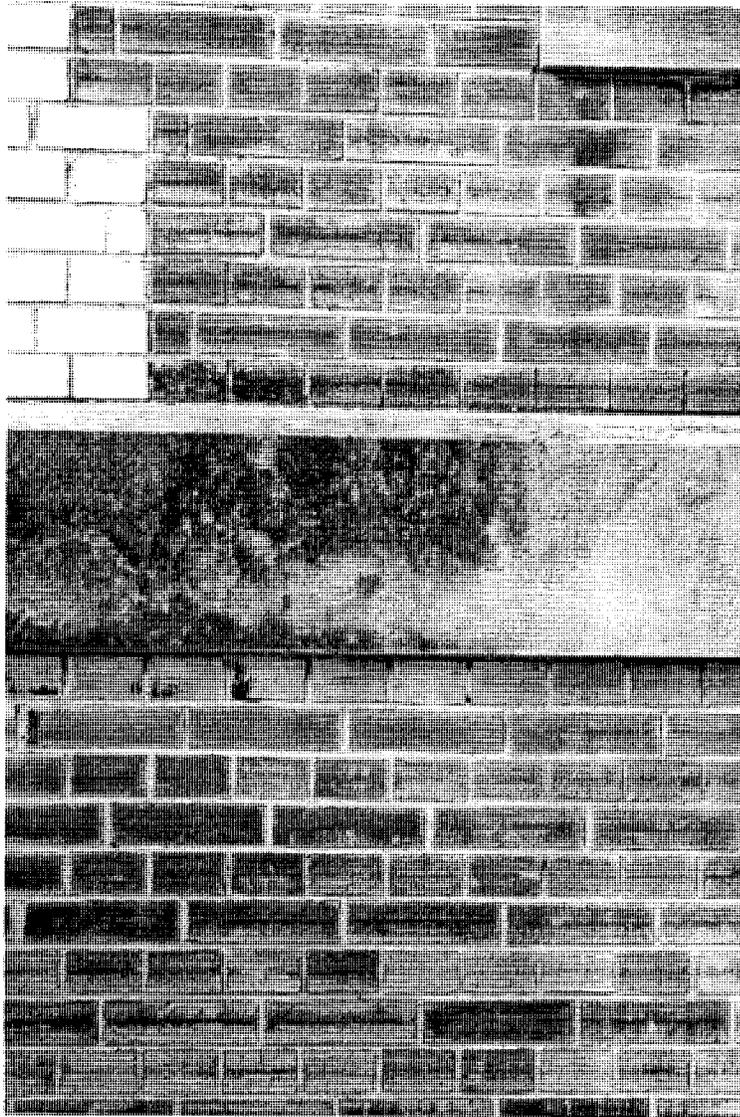
Figure 8-18

After 24 hours of water mist here on the east elevation of Building 4 the appearance of neither brick nor the limestone water table has altered significantly.

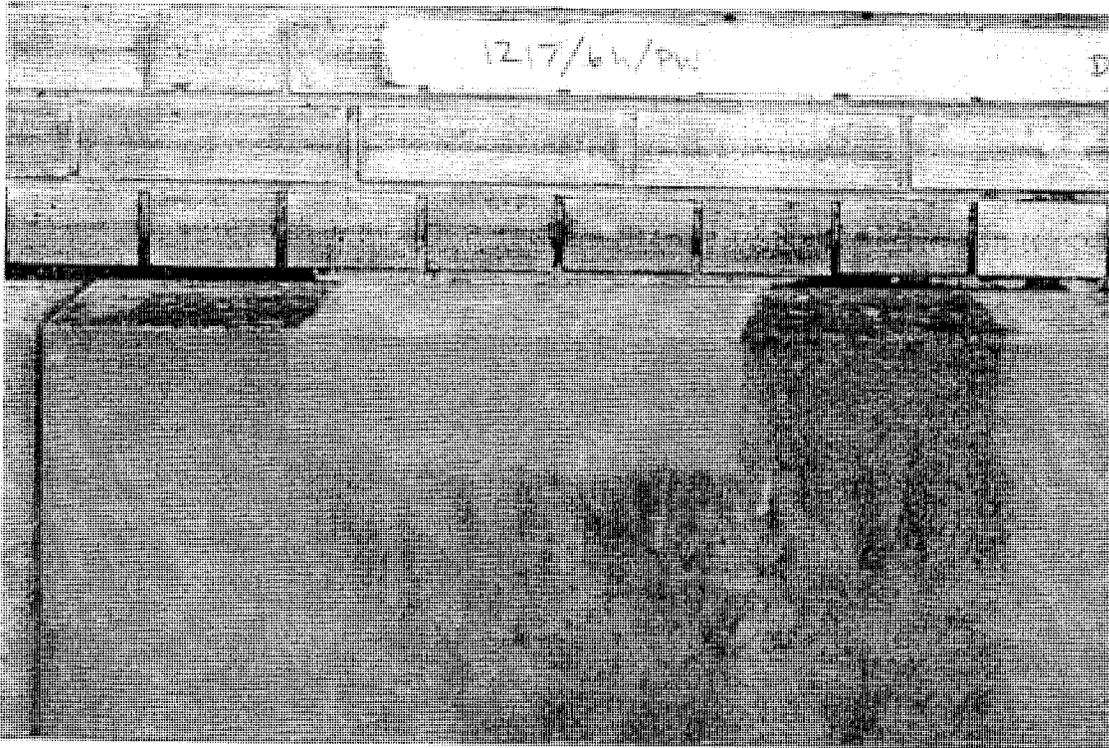
Figure 8- 23

A section of the limestone water table on the north elevation of Building 4 was also cleaned using PROSOCO'S 1217 poultice for 6 hours followed by power washing. Good cleaning is also achieved by this method which is intermediate in aggressiveness to the detergent and alkaline pre-wash/acid after-wash methods. The before cleaning condition can be seen to the left and the to the right of the cleaned area.

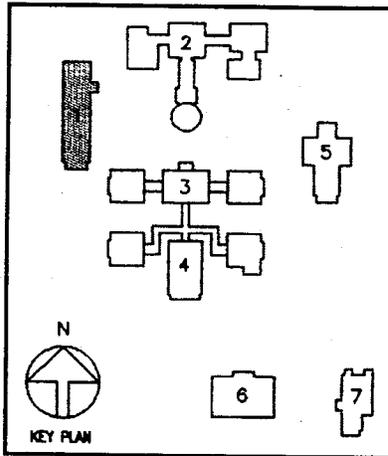
## BUILDING 1: FEMALE NURSES' QUARTERS

Most of the exterior of Building 1 is designated a Restoration Zone including its mass, form, fenestration, main entry, sun porch and other material and features as noted below. Only the areaways are noted as Rehabilitation Zones, and there are no Renovation Zones.

It is recommended that the main entry be restored to its original appearance as noted in the original architectural drawings. This will entail the removal of the obtrusive aluminum and glass vestibule, repair of the surrounding historic fabric and the installation of a new wood and glass door and surround.

The existing original windows and frames should have the paint removed and be repaired. They should then be repainted the original dark green color. It is recommended that screens be installed in the lower half of the window openings so that the windows may be operated in warm weather. The frames of the screens should be color finished to match the windows.

All stress cracks in the masonry should be identified and repaired. All open joints in the masonry should be repointed with mortar to match existing. Spalled and broken masonry units should be replaced to match the existing. Granite elements should be cleaned. Rebuild window wells at the basement level.

The cementitious coating on the main entry stair and porch is obtrusive and is probably obscuring surface and/or structural deterioration. It is recommended that these elements be removed and recast.

The concrete areaways are in very poor condition and should be rebuilt.
