DRINKING WATER ENVIRONMENTAL SAMPLING REPORT

Bannister Federal Complex
1500 East Bannister Road
Kansas City, Missouri

Project Number: 91161

RE: Bannister Federal Complex – Drinking Water Sampling – January 2012
Project # 91161

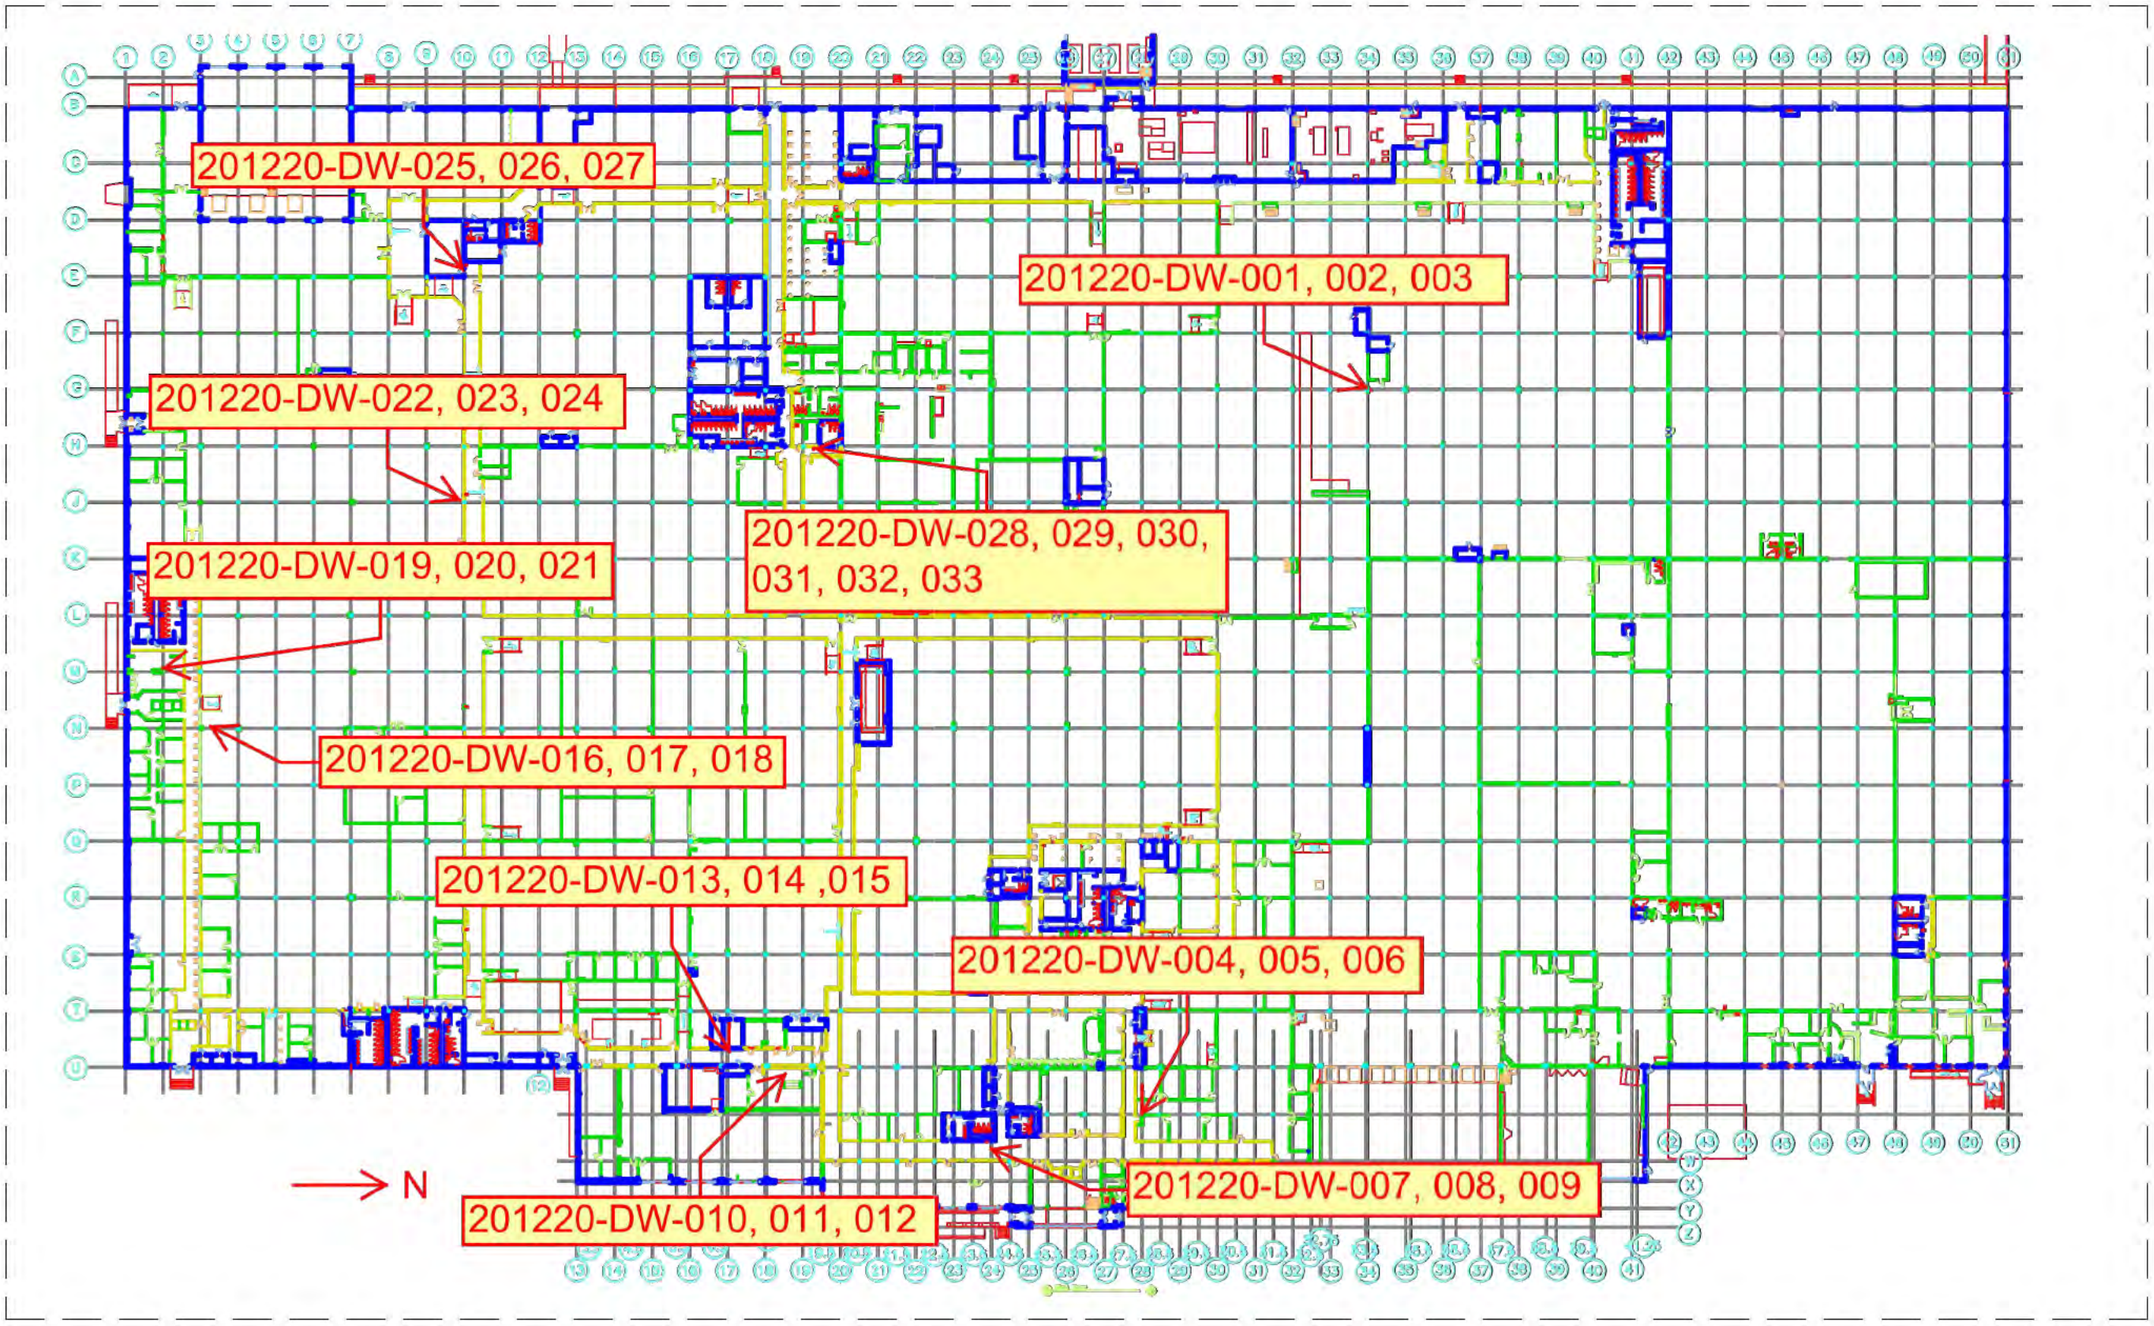
TITLE: BLDG 2306 SAMPLING LOCATIONS	DRAWN BY: JWH	DATE: 2-16-2012	
CLIENT NAME: GSA HEARTLAND REGION			
PROJECT NAME: JANUARY 2012 DRINKING WATER SAMPLING	SCALE: NTS	PROJECT NUMBER 91161

All samples were below the Secondary MCL for iron except for samples 201220-DW-001, 201220-DW-004, 201220-DW-007, 201220-DW-013, 201220-DW-016, 201220-DW-025, 201220-DW-028 (ranging from 13 to 0.51 mg/L). These samples were all collected from Building 2306.
