ENVIRONMENTAL SAMPLING REPORT

Bannister Federal Complex
2306 / 2312 East Bannister Road
Kansas City, Missouri

Project Number: 91035

April 19, 2011

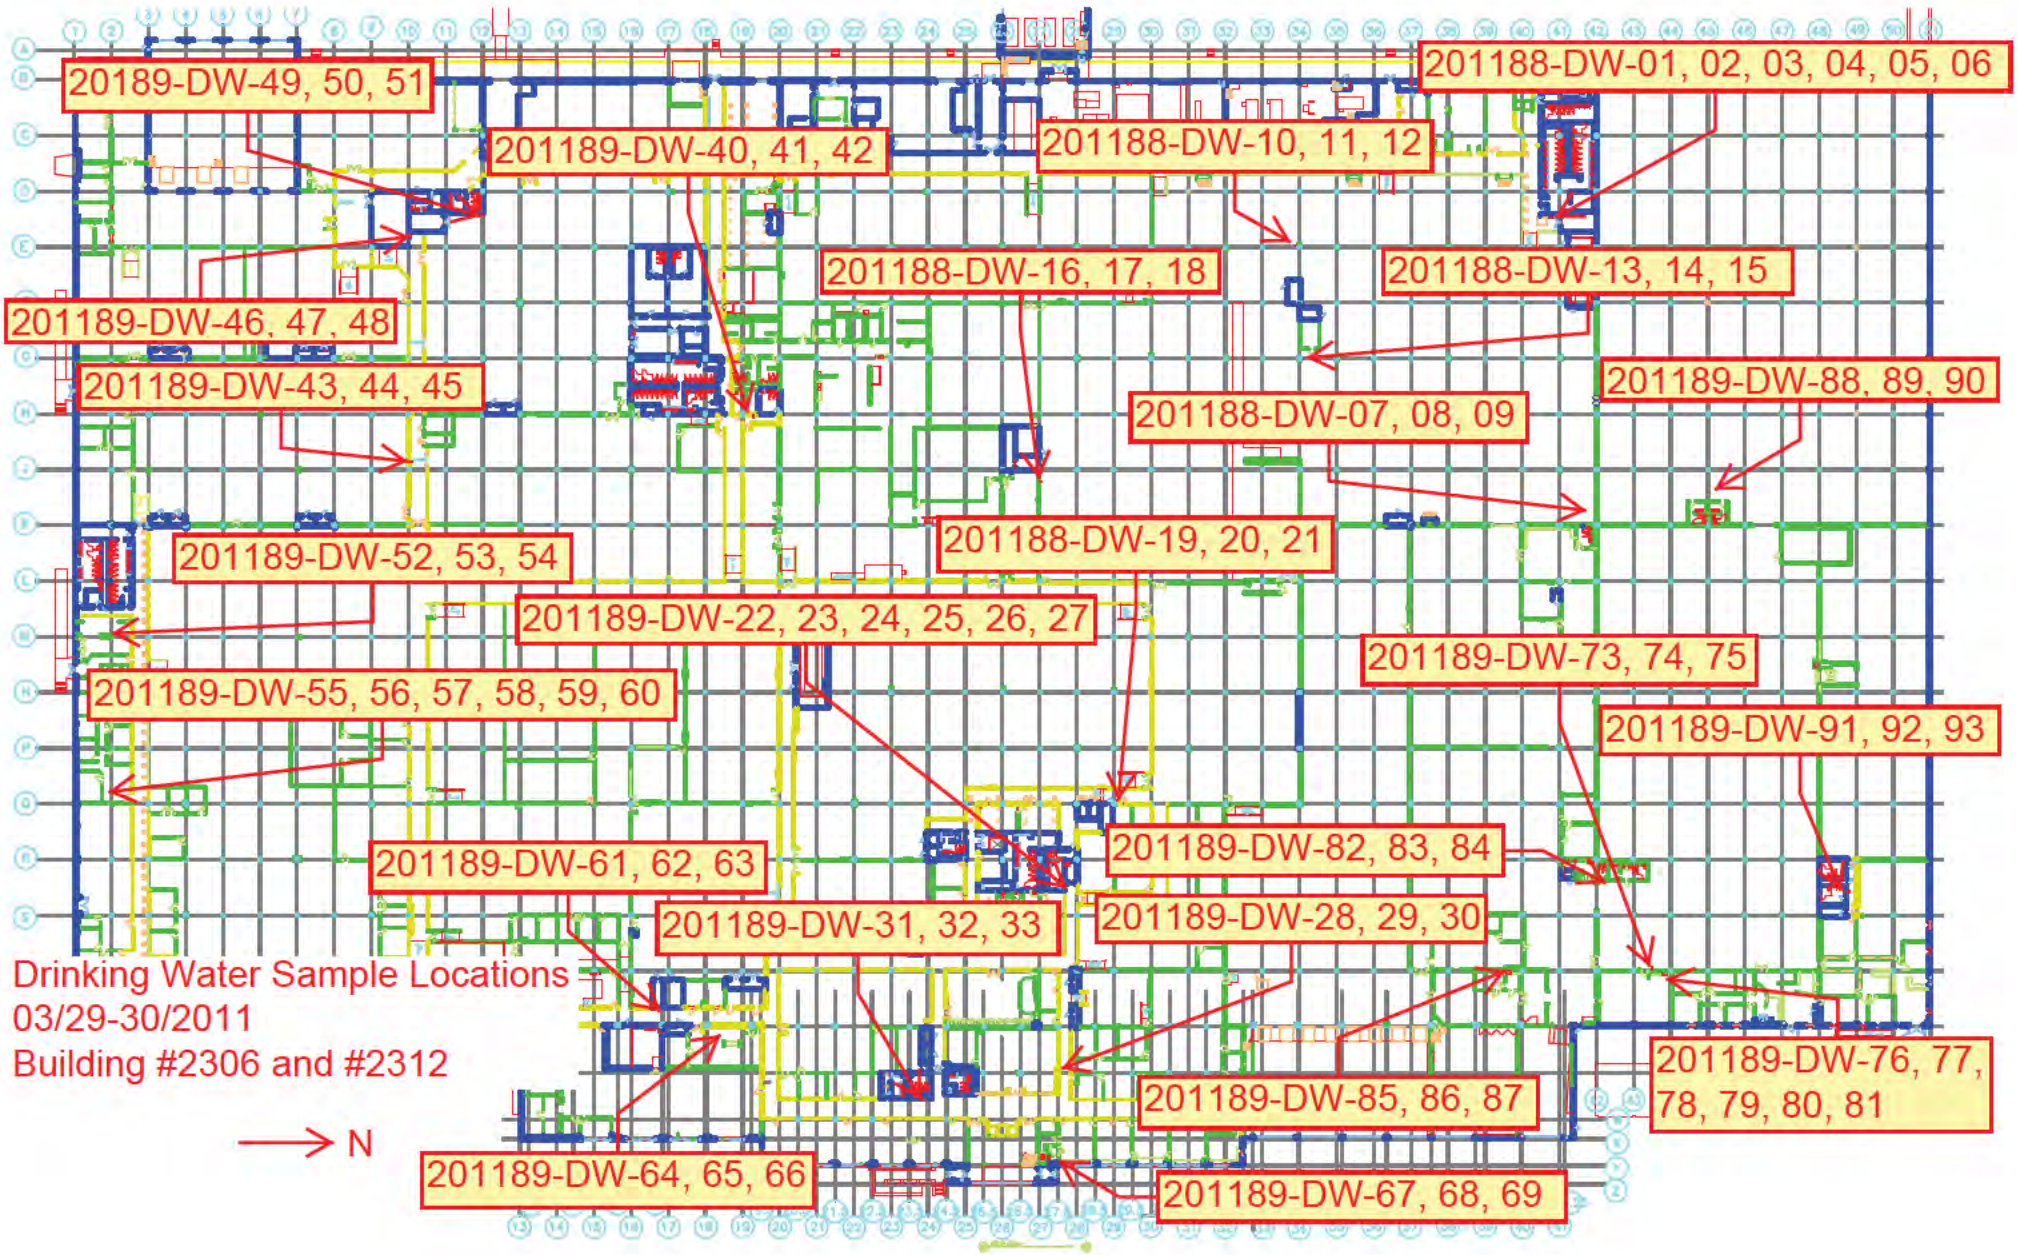
Water Sample Location Diagrams

Sample 201189-DW-085 (0.076 mg/L) was the only sample with a concentration above the MCL for lead. This sample was collected from the darkroom sink near column T38.5 within Building #2312. A filtration system was not noted on the water supply to the sink.

20189-DW-49, 50, 51
201188-DW-01, 02, 03, 04, 05, 06
201189-DW-40, 41, 42
201188-DW-10, 11, 12
201188-DW-16, 17, 18
201188-DW-13, 14, 15
201189-DW-46, 47, 48
201189-DW-43, 44, 45
201189-DW-88, 89, 90
201188-DW-07, 08, 09
201188-DW-19, 20, 21
201189-DW-52, 53, 54
201189-DW-22, 23, 24, 25, 26, 27
201189-DW-73, 74, 75
201189-DW-55, 56, 57, 58, 59, 60
201189-DW-91, 92, 93
201189-DW-82, 83, 84
201189-DW-61, 62, 63
201189-DW-31, 32, 33
201189-DW-28, 29, 30
Drinking Water Sample Locations
03/29-30/2011
Building #2306 and #2312
201189-DW-76, 77, 78, 79, 80, 81
201189-DW-85, 86, 87
N
201189-DW-64, 65, 66
201189-DW-67, 68, 69
