Expanded Site Inspection Report

**Pedricktown Support Facility
Salem County, New Jersey**

December 21, 1993

***Versar* Inc.**

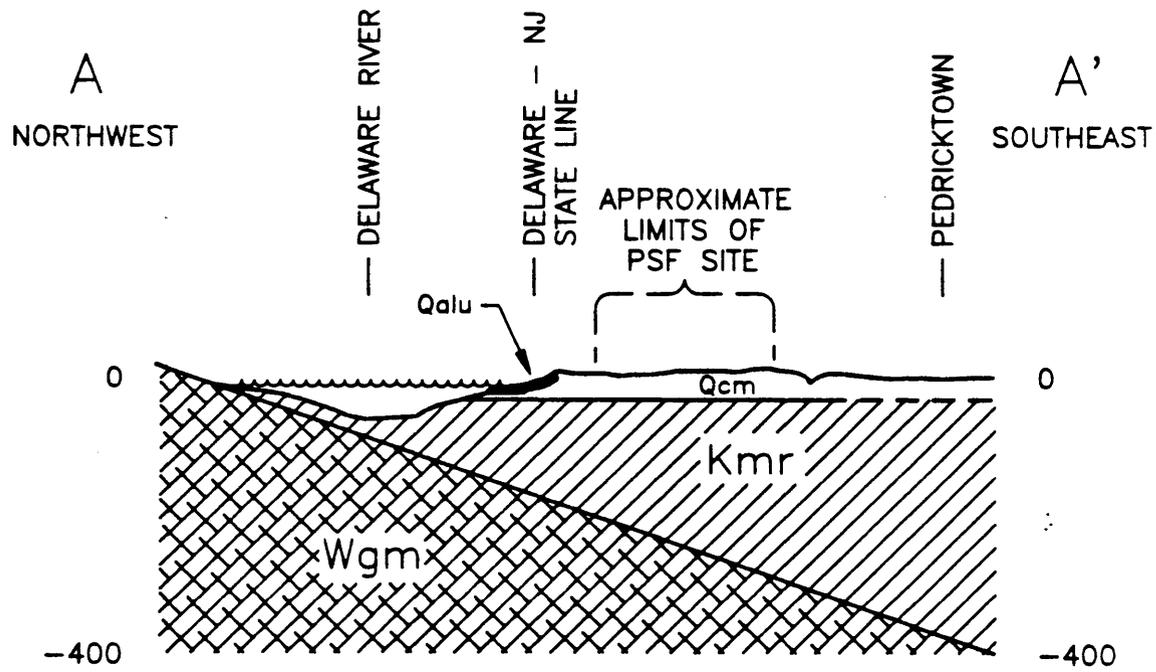
FIGURE 2.1
 LOCALIZED STRATIGRAPHY OF THE PSF SITE

ERA	SYSTEM	EPOCH	FORMATION	DESCRIPTION
CENOZOIC	QUATERNARY	HOLOCENE	HOLOCENE UNDIFFERENTIATED ALLUVIUM	ORGANIC SOILS, MEDIUM TO COARSE SANDS, SILTS AND GRAVELS.
		PLEISTOCENE	CAPE MAY FORMATION	MEDIUM TO COARSE QUARTZOSE SAND WITH ABUNDANT GRAVEL AND MINOR AMOUNTS OF CLAY.
MESOZOIC	CRETACEOUS	—	POTOMAC GROUP—RARITAN AND MAGOTHY FORMATIONS	MEDIUM TO FINE QUARTZ SANDS INTERBEDDED WITH VARIEGATED CLAYS
PRECAMBRIAN	—	—	WISSAHICKON FORMATION	SCHIST - GNEISS

- Kmr**
 POTOMAC GROUP - RARITAN AND MAGOTHY FORMATION
- Wgm**
 WISSAHICKON FORMATION
- Qalu**
 QUATERNARY HOLOCENE UNDIFFERENTIATED ALLUVIUM
- Qcm**
 PLEISTOCENE CAPE MAY FORMATION

NOTE:
 LINE OF SECTION IS SHOWN IN FIGURE 2.6.
 DATUM IS MEAN SEA LEVEL.

The top of the Wissahickon formation has an irregular shape and slopes 40 to 140 feet per mile to the southeast (Figure 2.1). The formation is characterized by joints and fractures within the stratigraphic section and crops out in the vicinity of Wilmington, Delaware.

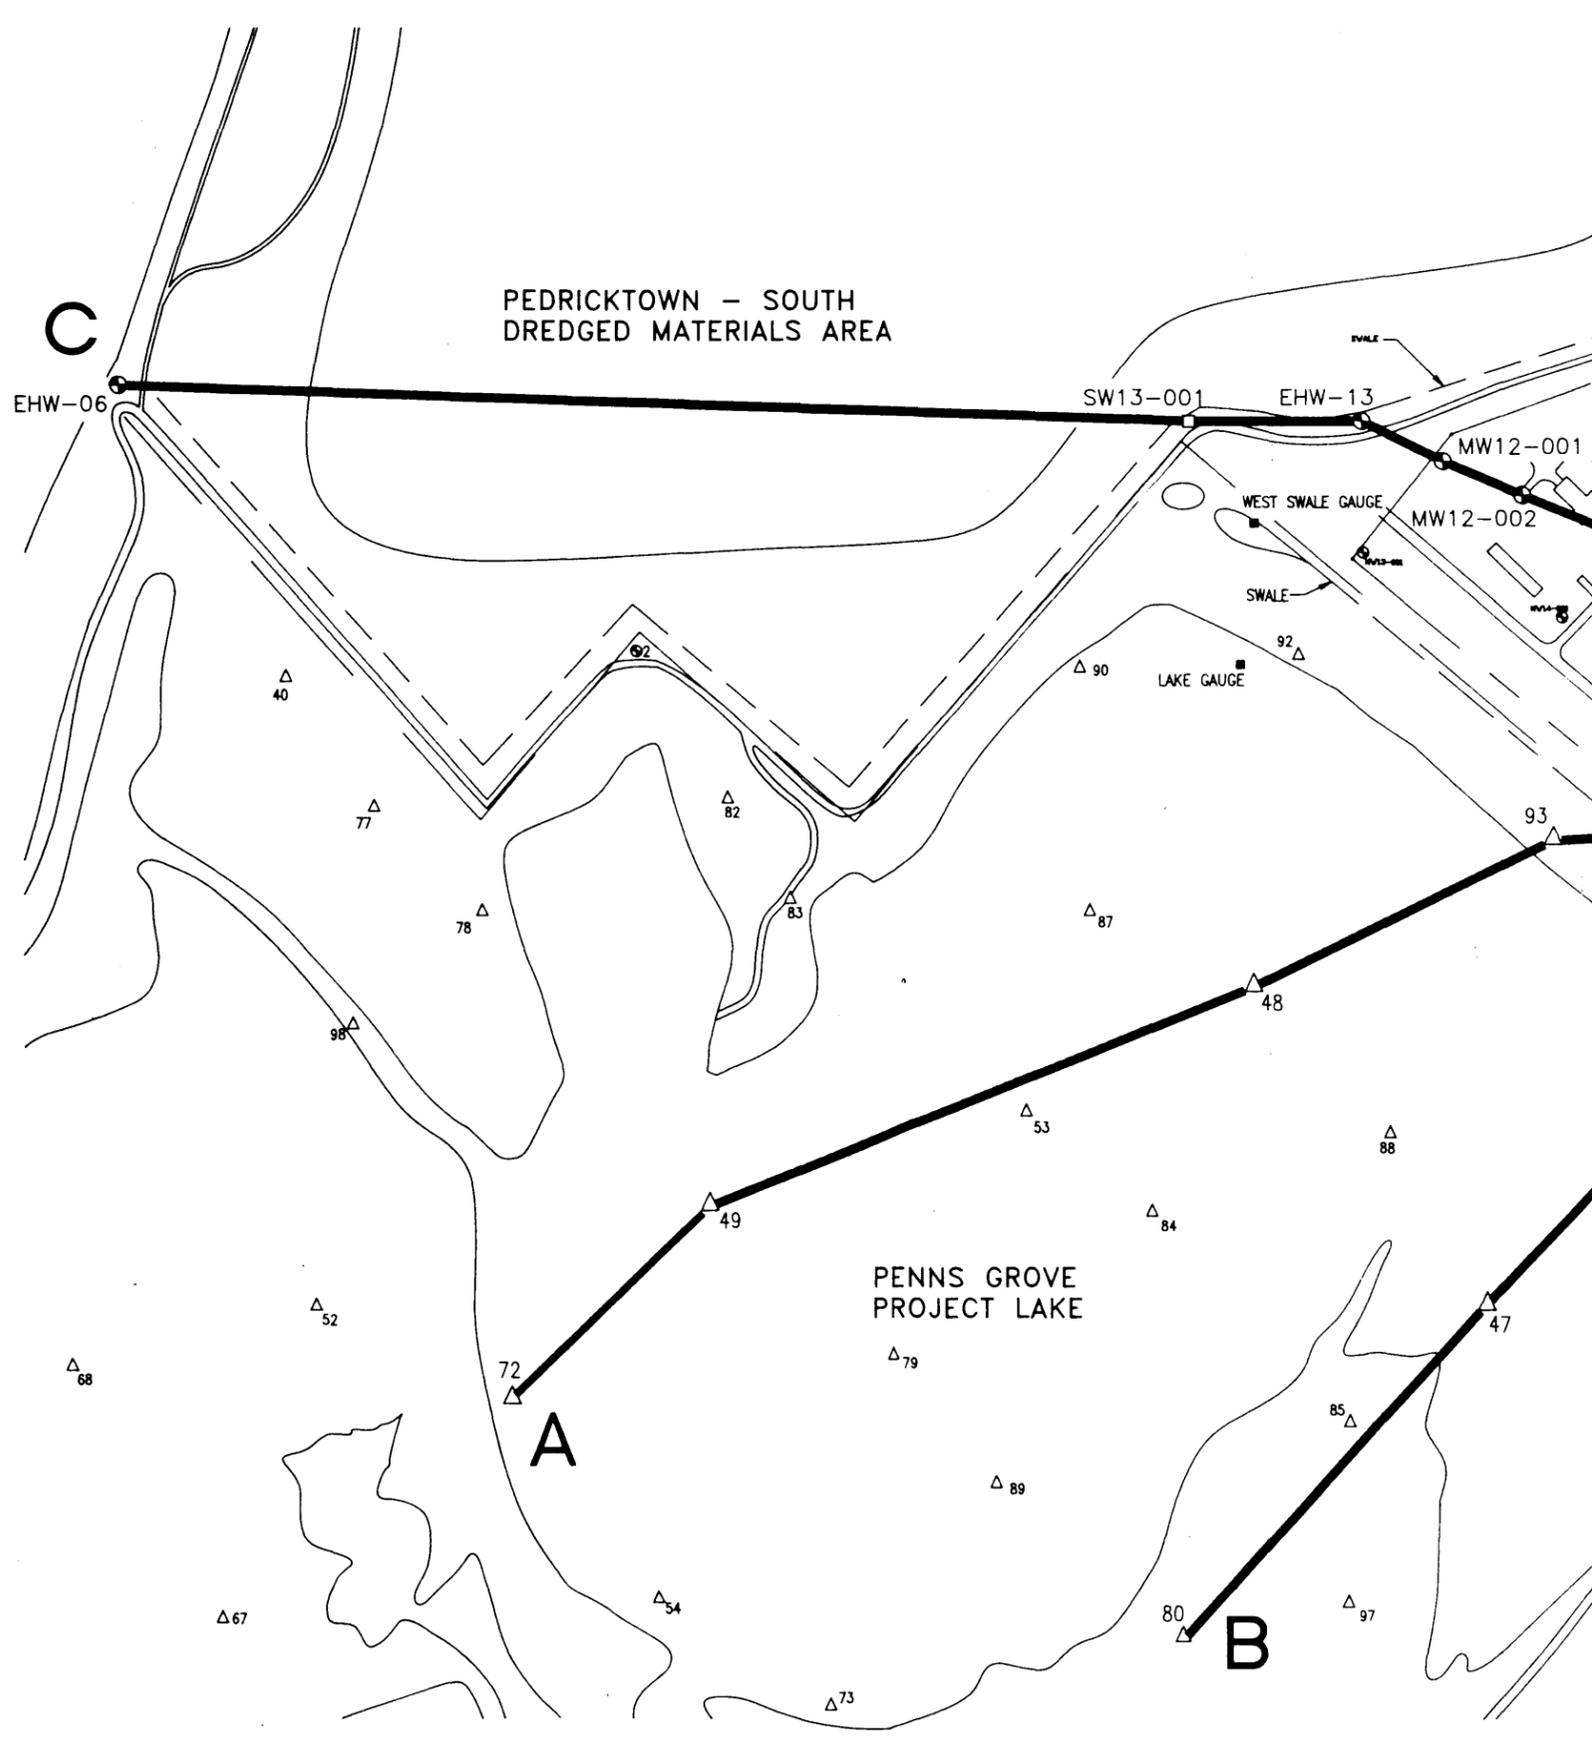
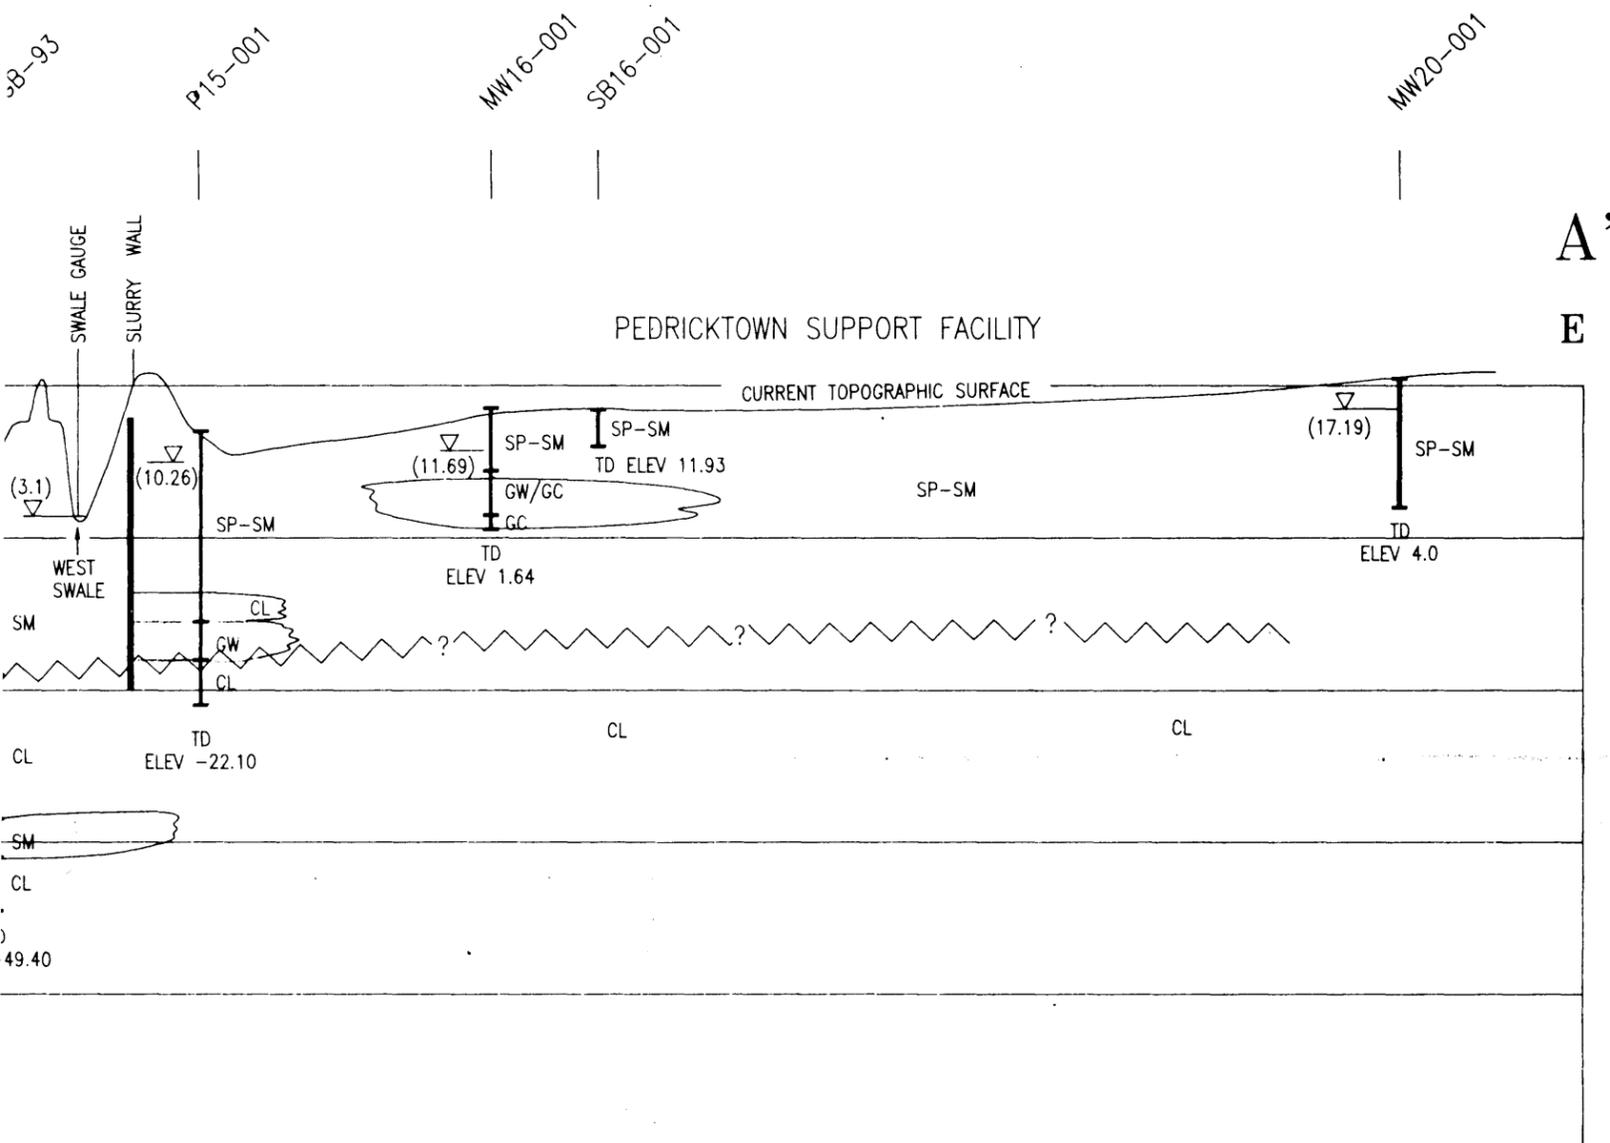
SECTION A-A'

LEVELS WERE MEASURED ON 6/28/93 AT HIGH TIDE.

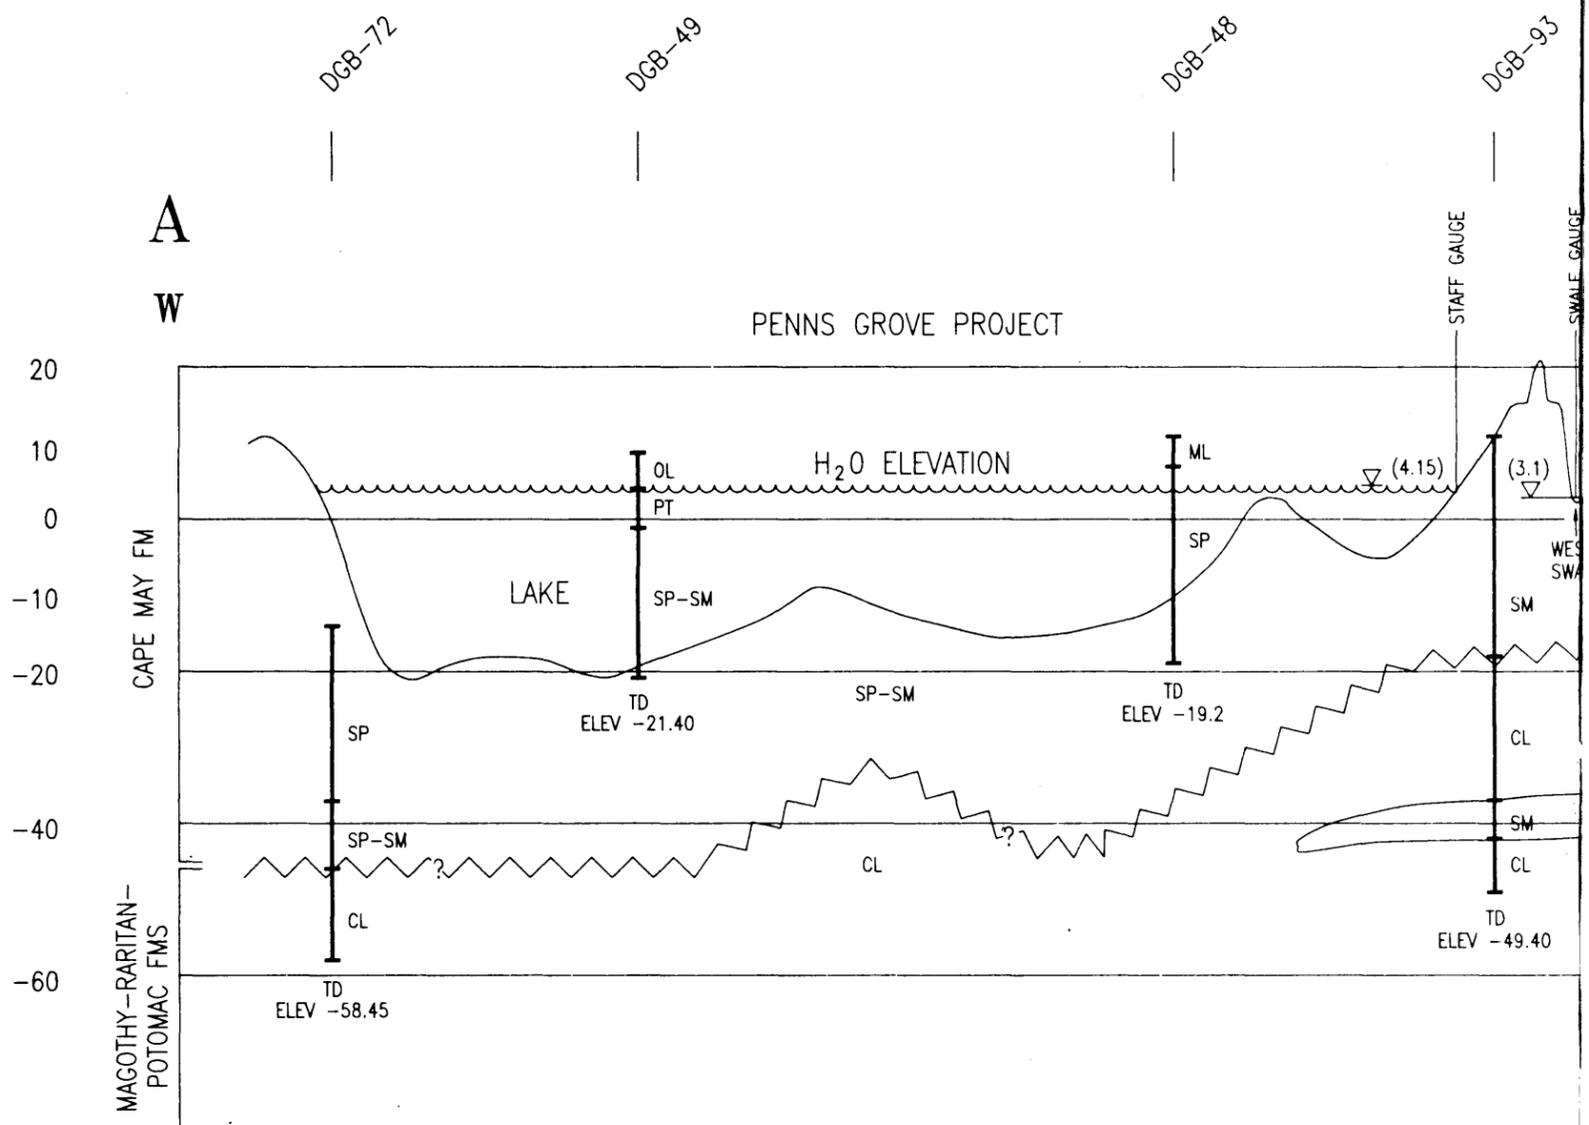
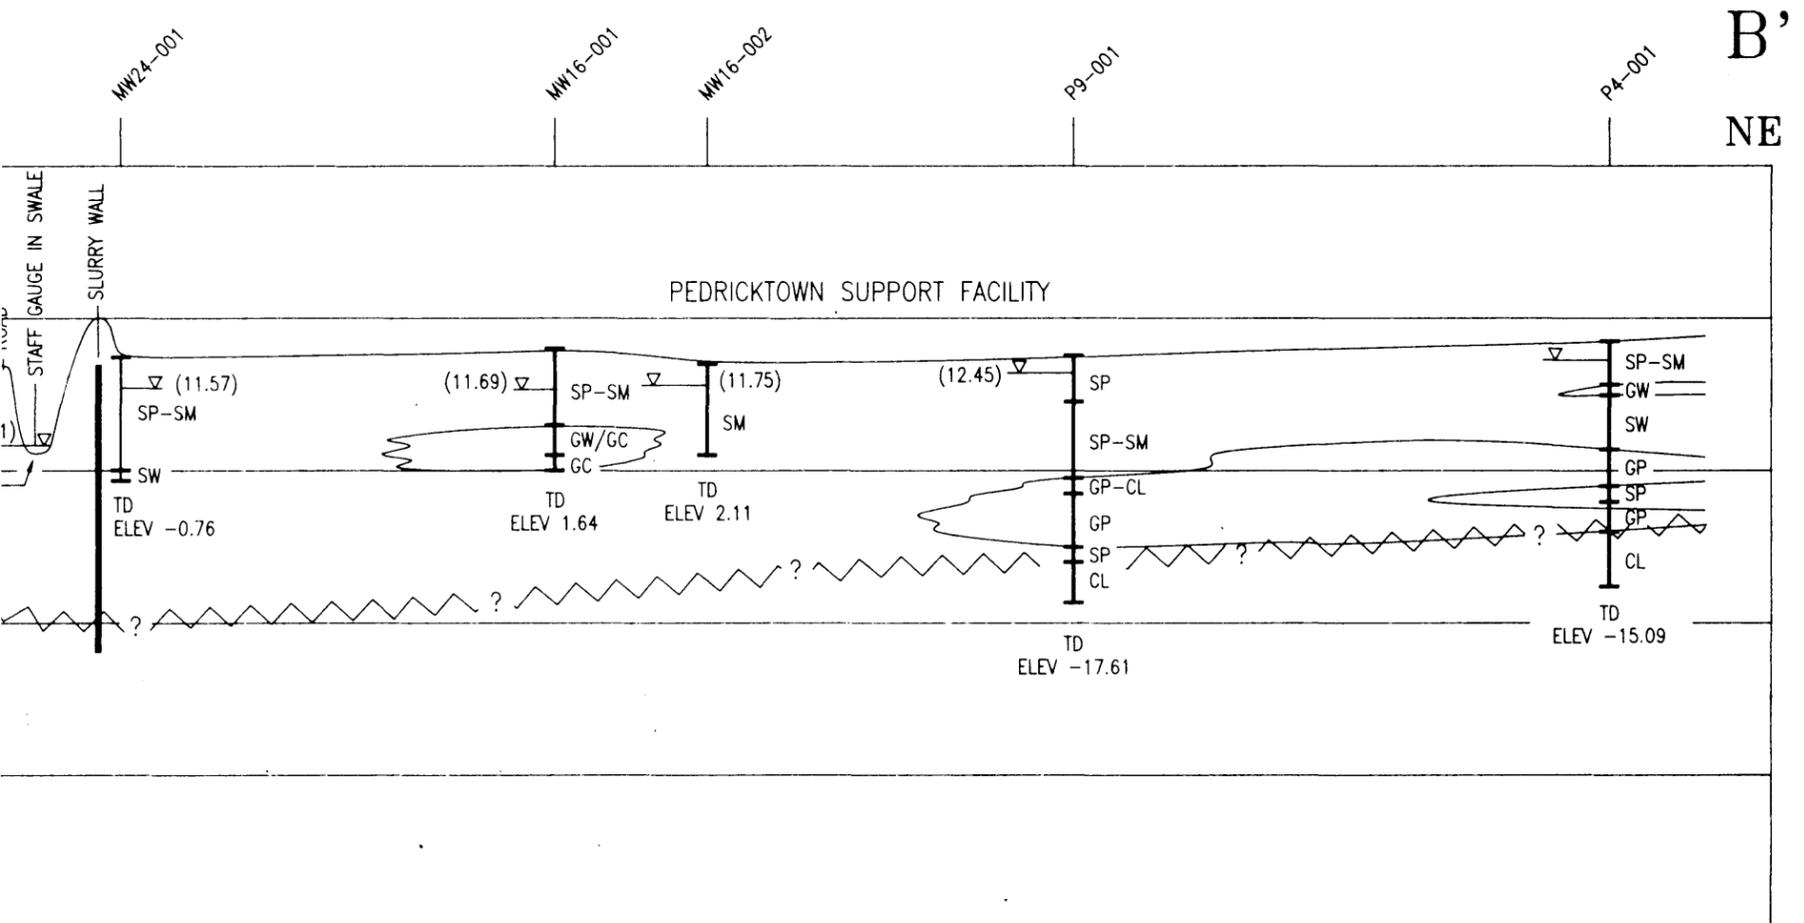
- ∇ (11.57) — GROUND WATER ELEVATION IN FEET ABOVE MEAN SEA LEVEL. WATER LEVELS
- TD ELEV. — TOTAL DEPTH ELEVATION OF WELL OR BORING IN FEET ABOVE OR BELOW MEAN SEA LEVEL
- UNCONFORMITY BETWEEN THE PLEISTOCENE CAPE MAY FORMATION AND THE CRETACEOUS UNCONFORMITY OF THE PENNS GROVE PROJECT.
- NOTE — INFORMATION ON THE LOCATION OF THE TOP OF THE CRETACEOUS UNCONFORMITY OF THE PENNS GROVE PROJECT.

CROSS SECTION B-B'

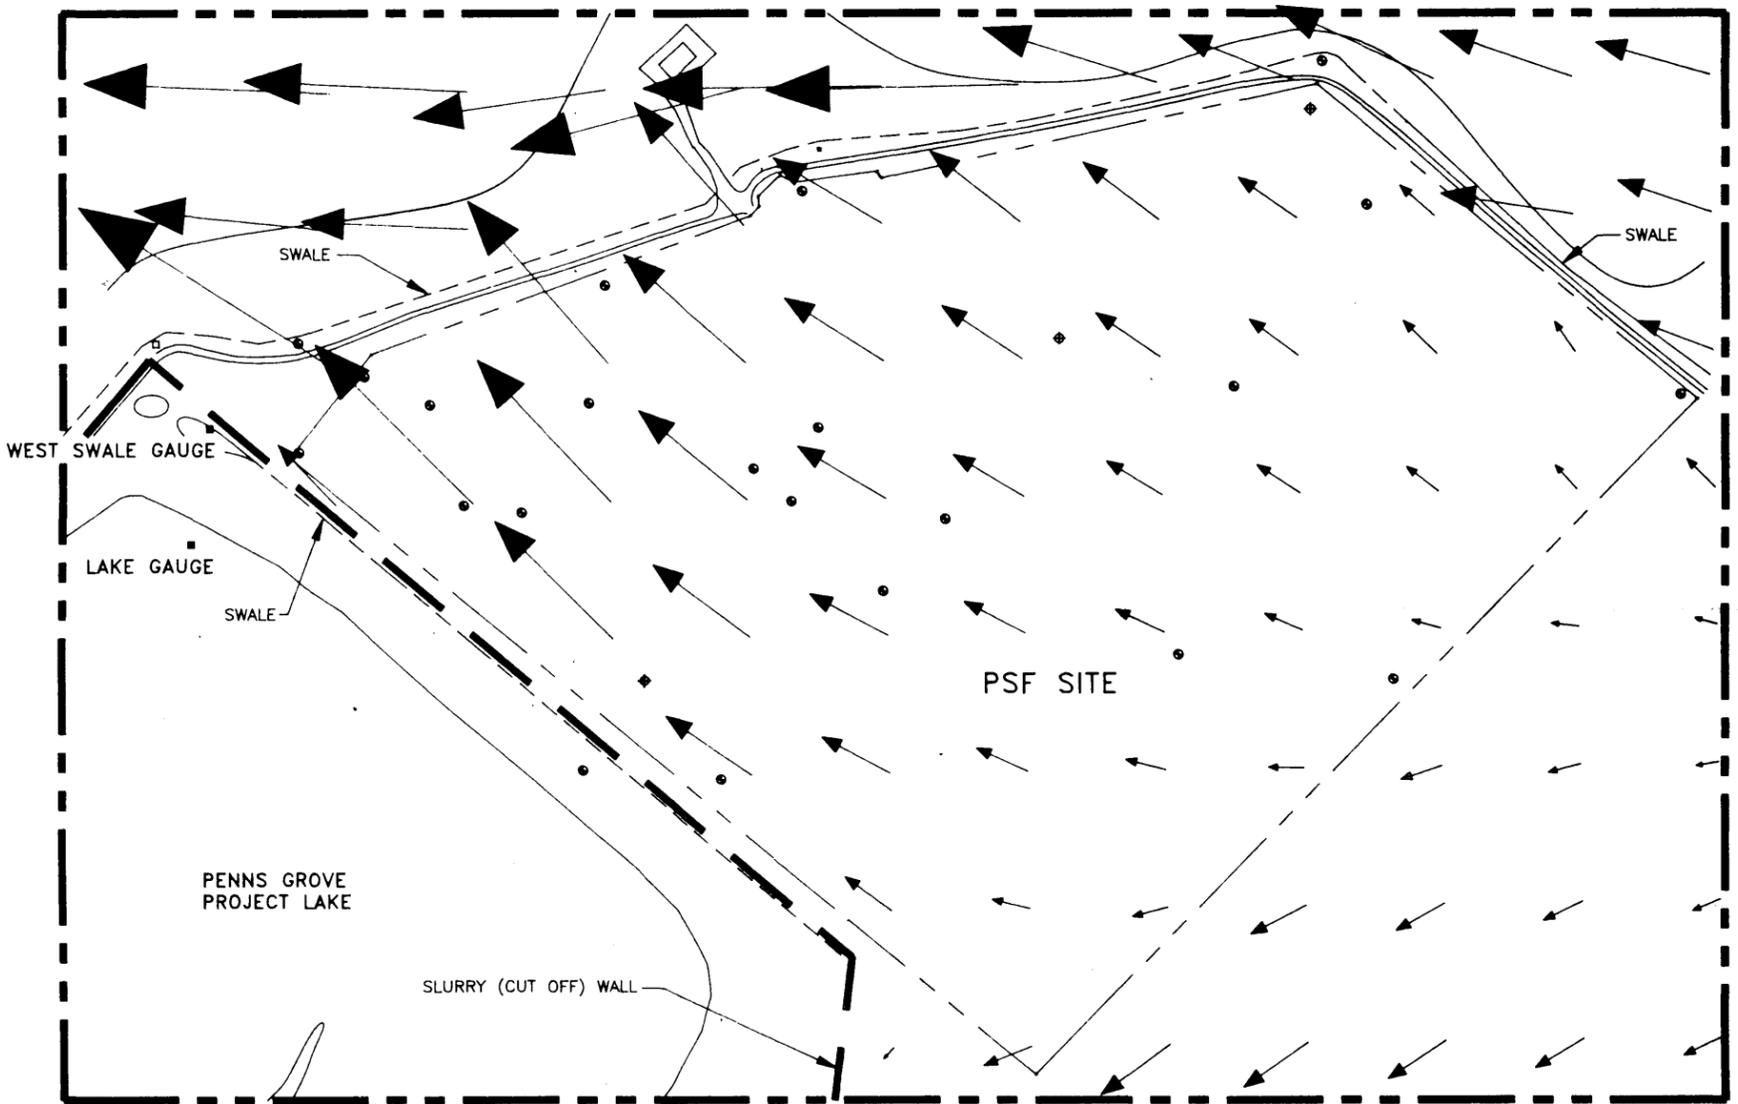
EXPLODED VIEW OF GROUNDWATER VELOCITY DISTRIBUTIONS AT PSF

(VELOCITY RANGE: AVG. = 0.18 FT/DAY
MAX. = 0.71 FT/DAY)

VECTORS INDICATE DIRECTION AND RELATIVE MAGNITUDE OF GROUNDWATER FLOW.

The groundwater model calculated groundwater velocities at PSF to have an average of $3.55 \times 10E-1$ ft/day. The groundwater velocities determined from the water table and hydraulic conductivity maps were calculated to have an average velocity of $3.32 \times 10E-2$ ft/day. Because the average velocities calculated by these two methods are similar, the groundwater velocities calculated by the model are assumed to be representative of the actual conditions at the PSF site (Appendix C).

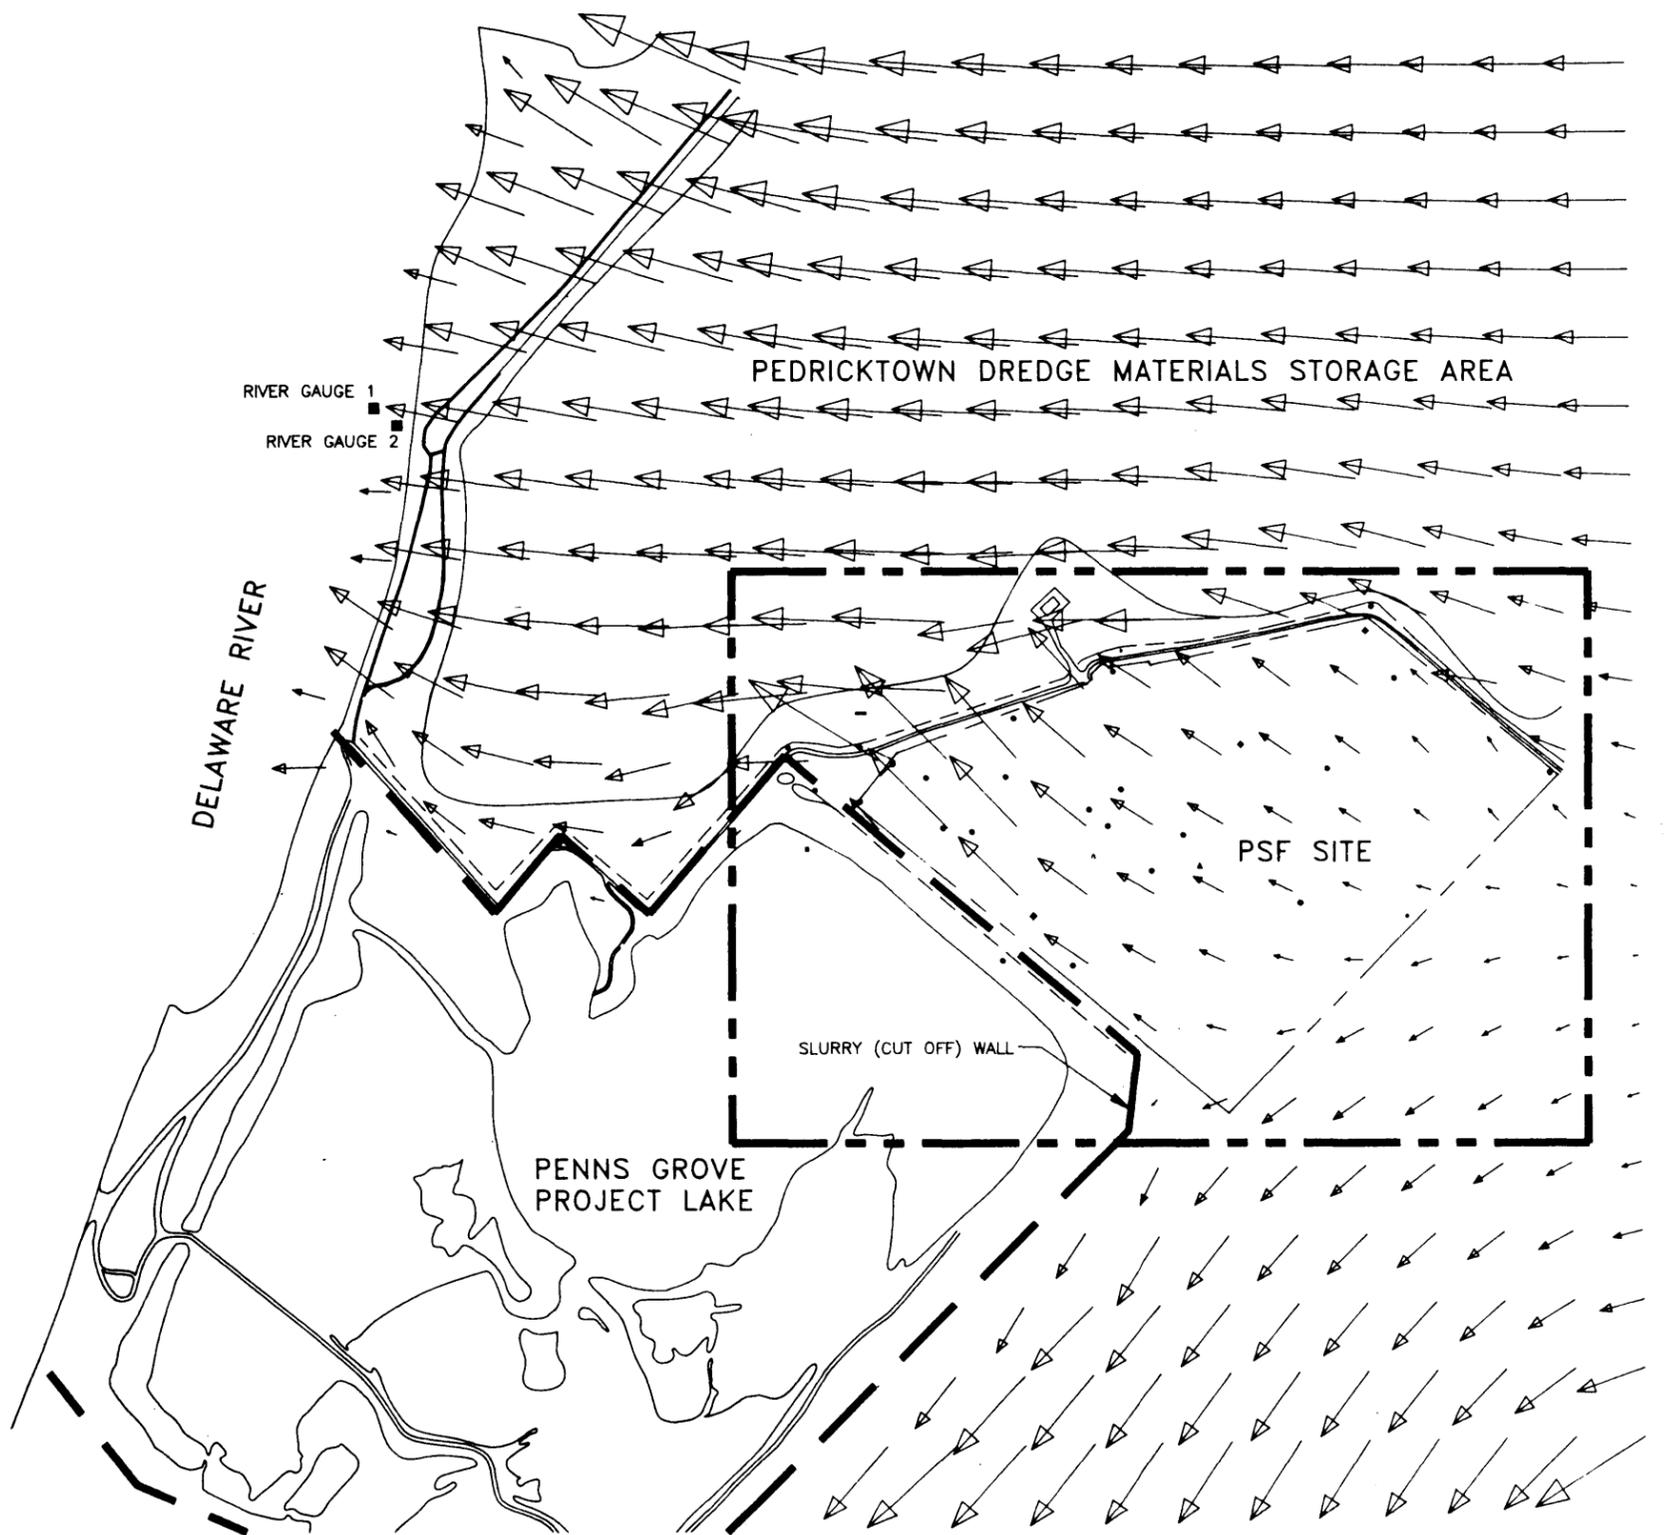
FLOWPATH[®] GENERATED GROUNDWATER VELOCITY DISTRIBUTION
FOR PSF AND CONTIGUOUS AREA
(PSFMODEL)

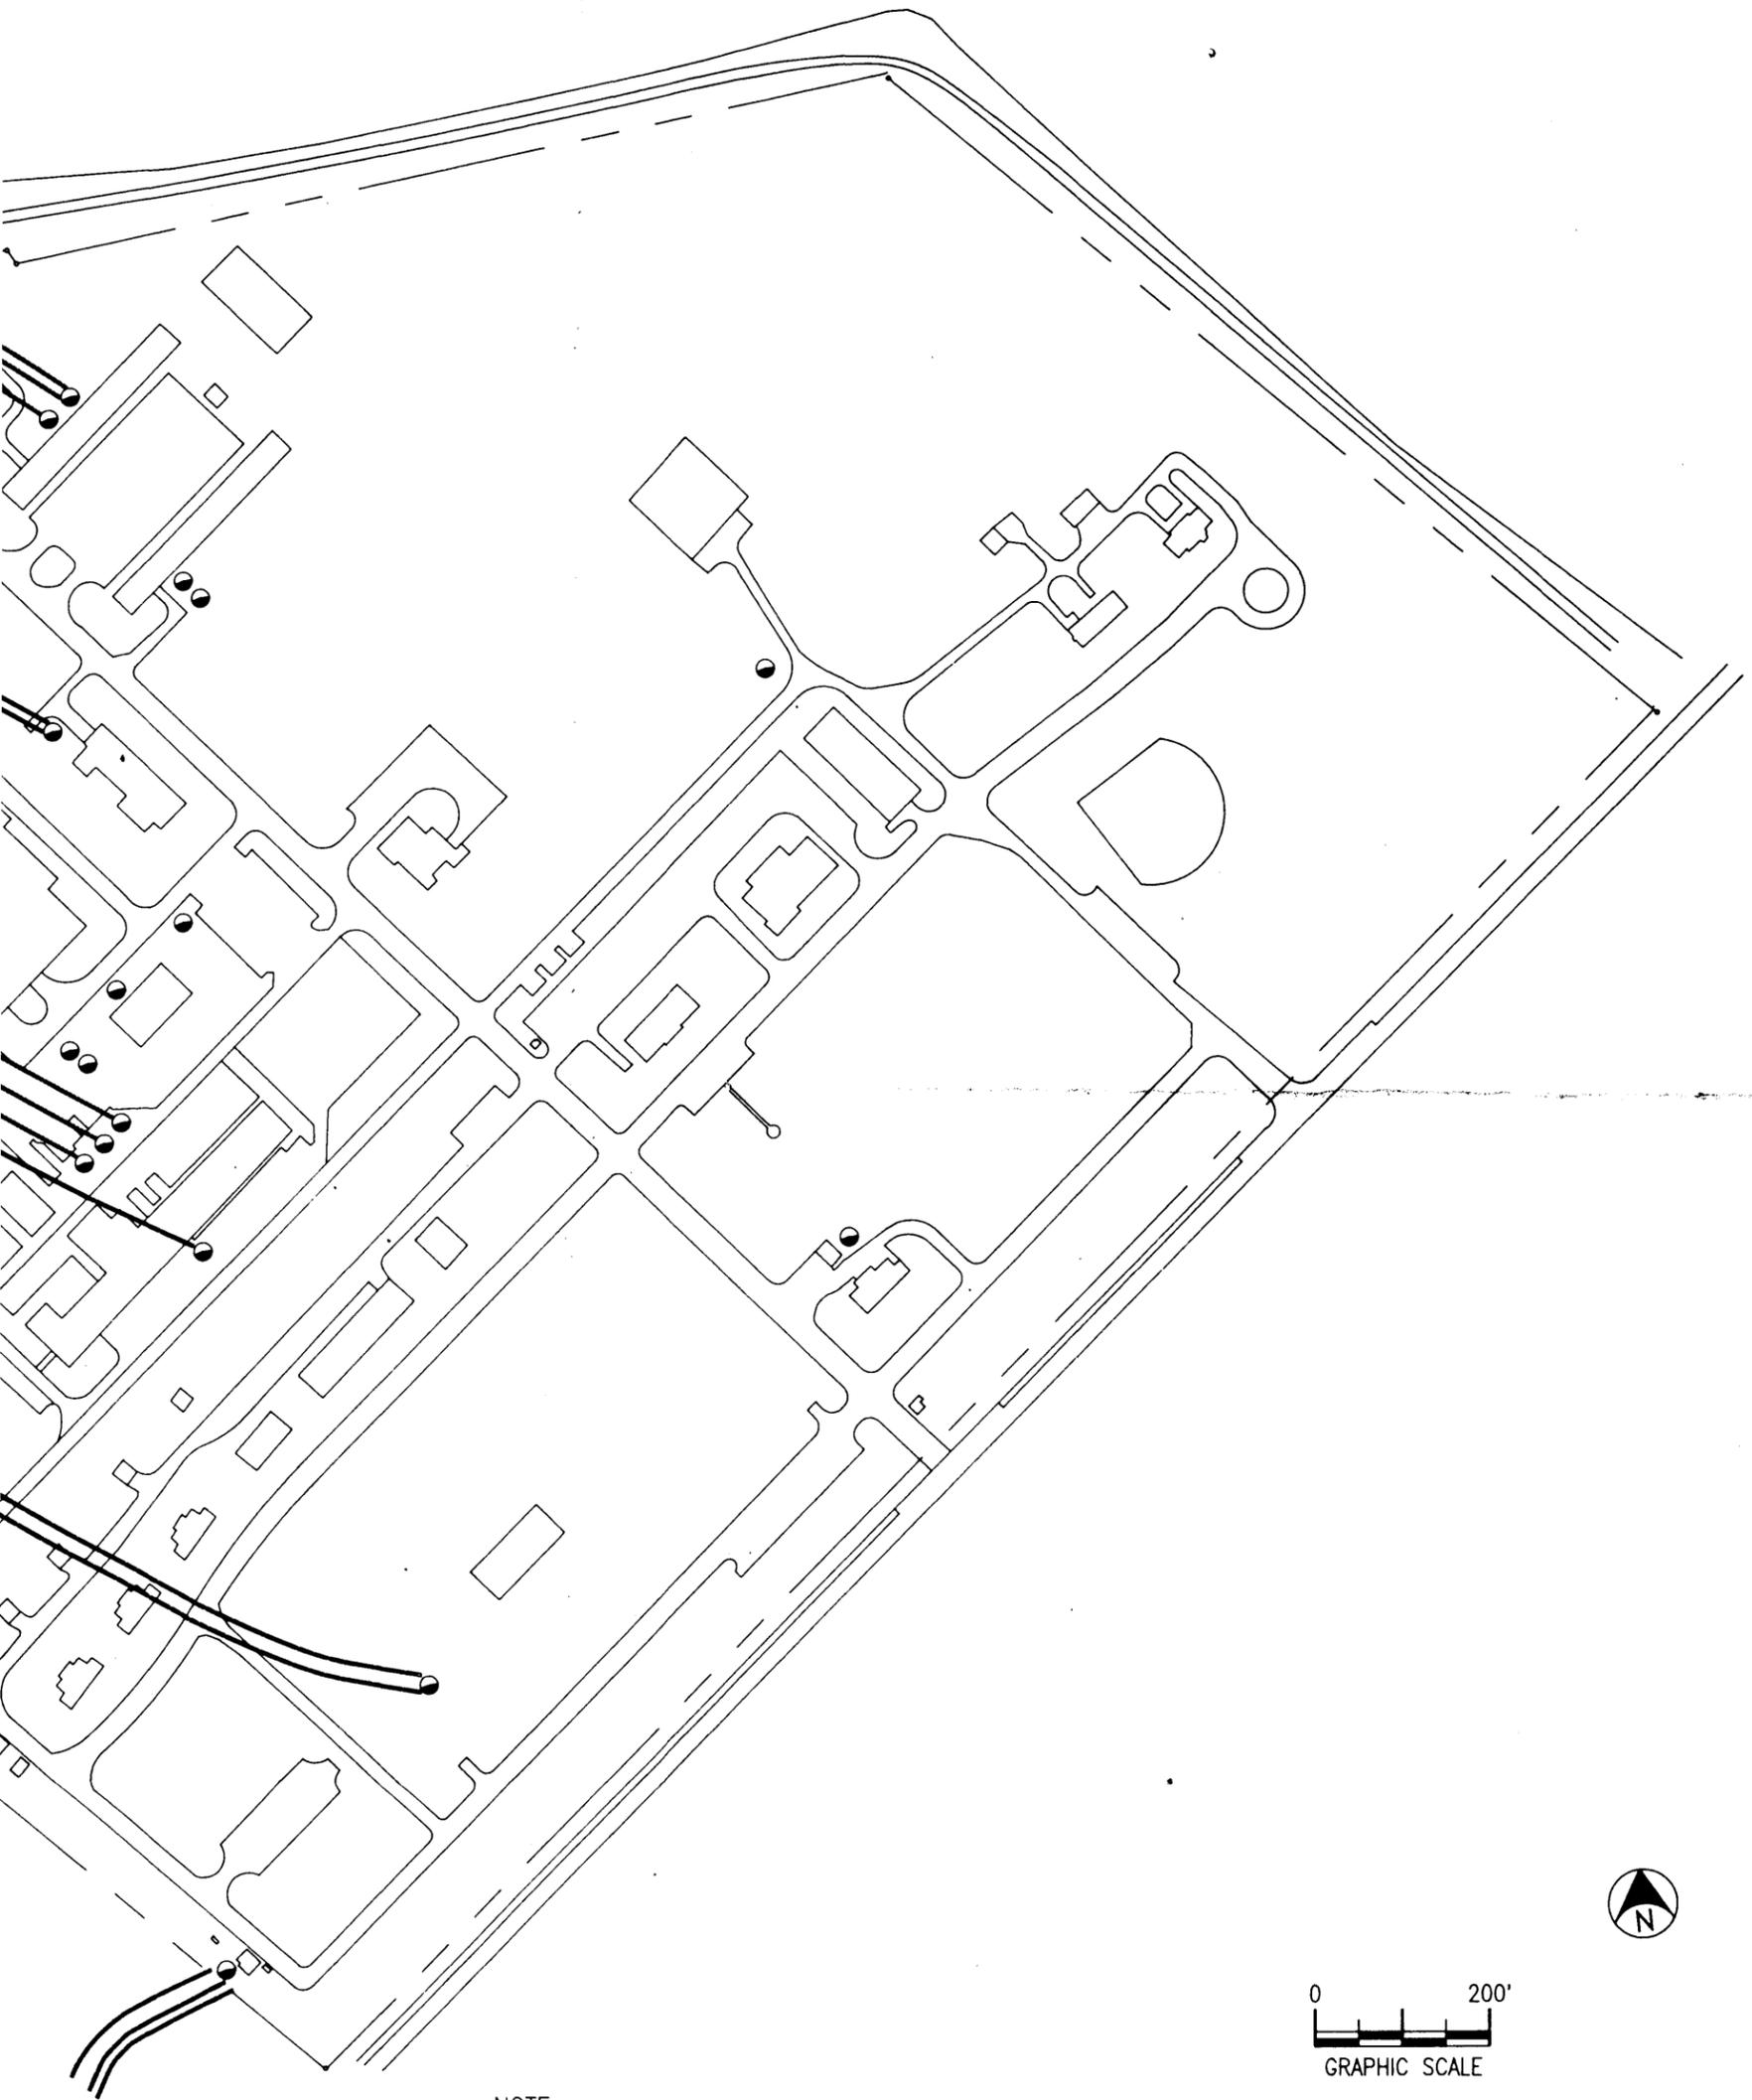
NOTE: (R)
 FLOWPATH DERIVED STEADY-STATE PARTICLE TRAJECTORIES (PATHLINES) ON MAP REPRESENT PROBABLE CONTAMINANT TRANSPORT PATHWAYS WHICH WOULD OCCUR FOLLOWING ANY SIGNIFICANT RELEASE TO THE AQUIFER AT THE LOCATIONS SHOWN.

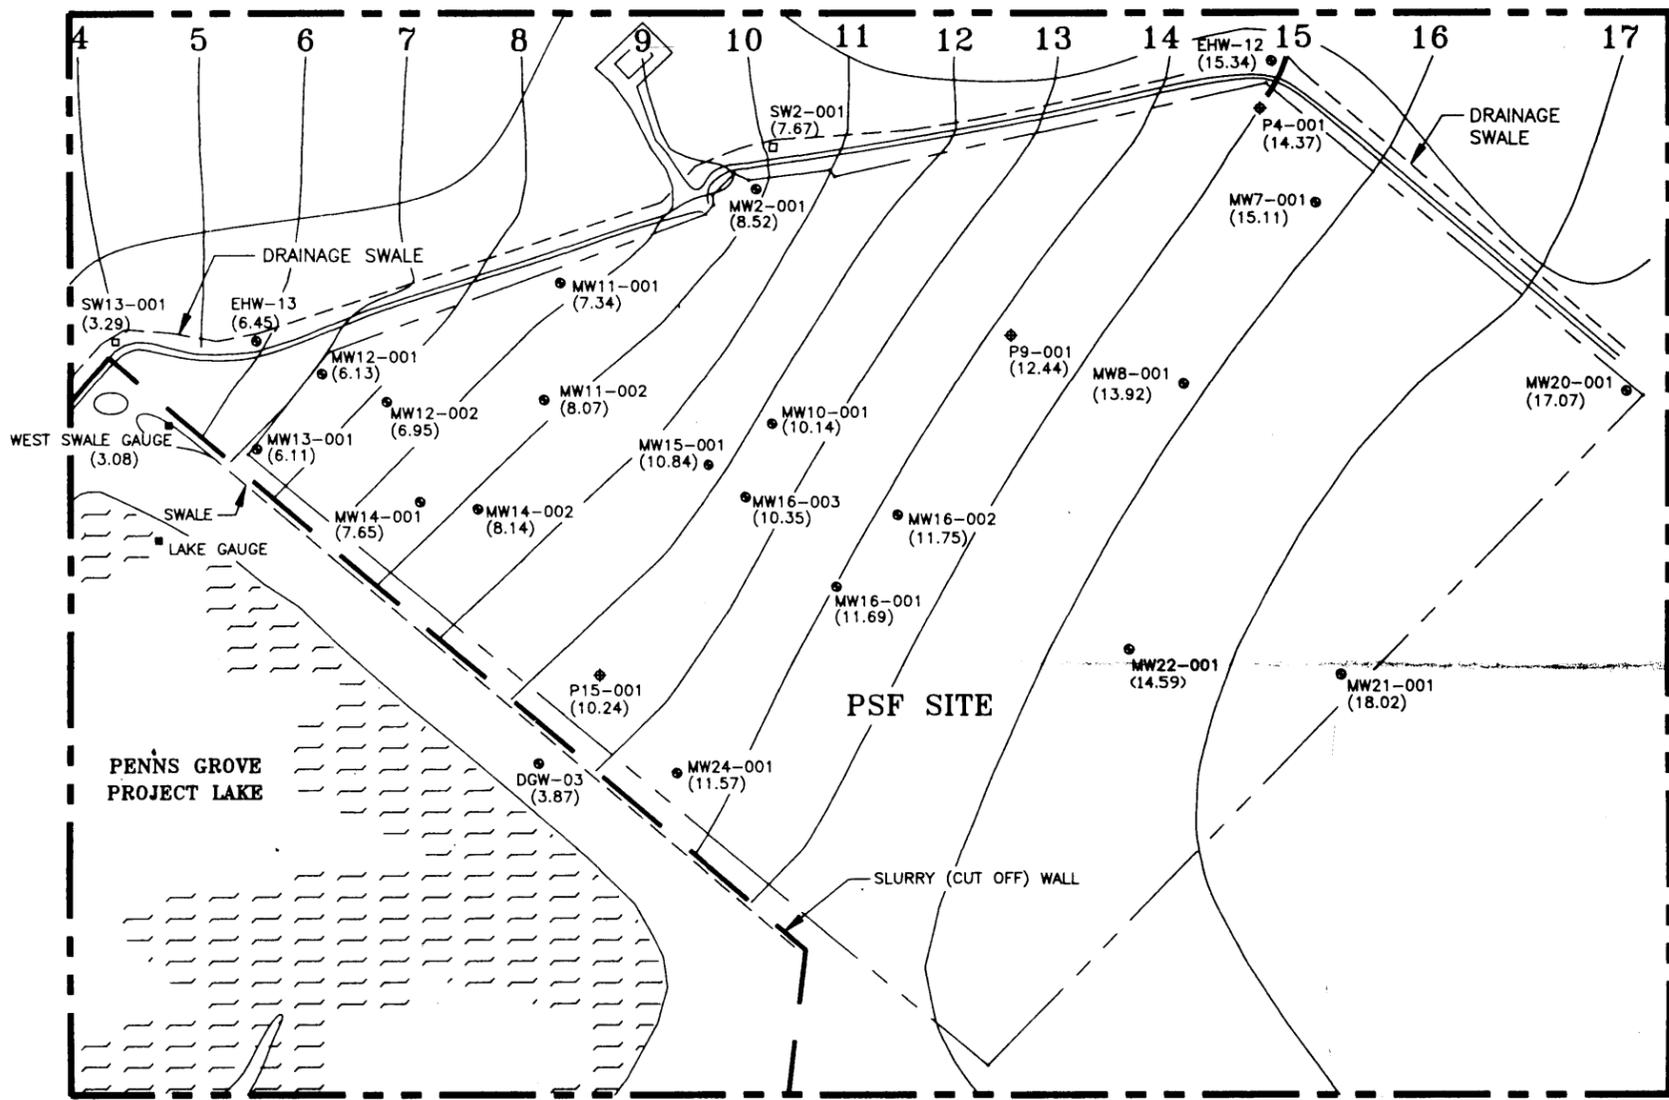
EXPLODED VIEW OF PSF SITE
 (WATER TABLE ELEVATION CONTOUR INTERVAL = 1 FOOT)

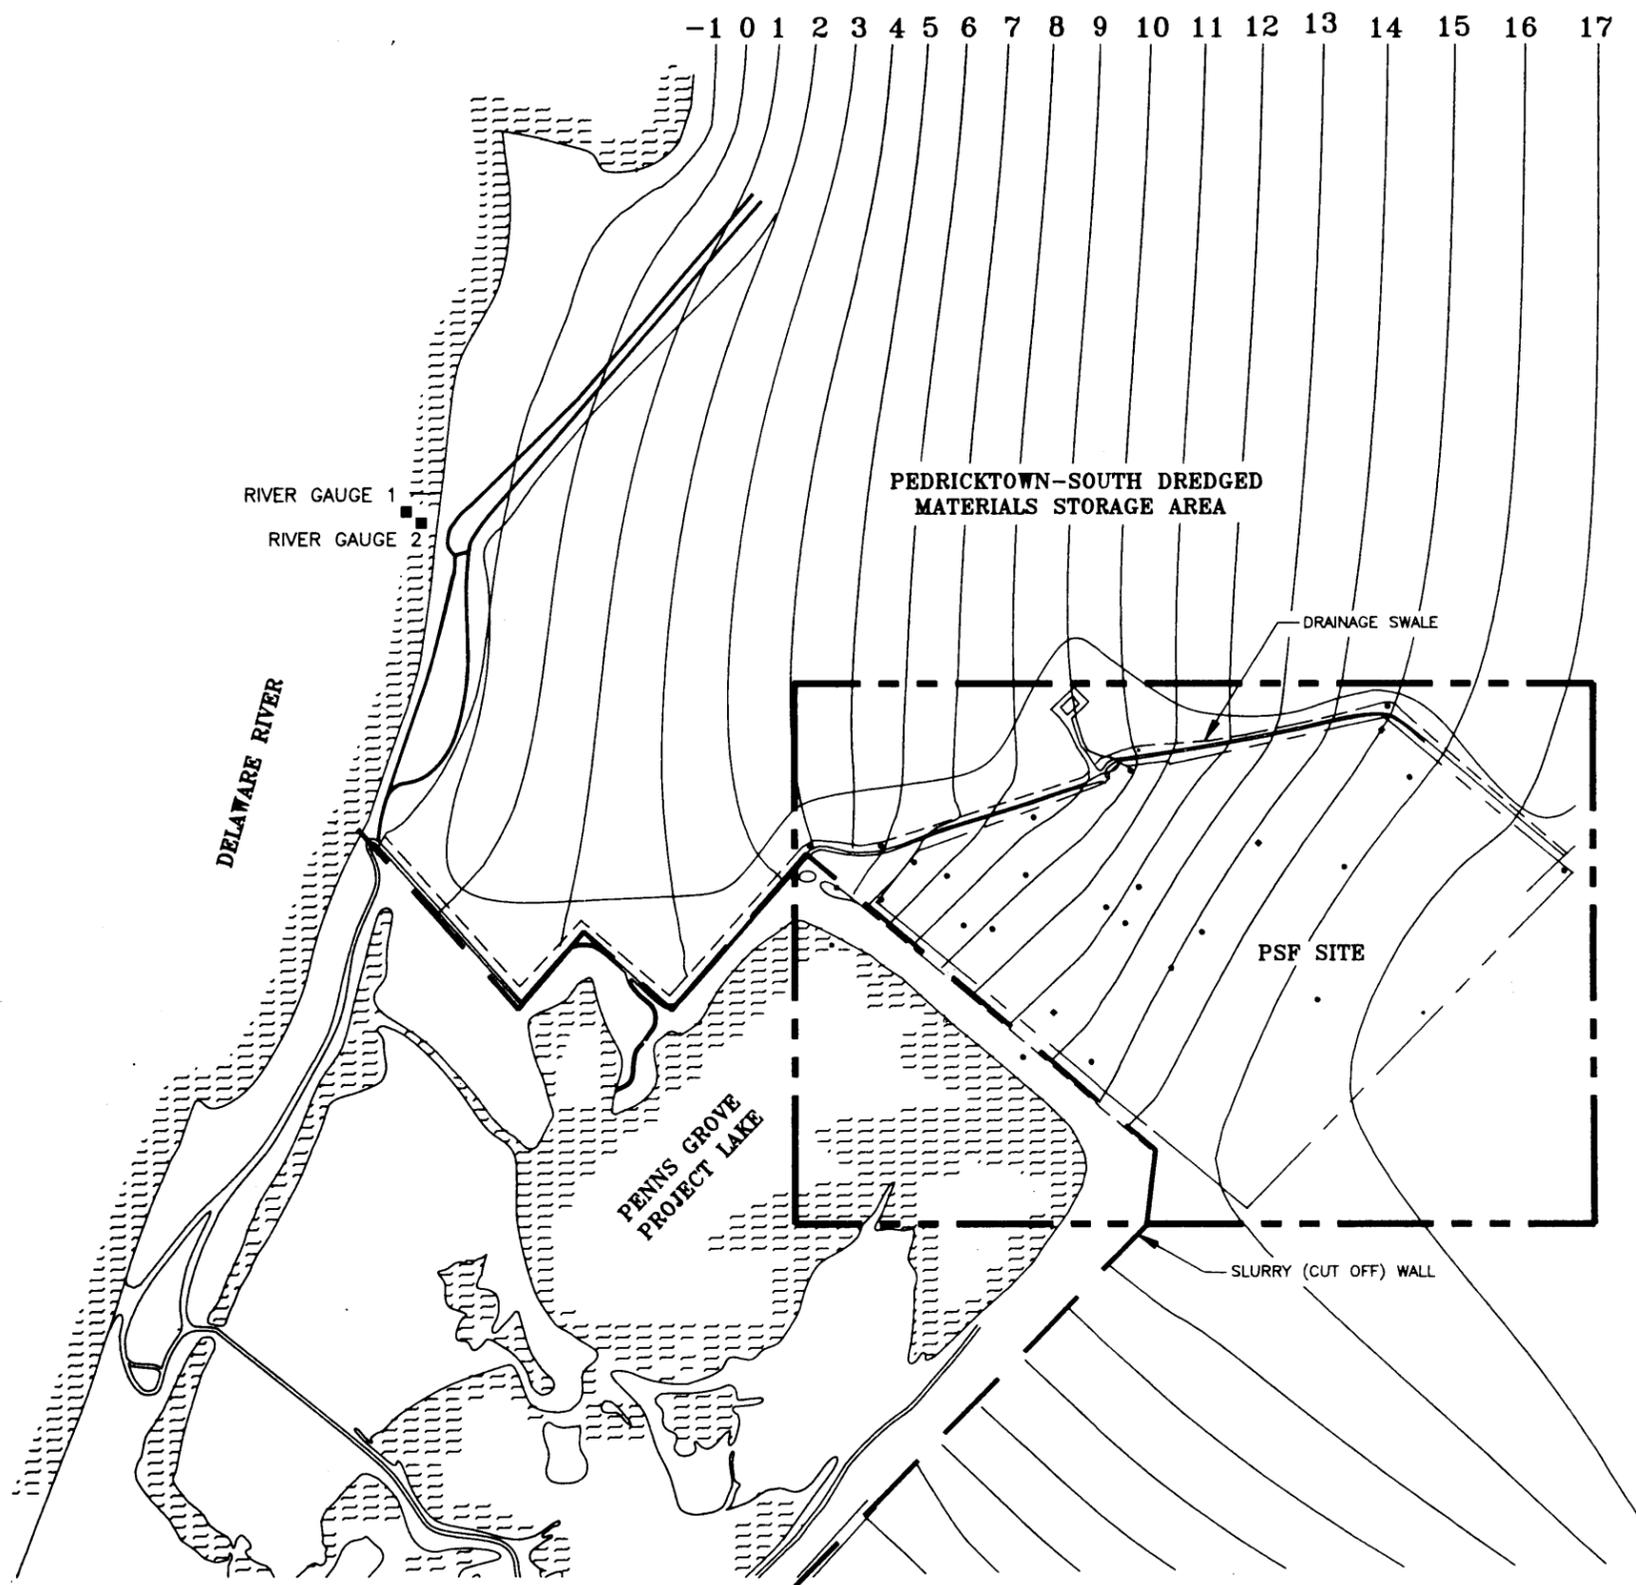
FLOWPATH[®] GENERATED HYDRAULIC HEAD
 DISTRIBUTION FOR PSF AND CONTIGUOUS AREAS
 (PSFMOD1L)
