TECHNICAL PRESERVATION GUIDELINES

APRIL 2009

HISTORIC BUILDING ROOFING

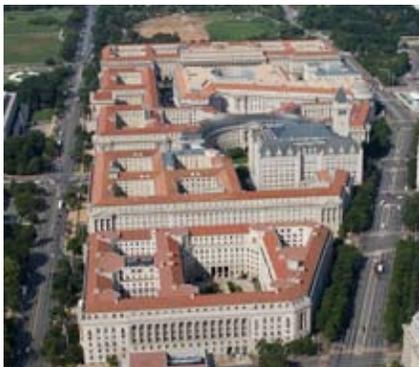
FIGURE 1 Clay tile roofing dominates and unifies aerial views of Washington's Federal Triangle, a vantage point also enjoyed by visitors to the Old Post Office tower in the center of the complex. Tile roof repairs require special care to achieve consistent color distribution across an entire roof.

Design and installation of variegated roofing requires special care to achieve consistent color distribution across the entire roof. Require matching not only the colors of the historic roofing but replication of the overall color distribution pattern. Removal and relaying of historic roofing is sometimes necessary to mix old and new for a well integrated result.

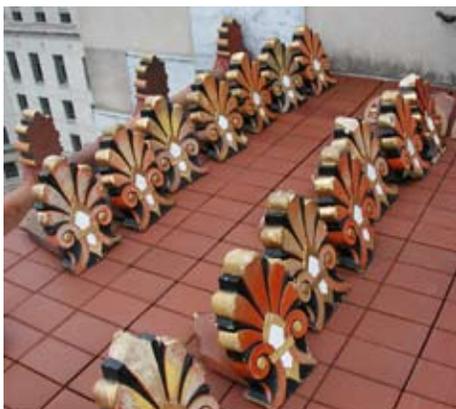
FIGURE 2 Damaged or missing features such as decorative acroteria should be repaired or replicated as part of a major roof project.

specified performance requirements, matching historic roofing performance characteristics to the extent possible. Except in cases when historic design or detailing flaws need to be revised to improve the roof or building's overall performance, A/E and contractor submissions should confirm that original attachment methods and roof detailing, especially at eaves and locations where materials join, replicate original roofing details and design intent. Missing features such as decorative acroteria and roof finials should be replicated and reinstalled as part of major roof repair or replacement projects.

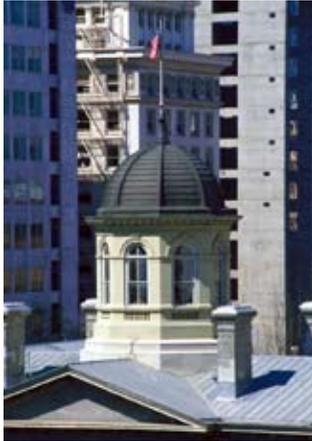
FIGURE 3 Repair and installation of slate, clay tile and metal roofing requires specialized construction skills. Competency of Restoration Specialist requirements reduce GSA risk by limiting competition to firms having successful experience with historic building projects of comparable complexity.

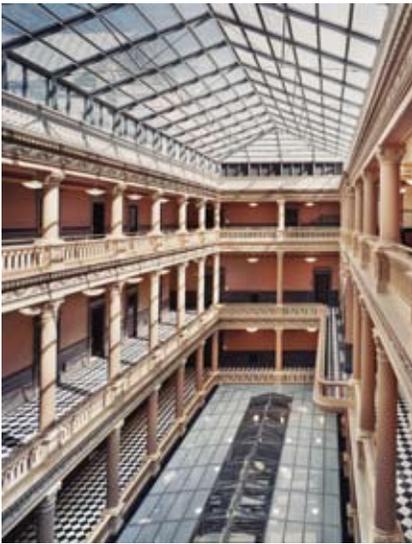
FIGURE 4 Include repair or replication of skylights concealed by previous roof repairs to improve the marketability of windowless workspaces.

Many historic buildings include skylights designed to admit daylight to interior cores, underground spaces and other windowless areas. Roofing projects may provide opportunities to improve the thermal performance and life cycle of these assemblies while improving the marketability of windowless workspaces. Explore restoring covered over skylights in occupied locations where they provide the only source of daylight. Where funding for restoration is not available, skylights should be stabilized to protect the building from infiltration and retained in place to allow for the possibility of future restoration.

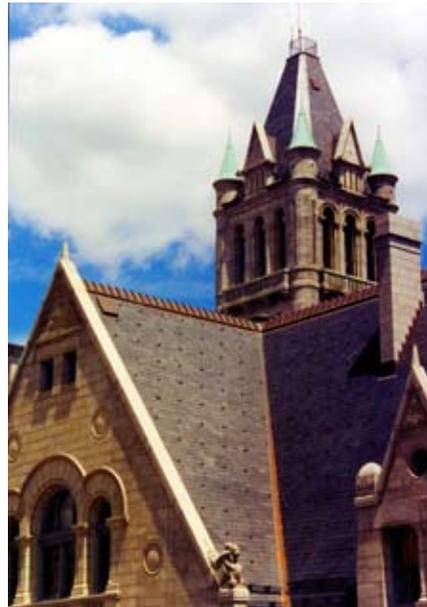
FIGURE 5 Sample review of materials, repair techniques and mockups ensure successful projects.

For all roofing work within historic building restoration zones, be sure to specify sample review of any new materials and repair techniques and require a mock up installation of new materials or assemblies for RHPO review, prior to overall fabrication and installation, to ensure that preservation design criteria have been met. Budgeting time and funding for mock ups helps to ensure against cost increases and delays that occur when a planned solution falls short of GSA expectations.
