### 985 Michigan Federal Building Detroit, Michigan

### FACT SHEET Water Quality Investigation

August 11th, 2023

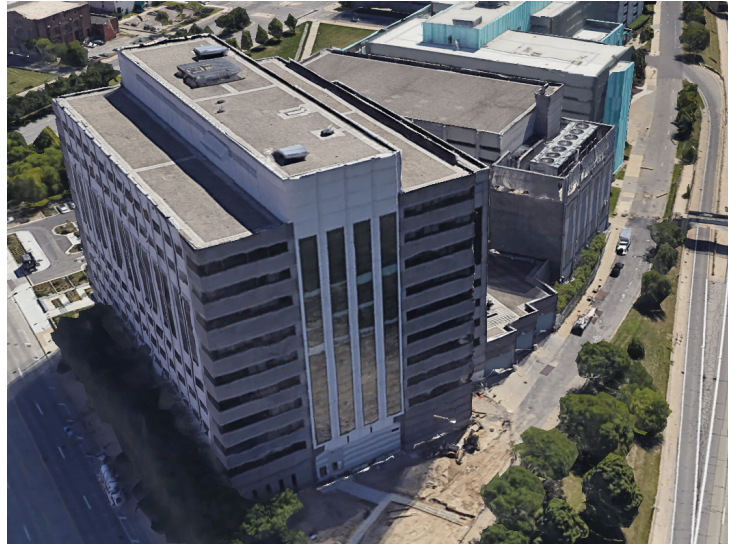
*Aerial view of 985 Michigan showing the main building and parking garage.  
Cooling towers are adjacent to the parking garage.*
