BUILDING PRESERVATION PLAN

202 South State Street
Chicago, Illinois, IL0318ZZ

Final Submittal

June 30, 2009

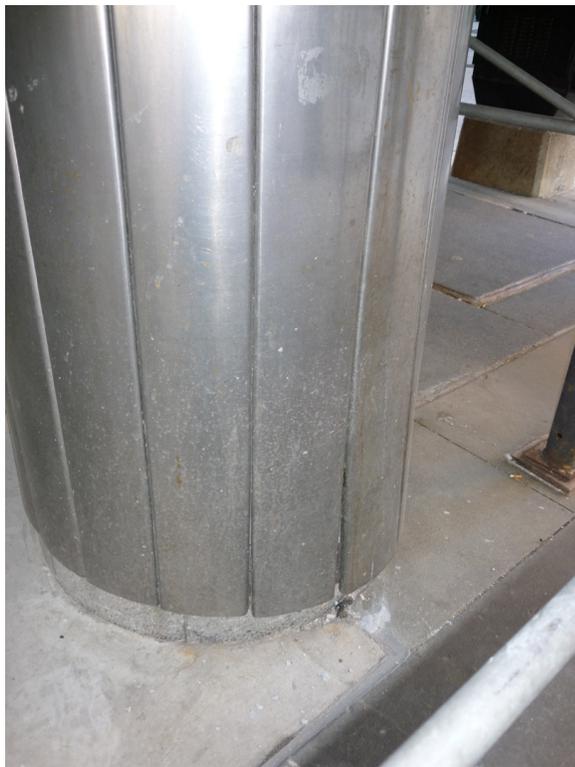
Image 61: Northeast exterior column and steel cladding.

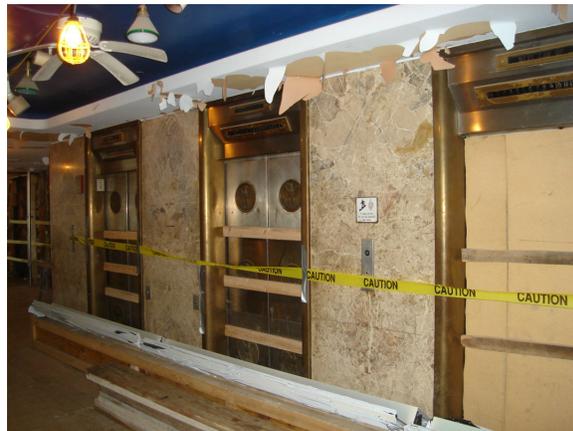
Image 62: Elevator lobby, first floor. Typical of all elevator doors on this floor.

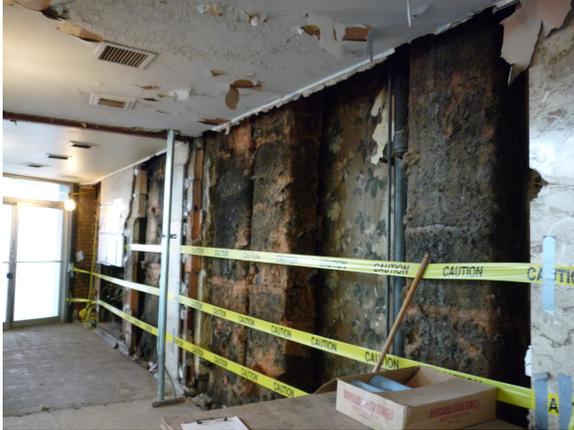
Image 63: South wall of main lobby. Much of the 1951 marble cladding has been removed.

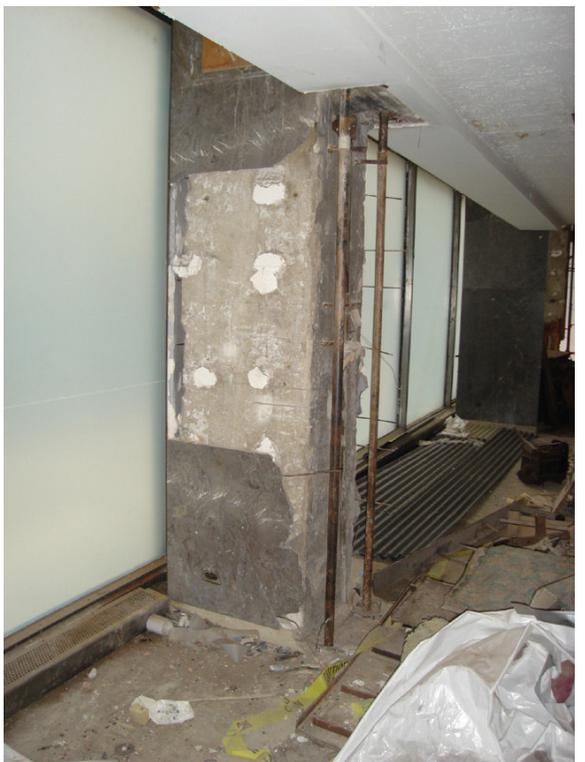
Image 66: Typical condition of columns along the north and east facades on the first floor.

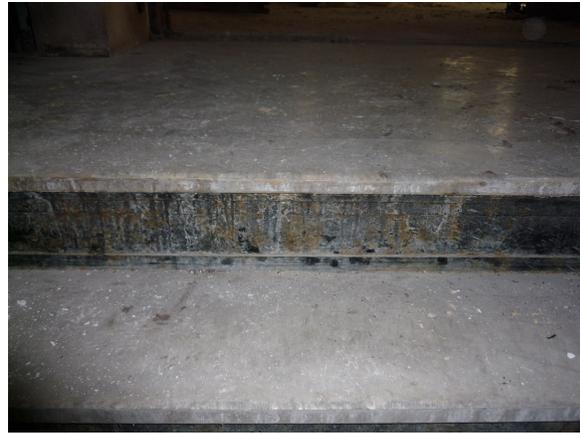
Image 68: Main stair, typical riser condition, floors 2 and above.

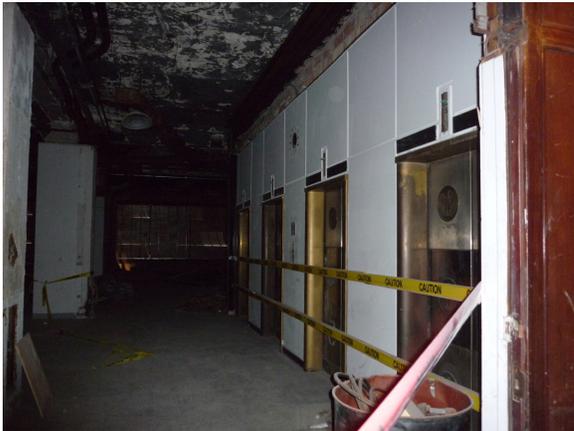
Image 73: Elevator doors, floor 2.

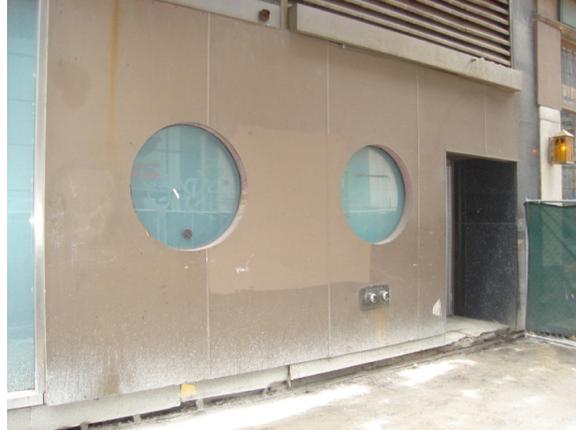
Image 76: Northwest entry, cladding over 1951 storefront.

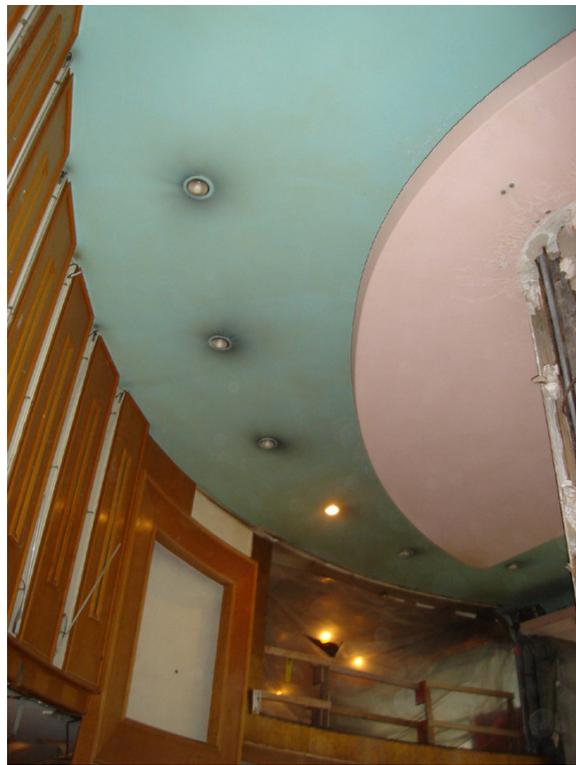
Image 78: First floor tenant space; 1951 lighting and ceiling.

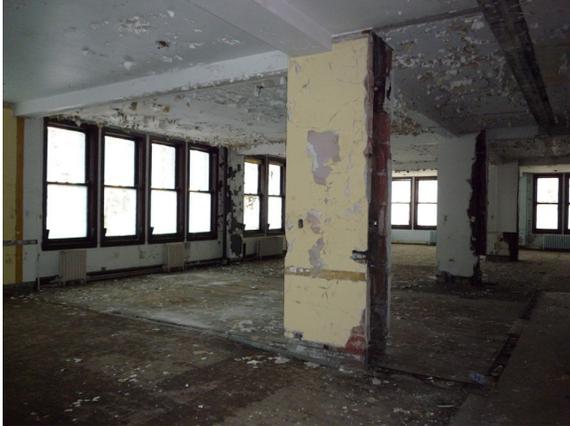
Image 81: 14th floor tenant space. Typical condition of floors 2-15.
