BUILDING PRESERVATION PLAN

220 South State Street
Chicago, Illinois, IL0315ZZ

GSAGS05P04GAD0224
JLA# 08622
Final Submittal
June 30, 2009

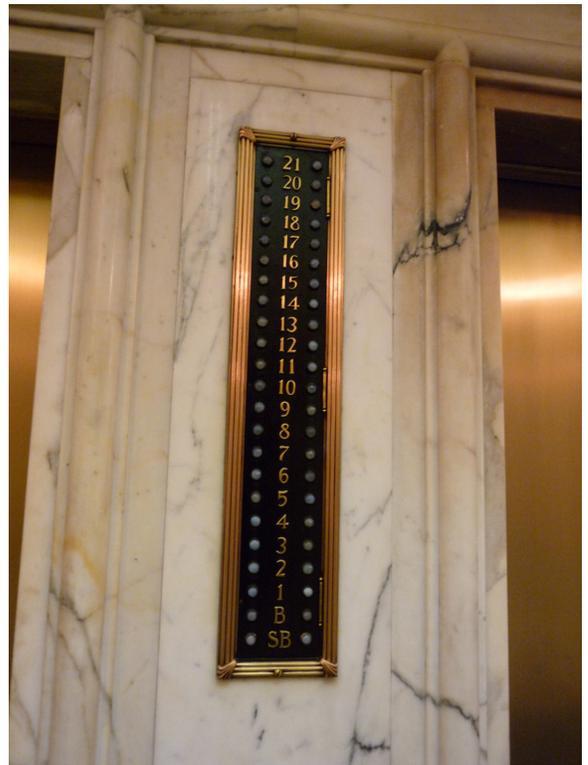
Image 46: Elevator indicator, main lobby.

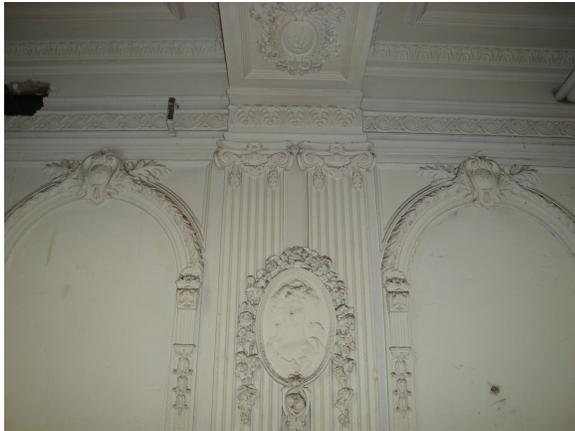
Image 47: 1st basement, decorative plasterwork.

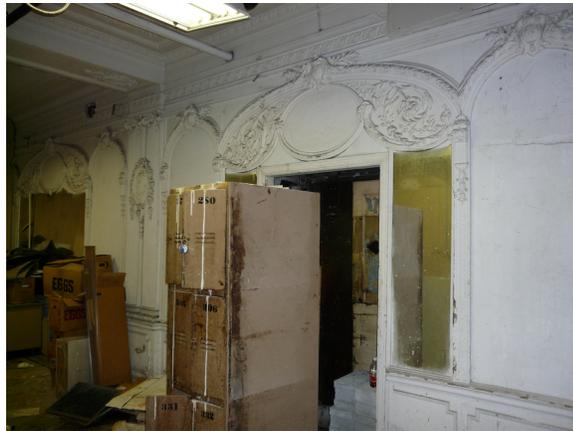
Image 48: 1st basement, decorative plasterwork.

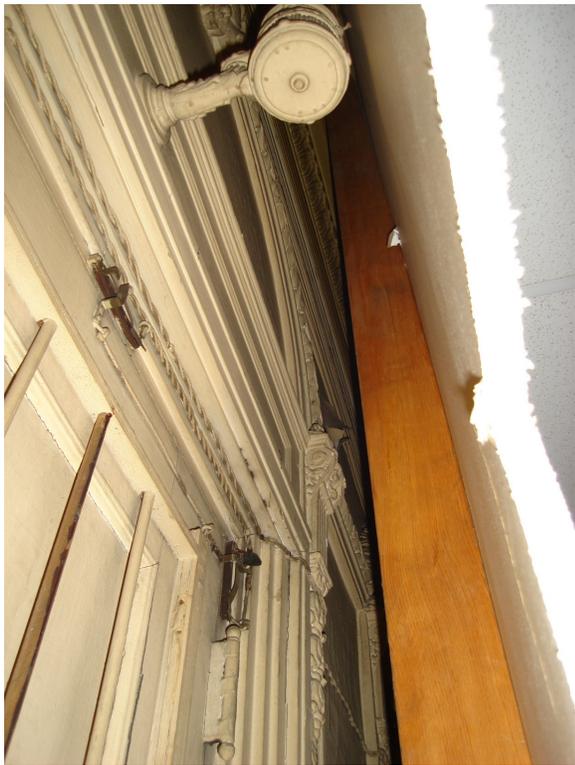
Image 49: 1st basement, decoration remaining on elevator wall and doors.

Item # (Cont'd)	Recommendation	Significance Rating (1-6)	Condition Ranking (G/F/P)	Urgency (C/S/M)	Image #	Cost Estimate	
						Unit Price	Total
1	Preserve, clean, and repair (HPTP 09310-03, 06, 08, 09, 0931102) in within "rehabilitation" zone.	1	P to G		54	\$ 14.00	\$ 33,880.00
2	Preserve and repaint existing. Repair damaged - assume 10% of total (HPTP 09210-04, 05).	1	P to F		47, 48	\$ 65.00	\$ 34,125.00
3	Preserve and repaint existing. Repair damaged - assume 10% of total (HPTP 09210-04, 05).	1	P to F		51	\$ 30.00	\$ 72,600.00
4	Preserve, re-wire and re-lamp.	1	P to F		52	\$ 350.00	\$ 2,800.00
5	Reconstruct missing portions of 3 fixtures.	1	p		52	\$ 1,800.00	\$ 5,400.00
6	Refabricate and install new fixtures based on remains of existing fixtures. Position to recreate original lighting scheme.				52	\$ 2,000.00	\$ 4,000.00
7	Bays to be uncovered and existing wood and plaster decor should be preserved and repaired (HPTP 09210-04, 05). For uniformity, plasterwork around the east most elevator door to be restored based on existing. If other elevators are to be used, redesign of doors to meet codes should be sympathetic to, but not detract from original doors. If elevators are not in service, existing doors to be fixed in place.	1	P to F		49, 50	\$ 1,500.00	\$ 7,500.00

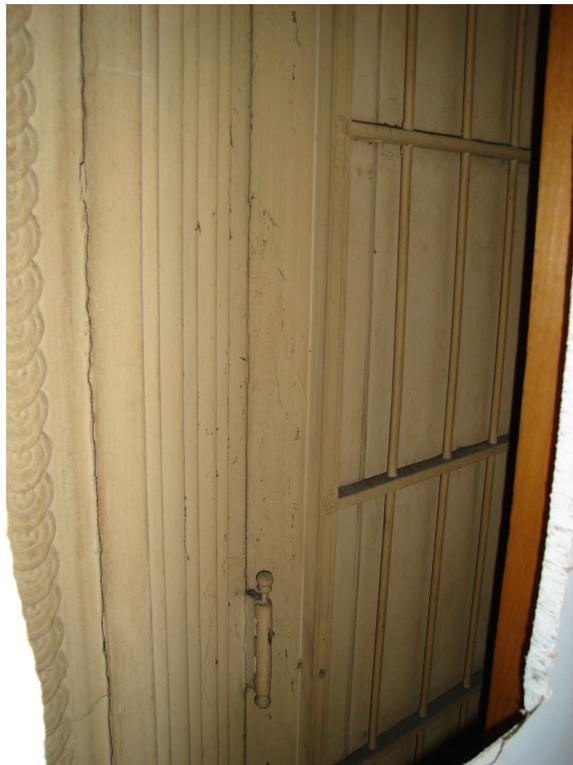
Image 50: 1st basement, decoration remaining on elevator wall and doors.

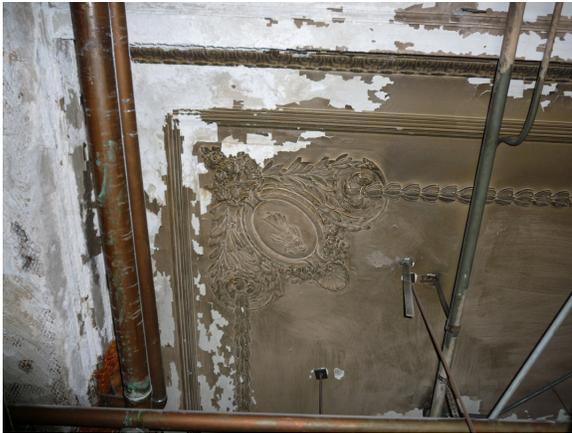
Image 51: 1st basement, plasterwork on ceiling.

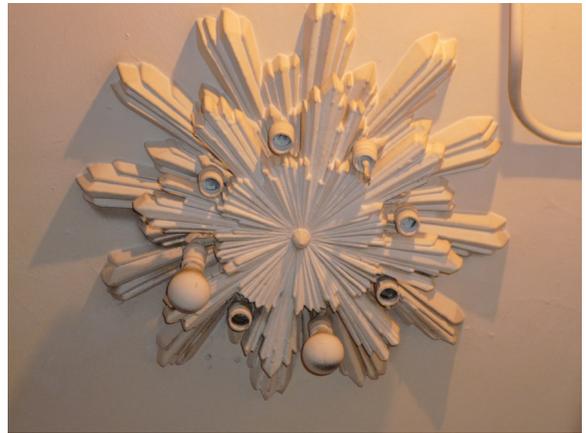
Image 52: 1st basement, ceiling light fixture.

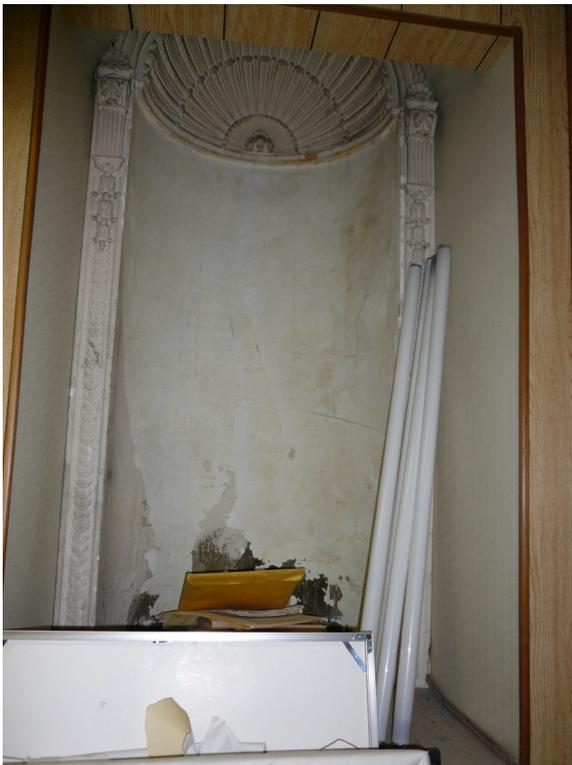
Image 53: 1st basement, statue niche.

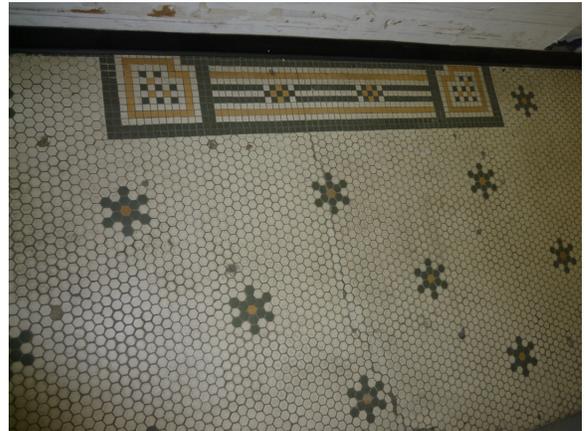
Image 54: 1st basement, mosaic tile floor.

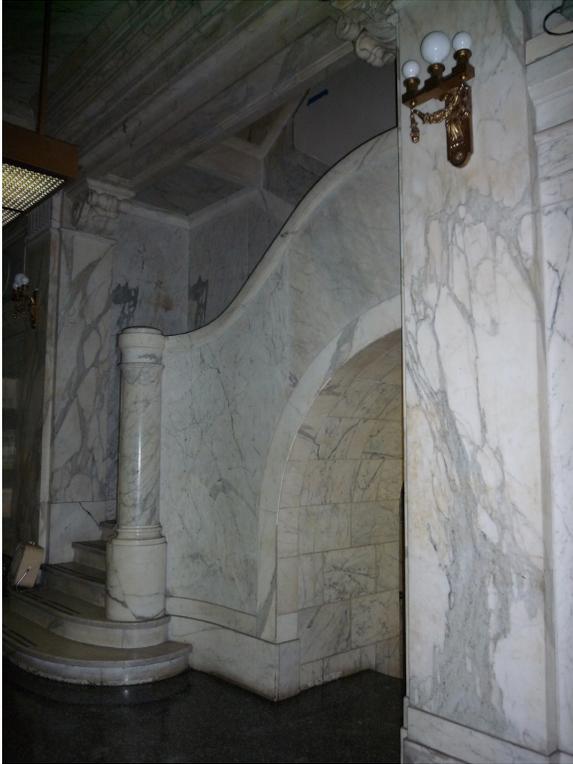
Image 55: East stair, first floor.

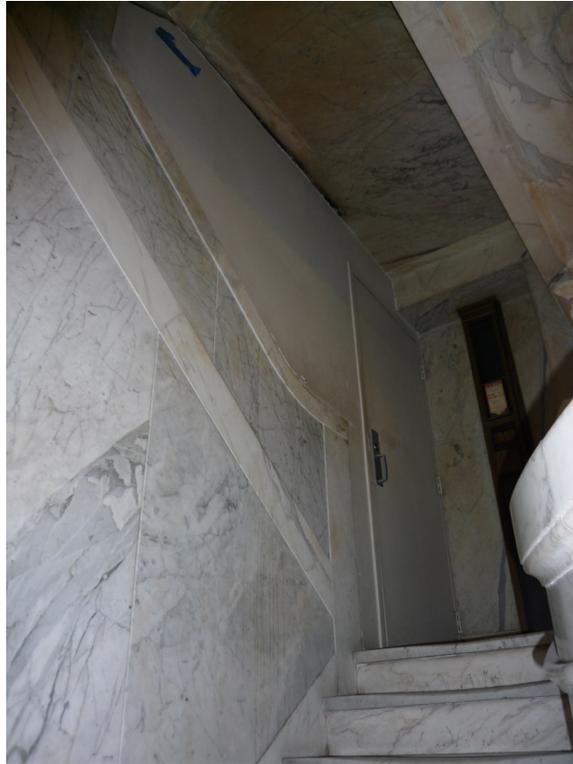
Image 56: East stair, transition between open first floor and enclosed stair.

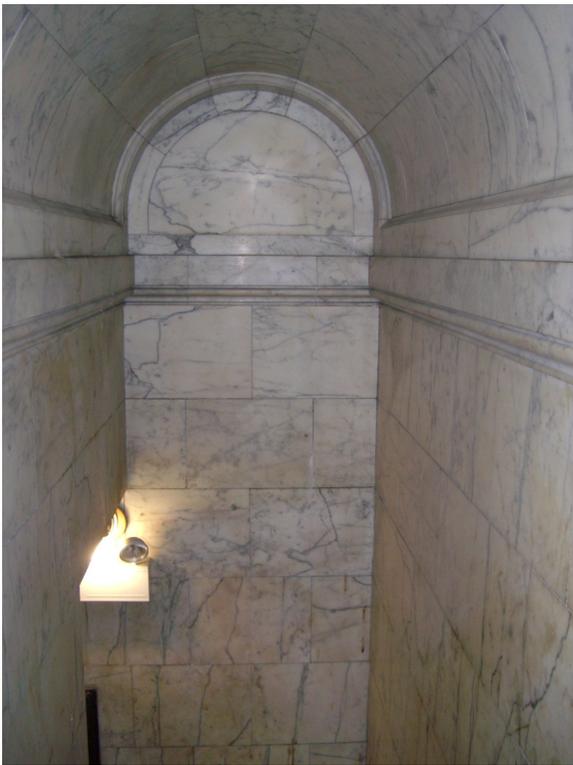
Image 57: East stair, barrel vault between first floor and first basement.

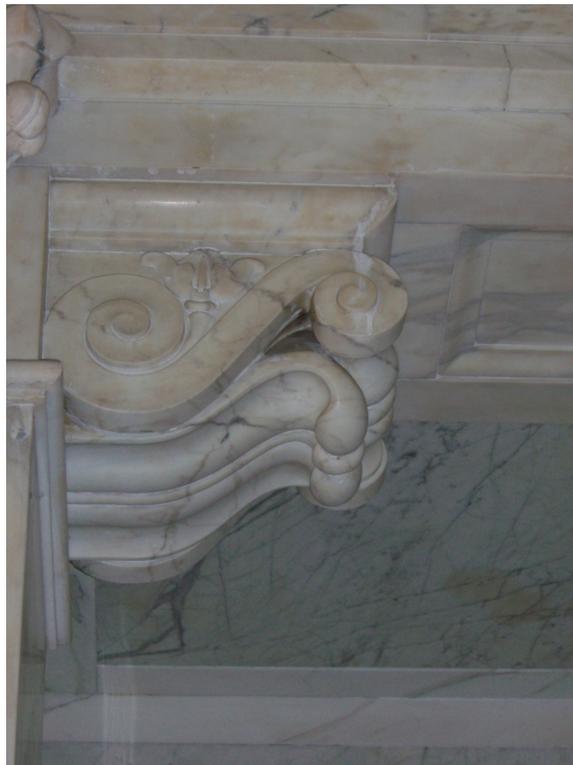
Image 58: Decorative bracket, east stair, first floor.

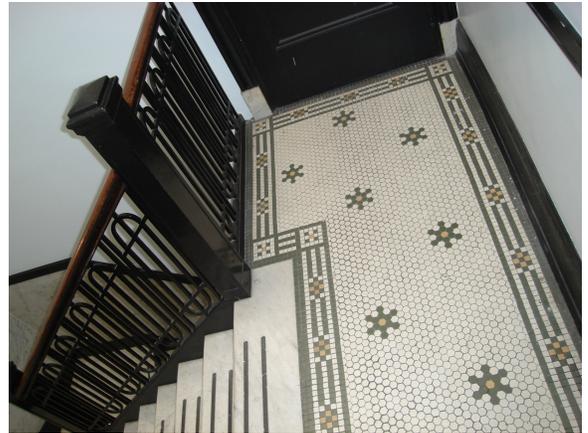
Image 60: East stair, original mosaic tile on upper landing.

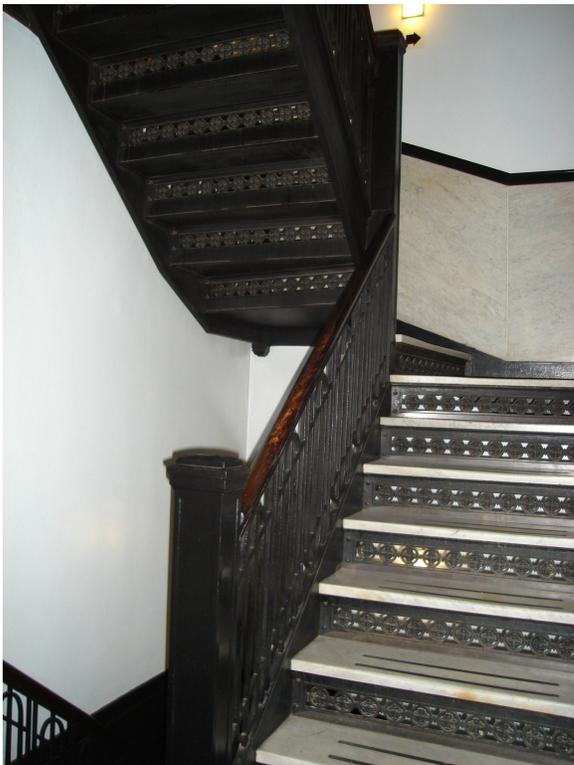
Image 61: East stair, marble treads and cast iron risers.

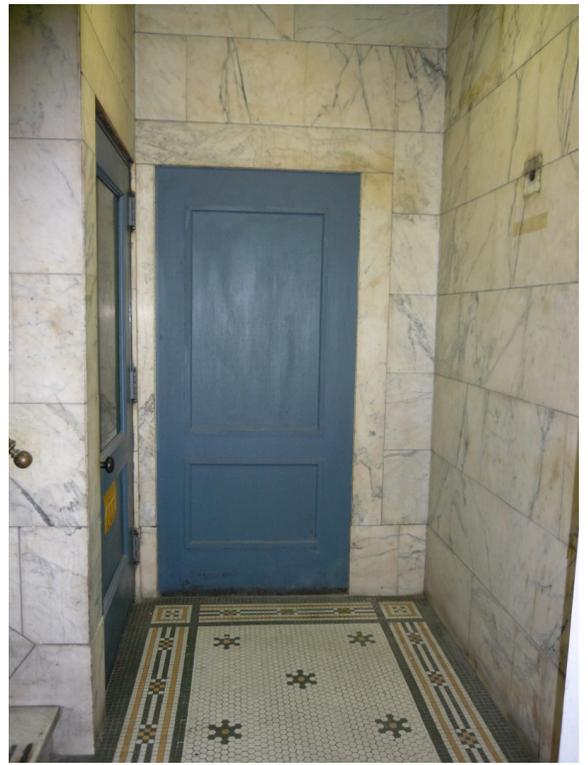
Image 62: East stair, original mosaic tile on first basement landing.

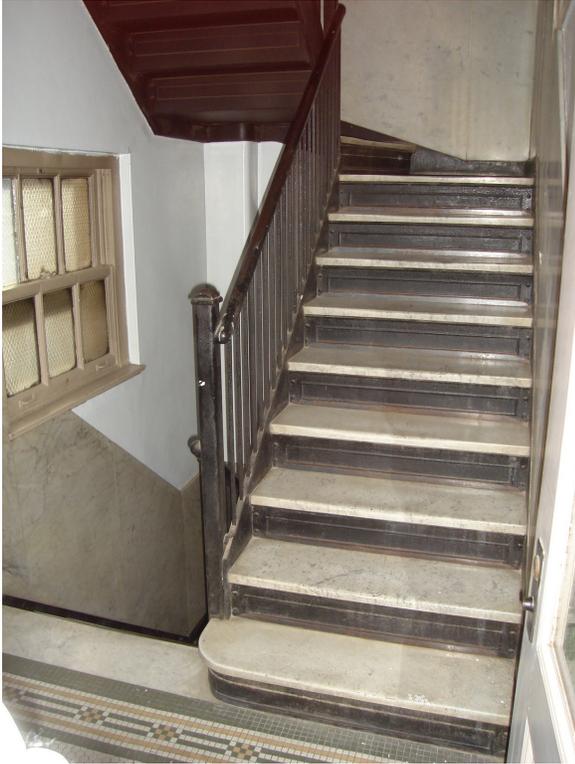
Image 63: West stair, cast iron structure and marble treads.

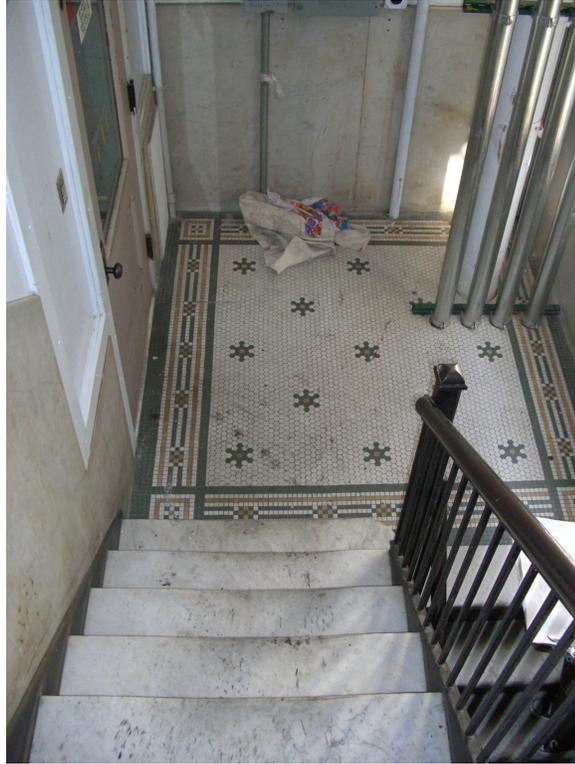
Image 64: West stair, typical mosaic tile landing.

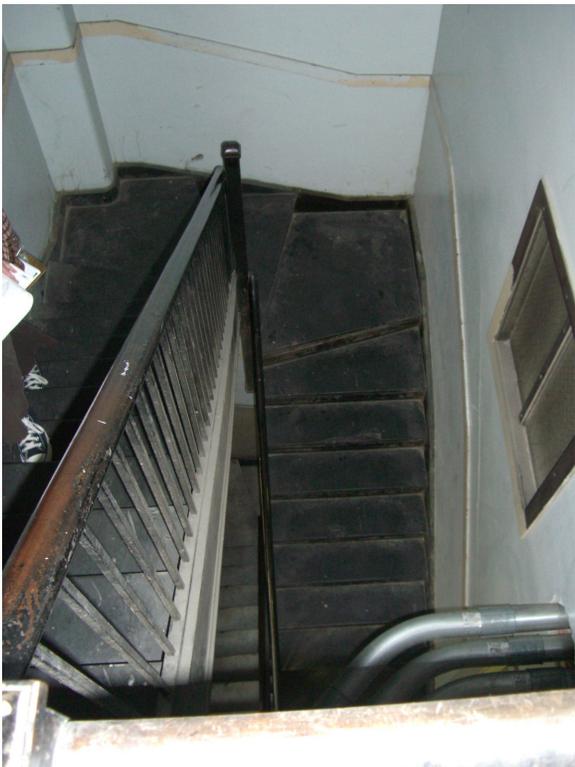
Image 65: West stair, slate treads between 22nd floor and roof.

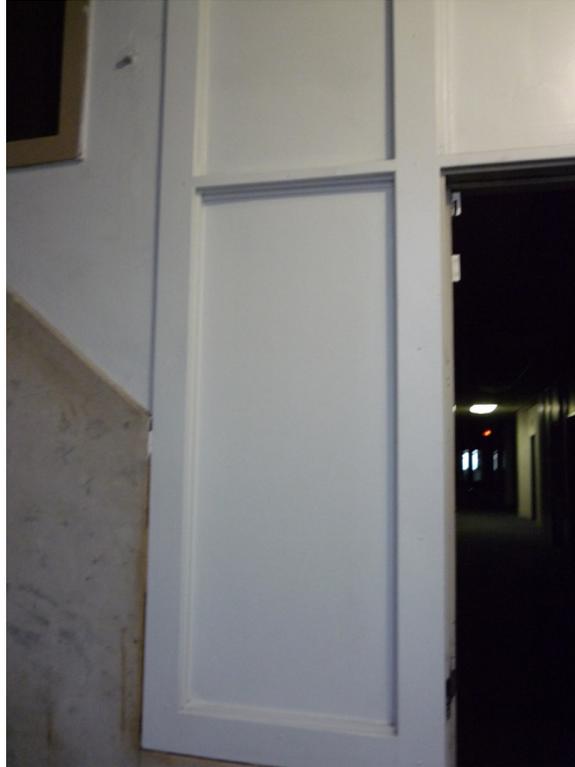
Image 66: Covered storefront, typical of west stair floors 2 through 21.

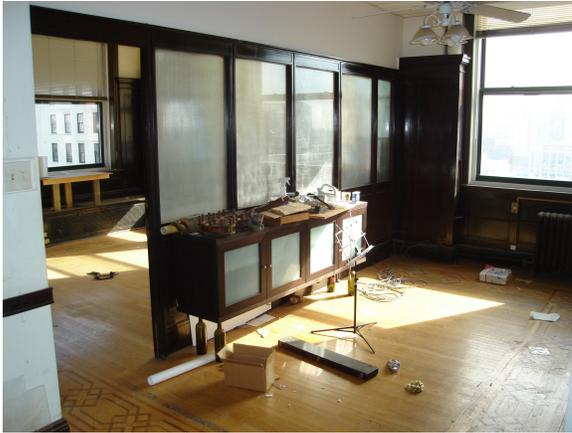
Image 67: 20th floor, southeast office suite.

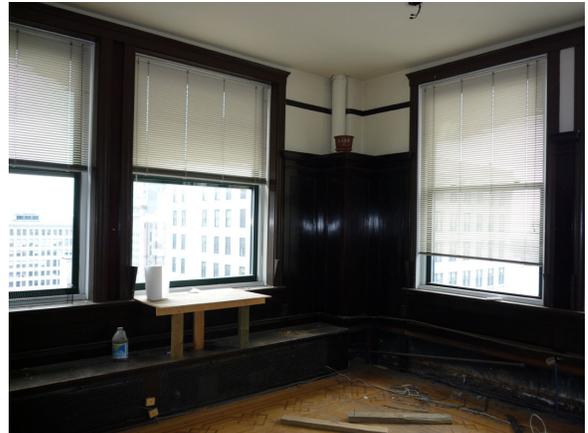
Image 68: 20th floor, southeast office suite.

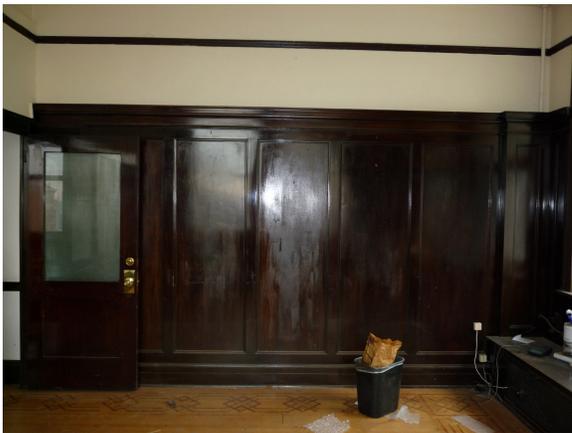
Image 69: 20th floor, southeast office suite,
partition wall.

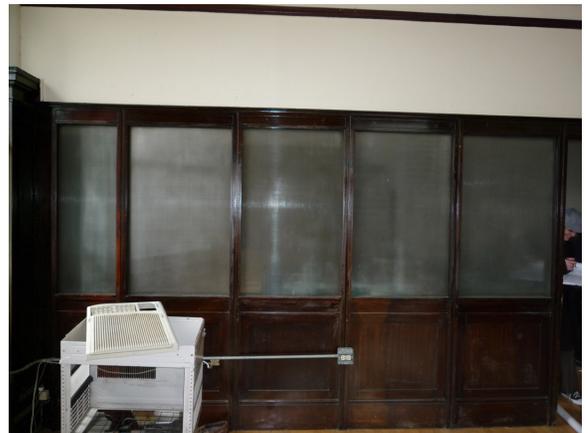
Image 70: 20th floor, southeast office suite,
partition wall.

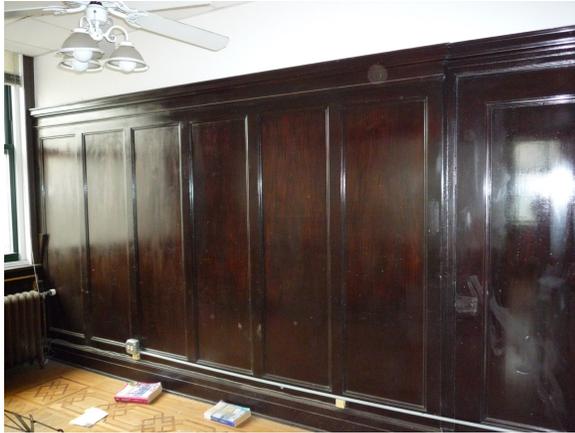
Image 71: 20th floor, southeast office suite, partition wall.

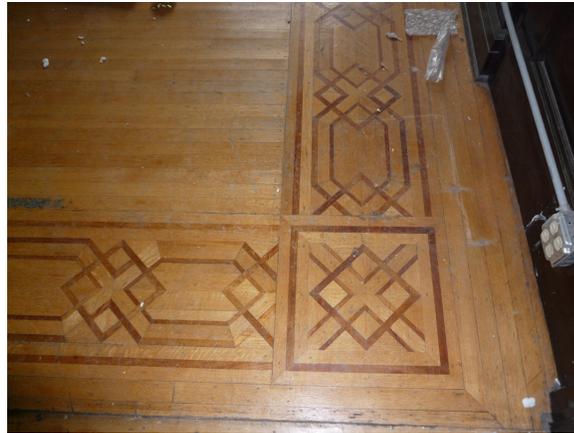
Image 72: 20th floor, southeast office suite, parquet floor.

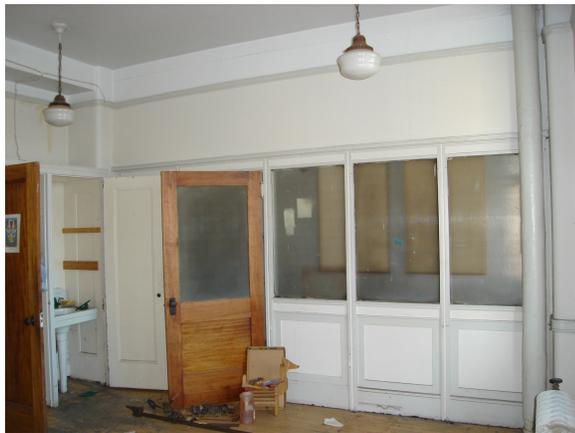
Image 73: 20th floor, southeast office suite, partition wall.

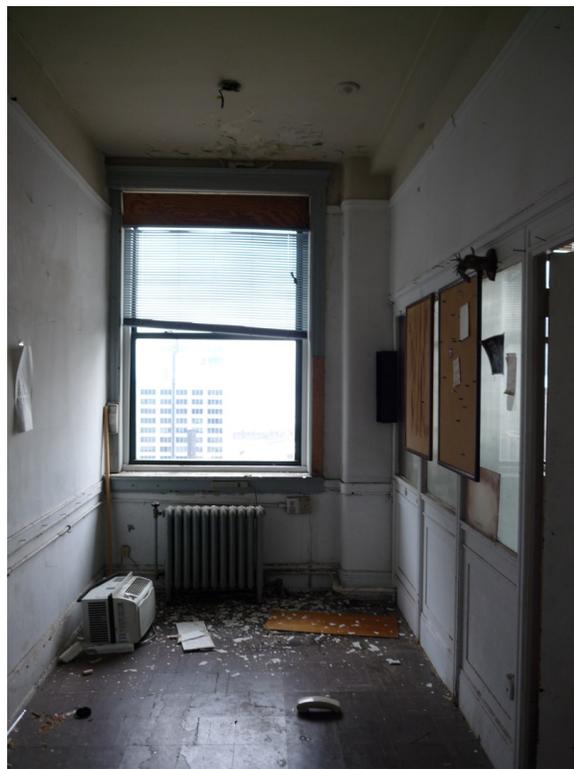
Image 74: 20th floor, southeast office suite.

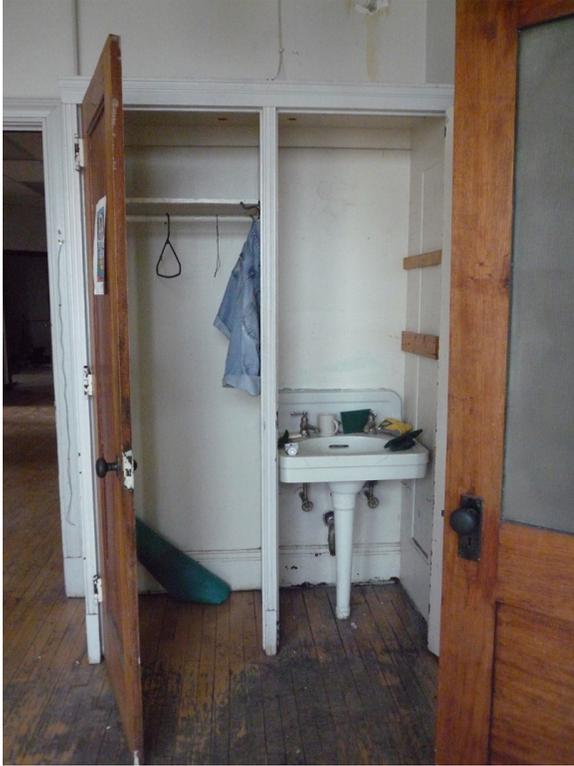
Image 75: 20th floor, southeast office suite, water closet.

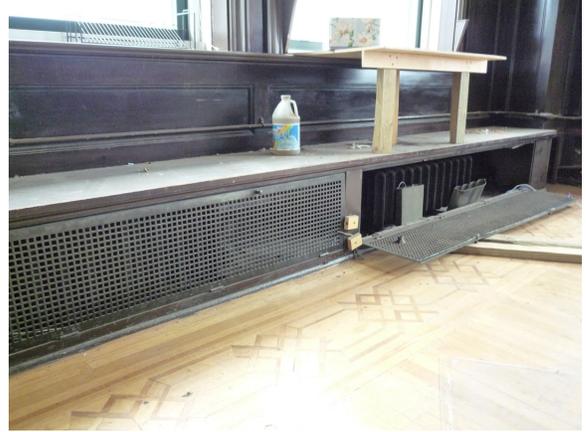
Image 76: 20th floor, southeast office suite, remaining radiator enclosure.

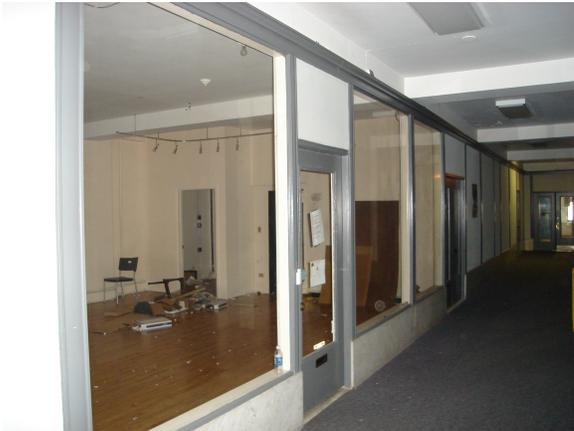
Image 77: Remaining storefront partition wall, main corridor 4th floor.

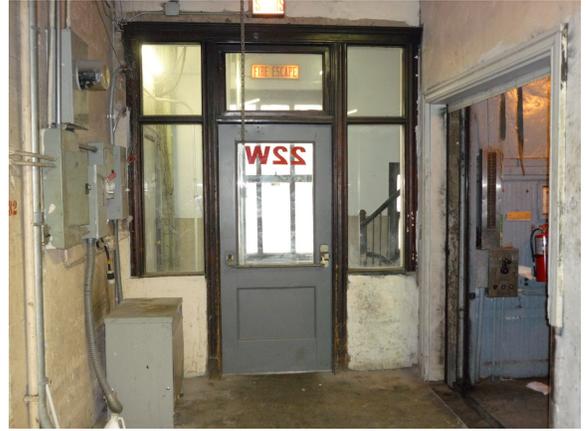
Image 78: Remaining storefront wall to west stair, 22nd floor.

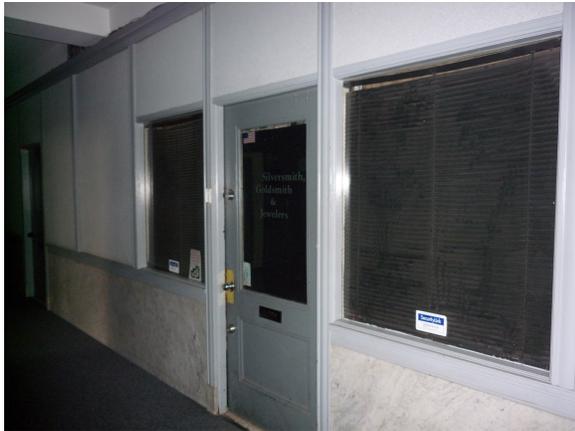
Image 79: Remaining storefront wall, main corridor 13th floor.

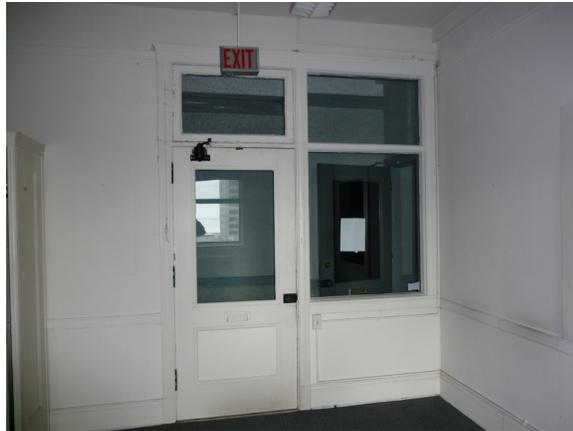
Image 80: Remaining partition wall, east office, 14th floor.

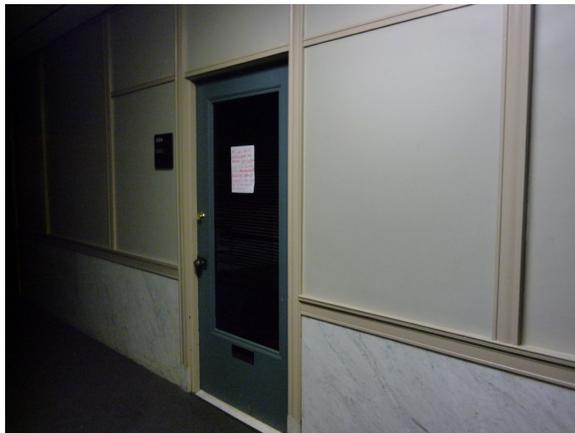
Image 81: Covered storefront wall, main corridor, typical of floors 2 through 21.

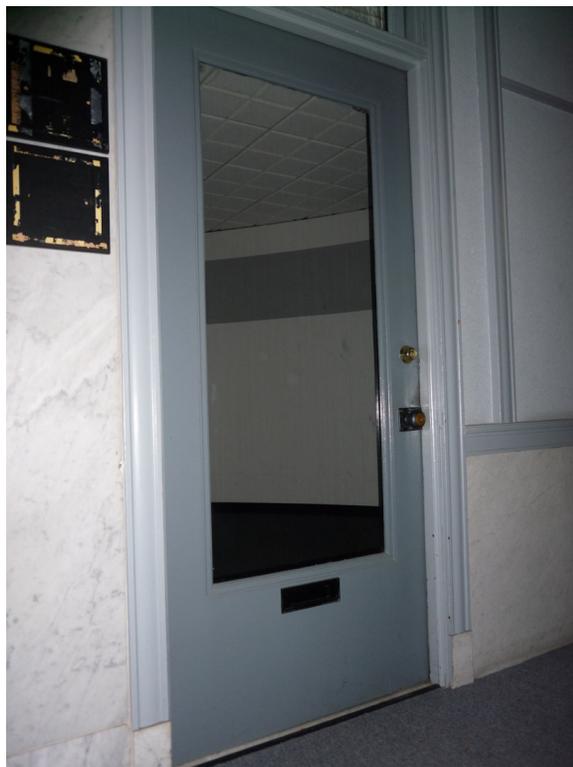
Image 82: Original door design, main corridor.

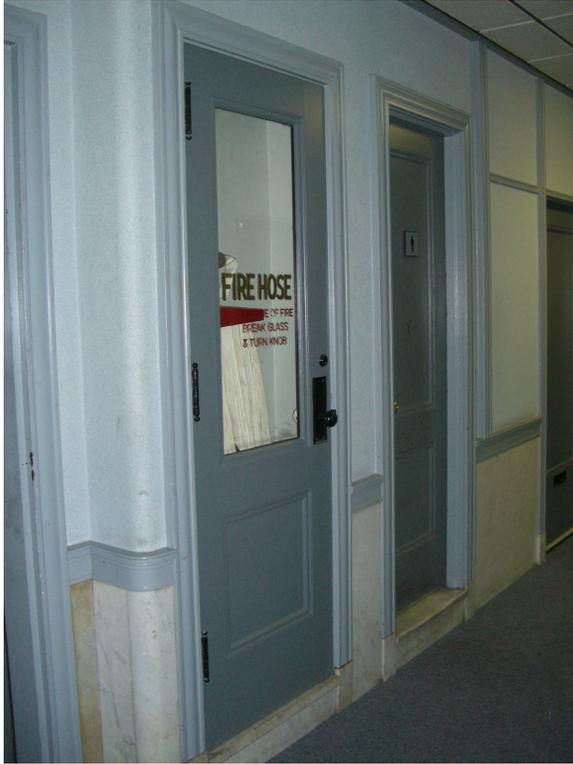
Image 83: Fire hose closet, typical of floors 2 through 21.

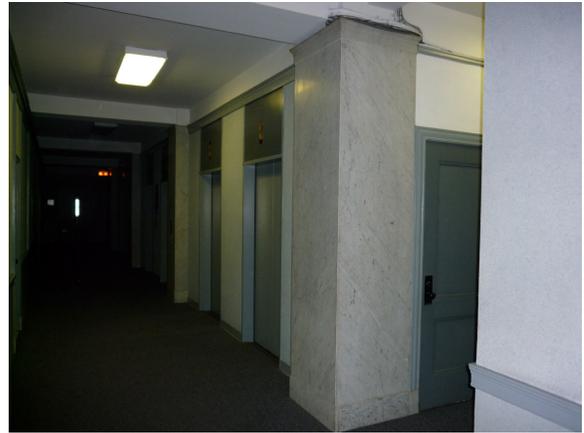
Image 84: Marble-clad columns in main corridor, typical of floors 2 through 21.

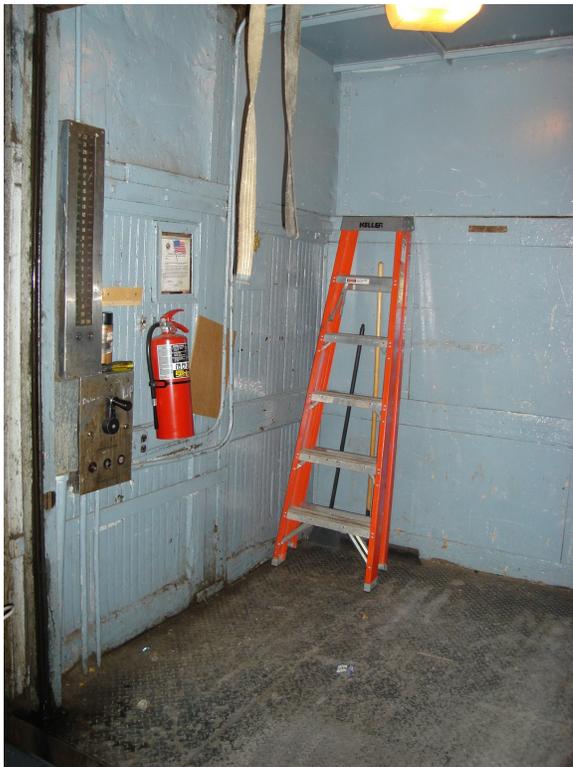
Image 85: Freight elevator.

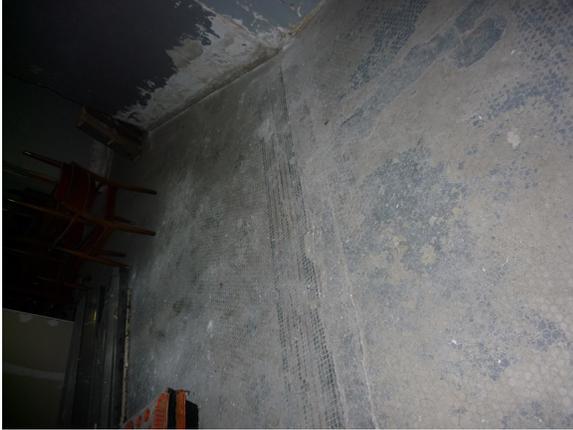
Image 103: Mosaic tile floor, first basement.

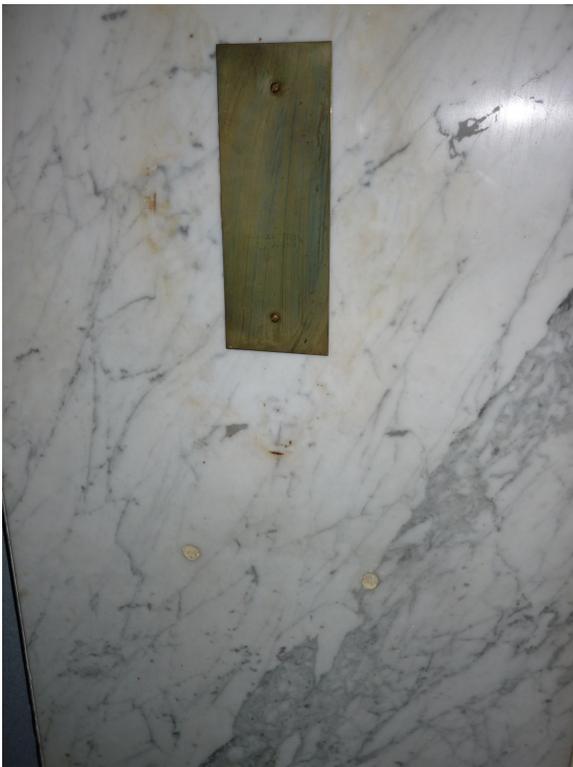
Image 105: Typical marble condition, elevator lobby, floors 2 through 21.

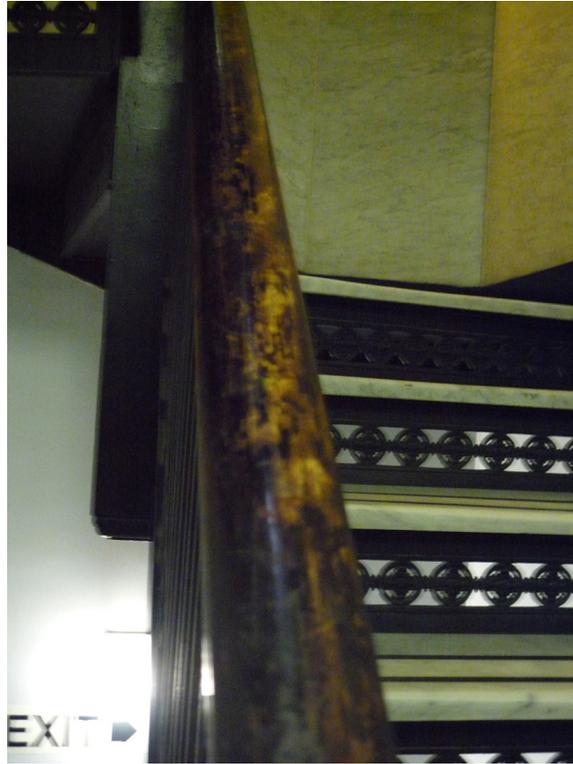
Image 112: Typical condition of railing finish, east stair.

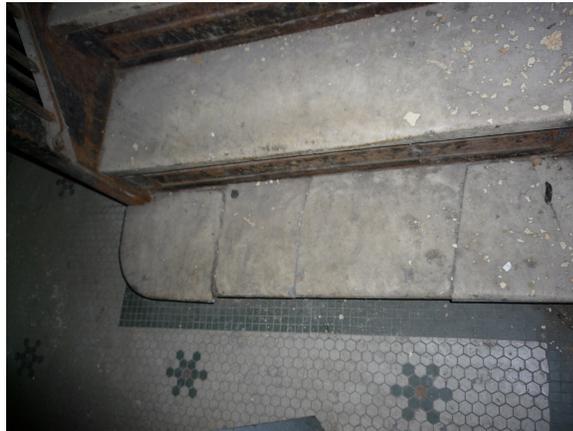
Image 114: West stair, typical condition from first basement to first floor.

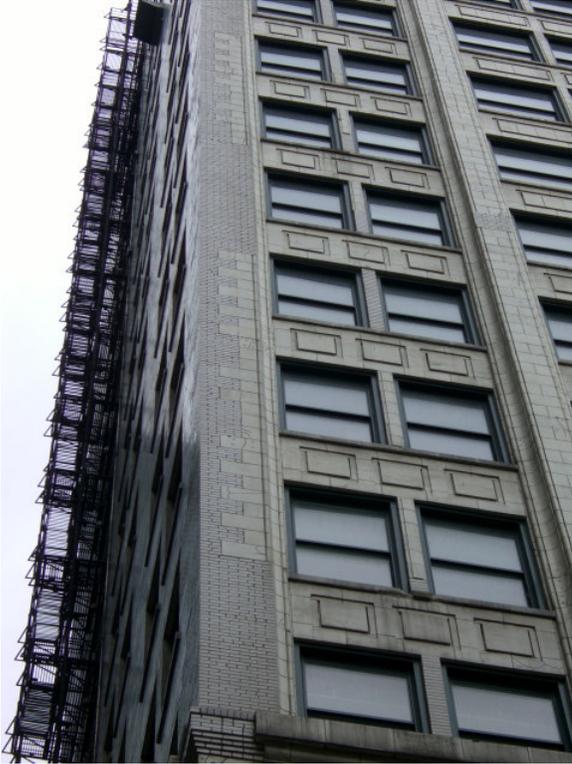
Image 115: Poor substitution of glazed brick for terra cotta, southwest corner.

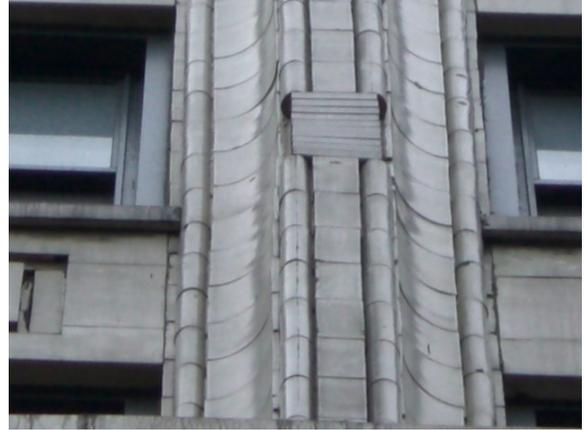
Image 116: Poor substitution of glazed brick for terra cotta, east façade.
