BUILDING PRESERVATION PLAN

**230 South State Street
Chicago, Illinois, IL0316ZZ**

Final Submittal

June 30, 2009

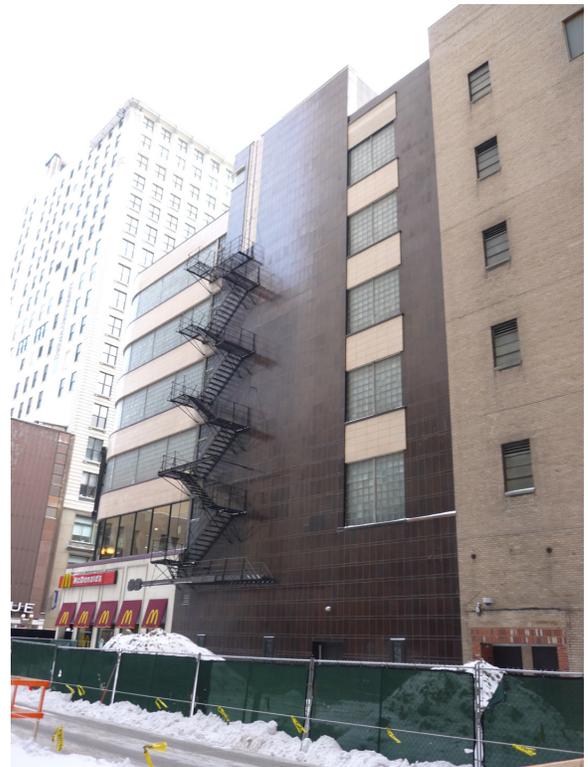
Image 21: North facade.

Item # (Cont'd)	Recommendation	Significance Rating (1-6)	Condition Ranking (G/F/P)	Urgency (C/S/M)	Image #	Cost Estimate	
						Unit Price	Total
1	Structural integrity for change of building's use to be evaluated. Replacement/renovation to follow original (unrealized) design. See "Recommendations" for further explanation.	3	F		1, 3, 15, 21,	\$ 46,000.00	\$ 46,000.00
TOTAL						\$	46,000.00

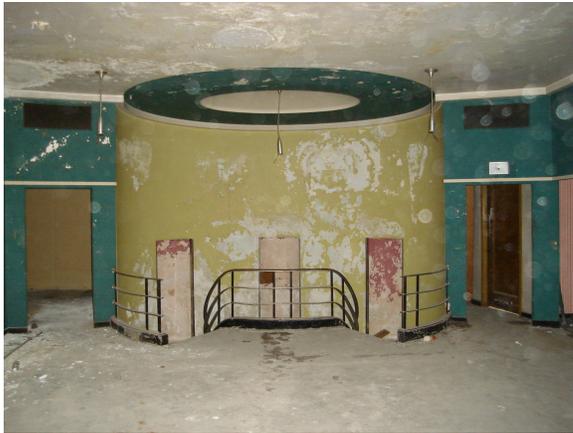
Image 26: Decorative stair, fifth floor, view west.

Cost Estimate	
Item # (Cont'd)	Recommendations	Significance Rating (1-6)	Condition Ranking (G/F/P)	Urgency (C/S/M)	Image #	Unit Price	Total
1	Clean and repair existing. HPTP 03710& 03711.	1	P		14, 26, 27, 28, 29, 59	\$ 35.00	\$ 4,550.00
2	Reconstruct original based on design of existing and historic photo.	1	P		28, 29, 61	\$ 1,200.00	\$ 57,600.00
3	Clean, polish, and repair existing. HPTP 05720-02. Replace missing sections.	1	P		29, 59	\$ 50.00	\$ 1,900.00
4	Reconstruct original railing based on design of existing and historic photo.				14	\$ 1,400.00	\$ 23,800.00
5	Strip existing paint and repaint. Paint analysis to be conducted to determine original color and results to be kept on record. Repair any surface defects.	6	P		26	\$ 30.00	\$ 8,040.00
6	Strip existing paint and repaint. Paint analysis to be conducted to determine original color and results to be kept on record. Repair any surface defects.	6	P		14, 28, 61	\$ 30.00	\$ 12,240.00

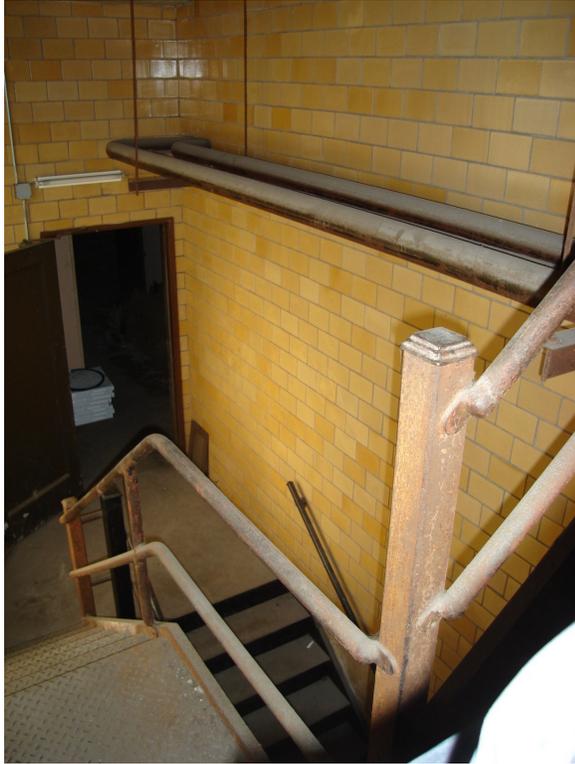
Image 30: West stair, upper floor.

Item # (Cont'd)	Recommendation	Significance Rating (1-6)	Condition Ranking (G/F/P)	Urgency (C/S/M)	Image #	Cost Estimate	
						Unit Price	Total
1	Clean & preserve.	1	G		30, 31	\$ 5.00	\$ 6,580.00
2	Remove paint to return to original glazed terra cotta walls.	1	F			\$ 50.00	\$ 40,000.00
3	Strip all paint from treads and floors & clean to restore to their original finish.	2	F		30, 31, 33	\$ 20.00	\$ 5,000.00
4	Strip, remove rust, and repaint stringers, risers, railing, and underside of stair to match floors 3-5.	4	F			\$ 35.00	\$ 16,660.00
5	Replace damaged upper portion (without design limitations).	3	P to G			\$ 16,860.00	\$ 16,860.00
6	All doors & frames to be replaced with code compliant fire doors that match the design of the originals.	3	P to F		32	\$ 2,529.00	\$ 17,703.00
TOTAL						\$	102,803.00

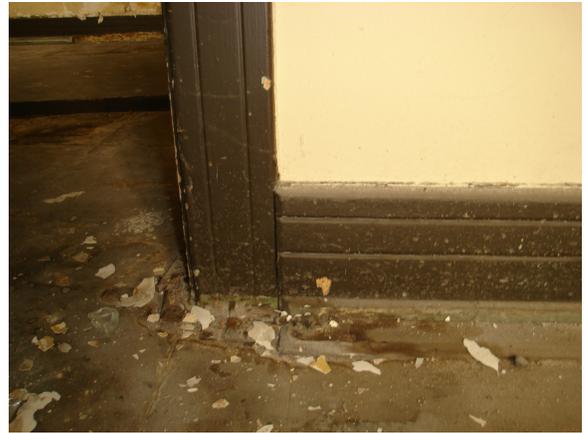
Image 35: Door trim and wall base, sixth floor.

8	Preserve in place.	2	G		37	\$ 400.00	\$ 400.00
9	Provide new elevator call buttons at floors 4 & 5, design to be based on remaining original call button on 6th floor.				37	\$ 400.00	\$ 800.00
10	Preserve and reuse doors within building. Strip existing finishes and repaint.	2	G		46	\$ 800.00	\$ 4,800.00
11	Repair, preserve, and reuse doors within building. Strip existing finishes and repaint.	2	P to G		34, 35, 36, 46, 60, 62	\$ 800.00	\$ 4,800.00
12	Restore pendant lights using existing remains (if possible) or refabricate original design using new material.	1	P		11, 26, 40	\$ 250.00	\$ 3,000.00
13	Repair and reuse. Upgrade electrical mechanisms to meet current standards.	2	F		12, 42	\$ 110.00	\$ 14,960.00
14	Clean, rewire, relamp, refurbish, and restore to working condition.	2	F		12, 41	\$ 200.00	\$ 1,800.00
15	Patch and repaint.	2	F		39	\$ 25.00	\$ 3,550.00
16	Preserve, repair, repaint, and reuse within building.	2	F		35	\$ 30.00	\$ 18,000.00

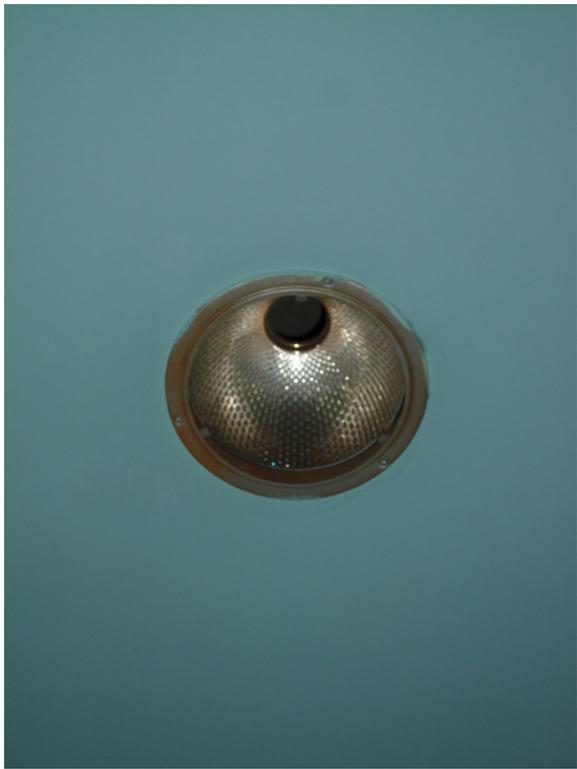
Image 41: Recessed light fixture, fourth floor.

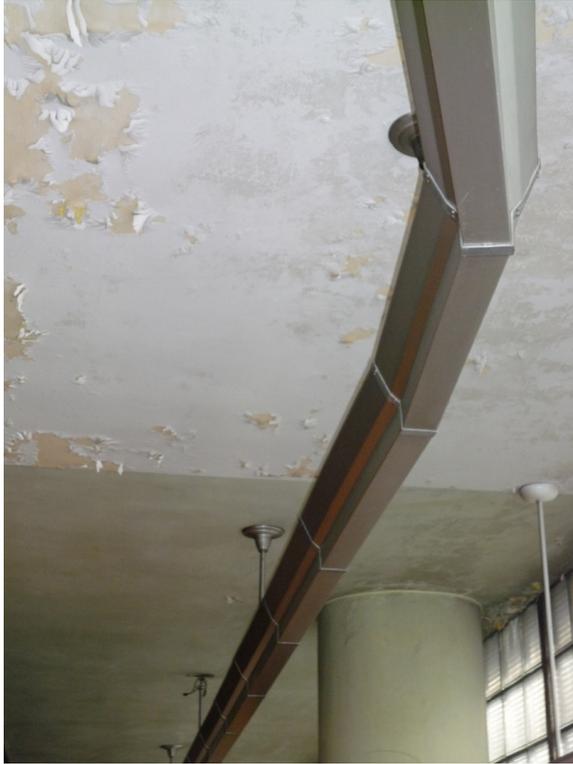
Image 42: Linear light fixture, fifth floor.

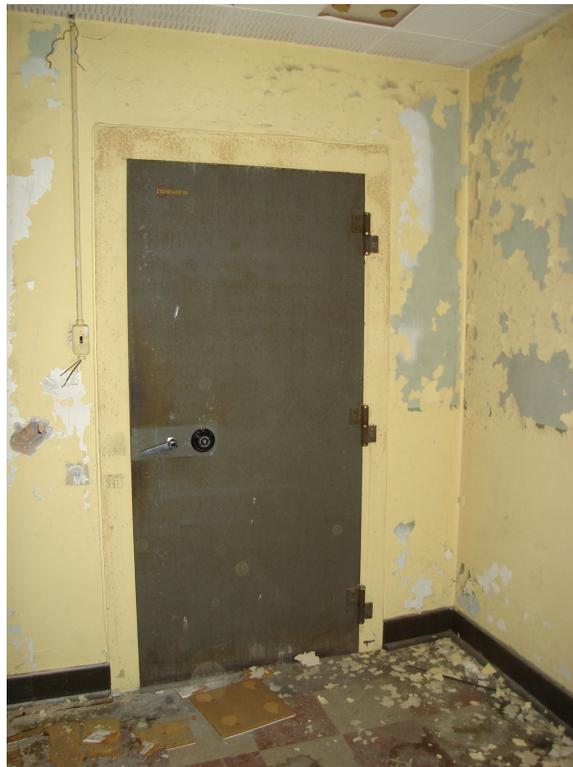
Image 44: Safe door, sixth floor.

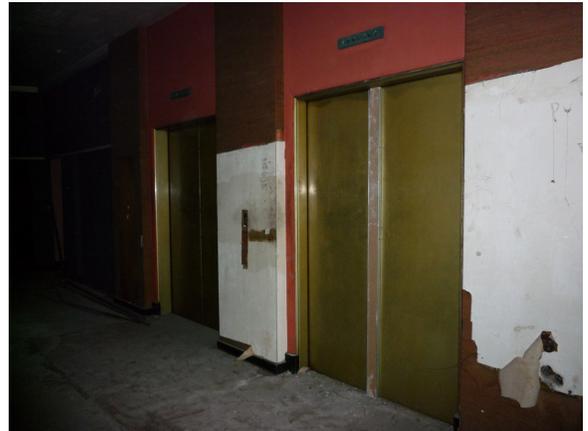
Image 45: Elevator doors, fifth floor.

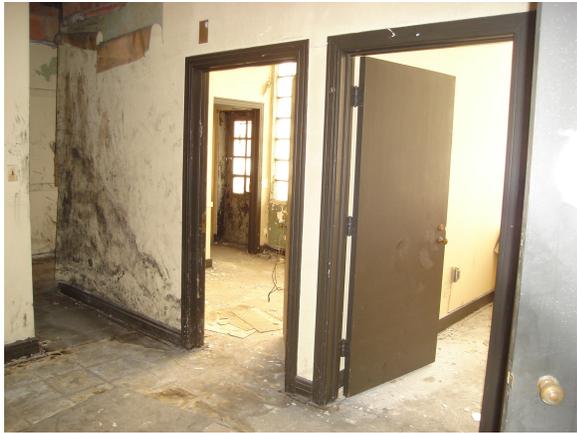
Image 46: Typical doors and trim, sixth floor.

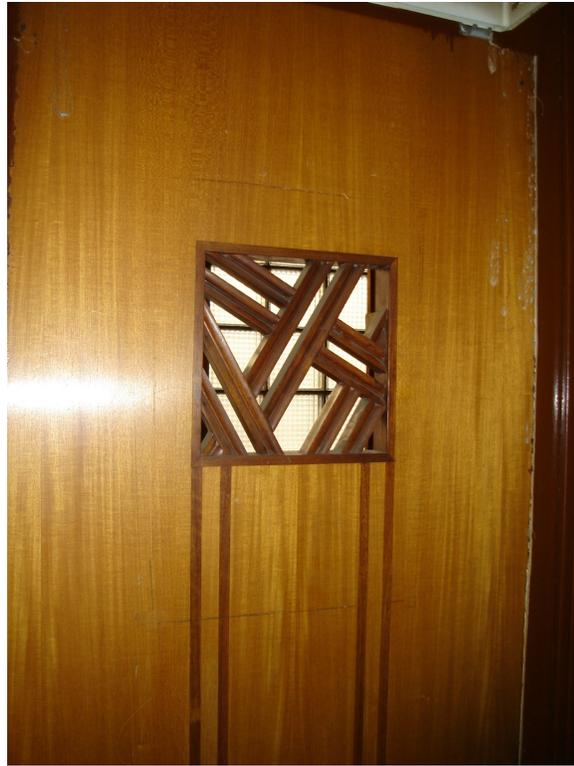
Image 47: Wardrobe door, fourth floor.

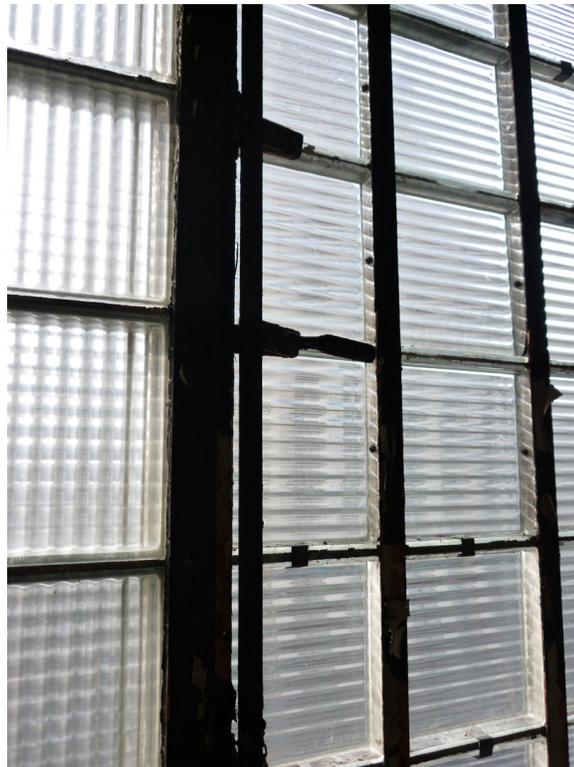
Image 49: Operable window, south end of east façade, typical of floors 3 through 6.

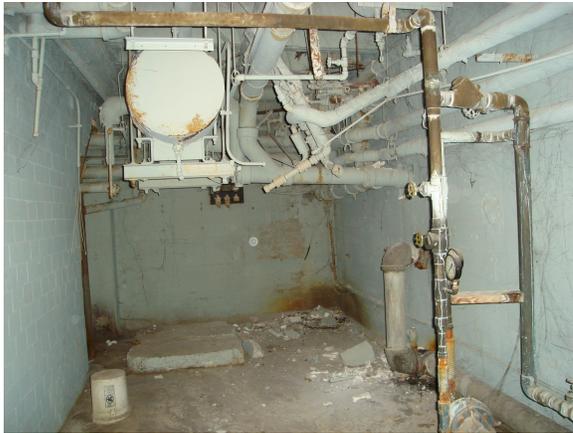
Image 50: Plumbing equipment, basement.

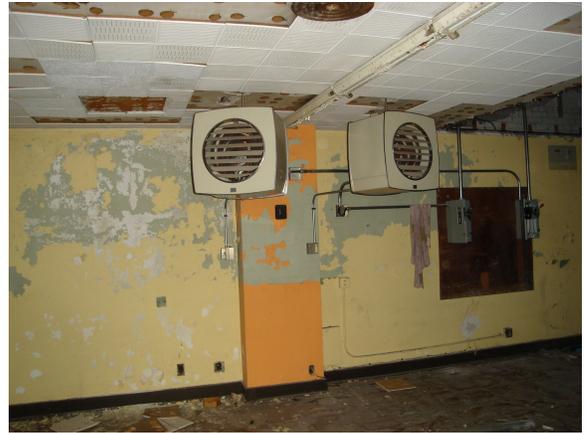
Image 51: Mechanical equipment, sixth floor.

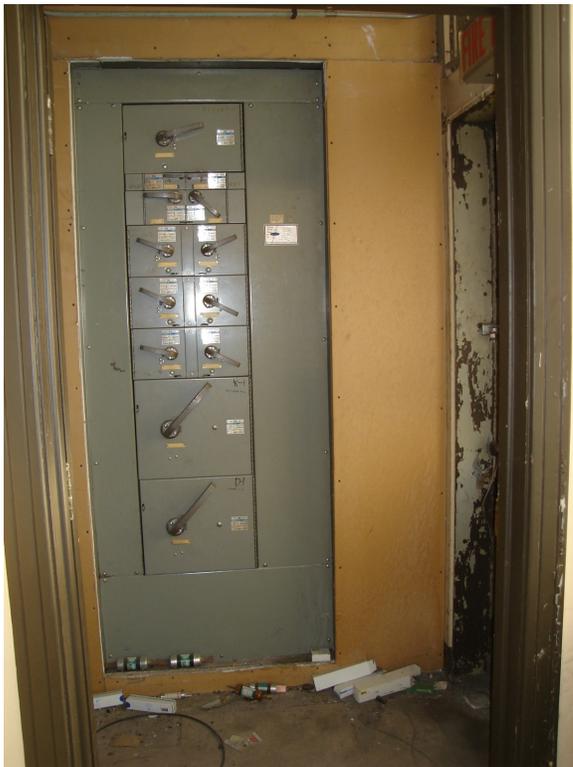
Image 52: Mechanical (elevator) panel, sixth floor.

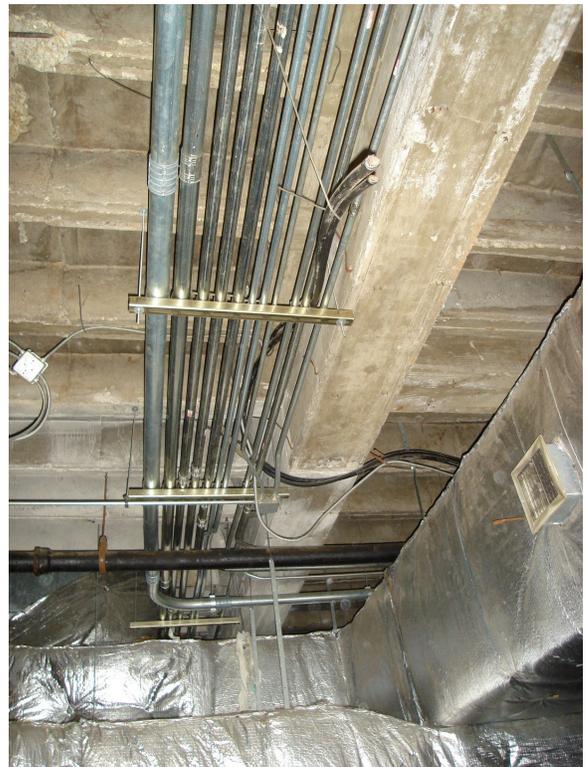
Image 53: Mechanical equipment, sixth floor.

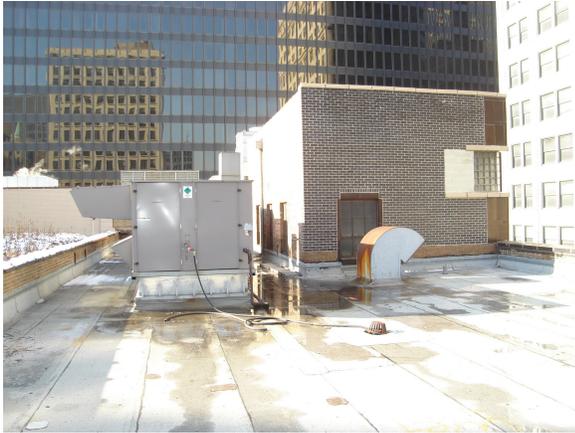
Image 54: Rooftop, view west.

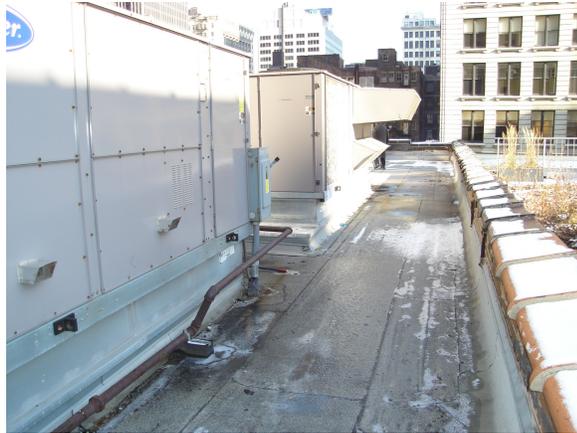
Image 55: Rooftop, view east.

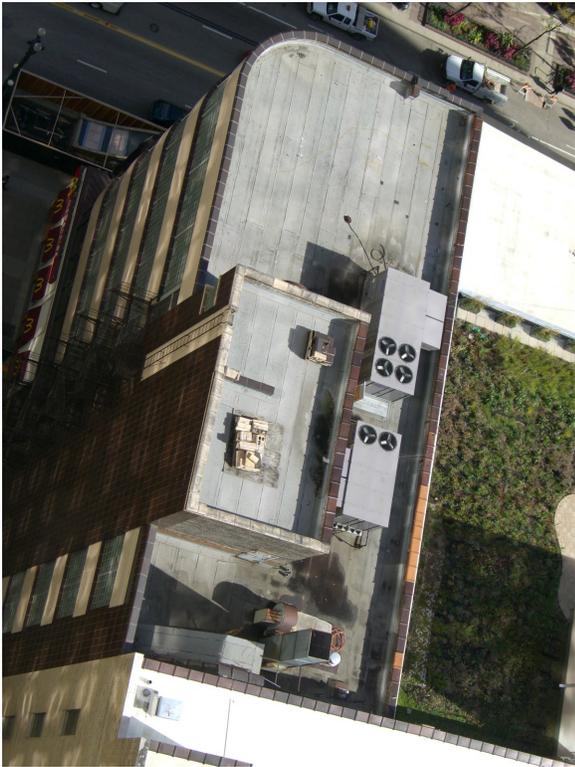
Image 56: Rooftop.

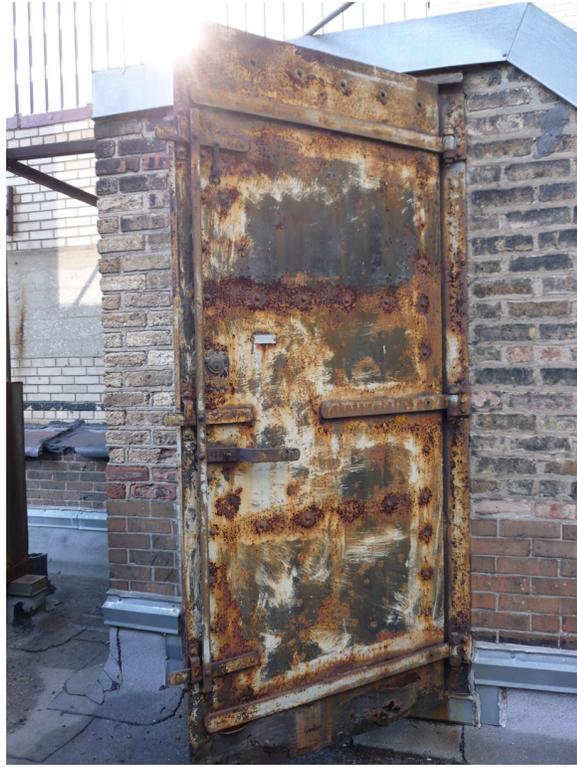
Image 57: Rooftop, door to west stair.
